Expansion of Research and Residential Facilities for The Swire Institute of Marine Science, Faculty of Science, The University of Hong Kong at Cape d' Aguilar, Shek O, Hong Kong Submission of Monthly Environmental Monitoring and Audit Report No.39

MONTHLY ENVIRONMENTAL MONITORING AND AUDIT (EM&A) REPORT (NO. 39)

Expansion of Research and Residential Facilities for the Swire Institute of Marine Science, The University of Hong Kong at Cape D'Aguilar, Shek O

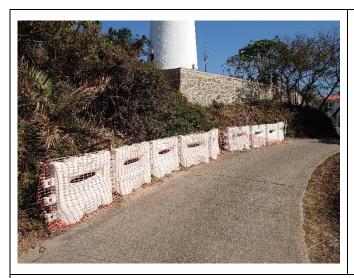
Observation - Item 1	
Observed 28 December 2020	Rectified by the Contractor on 04 Jan 2021
At site A and lighthouse, orange nets need to be replaced	Orange net is replaced

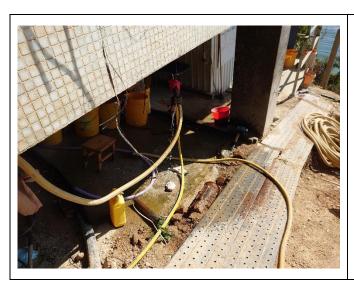
Observation - Item 3

Observed 28 December 2020	Rectified by the Contractor on 04 Jan 20201
At site F, water tap should be turned off when not in use. Runoff should be collected in a sedimentation tank and	Water tap is repaired and runoff is mitigated.
treated before discharging.

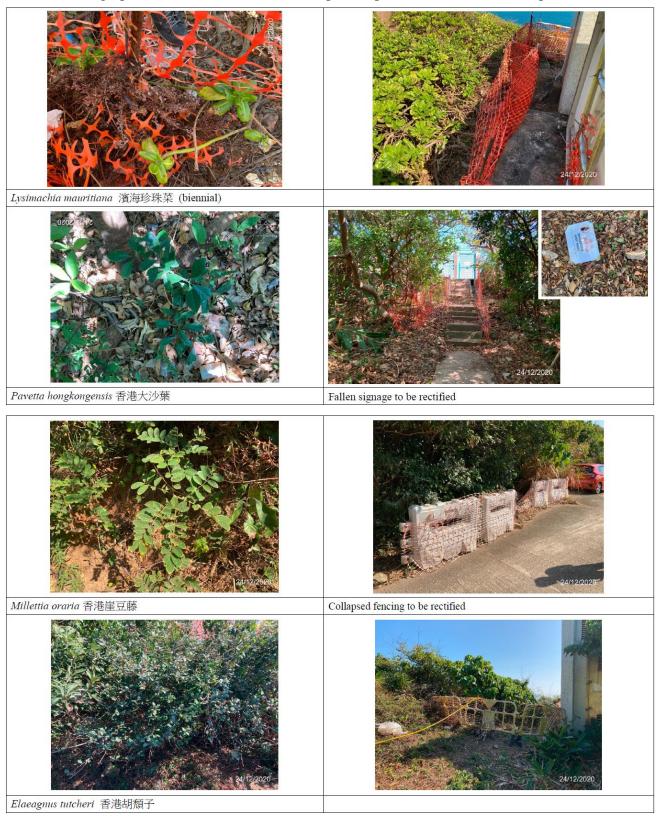
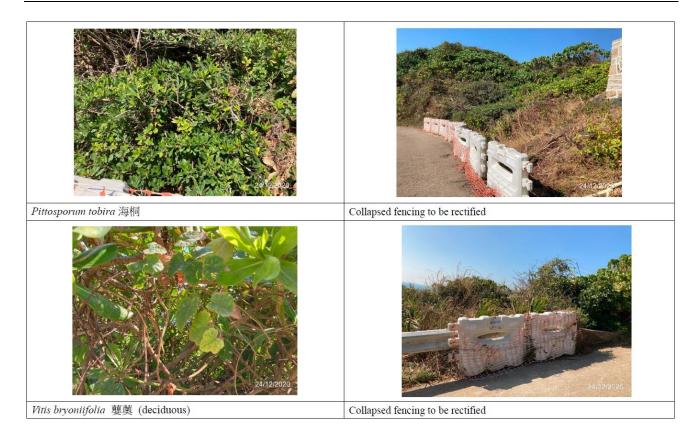
Plate 1. Photographic records of the six recorded plants species of conservation importance.

- 2.4.4. There is no change in form, health & structural condition and amenity value for all six recorded plant species of conservation importance.
- 2.4.5. Severe damage caused by Typhoon Mangkhut in September 2018 to the coastal vegetation remained. No Lysimachia mauritiana (濱海珍珠菜) could be observed in one of the protection zone near Academic Block (Site A) over 27 months. The original plants in this zone have certified as dead. The two rediscovered individuals and seedlings observed in vicinity have fruited during their end of biennial life cycle (Plate 1).

- 2.4.6. *Pittosporum tobira* (海桐) has shown slight dieback of twigs, with regeneration of young leaves. Invasive *Leucaena leucocephala* and *Lantana camara* within protection zone have been cleared together with other overgrown climbers.

- 2.4.7. Invasive species *Bidens alba* within protection zone of *Elaeagnus tutcheri* (香港胡頹子)has been cleared together with other overgrown climbers.
- 2.4.8. Most leaves of the deciduous Vitis bryoniifolia (蘡薁) has dropped.

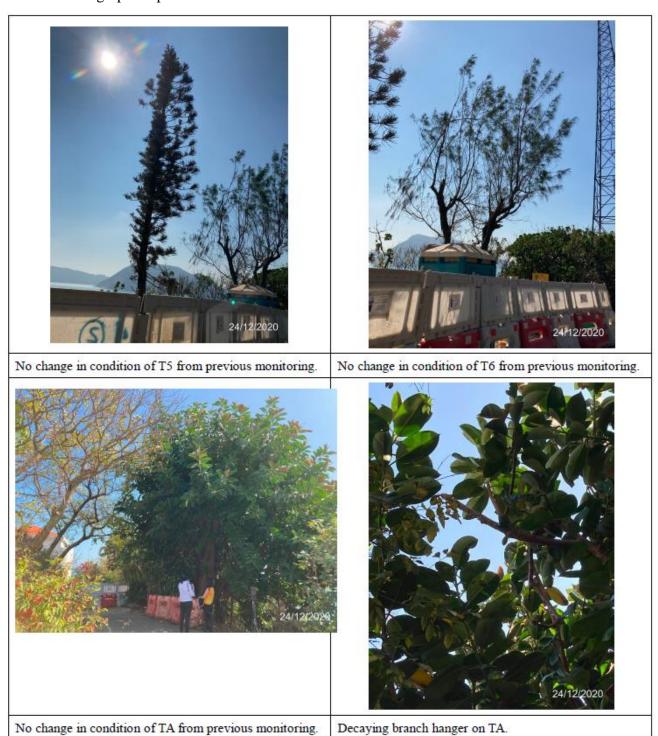
Plate 2: Photographic updates of the three retained trees that close to construction activities .

- 2.4.9. For the three retained trees, there is no change in overall condition of T5; while regeneration of new foliage made tree health of T6, as well as tree form of TA to be assessed from poor to fair. Broken branches in TA due to the typhoon damage should receive appropriate assessment and treatment. Corresponding photographic records of T5, T6 and TA are illustrated in Plate 2.

- 4.1.8. Broken branches in the retained tree TA due to the typhoon damage remained. Relevant authority shall be contacted for appointing a Certified Arborist or equivalent to conduct a Tree Risk Assessment (TRA) on this tree in order to get Lands Department's approval on taking corresponding actions (e.g. pruning). Once the TRA appointment is confirmed, good written

- and photographic records (e.g. personal, date and time, actions, etc.) should be made before, during and after any actions of treatment for the assessed tree (i.e. TA)
