## SECTION B – TRAIL AUDIT FINDINGS

## 8 TRAIL AUDIT FINDINGS

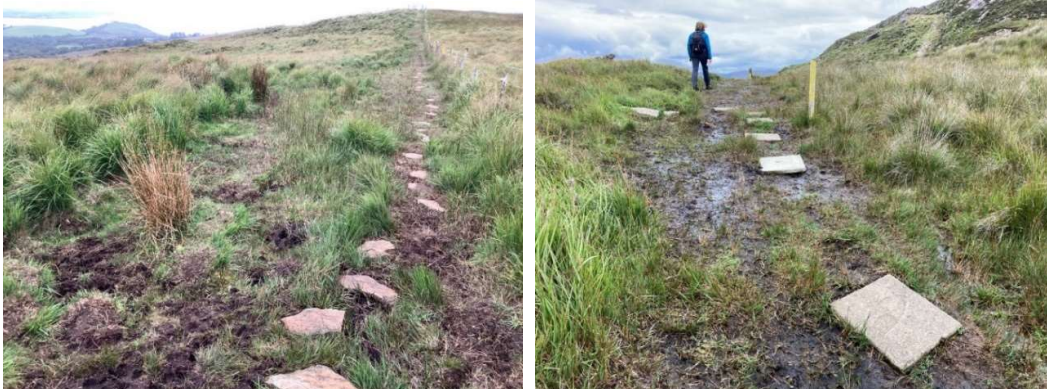
Construction across wet areas or deep peat has not been fully considered, which has left gaps in the built trail, and the use of individual stepping stones, rather than designed built trail, has not resulted in a functional path.

Figure 46 Use of stepping stones to traverse wet areas

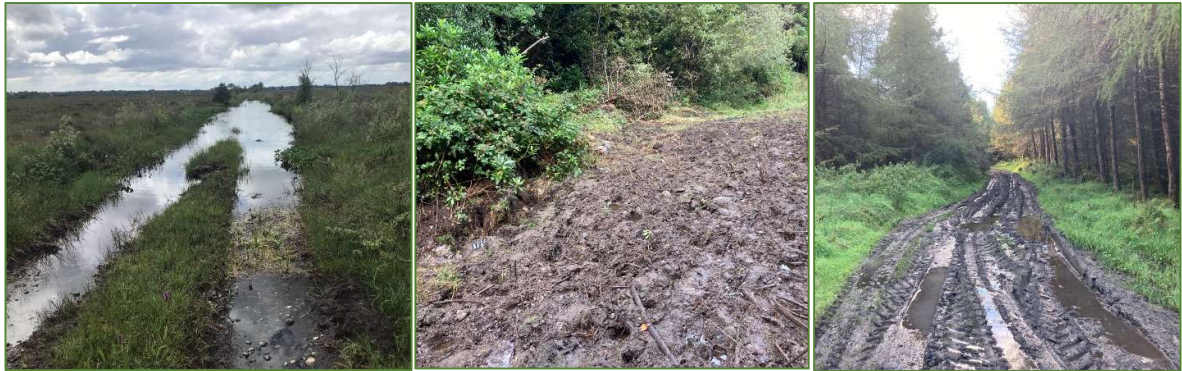
Figure 53 shows several sections of trail that are impassable due to poor drainage, poaching by livestock and damaged by vehicles.

*Figure 53 Poor condition trail - standing water, badly poached, damaged by vehicles*

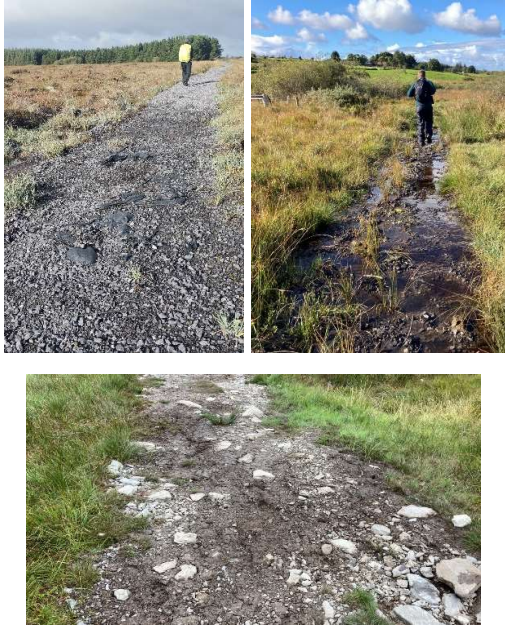
<p><b>Geotextile</b></p>	<p>Geotextile can be used to create sustainable trails, in situations where there is significant clay content in the soil (i.e. the soil is soft and 'sticky' when wet) and where the soil is very weak (i.e. it contains a lot of organic material such as peat).</p> <p>If the soil formation is hard or well drained and the sub-soil is granular with little or no clay content, a geotextile will not be required.</p> <p>The use of geotextile is only successful when combined with appropriate use of mixed gravel and dust subbase and finishing layer, along with compaction and settling techniques. Terram appearing through the gravel indicates that appropriate trail finishing techniques have not been completed.</p>

<p>Geotextile appearing through gravel, a gravel trail sinking where geotextile hasn't been used, gravel trail spongy and cracking where geotextile hasn't been used.</p>

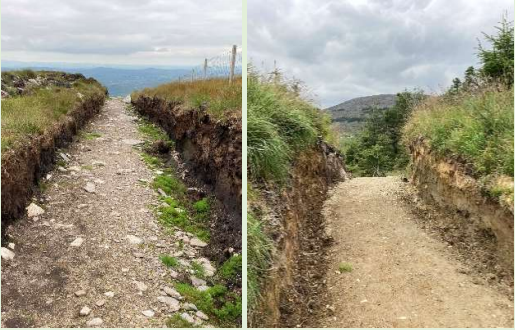
<p><b>Excessive removal of substrata</b></p>	<p>Sustainable trail build requires ground vegetation and topsoil to be removed to expose firm sub-soil and to form a formation tray for the trail to sit on.</p> <p>The depth of formation tray will depend on the strength of the sub-soil.</p> <p>Deep/ active peat should not be excavated to accommodate path construction due to its important properties in carbon sequestration.</p> <p>A sustainable trail will not cut through the landscape, but rather flow through the landscape.</p>

<p>Removal of peat and excessive removal of substrata to accommodate existing trail build on the BBW.</p>

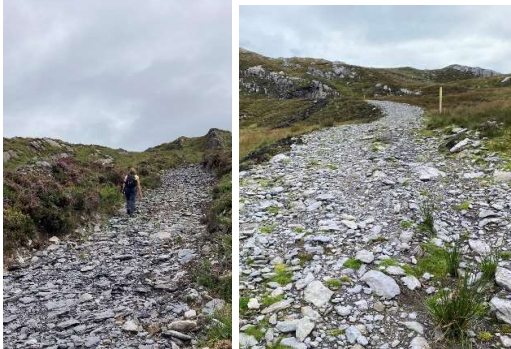
<p><b>Inappropriate trail width</b></p>	<p>Wider trails are required where vehicular access is necessary either for agricultural purposes or for emergency access. Where the purpose is walking only, unnecessarily wide trails detract visually from the landscape. See Section 4.3 for recommendations on trail width.</p>

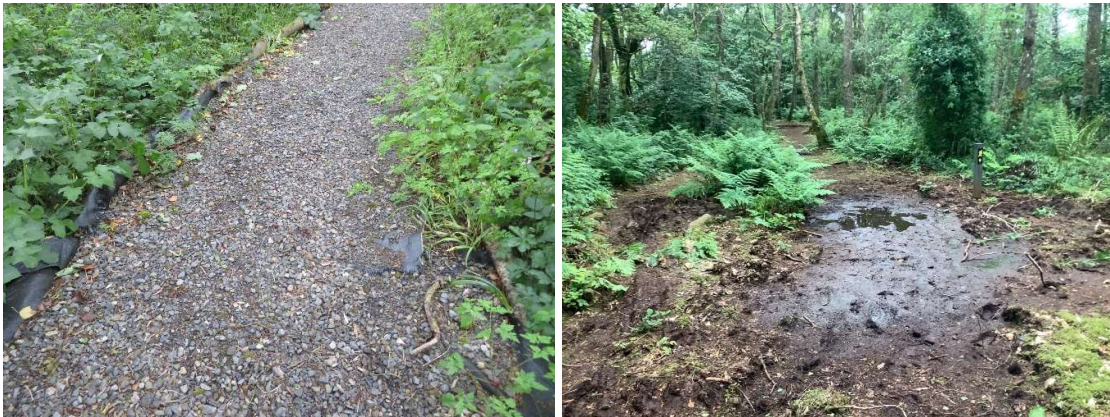
*Figure 74 Trail in poor condition on the Suck Valley Way*

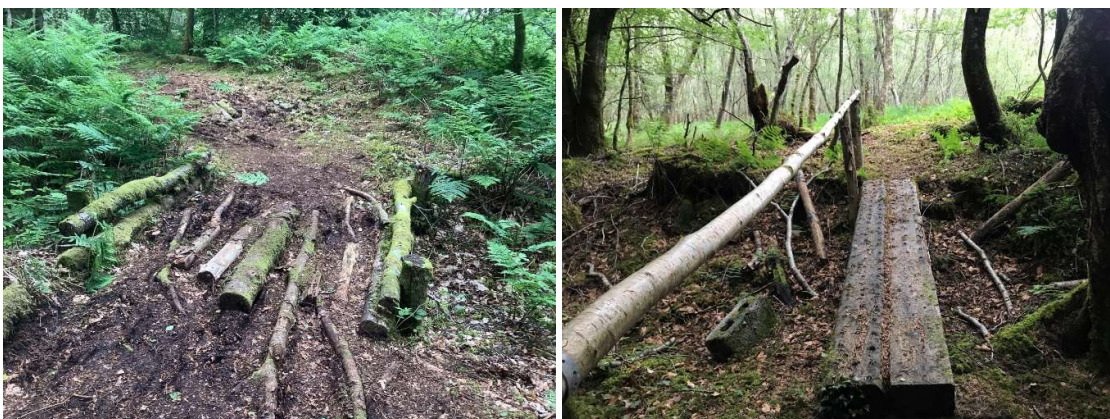
*Figure 75 Infrastructure not fit for purpose on the Suck Valley Way*

Wooden infrastructure should be replaced with durable metal or recycled plastic infrastructure such as bridges and A-frame stiles.

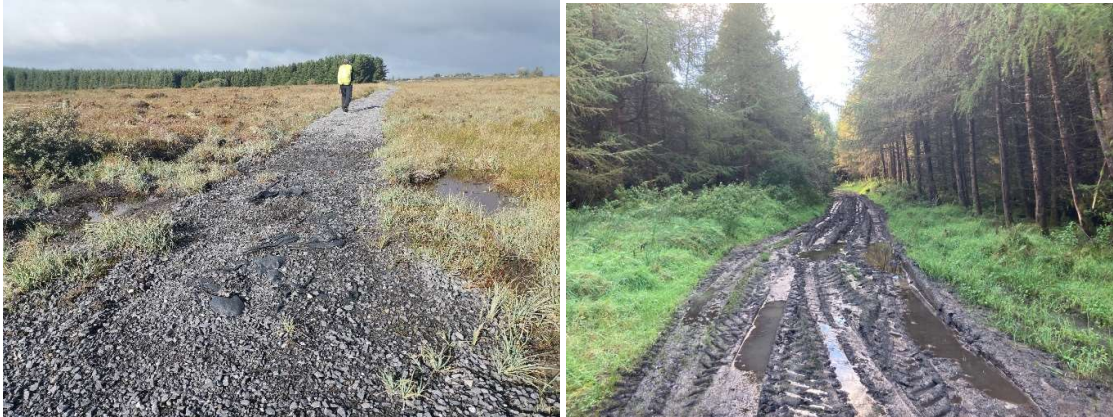
The Lung Lough Gara Way has not been part of the Walks Scheme and has not benefitted from landowners receiving payments to maintain the route on their land. The trail has been maintained in an ad hoc manner by local individuals, who have sourced funding independently. The route was submitted to the new round of Walks Scheme funding and was successful. Funding for trail maintenance and appointment of a RRO will be available in due course.

*Figure 78 Existing trail in poor condition on the Lung Lough Gara Way*

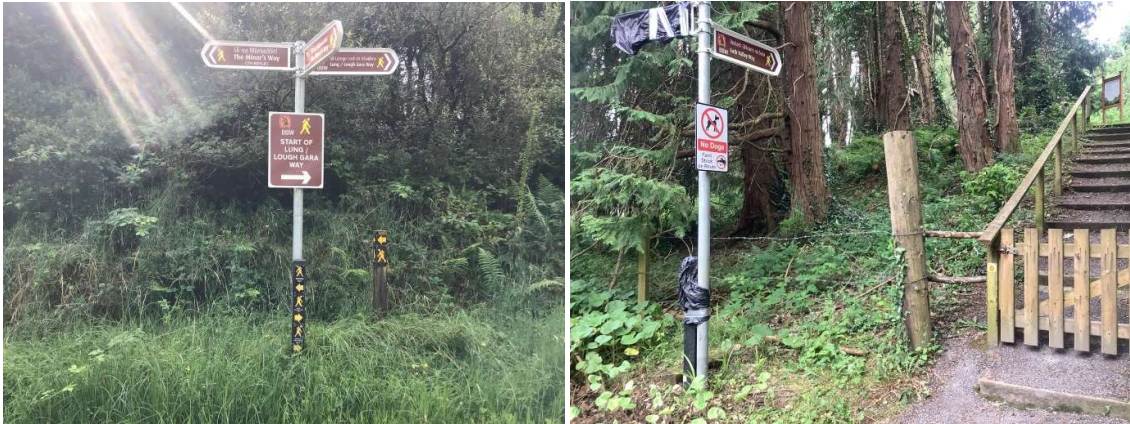
Waymarking for the BBW on the Lung Lough Gara Way section of the BBW is poor. The route is well waymarked using existing National Waymarked Trail signage, in this case, the Lung Lough Gara Way. But BBW signage is sporadic and the types of BBW signage varies between plate and finger post. At the time of audit, several Lung Lough Gara Way waymarker post arrows were taped over at several locations resulting in route confusion. The start of the route at Clonalis House also had taped over signage, again contributing to trail confusion (Figure 79).

Figure 79 Excessive and taped up signage on the Lung Lough Gara Way

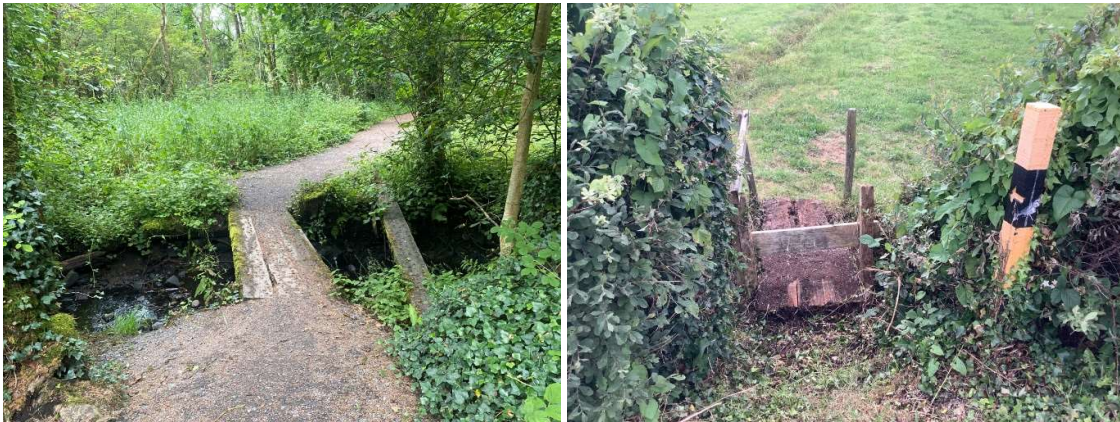
*Figure 83 Poor infrastructure on the Miners Way*

Wooden infrastructure should be replaced with durable metal or recycled plastic infrastructure such as bridges and A-frame stiles.
