Final archaeological report

**St. Marnock's Church
Burrow
Portmarnock
Fingal**

22E0601

7 November 2022

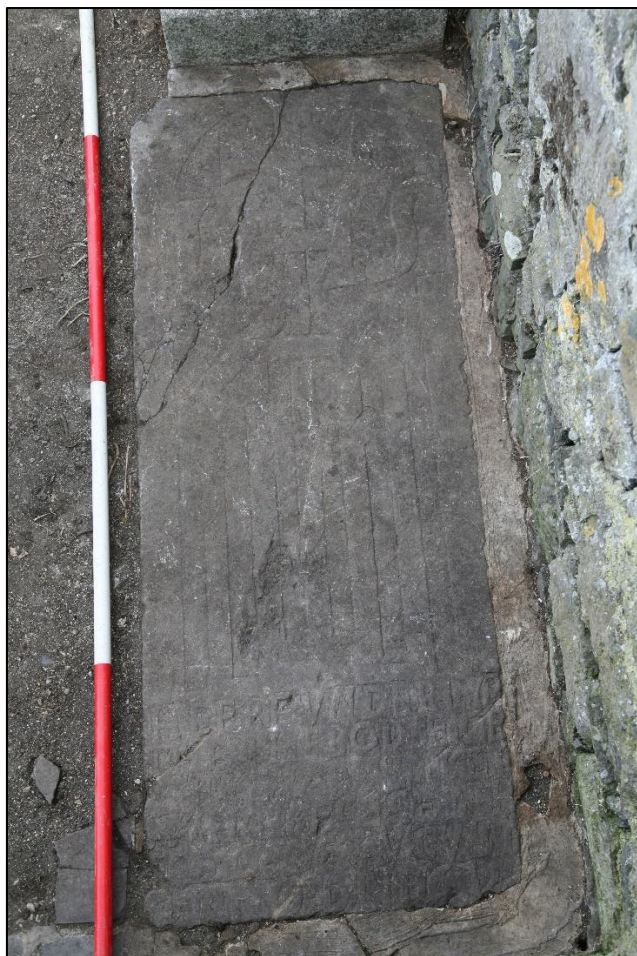
- 3.2 Prior to the erection of scaffolding on the eastern gable, the overgrowth was removed from the chancel and the area was cleaned-off, planned, levelled and photographed (Figure 8, Plates 3-6). In the southeastern corner the *ex situ* monument to Teresa Plunkett was recorded which comprised a limestone memorial (L: 1400mm; W: 550mm, orientated north-south, Plate 7; No. 5 on Figure 8). The monument was set into the ground (probably on a bed of lime mortar visible at the sides), with some cracking (from top centre to centre western side), and was otherwise intact. The monument does not appear to have been recorded by Paddy Healy (who had photographed the Barnwall memorial) and it may have been obscured at the time or was simply illegible. It would appear to have been placed in its present position c. 1862 when the table tomb was erected for John William Plunkett.

Plate 7 Teresa Plunkett memorial

Of more immediate concern is the presentation of the Barnwall memorial and the newly recovered Plunket slab, both of which are vulnerable to damage at their present locations. It is recommended that they both be taken up and affixed to the north wall of the chancel, without obscuring the blocked ope. The remaining funerary monuments can then be stabilised and the surface relaid using the existing slabs.

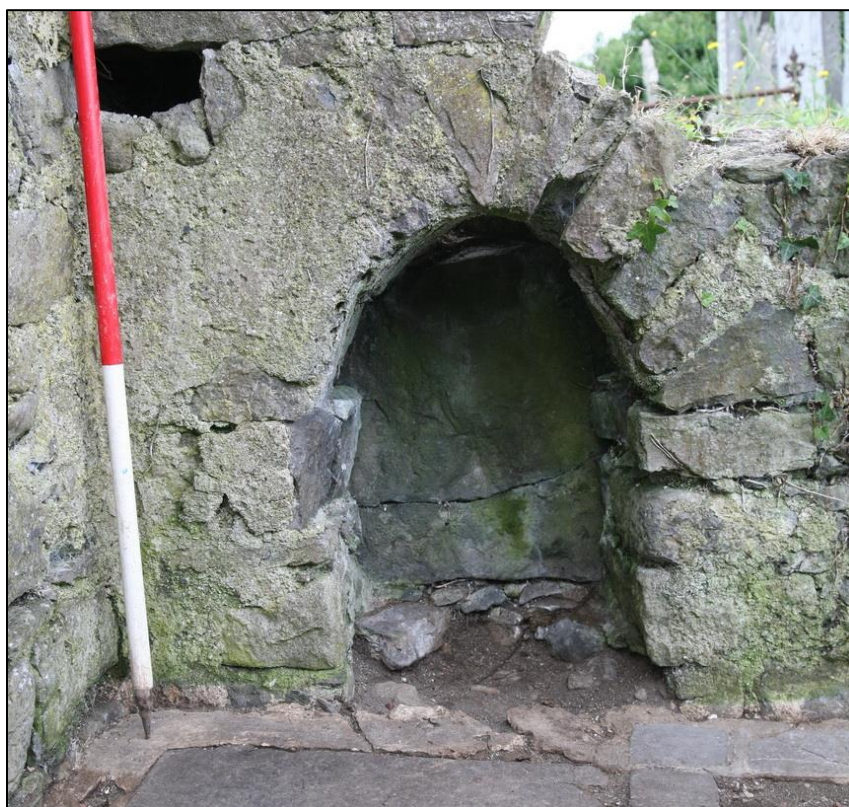
3.3 The piscina was cleared out of loose material and roots (Plate 8) where it was found that elements supporting the base of the font were still *in situ*. A large section of masonry missing from the wall above resulted in a void appearing to the rear of the arch. The wall was carefully rebuilt to the required level, ensuring that no damage accrued to the feature.

Plate 8 Piscina after clearance

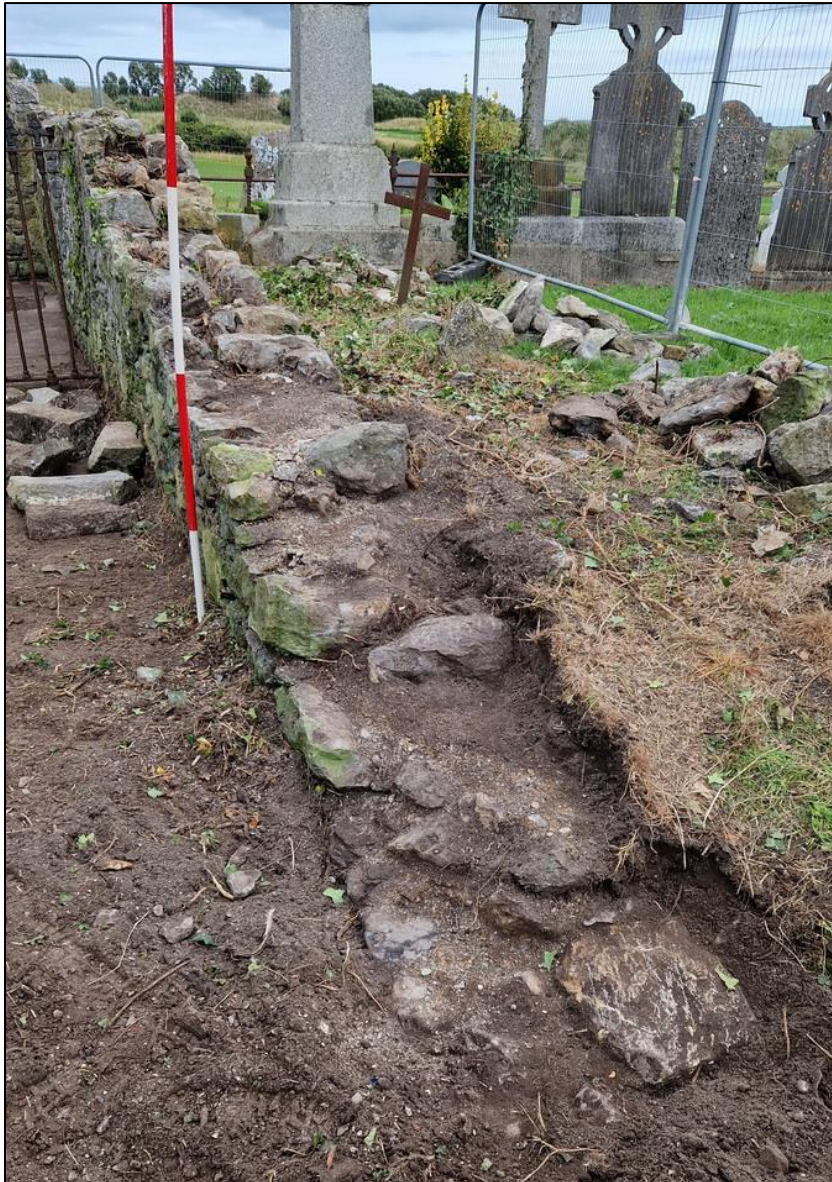
3.4 The wall to the east of the entrance was rebuilt in loose unmortared rubble to a relatively fair face. The rubble was removed by hand to a point where solid masonry was encountered (Plate 9). The mortar here was very different to that exposed elsewhere on site. It was yellow in hue and very gritty to the touch with inclusions of small pebbles and marine shell and very similar to medieval bonding mortars recorded on excavations in the city. Where there was no further masonry encountered at this level it is likely that this constitutes the primary eastern reveal of the entrance.

Plate 9 East entrance reveal after the removal of rubble

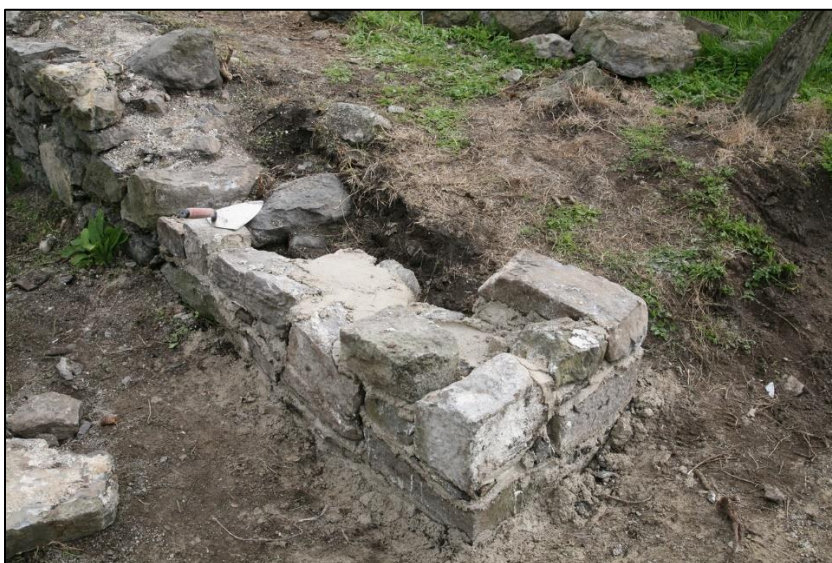
Plate 10 East entrance reveal under reconstruction

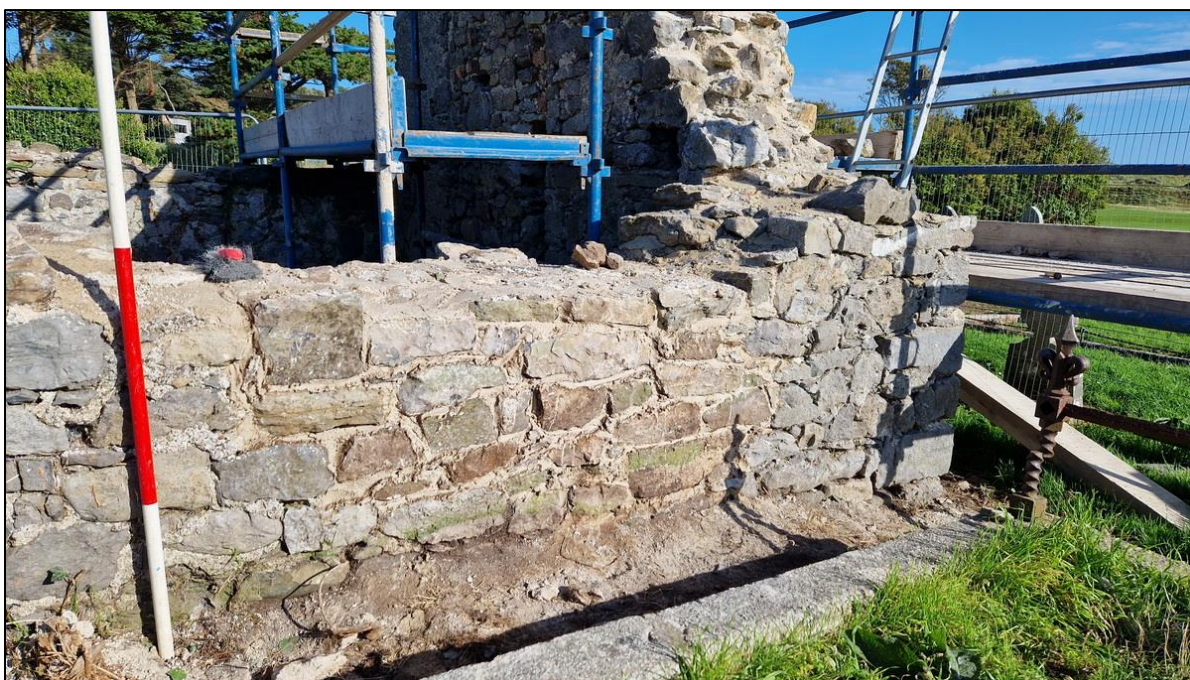
As referred to above, a considerable quantity of masonry had been removed over the area of the piscina further east. It is possible that the failure was a function of an ivy root growing up through the southeastern corner of the church which was removed without further disturbing the masonry. The area where the masonry had collapsed was then rebuilt in keeping with the style of the primary masonry (Plate 11).

Plate 11 Reconstructed section of masonry over piscina

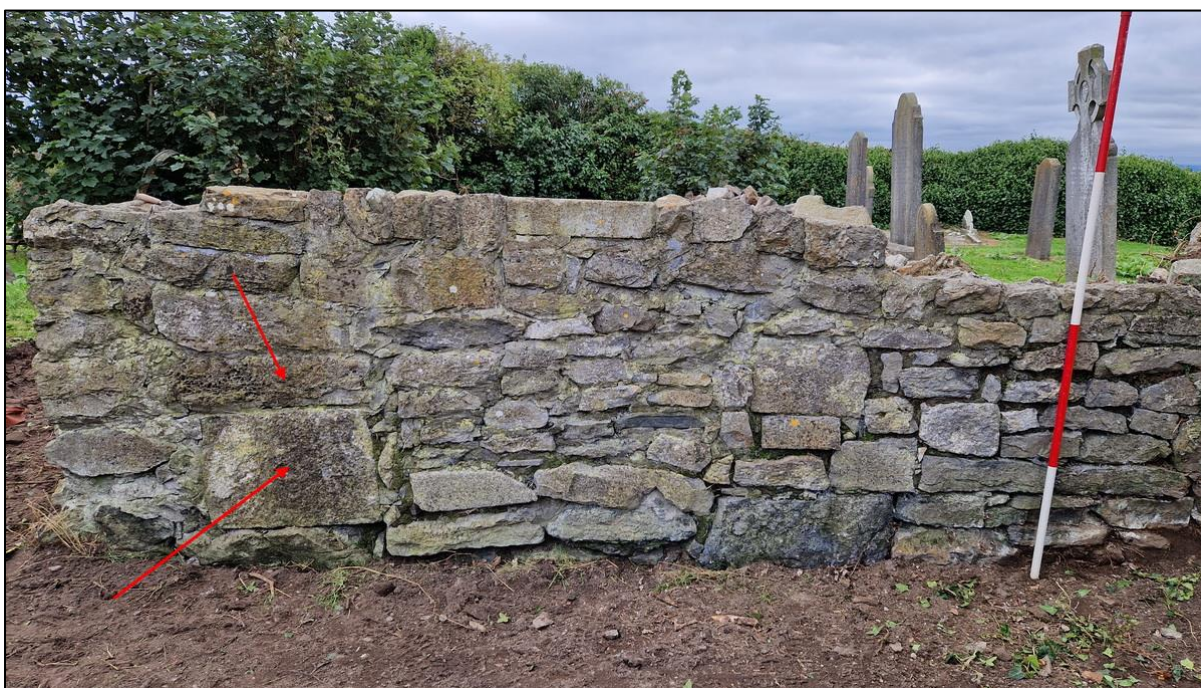
West of the entrance two fair faces had been reconstructed from ground level and the resultant void backfilled with loose rubble (Plates 12 and 13). The rubble was removed prior to the consolidation of the wall to investigate its stability and it was found that two pieces of architectural stone had been used in the reconstruction of the interior wall (Plate 14). One was a cill identical in design to that recovered from the rubble (22E0601:8) where below this was a large flat rectangular stone, similar to 22E0601:3, also recovered from the rubble.

Plate 12 Interior south wall, previous reconstruction work west of entrance. Reused architectural stone indicated

It was decided to retain the rebuilt section of wall and to consolidate using a lean-mix poured into the void, stitched across with helibars. The top of the wall was then flanchued to arrest water ingress (Plate 15).¹⁶

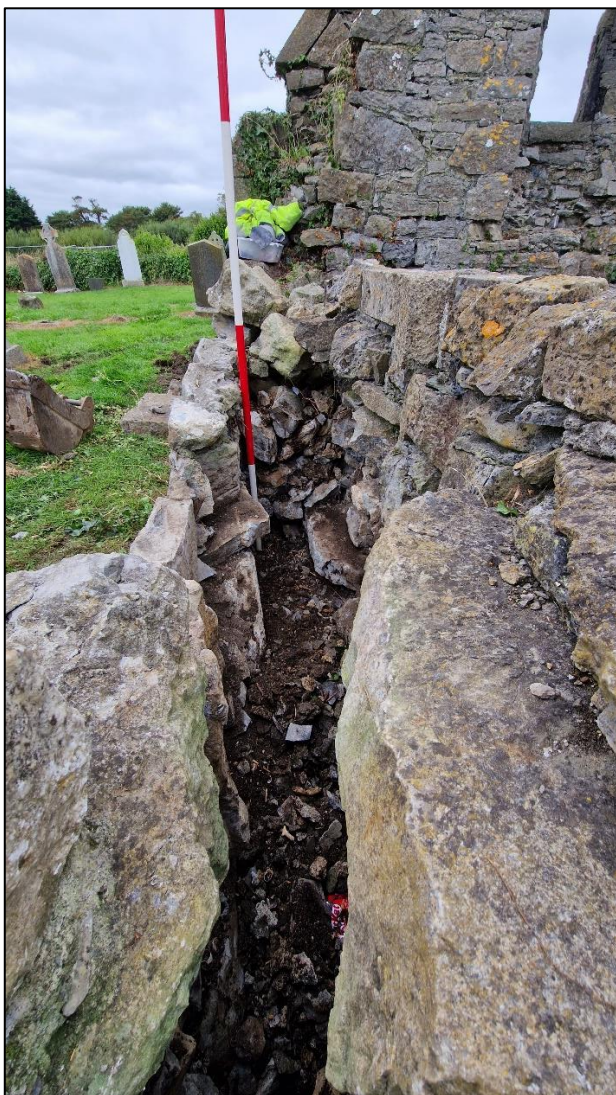
Plate 13 Void within south wall, west of entrance

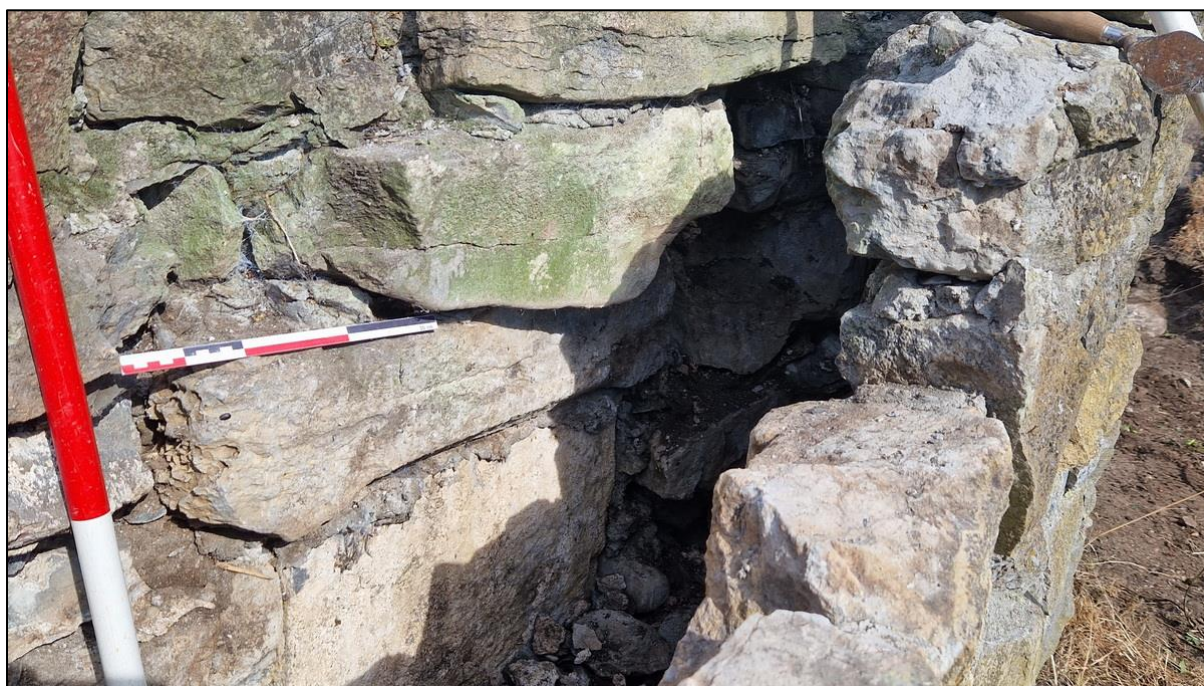
Plate 14 Cill rebuilt into south wall (below small scale), with larger stone directly below

- 4.4 Consideration should also be given to reconstructing the interior cill in the west gable, where several *in situ* stones indicate the primary slope. This could be undertaken with some more consolidation work at the junction of the west gable and the lateral walls.

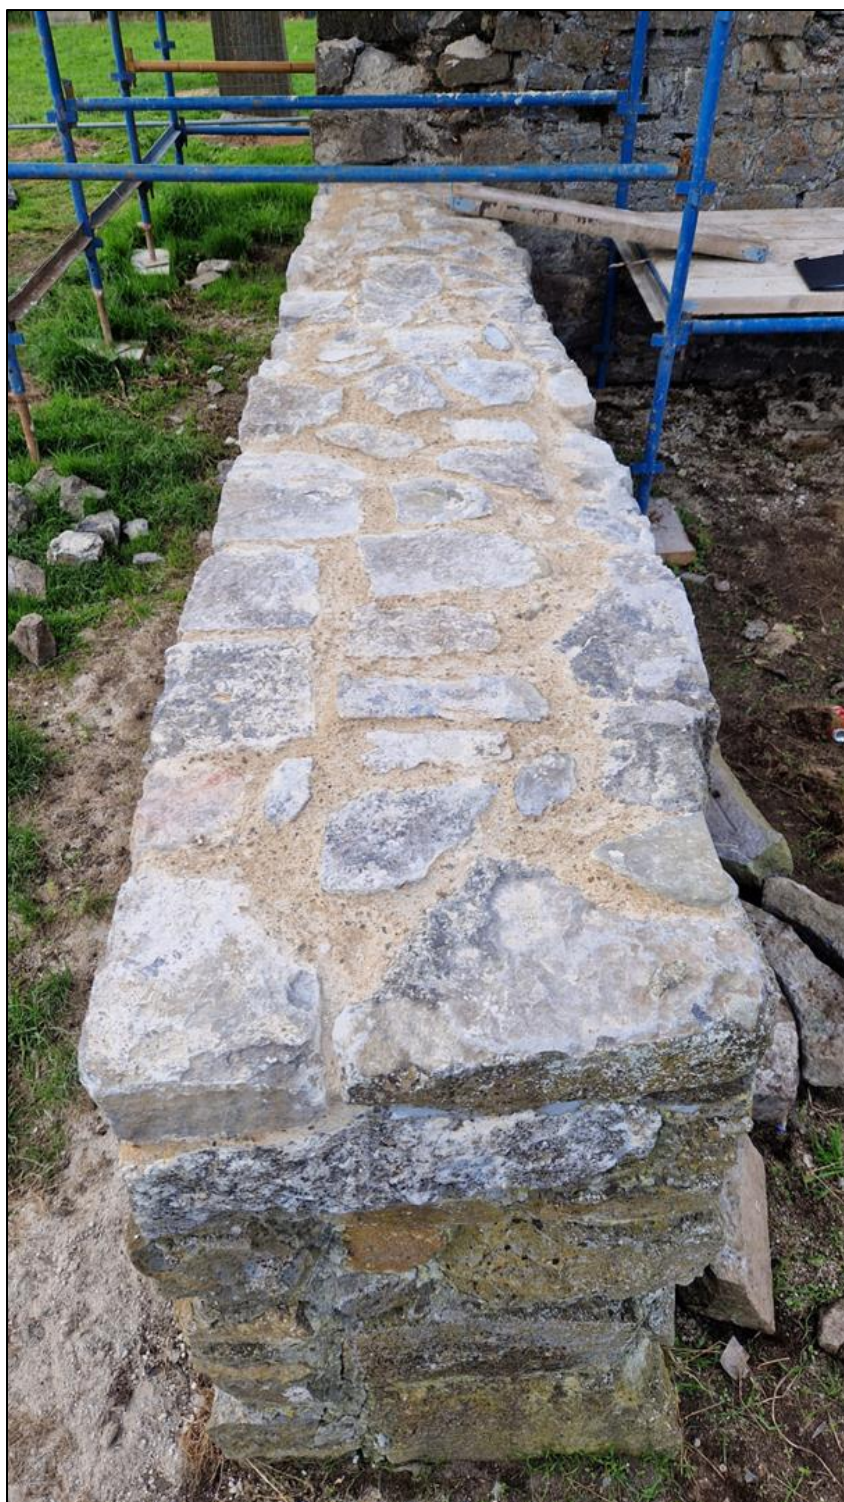
Plate 15 South wall west of entrance after flaunching

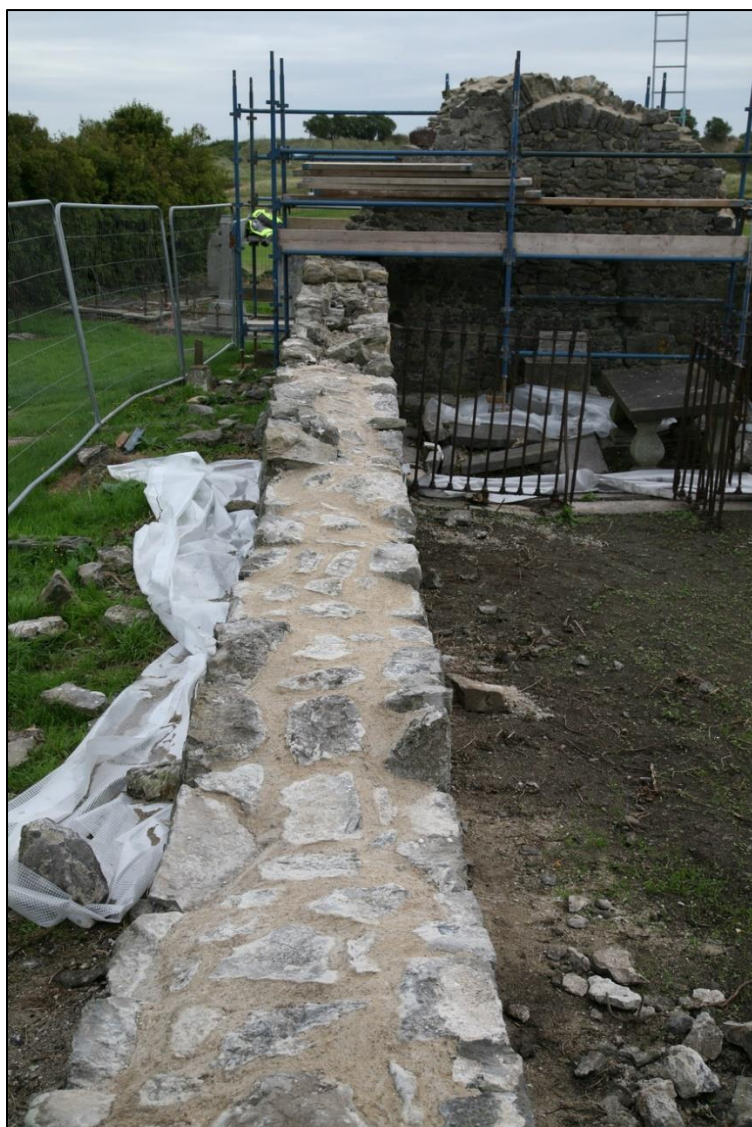
3.5 The western section of the northern wall had been rebuilt in a similar fashion, however the stones within were better compacted and there was no necessity to provide further internal structural support. Here, the junction between the primary masonry and the work undertaken c. 2010 was better defined and there was less repointing required. The wall tops were flanché where there was less rebuilding required than on the wall opposite (Plate 16).

Plate 16 North wall after launching

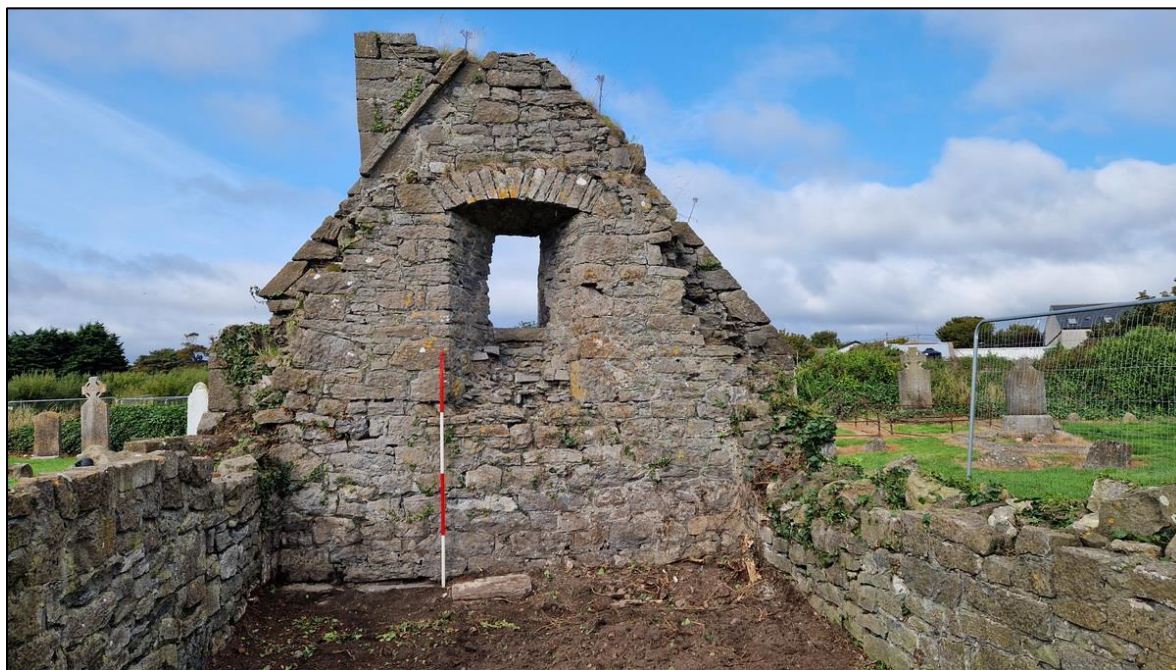
The head of the small window in the western gable was cracked and underwent invisible repair work which involved the insertion of a steel bar. The sloping cill below was consolidated but not rebuilt, where there survived *in situ* stones suggesting the angle of the slope.

Plate 17 West gable after removal of rubble and ivy
