VAPOUR CLOUD EXPLOSION AT THE IOC TERMINAL IN JAIPUR

D.M. Johnson, GL Noble Denton, Loughborough, Leics, LE11 3GR

At approximately 6:10pm on 29th October 2009, a leak of gasoline occurred on the Indian Oil Corporation's (IOC) Petroleum Oil Lubricants Terminal at Jaipur, India. This leak continued for some 75 minutes, when the vapour cloud ignited, resulting in a severe vapour cloud explosion (VCE), eleven fatalities and many tank fires. The sequence of events and cause of the spillage were investigated by an independent Indian committee. However, the VCE in the Jaipur incident shared a number of characteristics with the VCE at the Buncefield terminal in the UK in December 2005. Given these similarities, evidence related to the Jaipur VCE was collected by the author over a three day period at the site during February 2010, at which time much of the evidence on the site was relatively undisturbed. The combination of the evidence from the two incidents, supported by information from a small number of previous incidents, provides both an indication of the VCE potential for dense vapour clouds and the nature of key forensic evidence that is likely to be observed following such events.

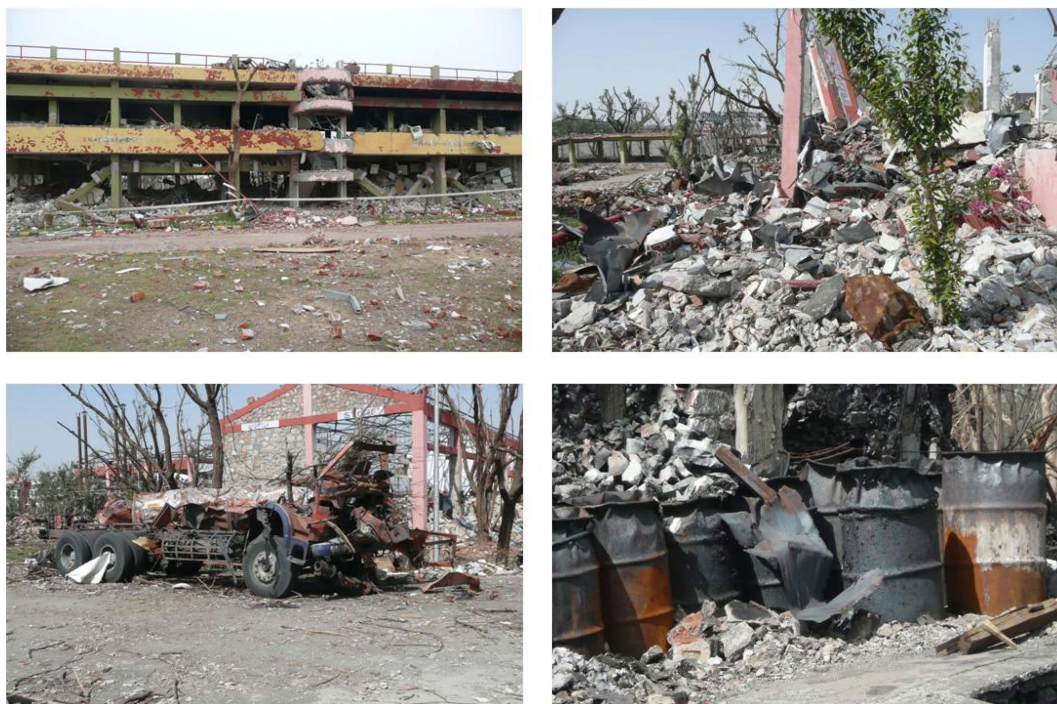
Figure 2. Examples of Onsite Pressure Damage

The incident on the IOC Jaipur terminal involved widespread severe pressure damage over almost the entire site. This evidence included overpressure damage to buildings, storage tanks, vehicles, steel drums and steel boxes. Examples of the damage observed are given in Figure 2. This shows damaged buildings, steel drums crushed down to their liquid level and a severely damaged road tanker.

Much of this evidence has a close similarity to the evidence observed in the Buncefield incident, and the investigation of that explosion indicated overpressures of at least 200kPa and probably significantly in excess of this level. The evidence from Jaipur indicates that the vapour cloud explosion generated these high overpressures over most of the IOC site.

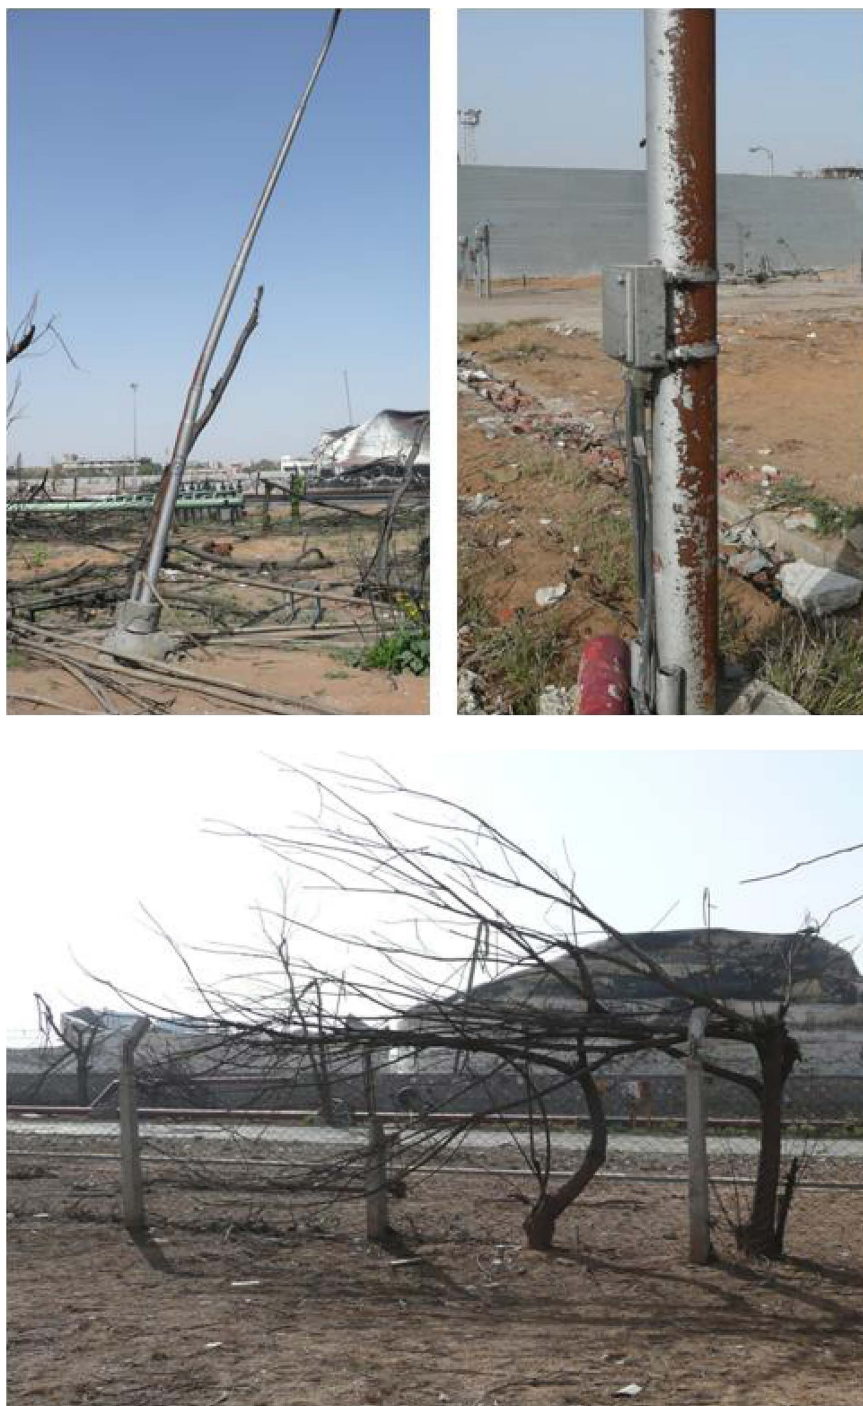
Figure 3. Examples of Directional Indicators

The directional indicator evidence was again very consistent with that observed at Buncefield. Examples of directional indicators are shown in Figure 3.

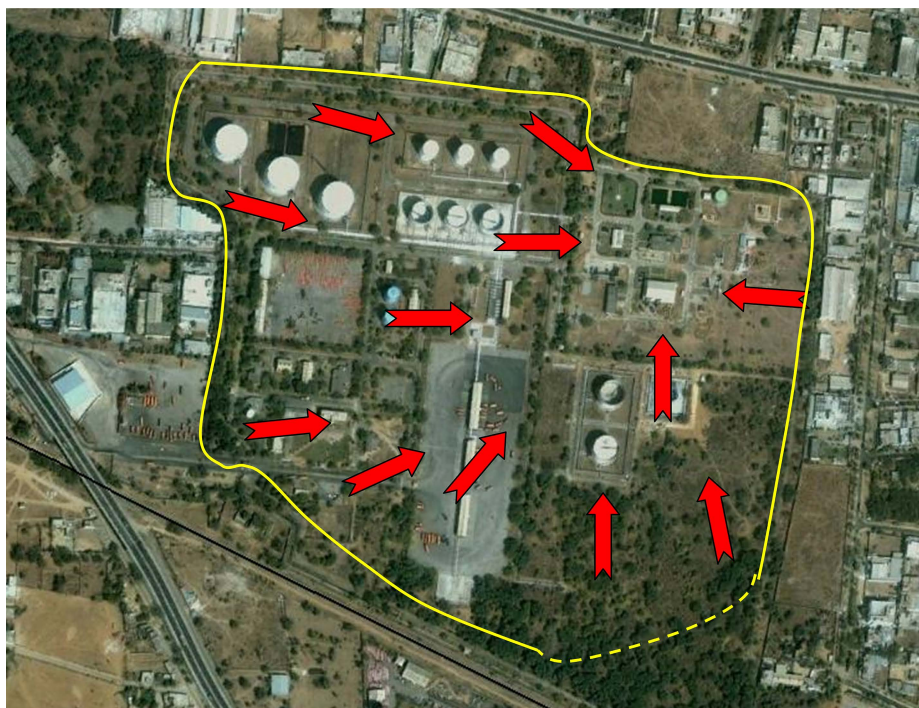
Figure 4. Overview of Directional Indicators and Estimated Cloud Boundary (yellow line)

The measurements were collated and a summary of the information within the flammable vapour cloud is shown in Figure 4, where the arrows indicate the approximate direction for each area of the site. Many of the indicators were in open areas, which is again inconsistent with the vapour cloud explosion being as a result of a deflagration only as a high pressure deflagration would not be sustained

in an open area. They are consistent with a detonation however.

The directional indicators point towards the Pipeline Division area, indicating that it was in this area that any detonation initiated.

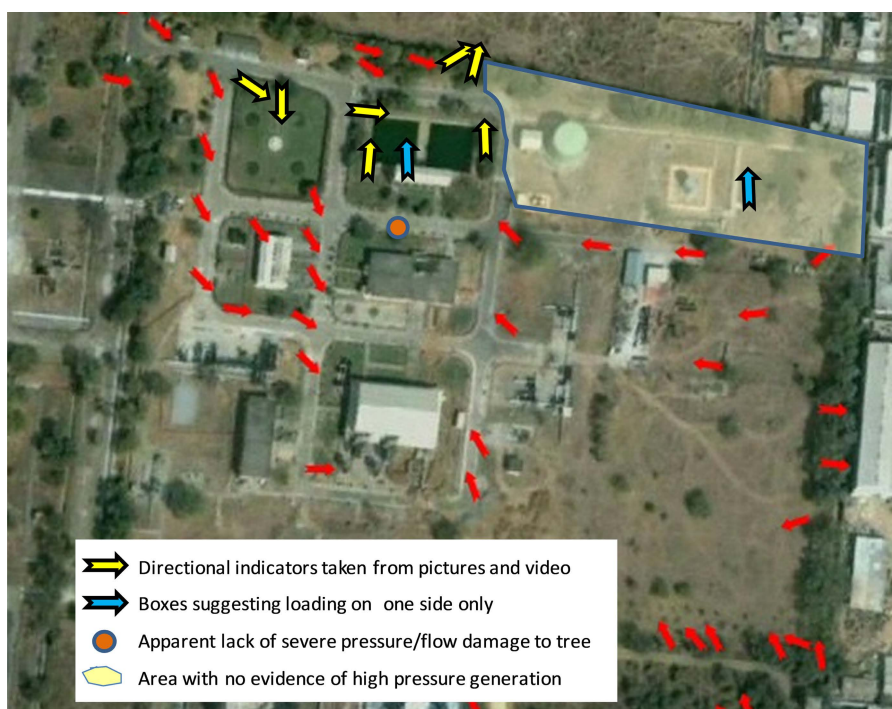
Figure 5. Directional Indicators in the Pipeline Division Area

Figure 5 shows the detailed directional indicators measured in the Pipeline Division area during the site visit

in February (red arrows). Directional indications from two instrument boxes that appear to have been exposed to a directional pressure loading only are shown as blue arrows. In addition, it can be seen that on the east side of the site, some directional indicators point 'outwards', suggesting they were outside the flammable cloud. Also shown are the positions of the tree that did not appear to have suffered severe pressure/flow damage.

There was also an area where a flammable cloud appeared to have been present but where there was no significant pressure generation. This has been marked in yellow on the figure.

Unfortunately, the Pipeline Division was the one area of the site that had been cleared of debris, so much of the evidence had been destroyed. As a consequence the information had to be supplemented by photographic and video material taken before the clearance work was started. Directional indicators taken from this earlier material are shown as yellow arrows.

It seems likely that a flammable cloud was present in the yellow shaded area at the time of the explosion as the trees along the section of the north wall to the east of the green firewater tank were all fire damaged. In addition, there was no particular change in the ground level to in the vicinity of the green firewater tank that would have prevented the vapour cloud from spreading into this area.

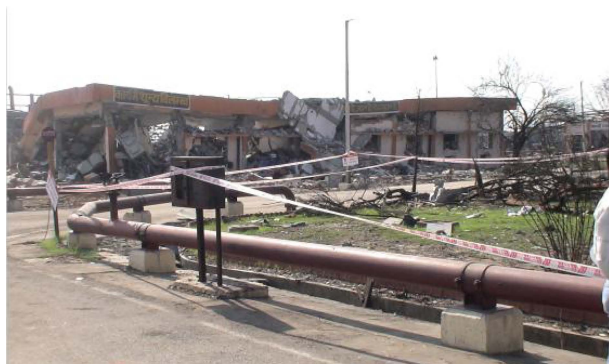
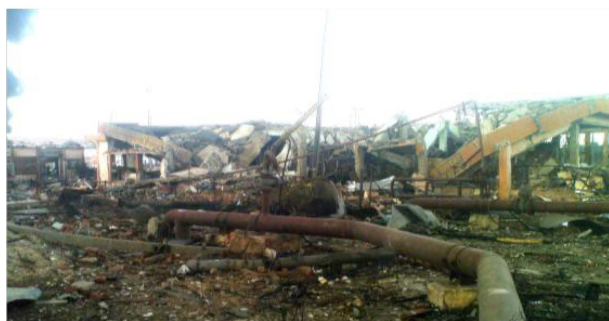
Figure 6. Control Room in Pipeline Division Area (top picture from north, bottom picture taken from south)

The damage to the control room is shown in Figure 6. Damage to the north side of the building was less severe than that on the south side of the building, where there was complete collapse of the building. The building gives the appearance of having been 'squashed' down on the south side.

- It appears to provide a dividing line between high pressure damage to the south and a lower level of damage on the north side. This is also supported by the apparent lack of damage to the tree on the north side of the control room, as indicated on Figure 6.
- The collapse of the roof downwards on the south side does not initially appear consistent with an internal explosion that vented out from the south side building. It might be expected that an internal explosion would have blown the roof upwards and away from the building. However, it is possible that the concrete roof would have had sufficient inertia such that it did not have a chance to move significantly during an internal explosion. If the

flame venting from the building then resulted in a transition to detonation, the high external pressure could have pushed the partially failed roof downwards. In the absence of any further evidence, however, though this explanation could be considered to be physically plausible, it must be viewed as speculation.
