Analysis of Train Derailment in Collision with a Road-Rail Vehicle in the Station Yard of Kawasaki Station

A deadhead train collided with road-rail vehicle at Kawasaki station on the Keihin-Tohoku line in 2014, resulting in the 1st car being damaged and the 1st and 2nd car overturning. Damage was severe, even though the lead car of the train was designed to absorb the impact of a collision with a dump truck at a level crossing. We therefore investigated the cause of the damage by inferring the situation from collision to overturning from traces found on the train cars, road-rail vehicle, and track. From that, we studied improvements that could be made to safety in collisions similar to this accident.

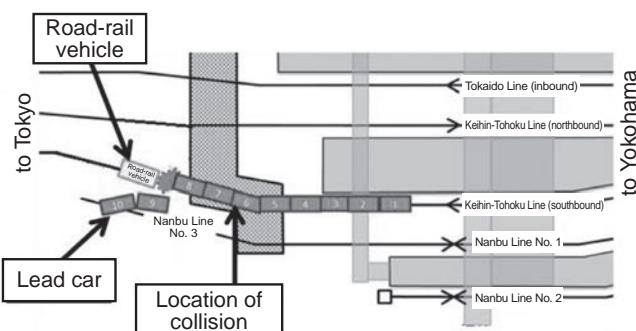
Fig. 1 Plan of the Yard of Kawasaki Station

At 1:11 a.m. on February 23, 2014 (Sun.), the driver of a Keihin-Tohoku Line deadhead train consisting of ten series E233 EMU cars found a road-rail type construction carrier vehicle (hereinafter, the “road-rail vehicle”) approx. 100 m ahead while cruising in the station yard at approx. 65 km/h. He immediately applied the emergency brake; however, the train collided with the road-rail vehicle, causing derailment of the lead car (car No. 10) and the second car (car No.9). The train halted with the lead car overturned left of the direction of travel and the second car at an approx. 45° angle left of the direction of travel (Fig. 1).¹⁾

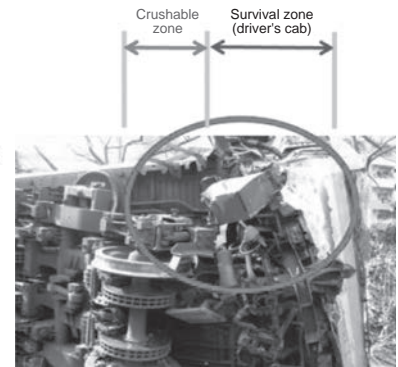
Fig. 3 Damage to Lead Car

As a measure against collision with a dump truck at a level crossing (Fig. 2),²⁾ the lead car that collided with the road-rail vehicle was designed to have a crushable zone that would intentionally deform to absorb impact energy and a survival zone that would reduce deformation in order to protect the crew as well as a shock absorbing coupler between that car and the second car.³⁾ Nevertheless, the collision severely damaged the front and the underframe of the lead car, and the survival zone was greatly deformed while the crushable zone was not deformed much (Fig.3). On top of that, the car overturned.

The positions of the lead car and the road-rail vehicle relative to each other (Fig. 4) suggest the process by which the front of the lead car was severely damaged on the right side in the direction of travel (Fig. 3) is as follows. First, the end beam of the lead car impacted the road-rail vehicle at a position inside of the side beam (Fig. 5-1). The collision caused damage to the corner post of the car (Fig. 5-2) and consequently buckled the side beam of the lead car outward. In such a collision, impact energy conveyed to the crushable zone behind the end beam should have deformed that zone; however, the buckled side beam probably deformed the survival zone instead of the crushable zone in this collision.

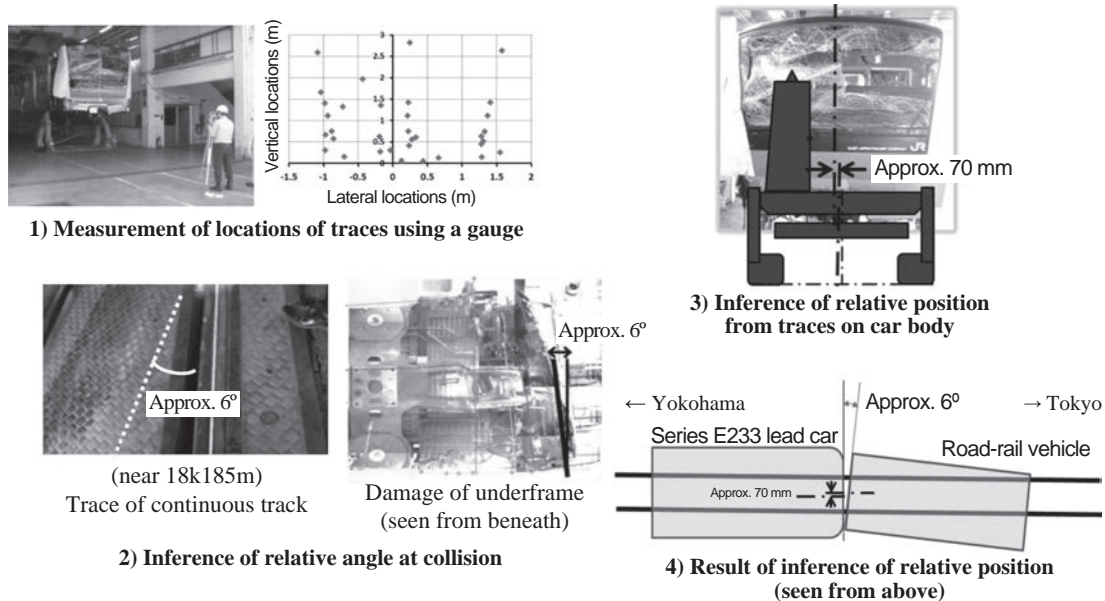
Fig. 4 Inference of Relative Position at Collision

In order to identify the positions of the lead car and road-rail vehicle relative to each other at the collision, we inferred the relative angle between the car and the road-rail vehicle (Fig. 4-2) from traces on the car (Fig. 4-1) and track and damage to the underframe of the lead car. Our conclusion is that the lead car collided with the road-rail vehicle at an angle of approx. 6° with an offset of 70 mm between the ends of centerlines of the lead car and the road-rail vehicle (Fig. 4-3, 4).

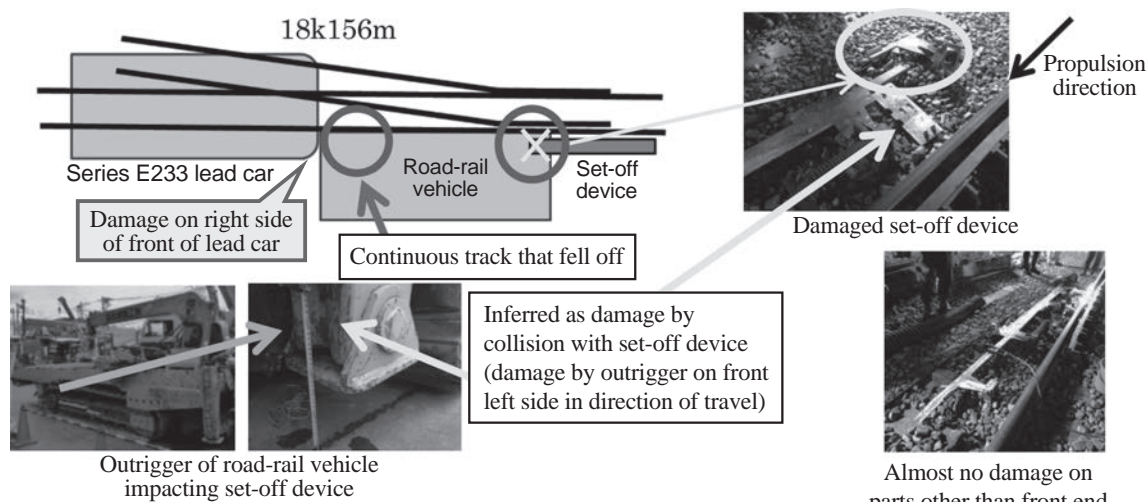
Fig. 6 Inference of Situation Immediately before Collision

Damage to the track suggests that the process from collision up to overturning of the lead car was as follows. The road-rail vehicle was located on the right side of the train in the direction of travel as shown in Fig. 6. The buckled side beam of the lead car (Fig. 5-3) propelled the road-rail vehicle along the track, and subsequently, an outrigger of that vehicle hit a set-off device placed on the right side of the track. The travel of the road-rail vehicle was blocked and that lifted the rear part of that vehicle and the front of the lead car, causing the car to overturn at the same time. It is inferred that, due to breakage of the car body between the corner post and the side beam, the road-rail vehicle impacted the side of the lead car that began overturning.

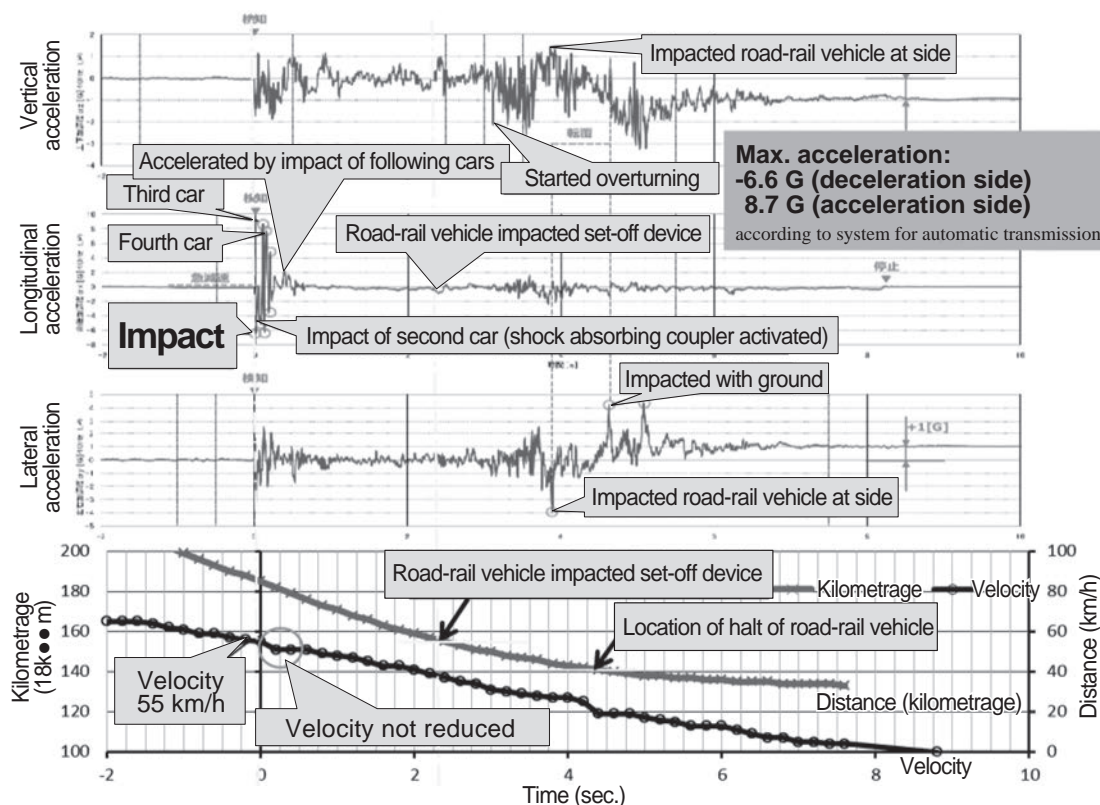
Fig. 7 Verification Using Records of System for Automatic Transmission of Train Protection Radio Signals and Operation Information Recorder

We verified whether the aforementioned inference agreed with the acceleration waveform at the collision recorded by the system for automatic transmission of train protection radio signals⁴⁾ and the velocity and kilometrage of the operation information recorder. The system for automatic transmission of train protection radio signals recorded vertical, longitudinal, and lateral acceleration at and around the collision, and the records showed that the first impact was 6.6 G (65 m/s²) and then the second and following cars impacted in series with the maximum acceleration being 8.7 G (85 m/s²) at the impact of the third car, which is less than the design target of 10 G (98 m/s²). We were able to confirm that activation of shock absorbing couplers controlled the impact of the second car, demonstrating that maximum acceleration was reduced by shock absorbing couplers. Since overturning of the lead car started after longitudinal impact at the position where the road-rail vehicle seemed to impact the set-off device, we could conclude that the inference in the previous paragraph agreed with the recorded data.

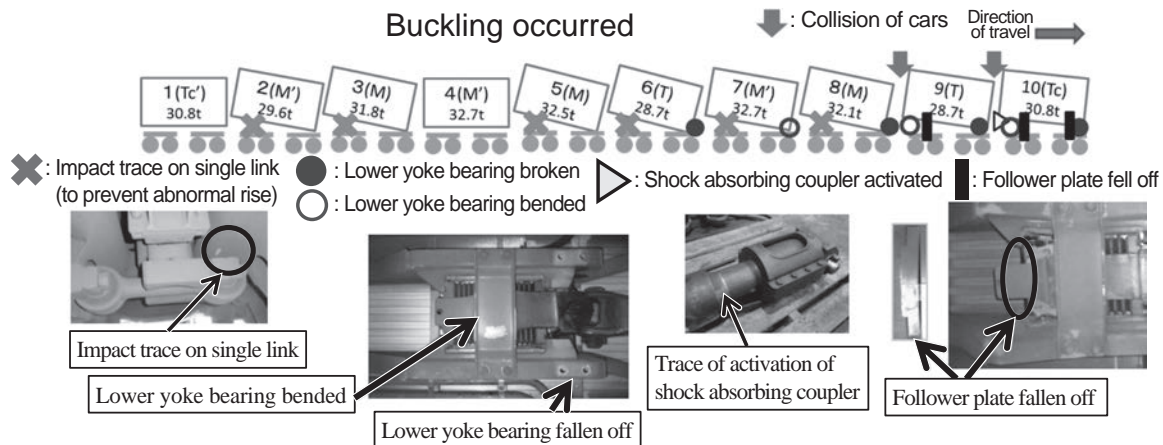
Fig. 8 Damage to Trainset

Investigating damage of individual cars of the trainset, we found that follower plates of the couplers of the first and second cars were deformed by impact and then fell off. Impact traces on the single links of the bogies suggest that buckling occurred as shown in Fig. 8 and damage on the lower yoke bearings of the first to fifth cars (No. 10 to 6) indicates that tilting of couplers caused major impact on those bearings. Such deformation and loss of a lower yoke bearing is often observed in buckling. Damage of a coupler including loss of a follower plate and a draft gear lower yoke bearing could cause impact of cars, resulting in greater damage.

- (1) Reinforce the car body between end beam and side beam in order to achieve car body structure that can convey impact energy on and around end beam to crushable zone.
- (2) Absorb impact energy and thereby abate damage by improving balance of strength between lower yoke bearing, follower plate, and car body frame in order to allow the underframe to deform.
