Relicensing Study 3.1.2

**Northfield Mountain / Turners Falls
Operations Impact on Existing Erosion and
Potential Bank Instability
Study Report**

Volume III – Appendices

**Northfield Mountain Pumped Storage Project (No. 2485) and
Turners Falls Hydroelectric Project (No. 1889)**

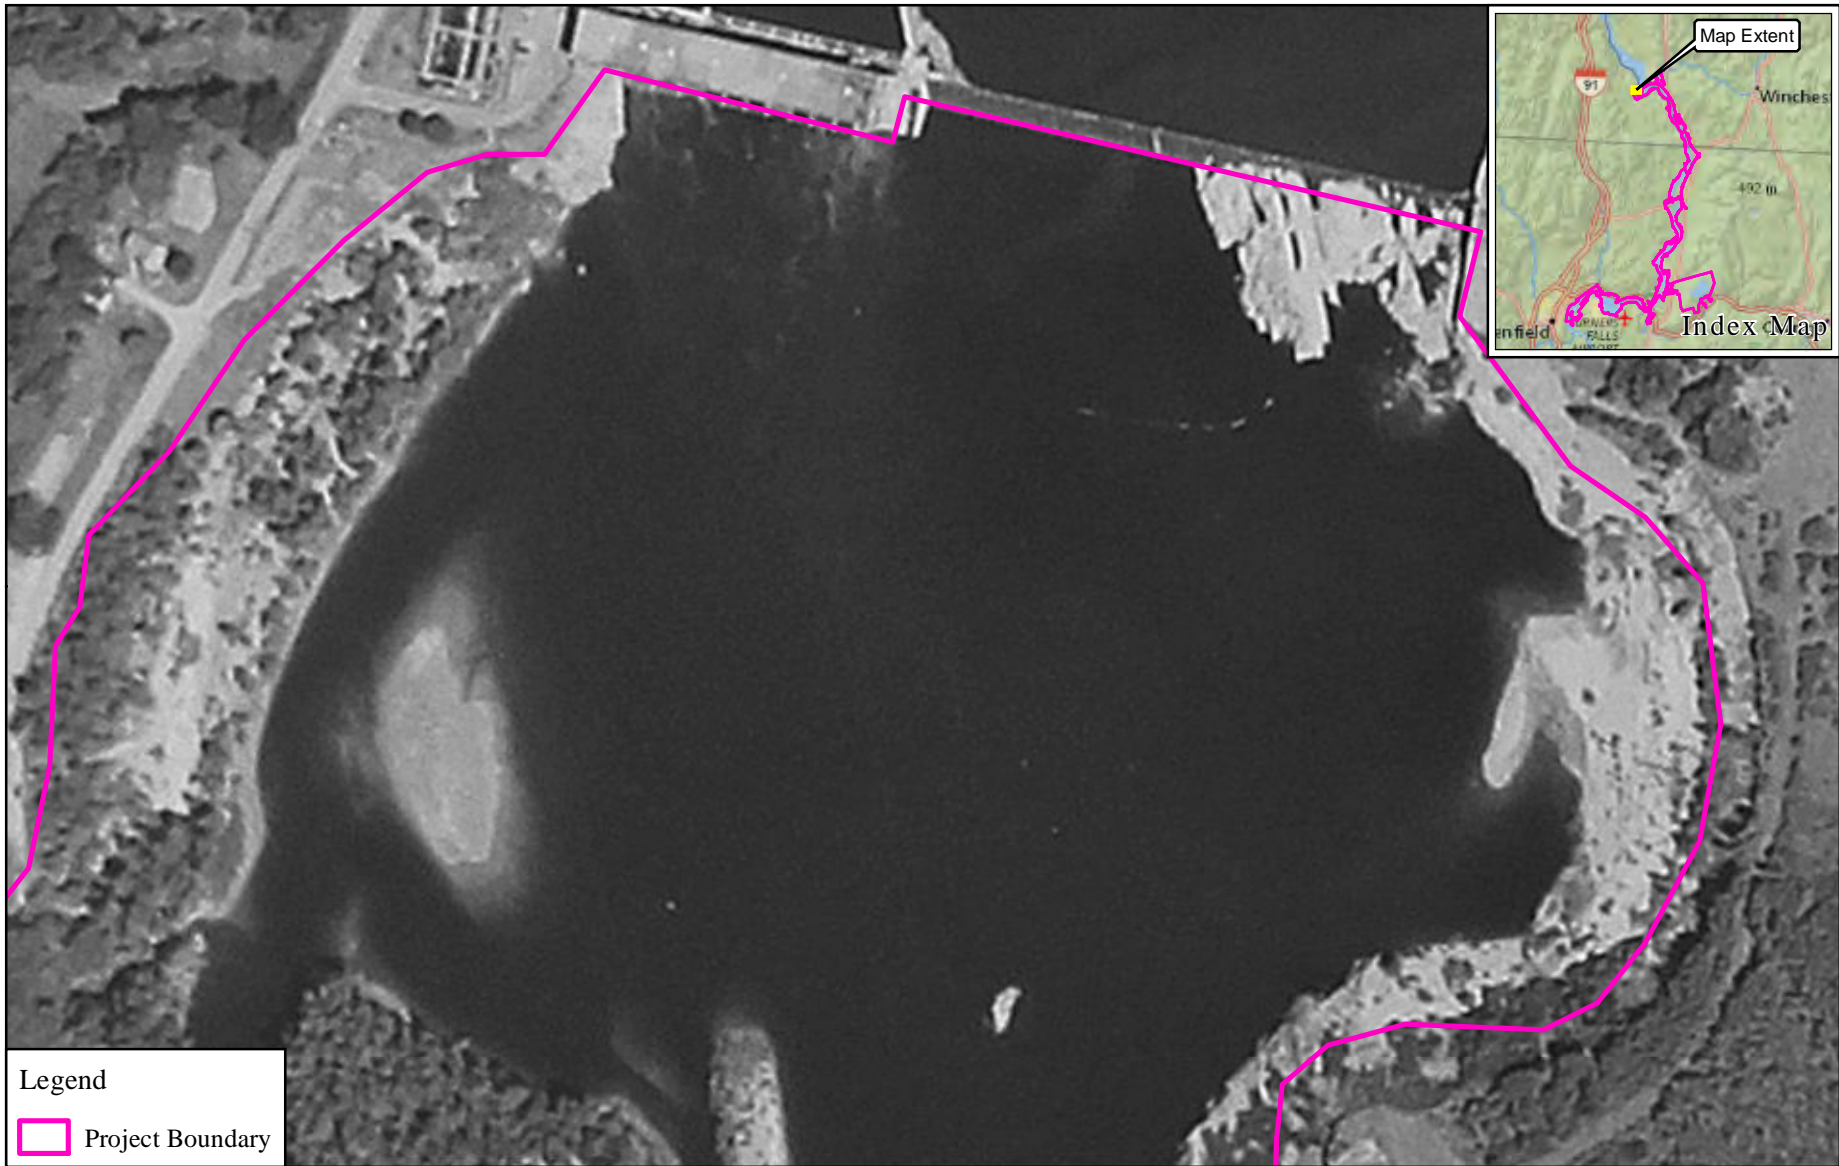
The 1952 photograph shows that the top of left bank is near the project boundary line (indicated in fuchsia). Recent photographs show that erosion has progressed beyond the line such that the bottom of the upper bank is beyond the line. The 2008-2010 and the Online Imagery were taken at relatively high flow conditions and show the turbulence and eddying associated with the release of flow through the left gates of Vernon Dam as well as the general turbulence in this reach of the river at these levels of flow.

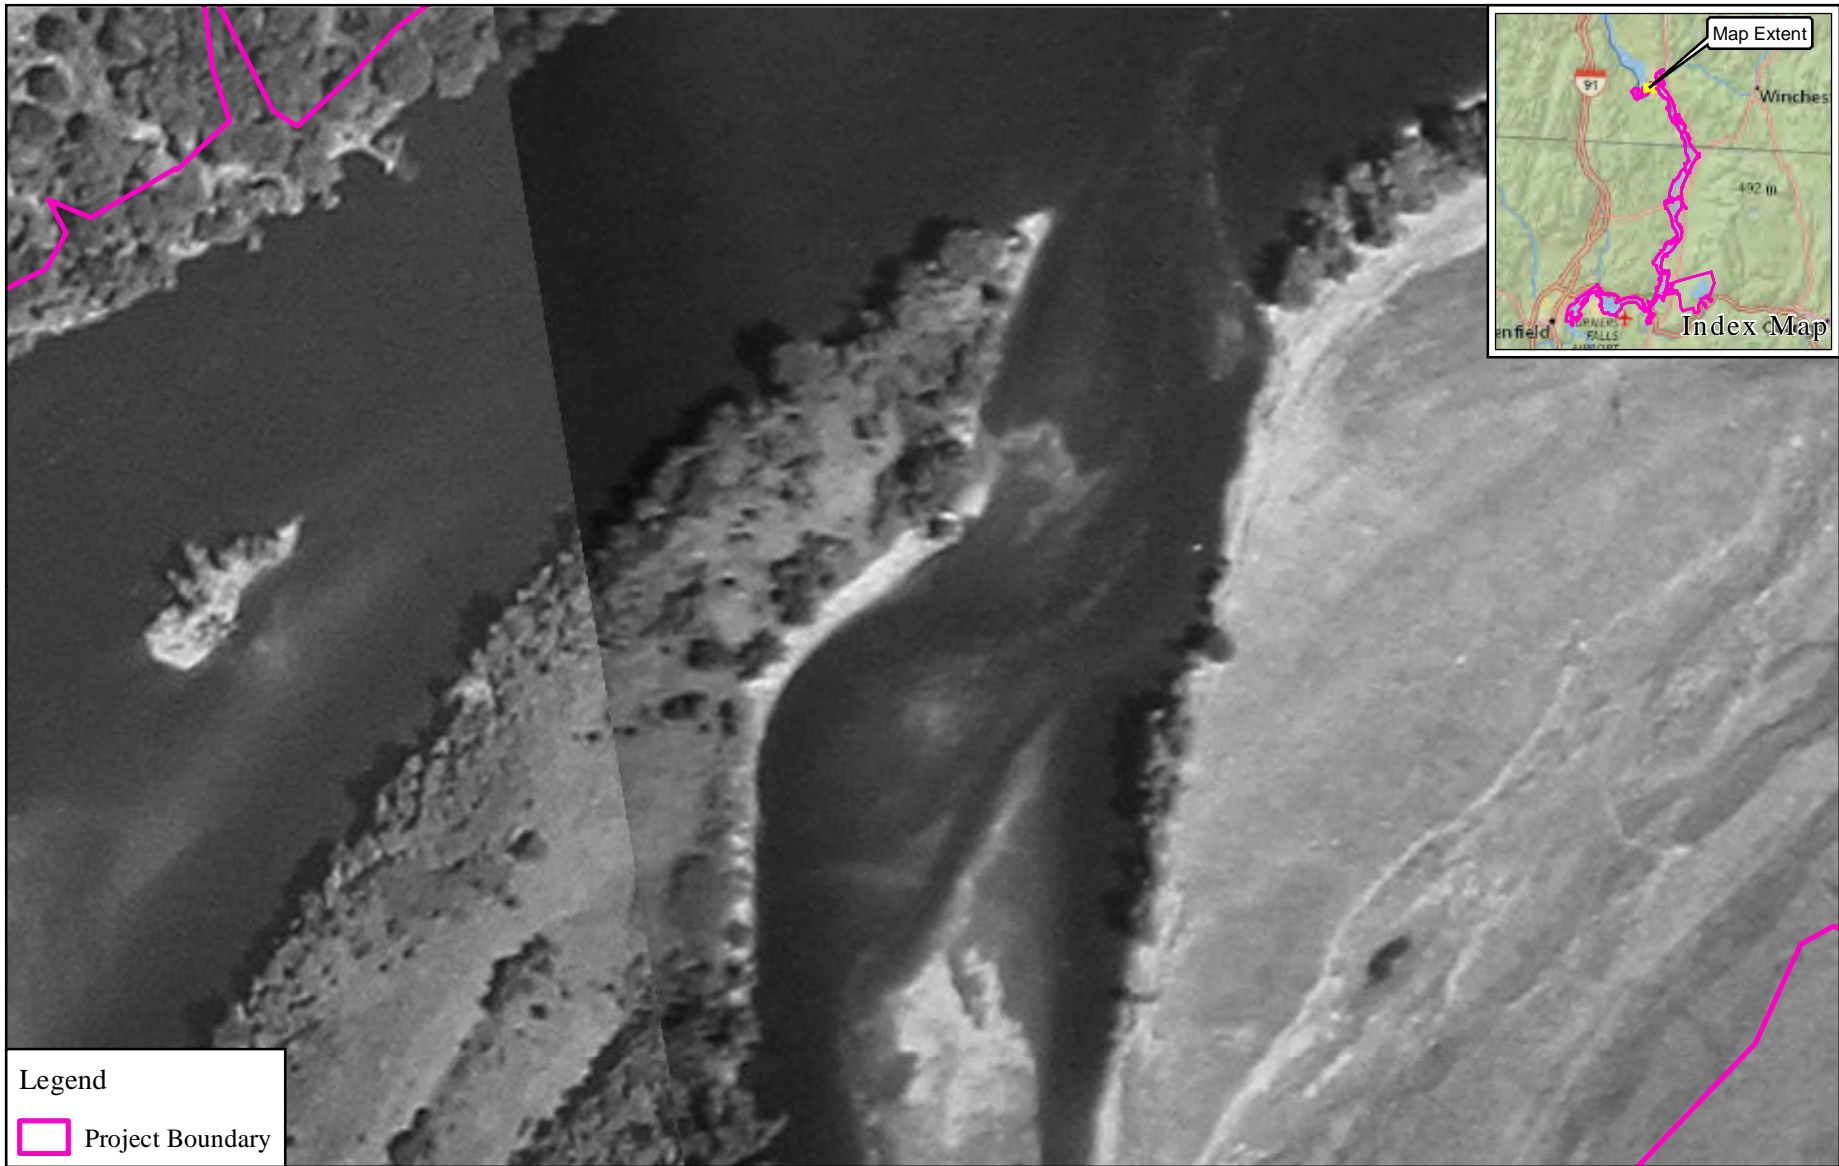
2 STEBBINS ISLAND

The 1952 photograph shows that there is little vegetation along the right bank of the river, bars and small vegetated islands to the left of the main island, and shallow flow conditions on both sides of the island. By the 2008-2010 set of photos, the downstream tip of the island had narrowed but the potentially eroded right bank which in 1952 had little to no vegetation on the bank had some establishment of vegetation on the bank. The 2014 and Online Imagery are similar to the 2008-2010 photograph.

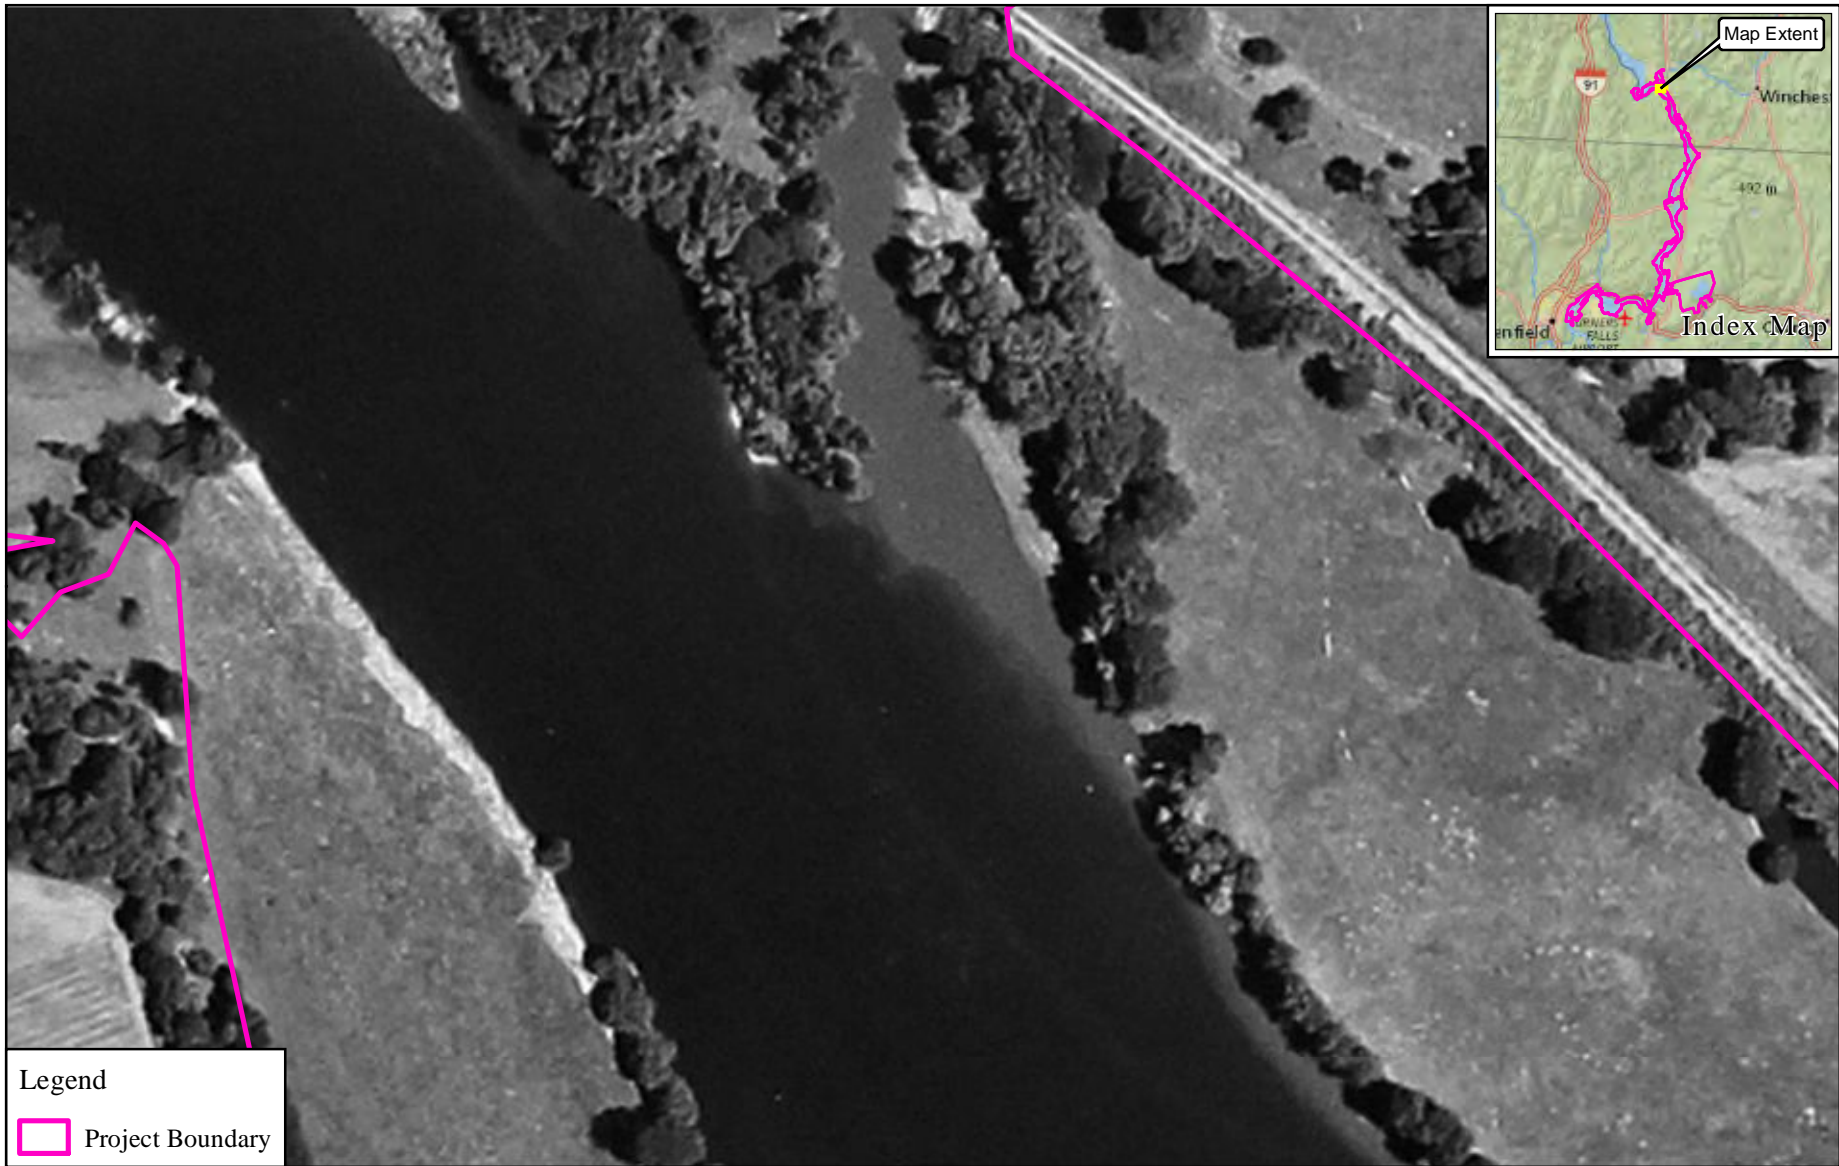
The 1952 photograph shows that the right bank of the river, opposite the confluence with the Ashuelot River, is eroded with no upper riverbank vegetation between the agricultural field and the river. The 2008-2010 and other recent photographs show an increase in riverbank vegetation along this same section of riverbank. On the Ashuelot side, upstream of the confluence the tip of land appears to have narrowed over time since 1952 and there is some decrease in the narrow riparian zone of upper riverbank vegetation downstream of the confluence.

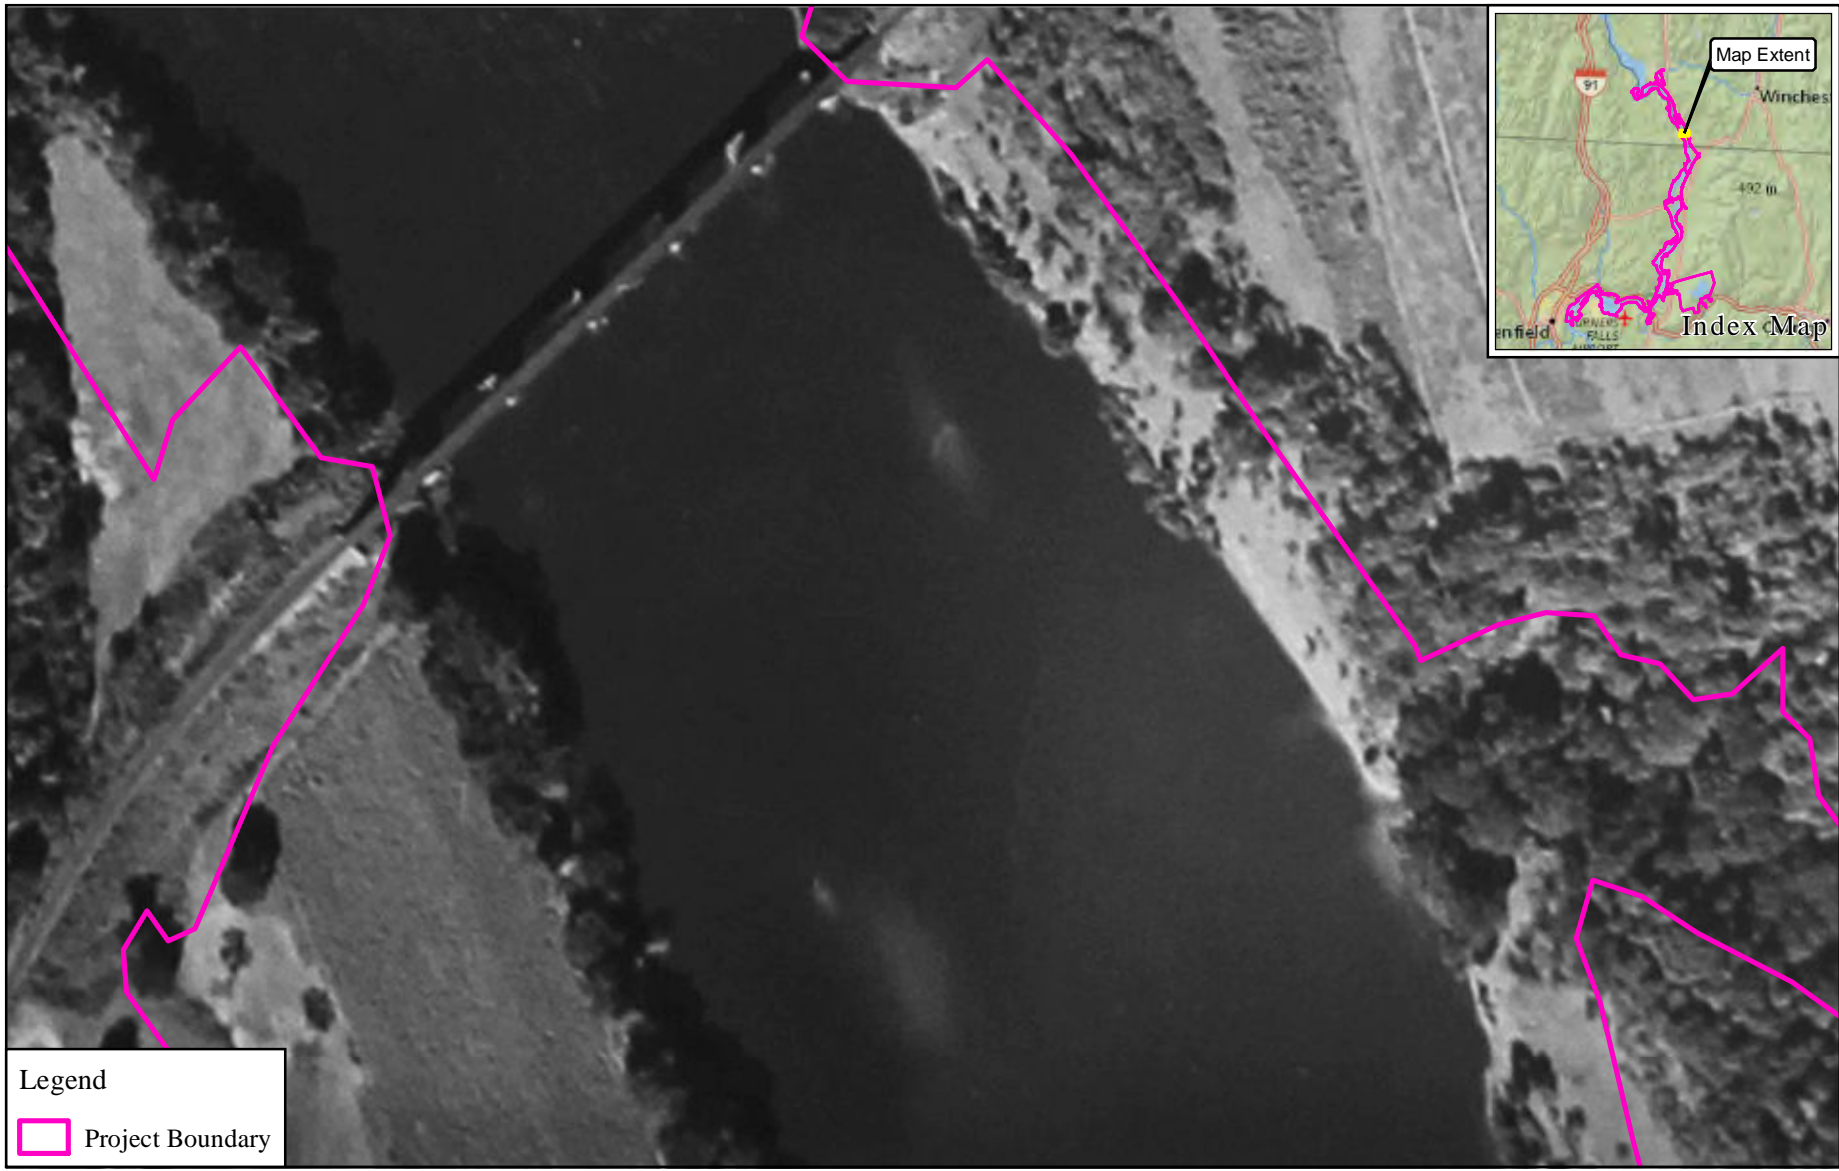
4 KENDALL

In the vicinity of the railroad bridge which has been subsequently abandoned and partially removed, in 1952 the right bank downstream of the bridge supports a band of riparian vegetation while the left bank is sparsely vegetated. In 1962, in the same location on the right bank erosion is evident with the bank shifting landward and no riparian vegetation remaining. On the left bank, a small erosion scallop has formed just downstream of the bridge with segments of reduced riparian vegetation. The bridge super-structure had been removed by the 1990s photograph, with all piers left standing in the river. By the 2008-2010 set of photographs, one of the piers had fallen into the river, probably due to scour around its base and no supporting structure to provide stability from above. The right bank is the Kendall site which was stabilized in 2008 through implementation of the ECP. Subsequent photos show the stabilized right bank and increased riparian vegetation along the left bank.

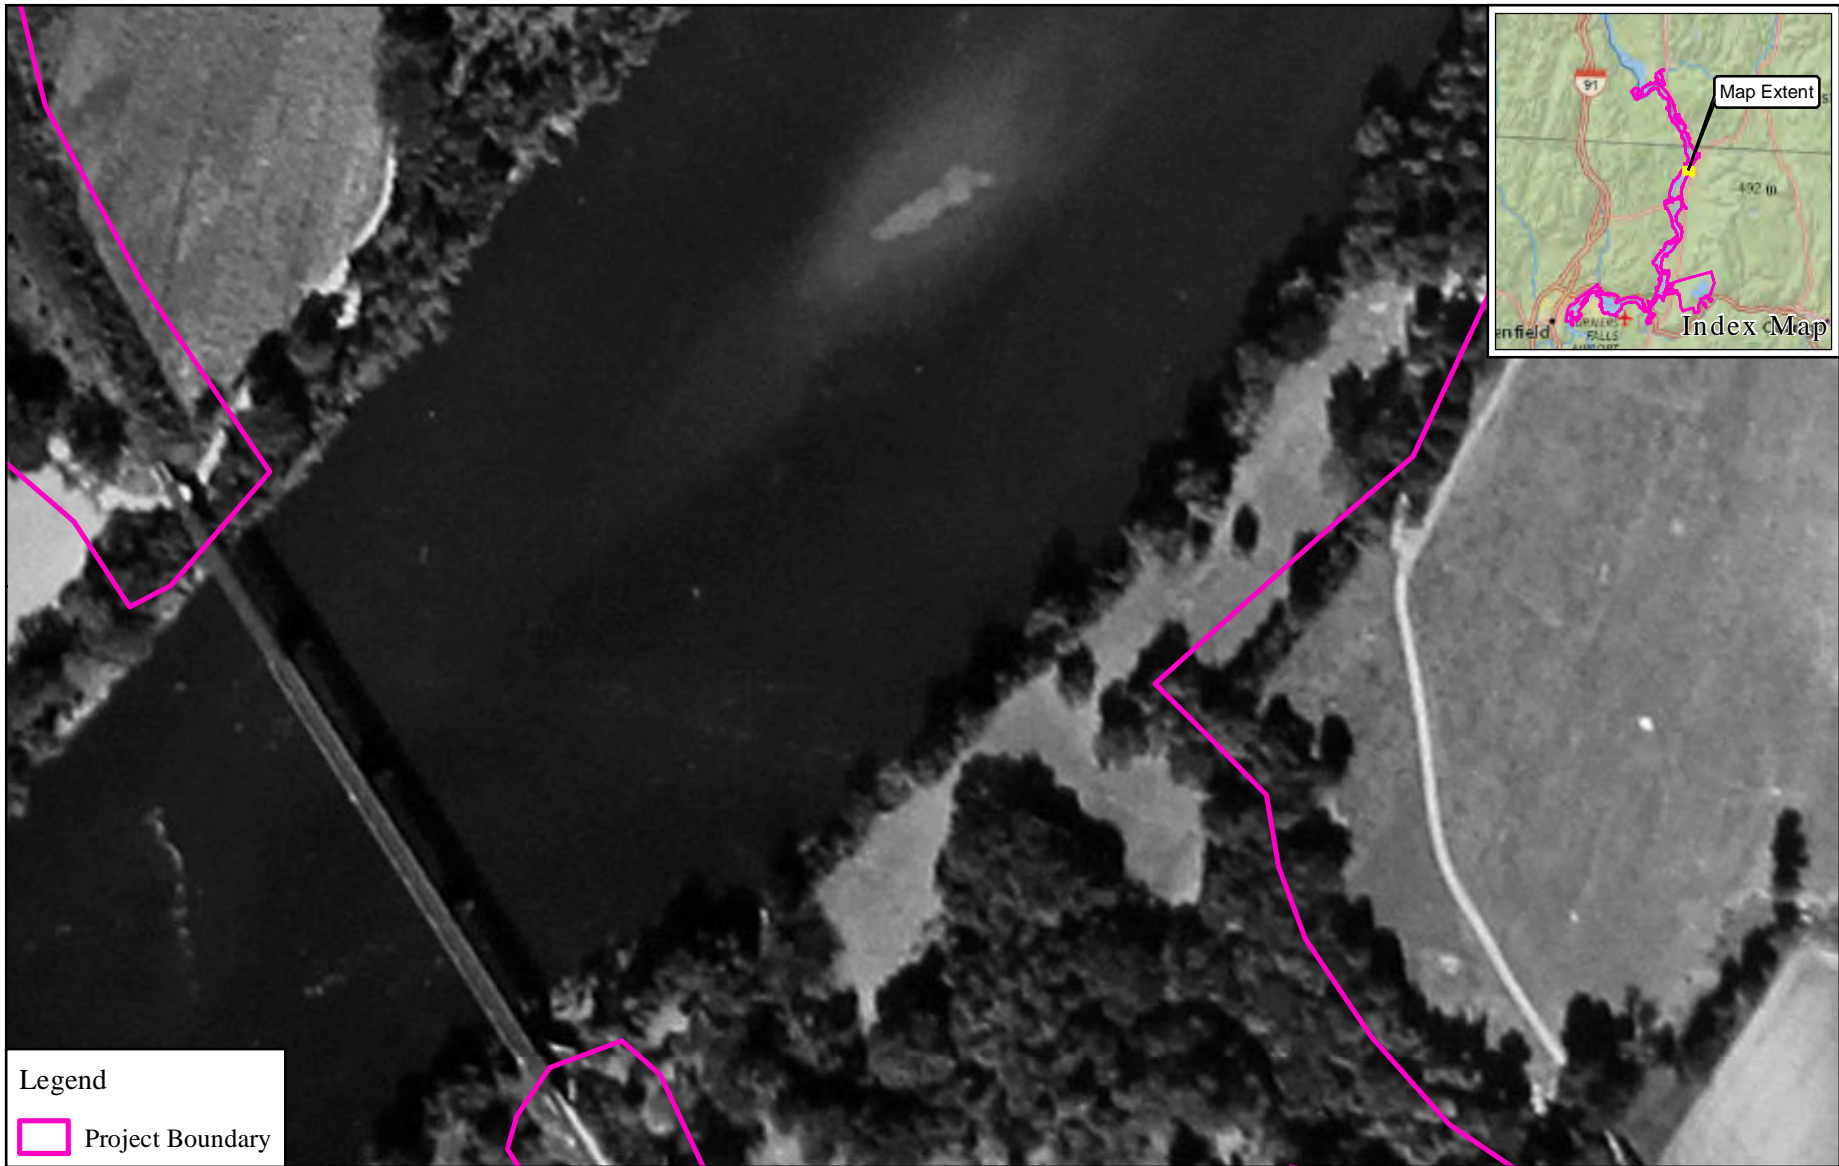
In the 1952 photograph, a band of riparian vegetation is found along both banks of the river upstream of the Schell Bridge. The extent of vegetation appears to be relatively consistent along the right bank through the series of photographs. On the left bank; however, the 1960s photograph shows erosion and a significant reduction in riparian vegetation. This area was called the Country Road Site, which was stabilized in 2006 through the ECP as shown in the 2008-2010 and more recent photographs.

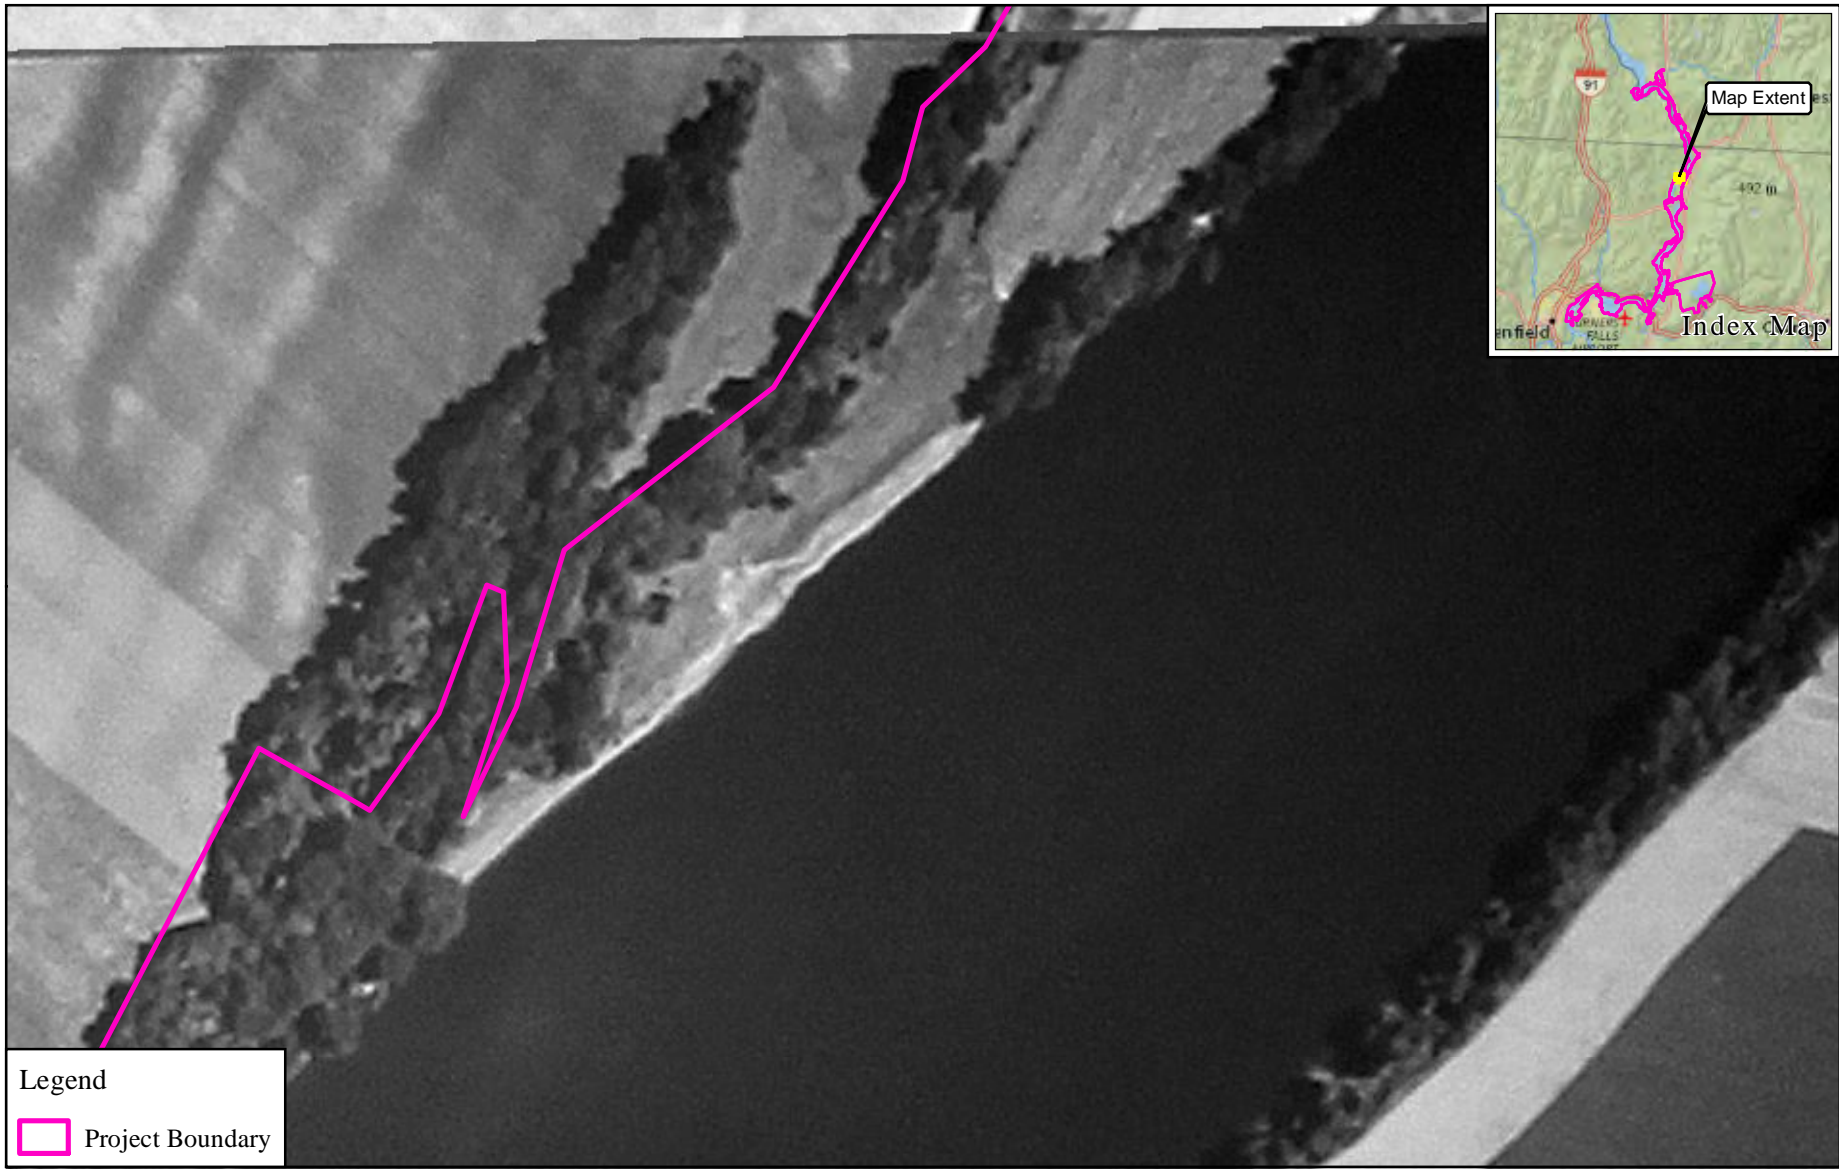
In the 1952 and 1960s photographs, there is an eroded section of riverbank with no significant riparian vegetation. During the 1990s, this site was selected for erosion repair, known as the Wickey site (constructed in 1996).

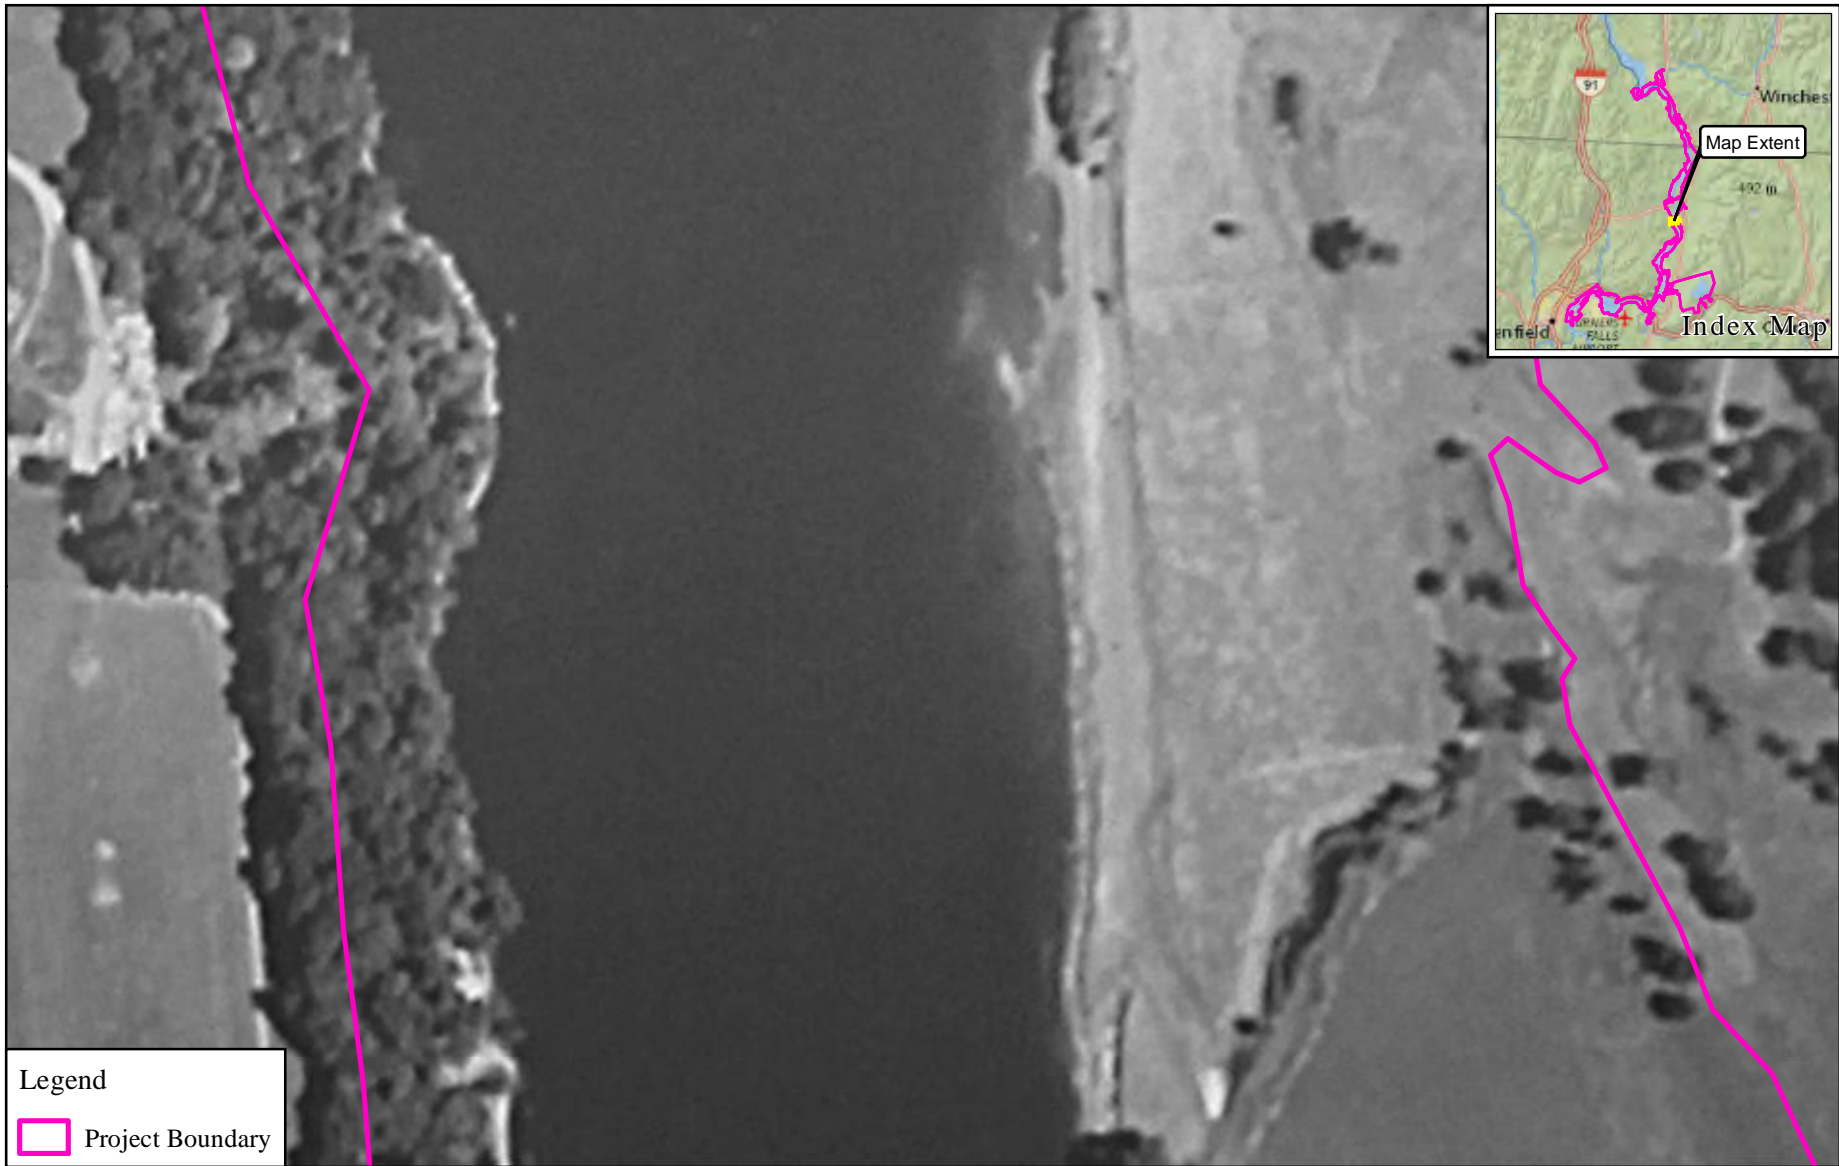
The left riverbank across the river from the Mt. Hermon School was eroded and absent riparian vegetation on the 1952 and 1960s photographs. A strip of riparian vegetation has become established along this riverbank as can be seen in the 1990s and subsequent photographs.

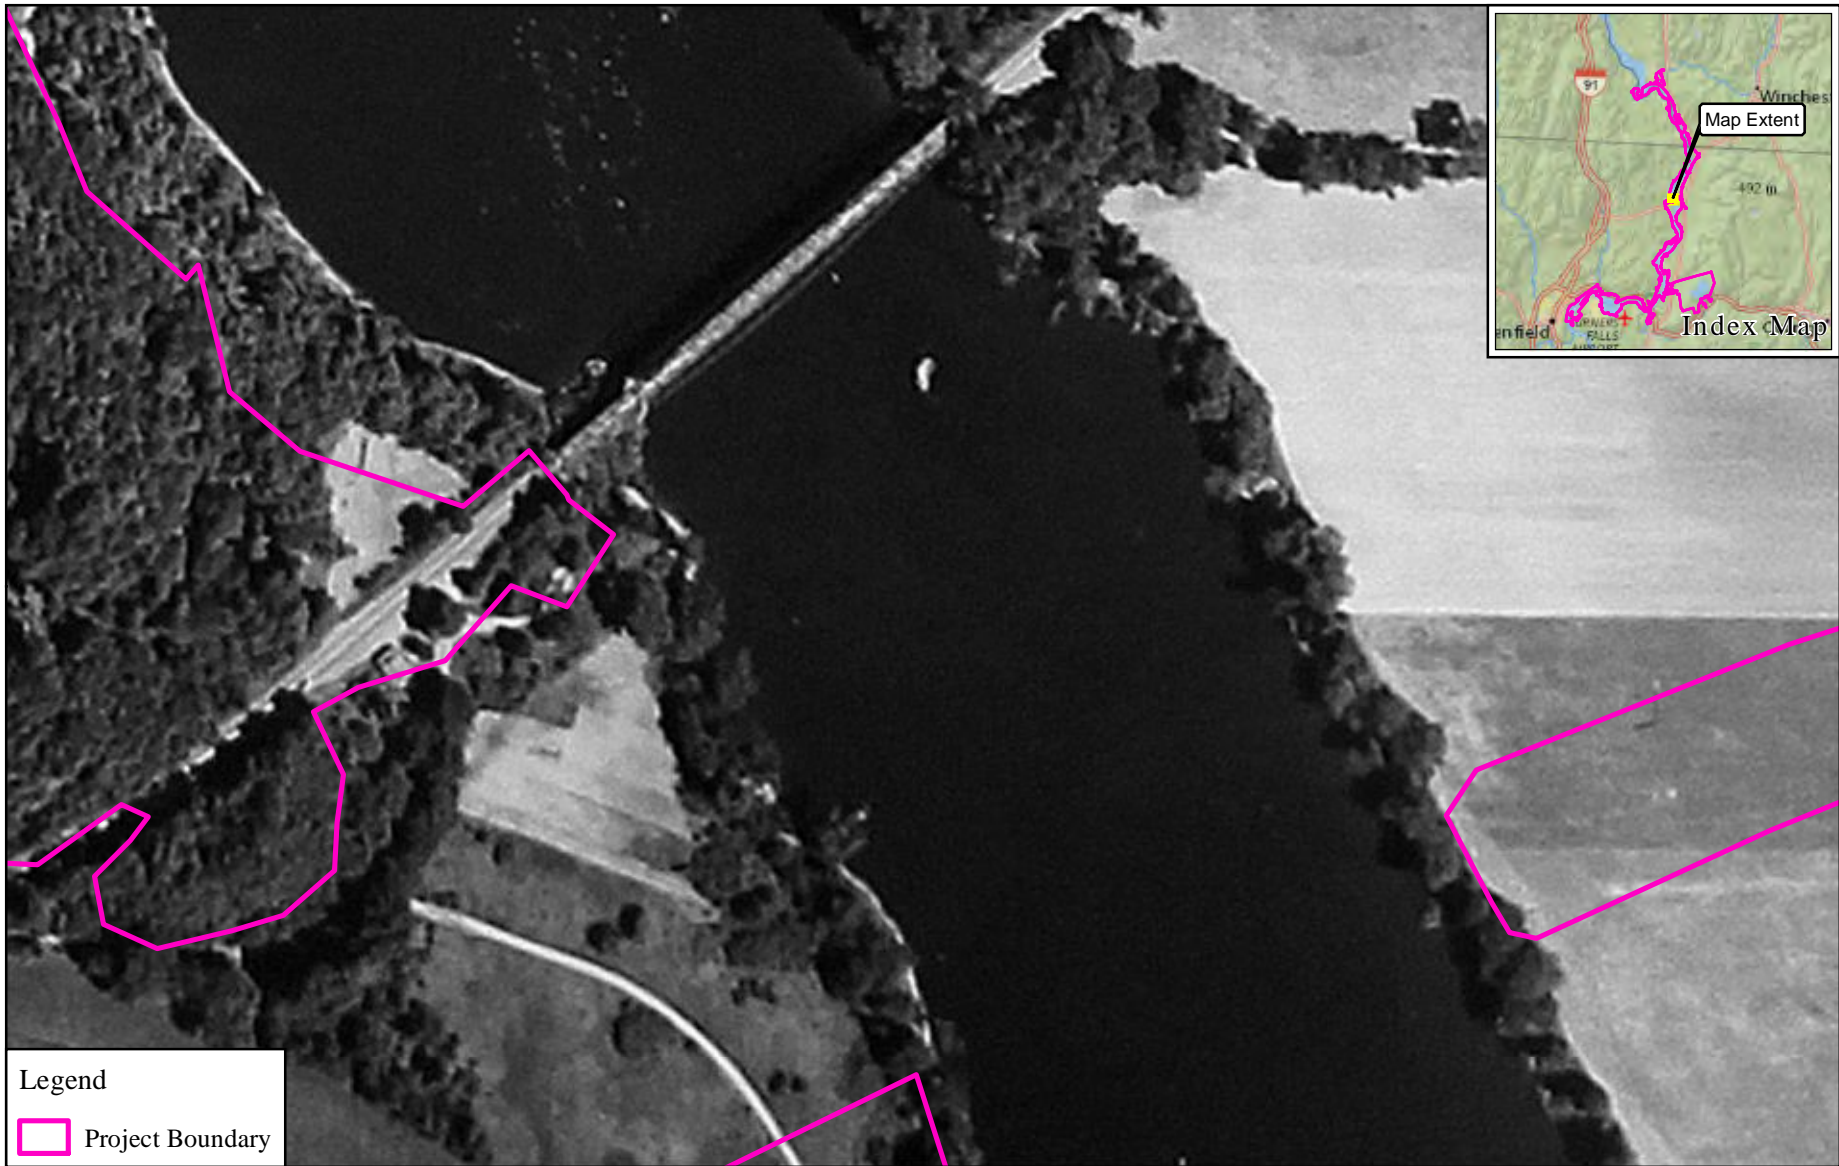
The right bank upstream of the bridge was stabilized in 1997 (Crooker) and no additional stabilization was conducted because of the unique and extreme hydraulics associated with the river in this reach where the bridge is located.

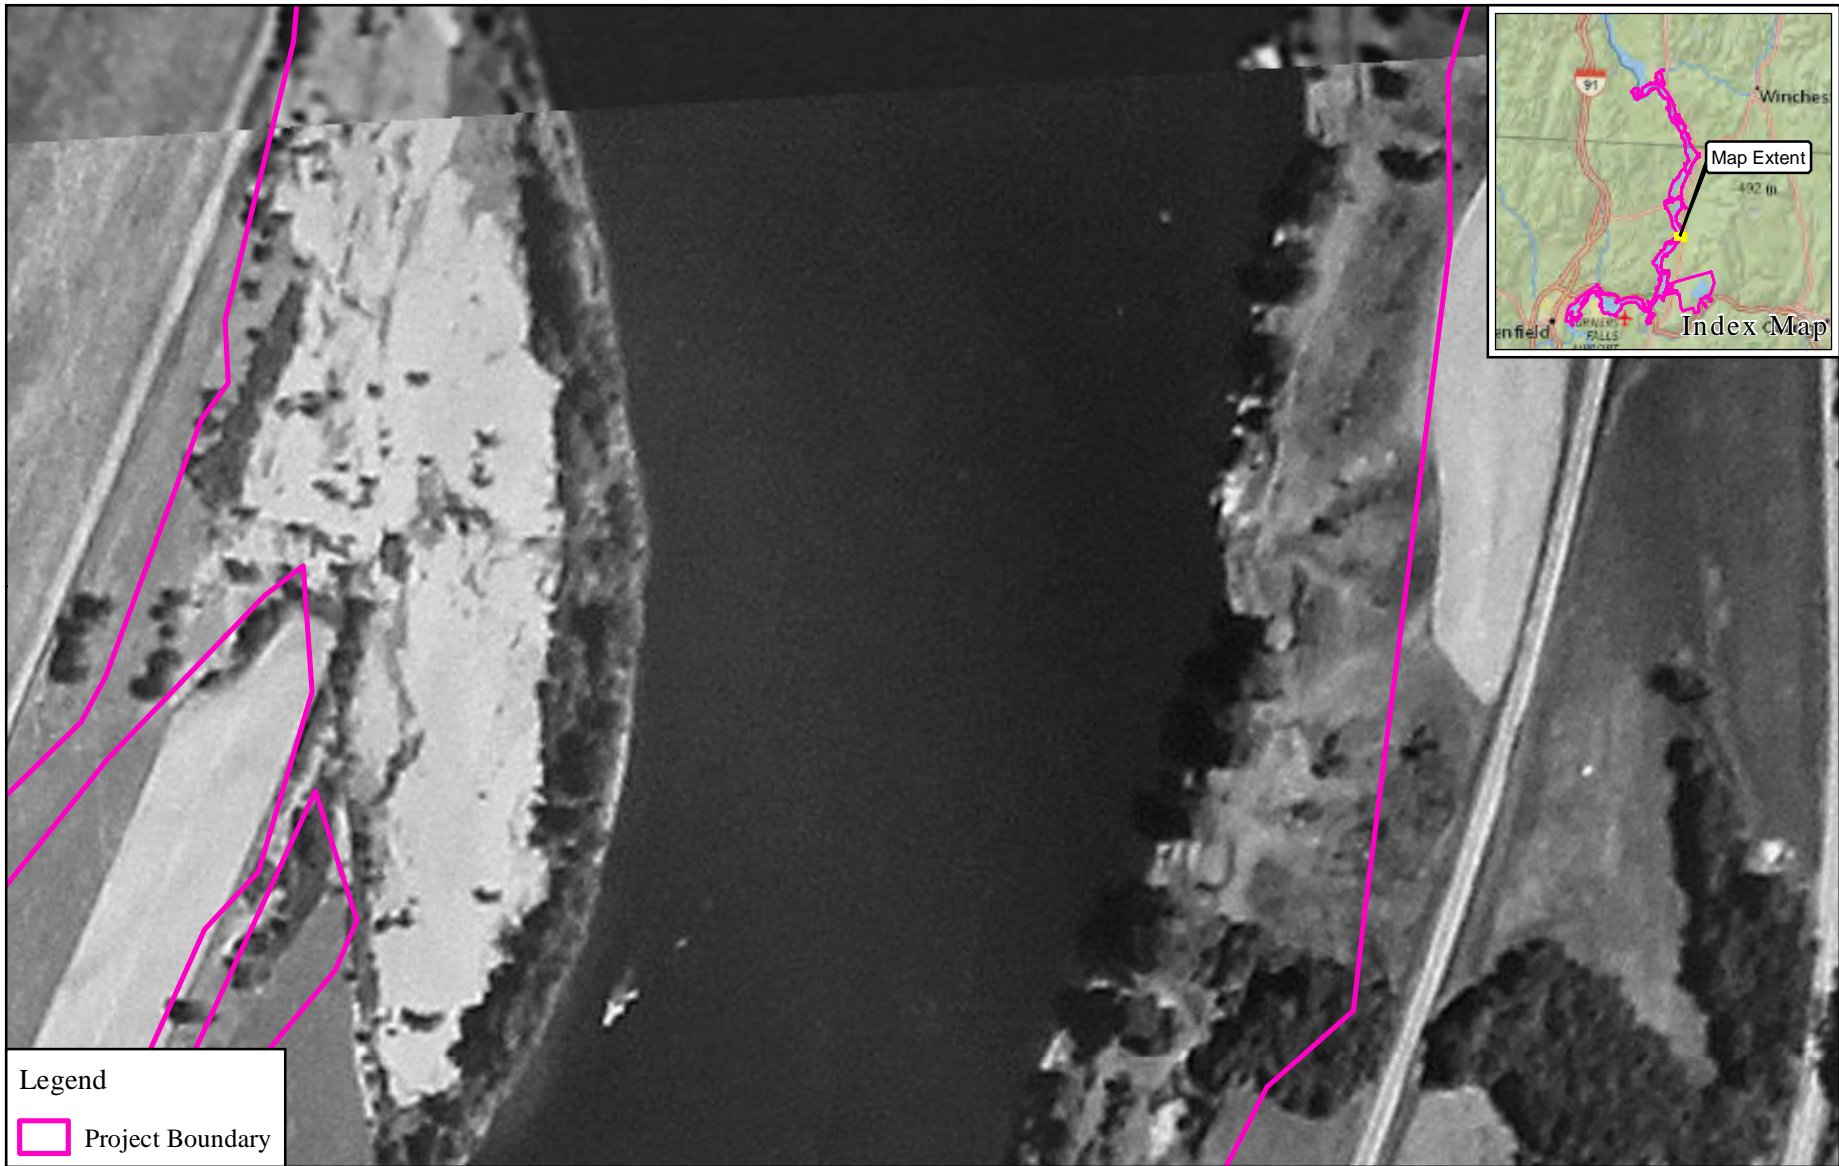
At a bend in the river upstream of Kidds Island the 1952 photograph shows a reach with some riparian vegetation. The 1960s photograph shows erosion and associated decrease in riparian vegetation. The right bank is the Urgiel downstream site which was stabilized in 2005 as shown in the 2008-2010 and subsequent photographs. The riparian vegetation has become denser over the years on the right bank.

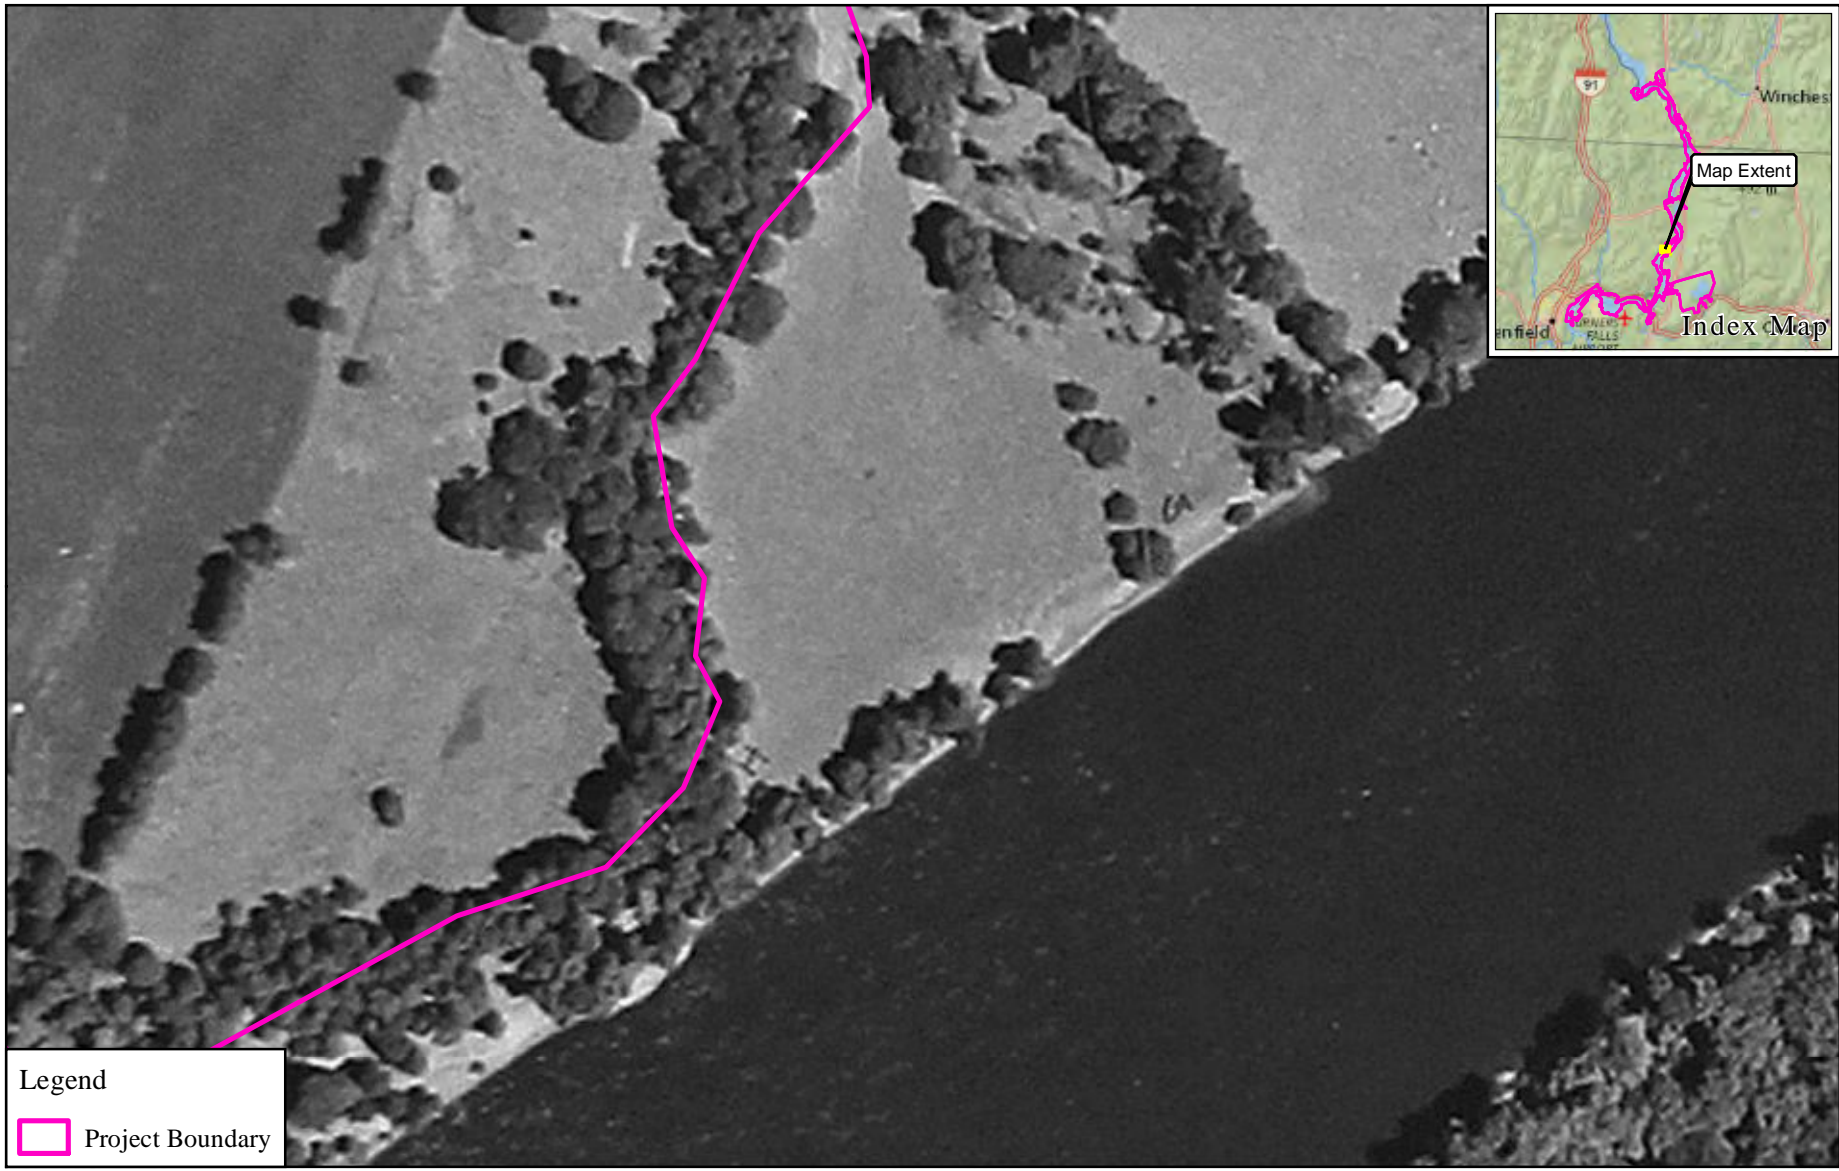
The right bank downstream of Otter Run was sparsely vegetated in 1952. By the 1990s photograph no riparian vegetation can be seen on the bank. This reach of the river is in the vicinity of Kidds Island where camping and significant boating activity occurred until recent years. This eroded area was identified in the ECP and is known as the Flagg site. The portion of the Flagg site downstream of Otter Run was restored in 2000 but has been affected by cattle which, while there has been an increase in vegetation and stability, the vegetation is limited by the effect of cattle.
