Relicensing Study 3.1.2

**Northfield Mountain / Turners Falls
Operations Impact on Existing Erosion and
Potential Bank Instability
Study Report**

Volume III – Appendices

**Northfield Mountain Pumped Storage Project (No. 2485) and
Turners Falls Hydroelectric Project (No. 1889)**

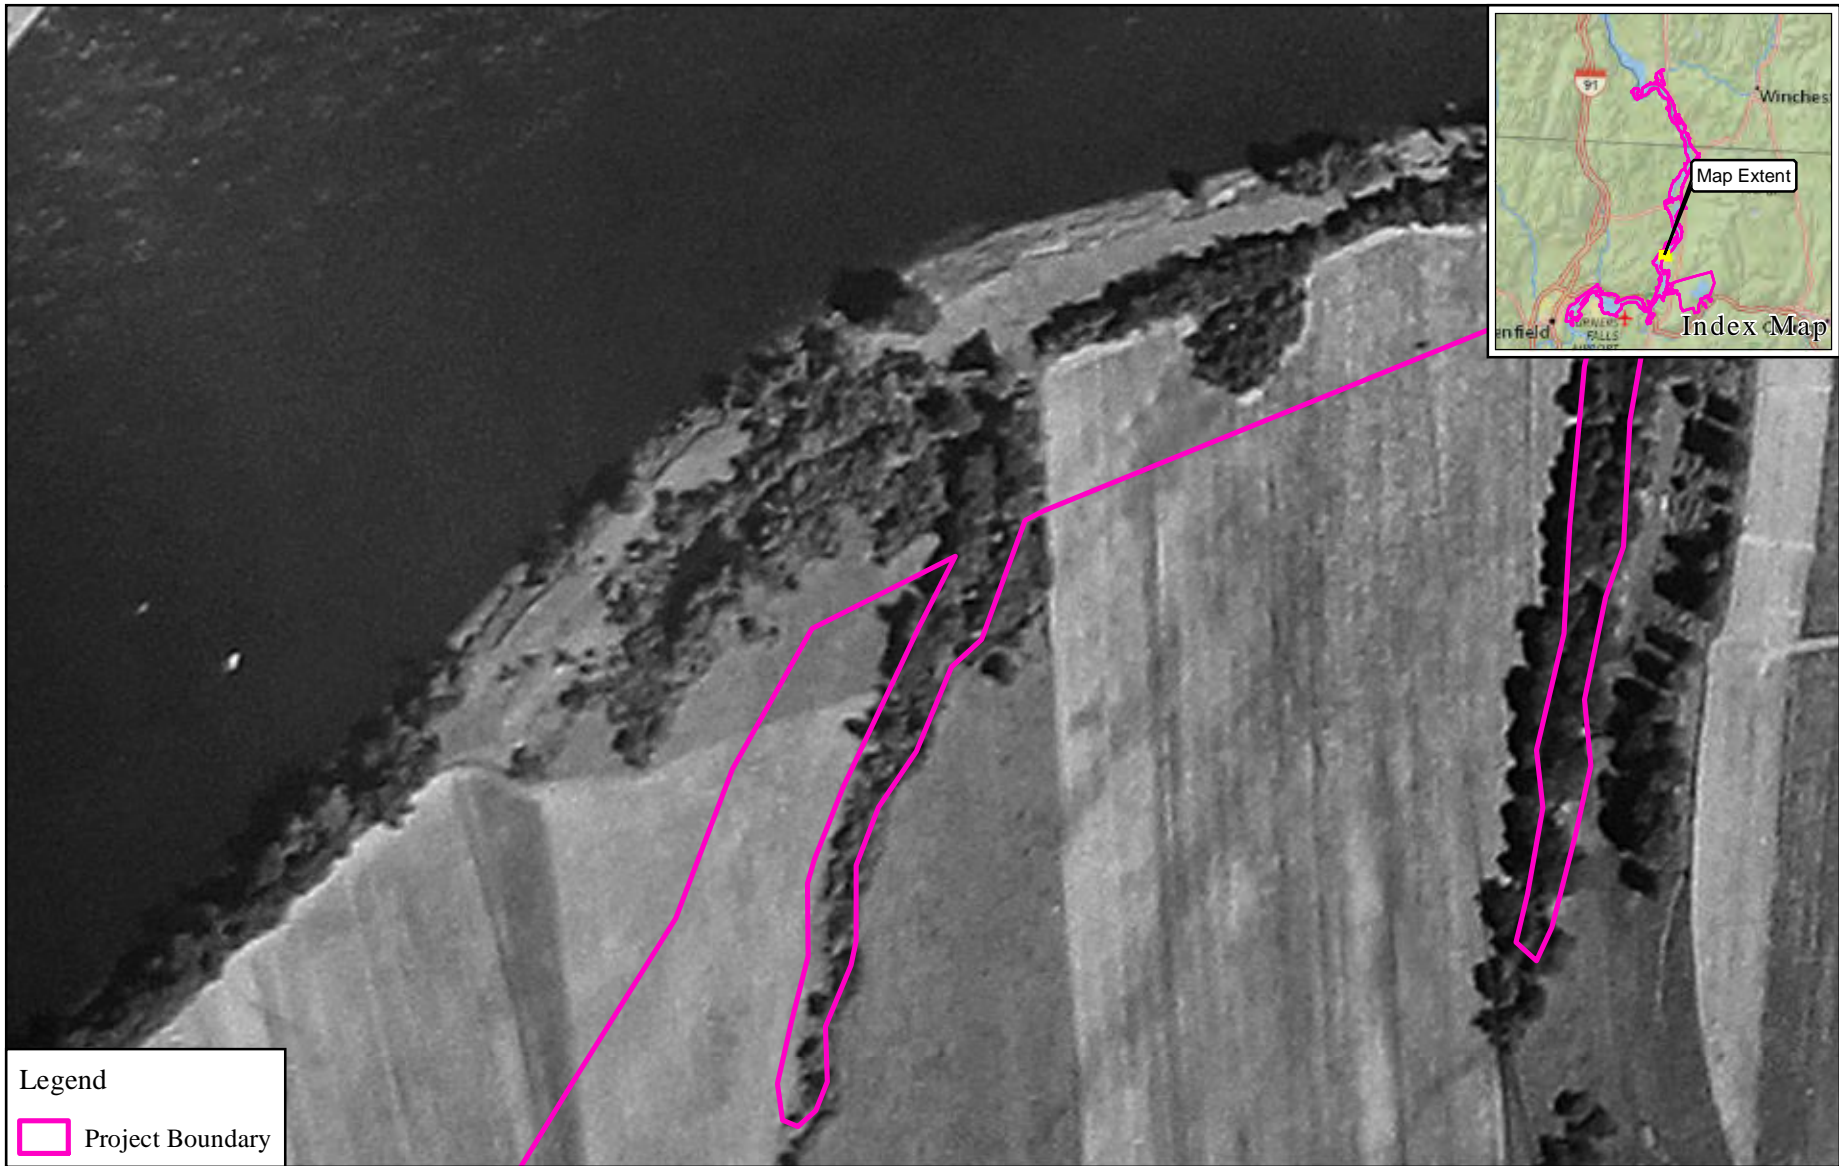
On the left bank downstream of Kidds Island the 1952 and 1960s photographs show eroded conditions with little riparian vegetation. By the 1990s, the narrow remnants of a field appear to have been eroded away and into another band of riparian vegetation.

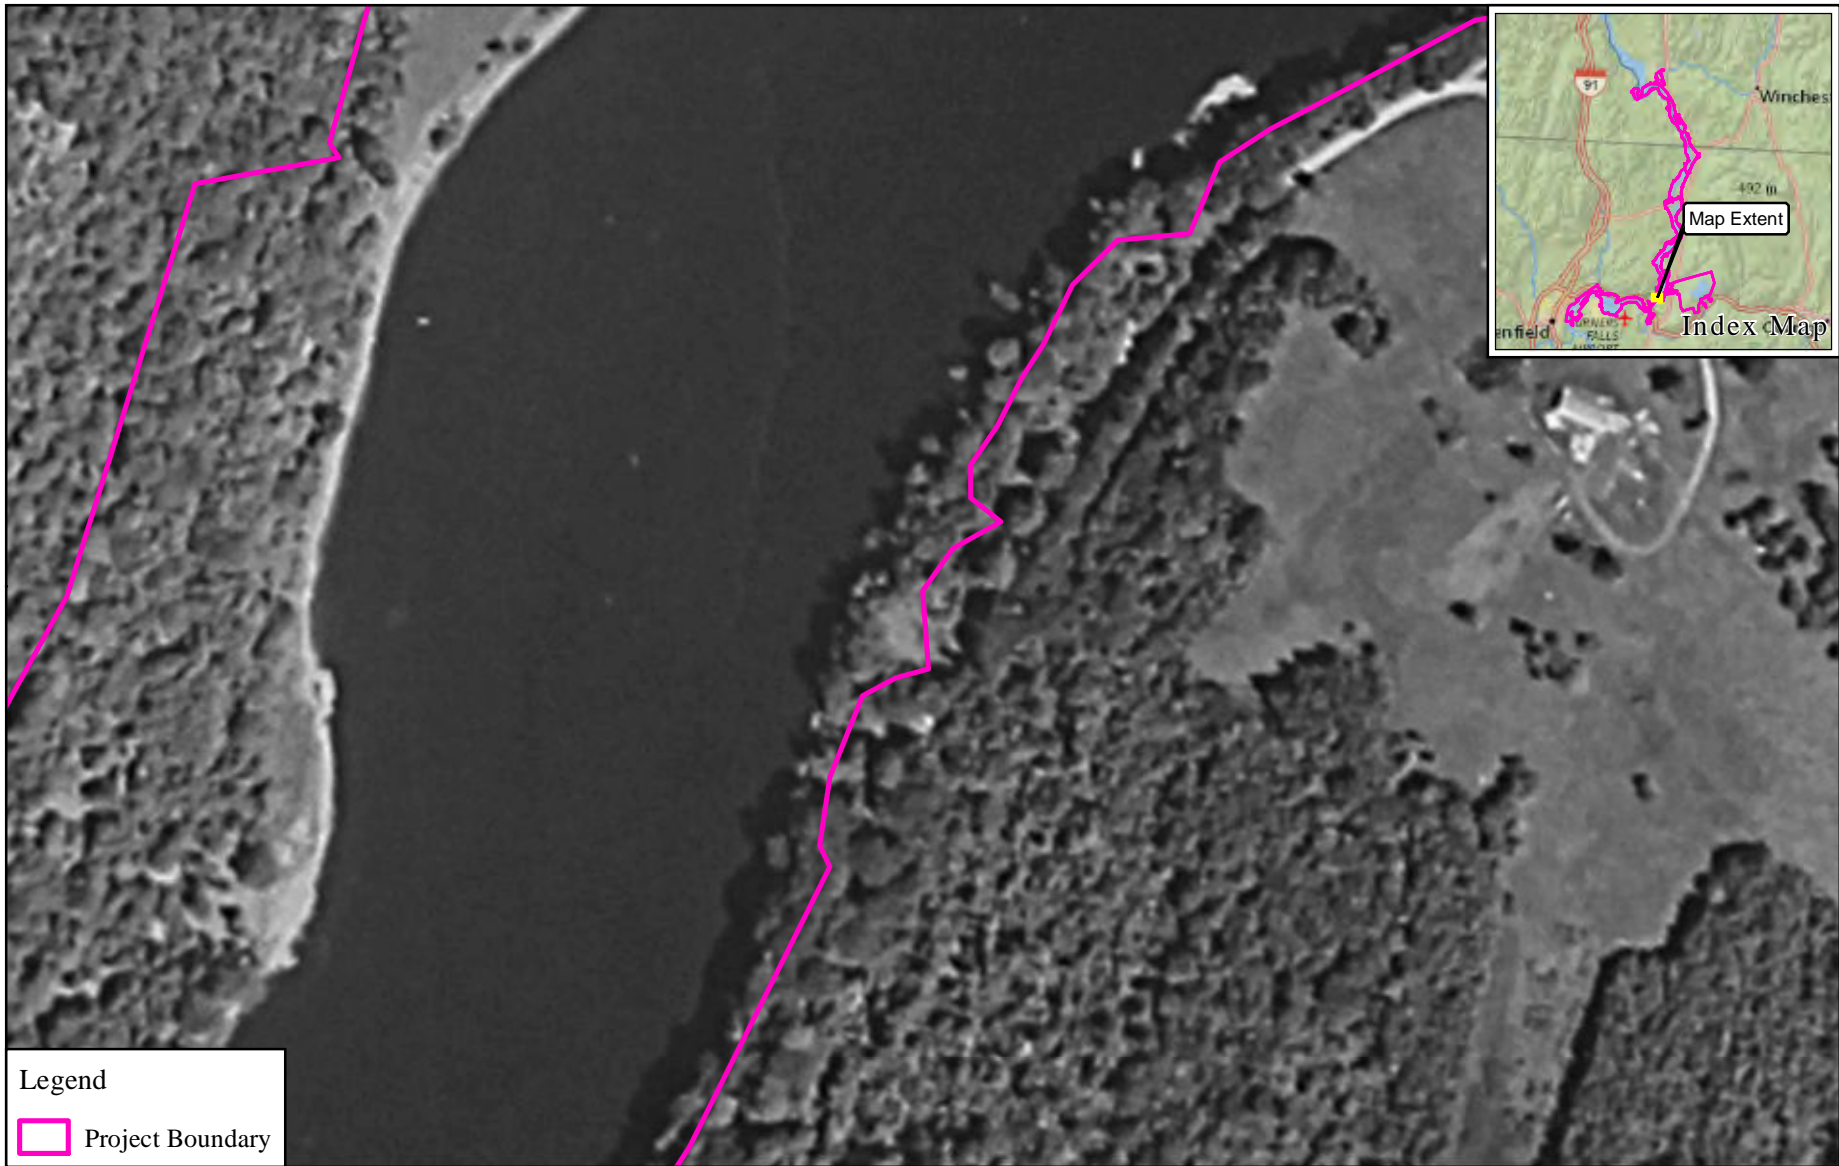
On the inside of the bend along the left bank erosion has occurred over time with the bank moving landward compared to the project boundary line as noted in changes in the bank from the 1952 to 1960s and subsequent photographs. This area was stabilized in 2003 through the ECP and is called the River Road Site.

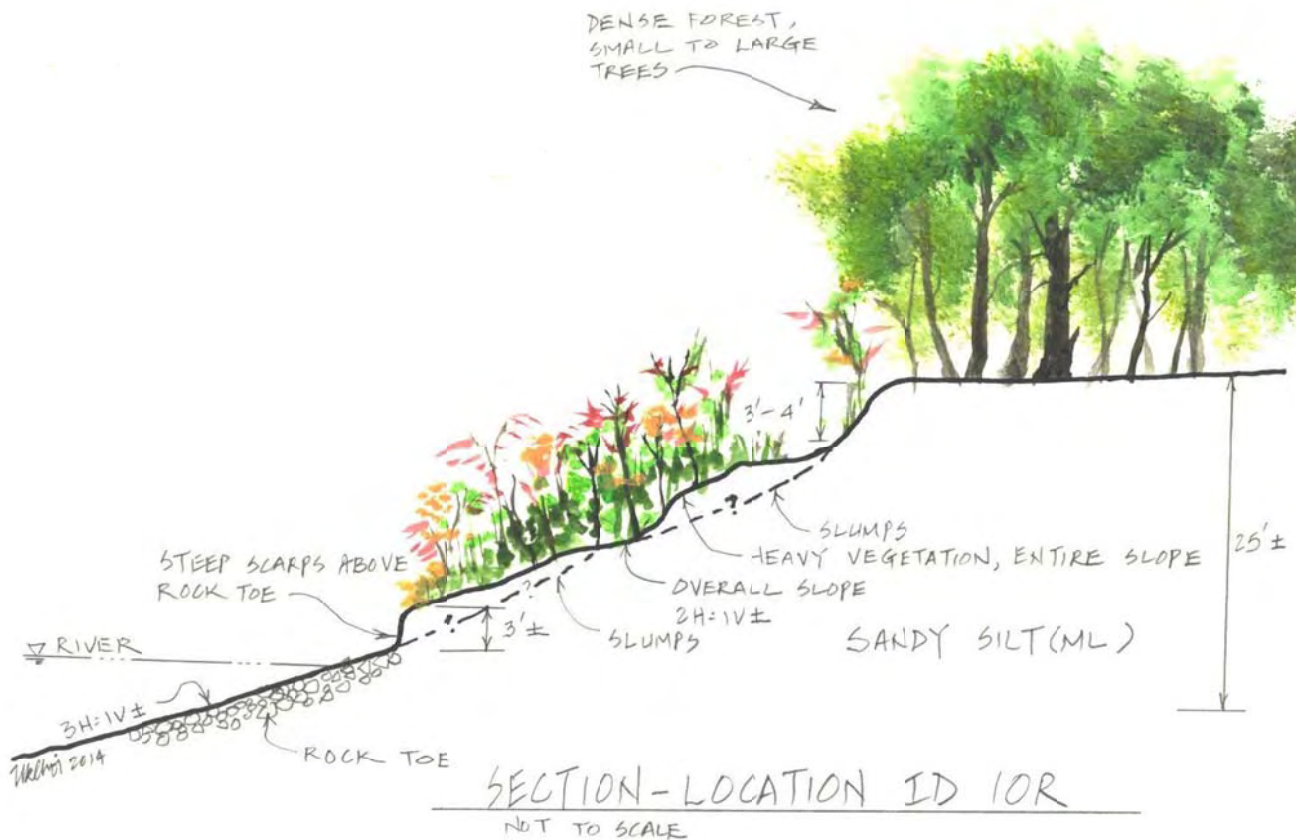
Site Sketch:

Rock Toe – 2" to 6" riprap rock, angular, hard, little deterioration.

Observed Erosion Features:

- Little erosion at rock toe, with no depressions or movements observed.
- Some slumping above rock toe, mid-slope, and near the top of slope of Upper Bank.

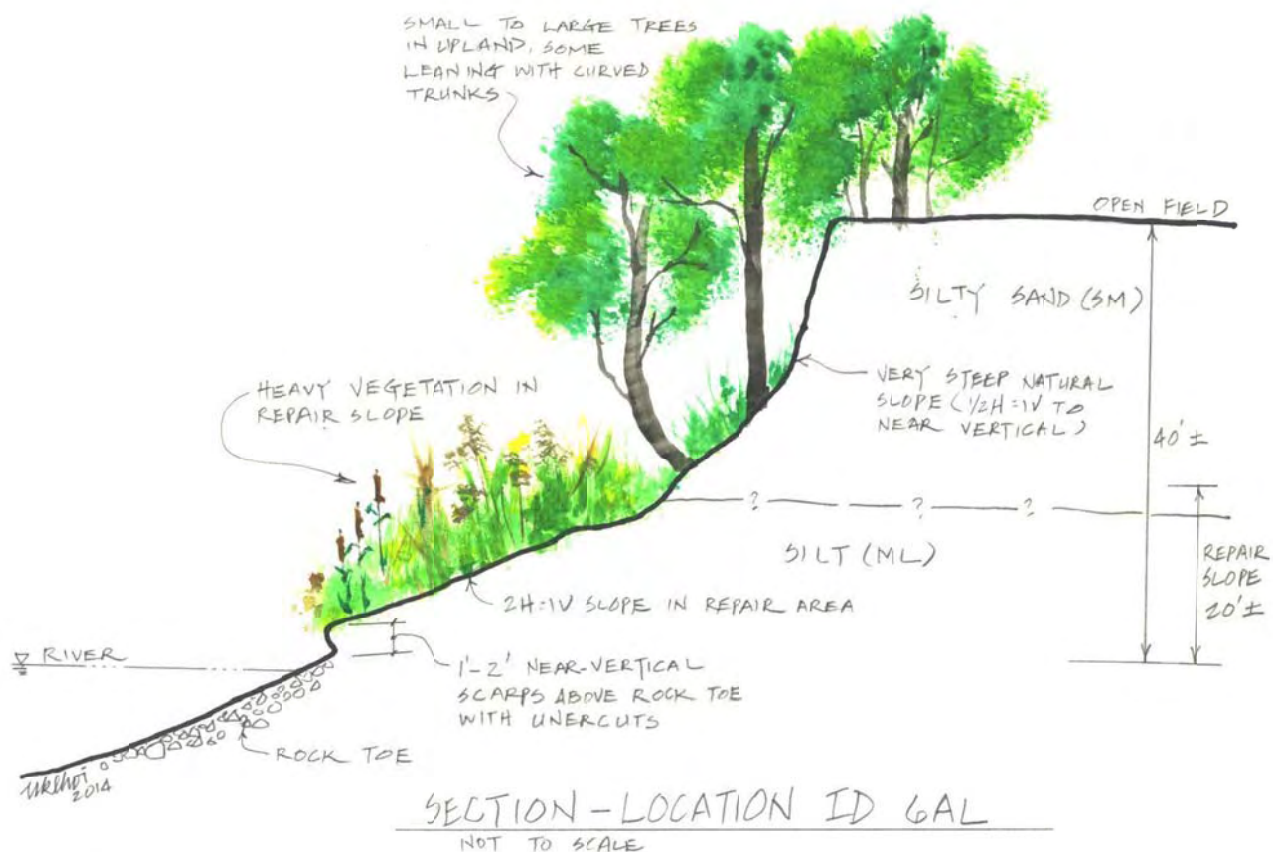
Site Sketch:

Rock Toe – 1" to 4" riprap rock, angular, hard, minor deterioration.

Observed Erosion Features:

- Little erosion at rock toe, with no depressions or movements observed.
- 1' – 2' high near-vertical scarps just above the rock toe, with minor undercuts.
- Very steep natural upland slope above repaired area.
- Some leaning trees in natural upland slope, some with curved trunks.

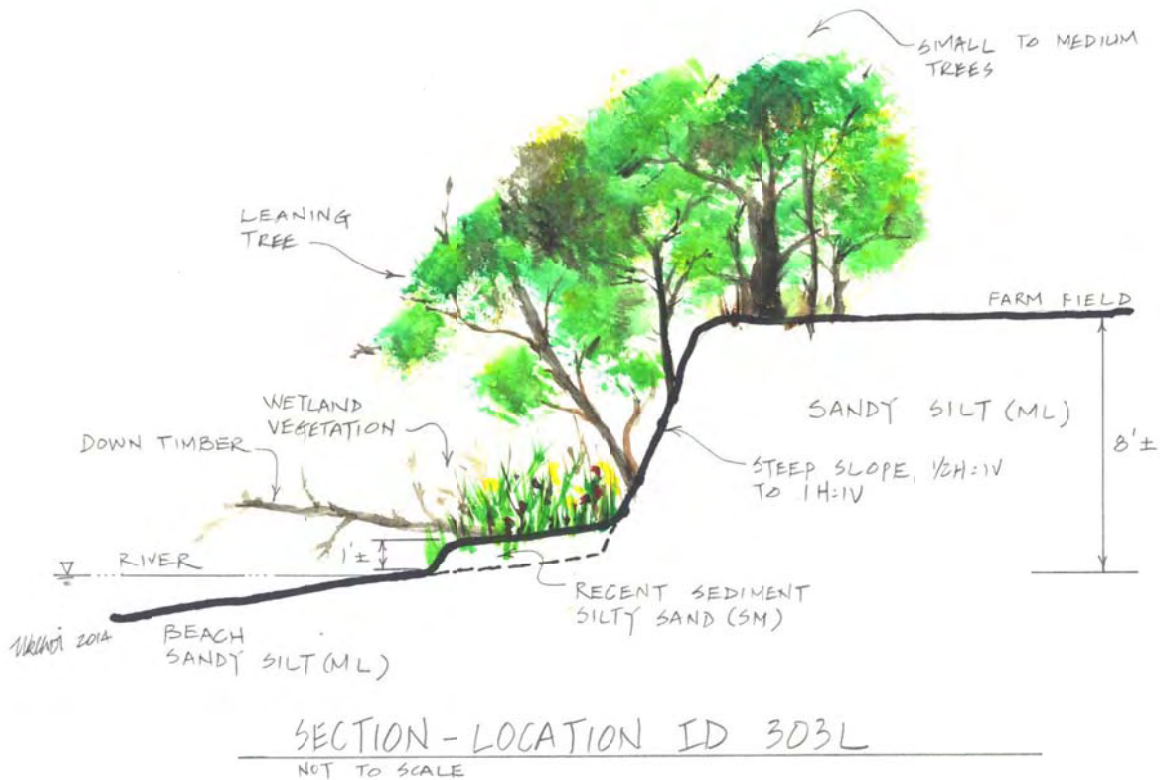
Site Sketch:

Observed Erosion Features:

- No erosion observed on Lower Bank, the top of which was filled with recent sediments.
- Steep slopes, entire Upper Bank.
- Some undercuts with exposed roots.
- Leaning trees.
- Few down timber
