SHASS MOUNTAIN PEAT LANDSLIDE

Factual Report

MGE0780RP0001
Shass Mountain Peat
Landslide Factual Report
F01
16th October 2020

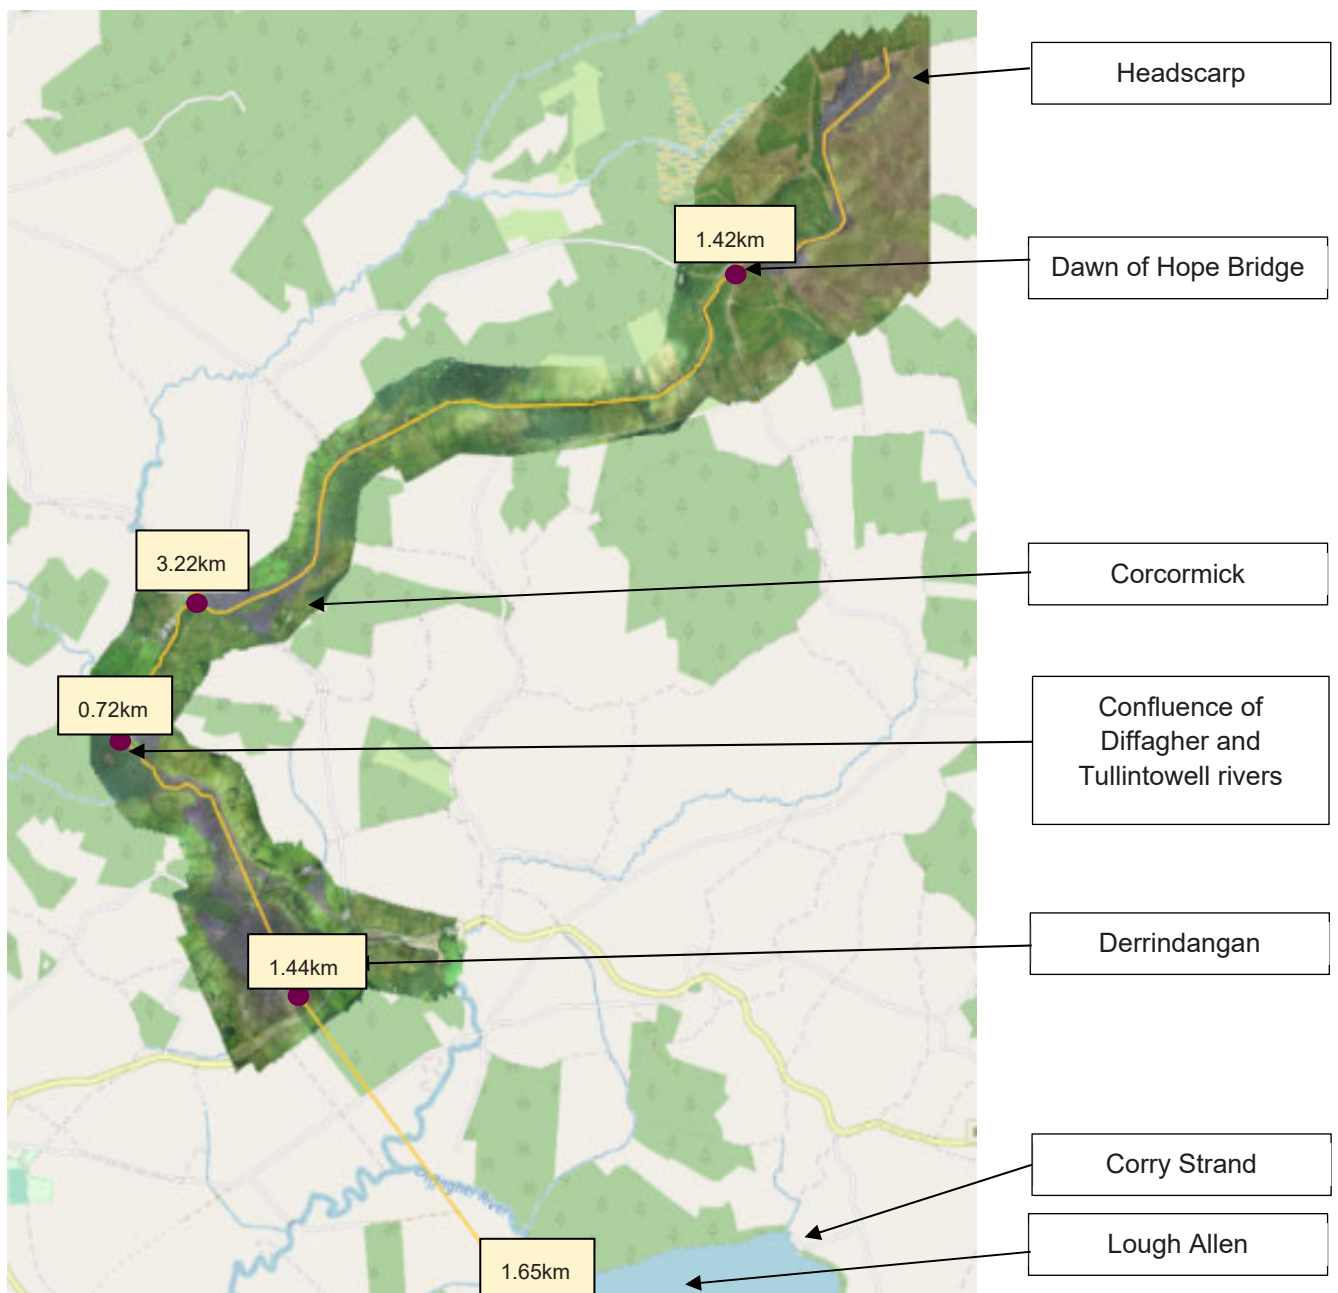
Figure 2-1 Extent of the Landslide and Sector Lengths (total = 8.45 km)

The landslide occurred within an area blanket bog on Shass Mountain, north-east of Drumkeeran, Co. Leitrim on the 28th June 2020, approximately 1.2km to 1.4km upstream of the Dawn of Hope Bridge. The evacuated peat travelled within the existing watercourses where it resulted in flooding of the flood plain in the townlands of Corcormick and Derrindangan. The majority of the peat carried downstream of the Dawn of Hope bridge remains on these flood plains. The Diffagher River carried some peat sediment and other debris to Lough Allen, approximately 8.45km from the starting point, where it has washed up on the shoreline, e.g. at Corry Strand. The trajectory of the landslide with distances from the headscarp is shown in **Figure 2-1**.

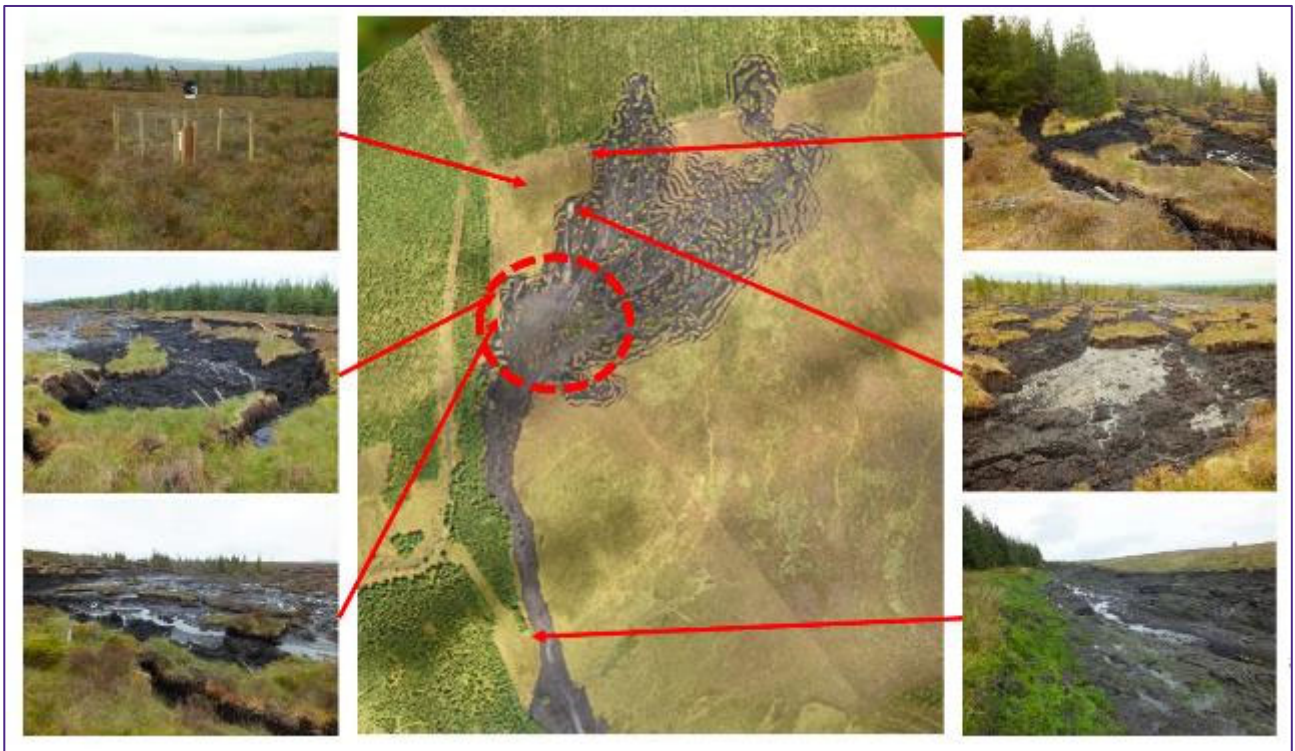
Figure 2-2 Starting Location of Landslide

The specific location where the landslide originated cannot be definitively stated. However, it is possible that the slide started in the area within the red dashed circle as shown in **Figure 2-2**. This hypothesis is based on the visible subsoil surface underneath the blanket bog which is a potential slip plane. The evacuation of peat from this area may have resulted in the destabilisation of the peat further upslope which is why there are islands of intact bog and standing trees within the affected area which 'floated' downslope with the peat. The subsoil layer under the blanket bog is also visible in places.

This is just one hypothesis of the timeline of the slide based on the current available information and discussion with relevant parties. To more accurately state causes of the slide, further studies would be required which have been listed in **Section 10.2**, Recommendations. This could include reviews of land-use; land-use change; drainage patterns; peat depths and properties; clay layer properties, extent and shape; and the impact of weather patterns on the landscape.

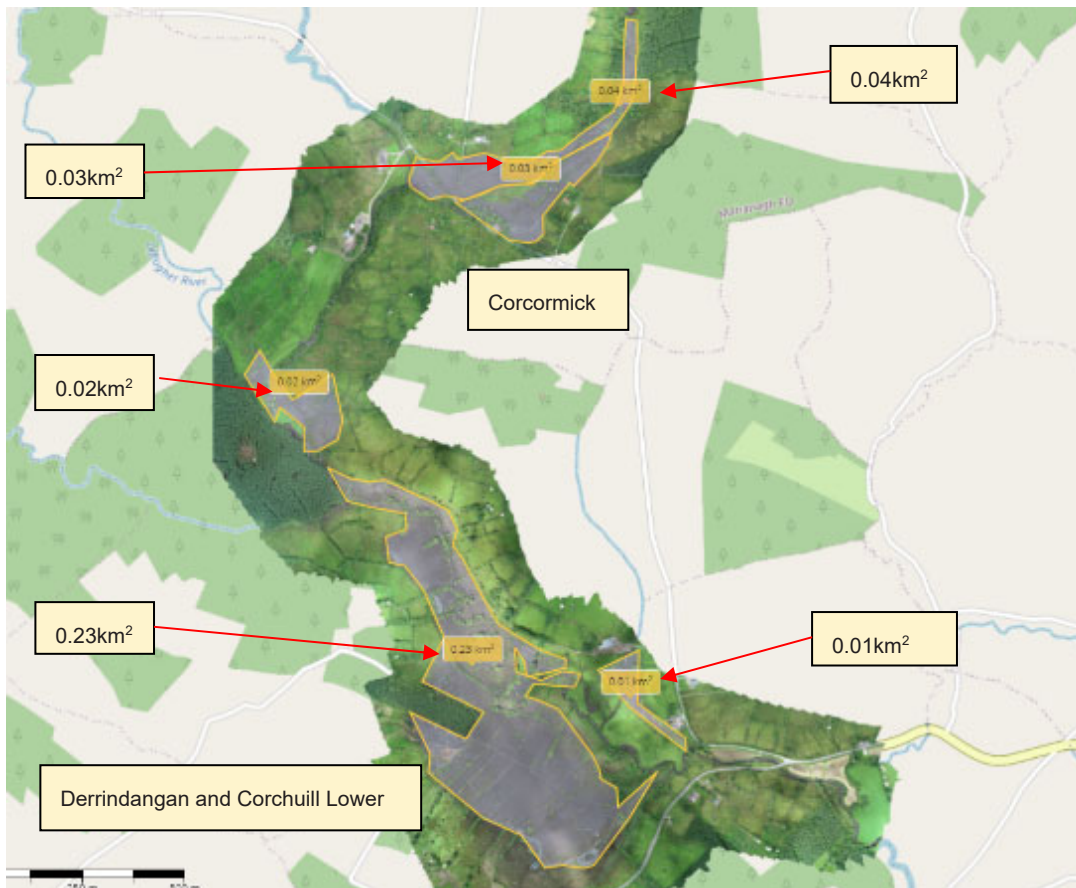
Figure 2-4 Inundated areas in the townlands of Corcormick (north) and Corcuhill Lower and Derrindangan

- Approximately 70,000m² (7 ha) of land was directly impacted in Corcormick. Assuming an average of 0.8m of peat material was deposited in this area, then the volume of peat material within the flood plain at Corcormick equates to 56,000m³ (56,000 tonnes).
- Approximately 260,000m² (26 ha) of land was directly impacted in Corcuhill Lower/ Derrindangan. Assuming an average of 0.4m of peat slurry was deposited in this area, then the volume of peat material within the flood plain at Derrindangan equates to 104,000m³ (104,000 tonnes).

The combined volumes of material deposited at Corcormick and Corcuhill Lower/ Derrindangan is 160,000m³ (160,000 tonnes).

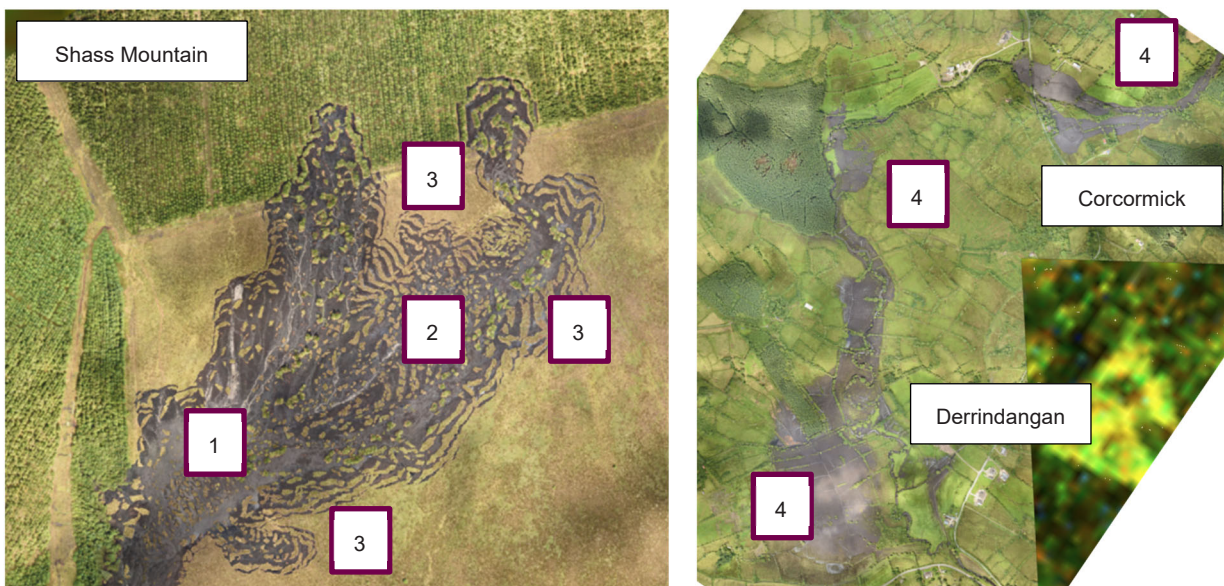
Figure 3-1 Elements of the Bog Flow/ Bog Slide on Shass Mountain Event

The landslide event on Shass Mountain presents all of the typical elements of a bog flow/ bog slide event (illustrated in **Figure 3-1**), which are:

1. Hypothesized source zone where the failure started;
2. Peat debris zone containing debris, peat blocks and mounds;
3. Zone of tension cracks and fissures in the adjacent peat mass; and
4. Downslope run-out zone, which stretches from above the head scarp on Shass Mountain above the Dawn Hope bridge to the R200 at Derrindangan, approximately 6.6km.

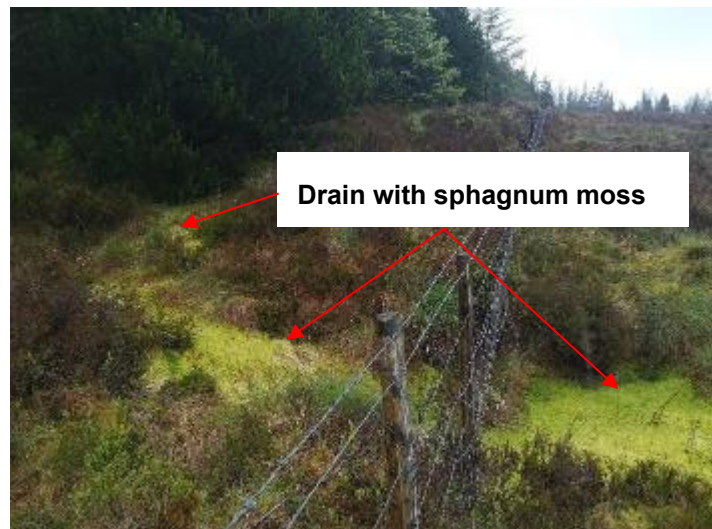
Figure 5-1 Perimeter drain revegetated with sphagnum moss on the edge of the forestry at Shass Mountain

For the establishment of the forestry at afforestation stage the area was drained with a series of mounds and furrows which connected to an external collector drain on the perimeter of the forested area. These drains could act as vertical pathways into the blanket bog. It was noted on a site visit after the event that the perimeter drain on the forestry edge has largely revegetated with sphagnum moss (**Figure 5-1**) and potentially transports reduced volumes of water since the time of planting. It has also been noted in the literature of the potential for cracking in the peat beneath forestry plantations allowing water to penetrate vertically into the lower peat layers. Evidence of this was not noted on the site walkover but should be considered in further detail at the Stage 2 report.
