# A Review of Criticality Accidents

2000 Revision

**LA-13638**

**Issued: May 2000**

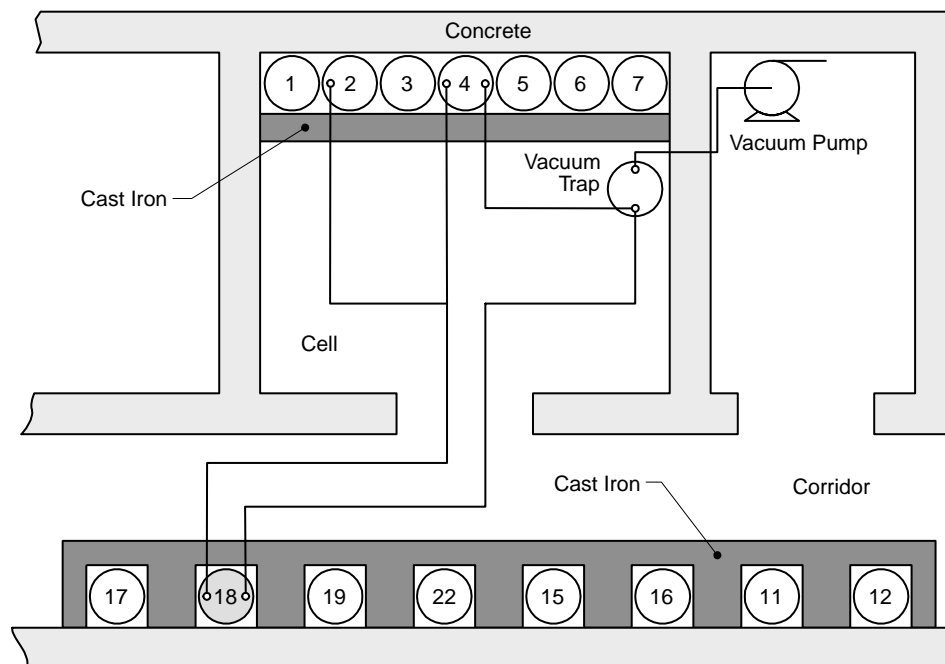
Figure 6. Layout of vessels and equipment in the staging area.

As part of the investigation, both experiments and calculations were performed to estimate the conditions for criticality in vessel 18. The results determined that 30 ℓ of solution containing 825 g of plutonium (27.5 g/ℓ) would be required for criticality. These values agree closely with the best estimate of the contents of vessel 18 at the time of the accident, 31 ℓ of solution with  $848 \pm 45$  g of plutonium (27.4 g/ℓ). One contributing cause of the accident was the unrecorded transfer of 5 ℓ of solution from vessel 1 to vessel 18.

60°C temperature rise was based on the coarse observation that the solution following the accident was at or near the boiling temperature. The accident caused no physical damage to any equipment. The operator positioned in the cell received an estimated dose of 100 rad. The operator near vessel 18 received an estimated dose of 1,000 rad. He suffered severe radiation sickness and amputation of both legs. He died 35 years after the accident.

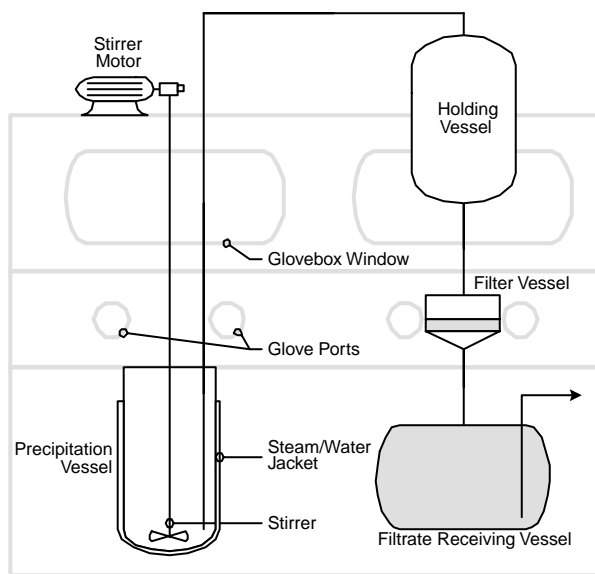
Figure 7. Equipment layout for the oxalate precipitation and filtration process.

- While not known for sure, it was suspected that minor defects in the filter fabric might also have contributed to an increased rate of precipitate accumulation in the filtrate vessel. Procedures called for the filter fabric to be replaced based on either visual evidence of defects or unusually high flow rates through the filter.

After dismantling the glovebox and cleaning the various pieces of equipment, a total of 3.06 kg of  $^{235}\text{U}$  was discovered in the filtrate receiving vessel. This material was primarily in two forms: a thin, hard crust, due to long-term buildup, and a flocculent precipitate, the concentration of which decreased with height in the vessel. The accident caused no mechanical damage to this vessel, and the room was not contaminated. The glovebox was taken apart, cleaned, and reassembled with essentially the original equipment. The operation was resumed after just a few days. During the downtime, a radiation meter was installed on the glovebox, operating instructions were revised, and enhanced operator training was implemented.

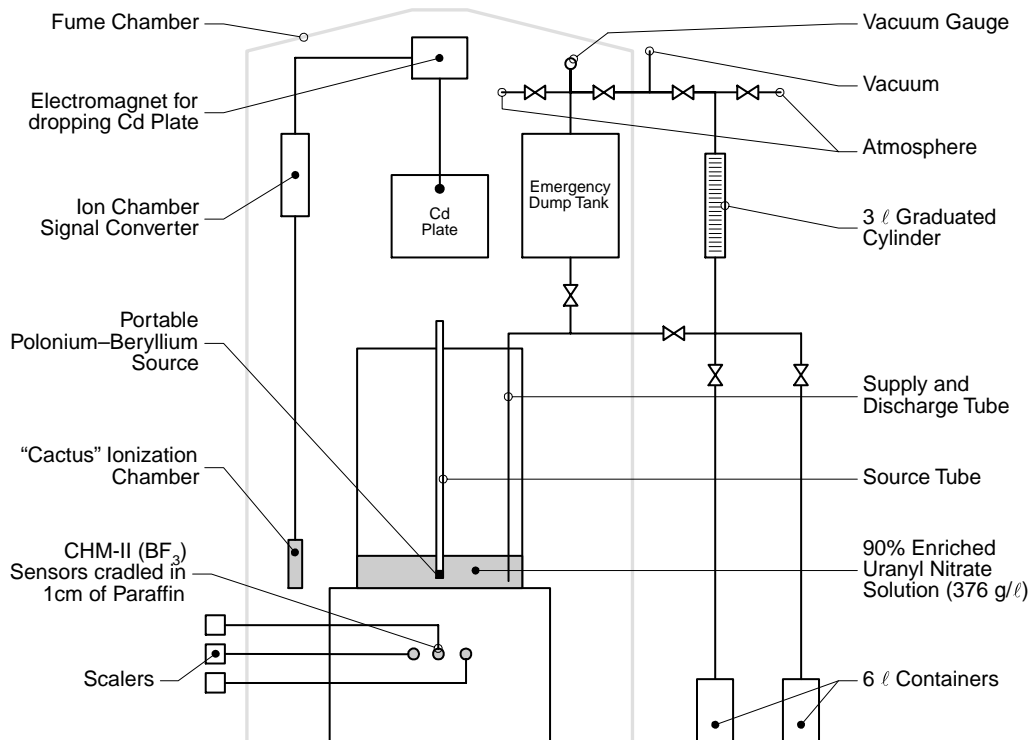
Figure 8. Layout of the experimental equipment.

They immediately noticed a flash (due to Cherenkov radiation), and simultaneously, fissile solution was violently ejected, reaching the ceiling about 5 m above. The three experimenters dropped the vessel and, along with a fourth experimenter who was located about 2.5 m away from the excursion, went immediately to the change room, showered, and were transported to the hospital. The combination of additional reflection from the three experimenters and the change in the geometry of the solution volume was sufficient to cause the system to exceed prompt critical. The small neutron background, estimated at only 100 neutrons per second, apparently also contributed to delayed initiation and thus to increased excursion energetics.

- Violation of the procedure that stipulated the complete draining of the experiment solution into 6 liter bottles.
- Unbolting and removing the experiment vessel when it contained solution. This was not specifically permitted in the operating procedure.

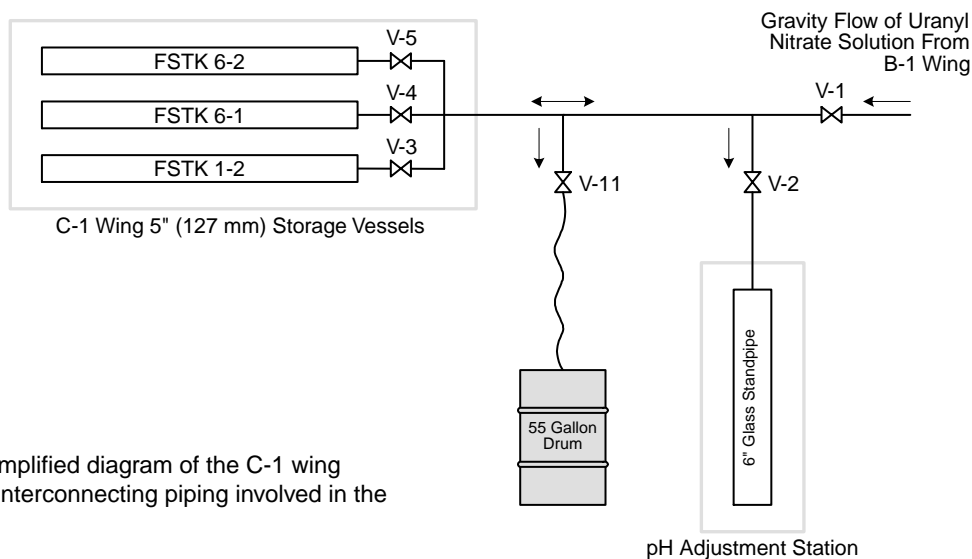
Figure 9 is a simplified diagram of the C-1 Wing vessels and equipment involved in the accident. The inventory required the disassembly and cleaning of the three, 5 inch (127 mm) diameter vessels\* (FSTK 1-2, FSTK 6-1, FSTK 6-2) used to store uranyl nitrate solution. Before resumption of operations, it was necessary to reassemble and to leak test the vessels. This entire process usually required several, 8-hour shifts to complete.

At ~01:00 during the shift preceding the accident (23:00 Sunday, 15 June, to 07:00 Monday, 16 June), the C-1 Wing supervisor noted that uranyl nitrate solution was present in a 6 inch (152 mm) diameter glass standpipe that was part of the pH adjustment station (Figure 9). He instructed an operator to drain the standpipe. At 05:00, the supervisor again noted uranyl nitrate in the standpipe and questioned the operator as to whether it had been drained earlier. The operator confirmed that it had been, and upon further

investigation, they determined that solution was leaking into the standpipe through valve V-2. The valve was closed, and the standpipe was again drained.

Unknown to anyone at the time, uranyl nitrate had been leaking from the B-1 Wing through valve V-1 from the early hours of the previous shift until about 13:30, when one of the operators checked it (and by applying pressure completely closed the valve), as instructed by the supervisor. Before this, the uranyl nitrate had been collecting in vessel FSTK 1-2, because valve V-3 had also been open.

Figure 9. Simplified diagram of the C-1 wing vessels and interconnecting piping involved in the accident.

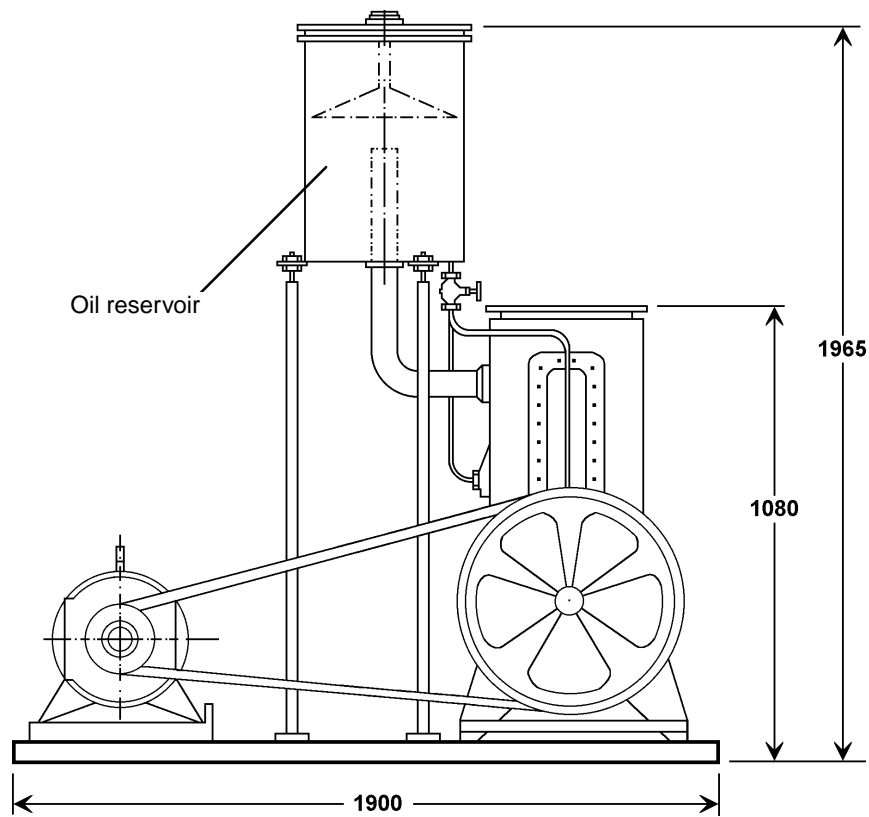
Figure 15. Vacuum pump diagram showing oil reservoir (Dimensions are in mm).

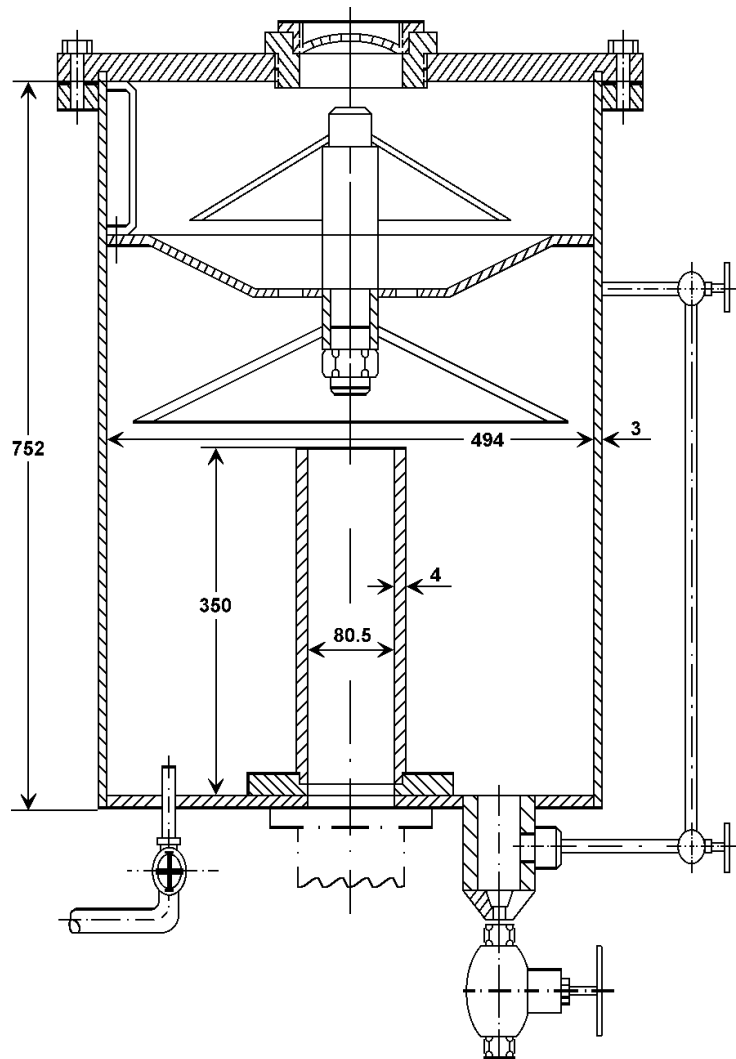
When the pump was turned on at 07:30, the oil in the pump's cavities was forced out into the central pipe of the oil reservoir. This sudden injection of oil containing uranium led to the second and much larger excursion. The shutdown of this excursion was due to a combination of temperature rise and radiolytic gas generation, which caused ejection of the oil from this central pipe back into the pump's cavities and the gas purification equipment. As with the first excursion, the

Figure 16. Oil reservoir (Dimensions are in mm).

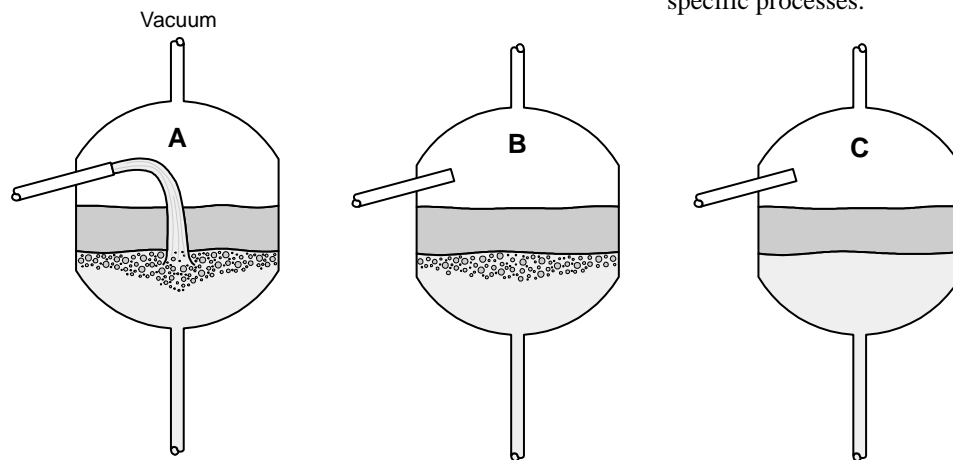
This excursion illustrates the subtle ways in which accidents can occur during solution processing. Although the deep trap was considered a safety feature for the control of contamination, it contributed directly to the criticality accident. The difficulty of understanding what had happened, even after it was known in which vessel the excursion occurred, is an excellent example of the impracticability inherent in attempting to calculate criticality accident probabilities for specific processes.

Figure 26. Solution transfer as reconstructed from the transparent plastic mockup of the transfer vessel. Configuration (B) is the postulated state at the time of the accident.

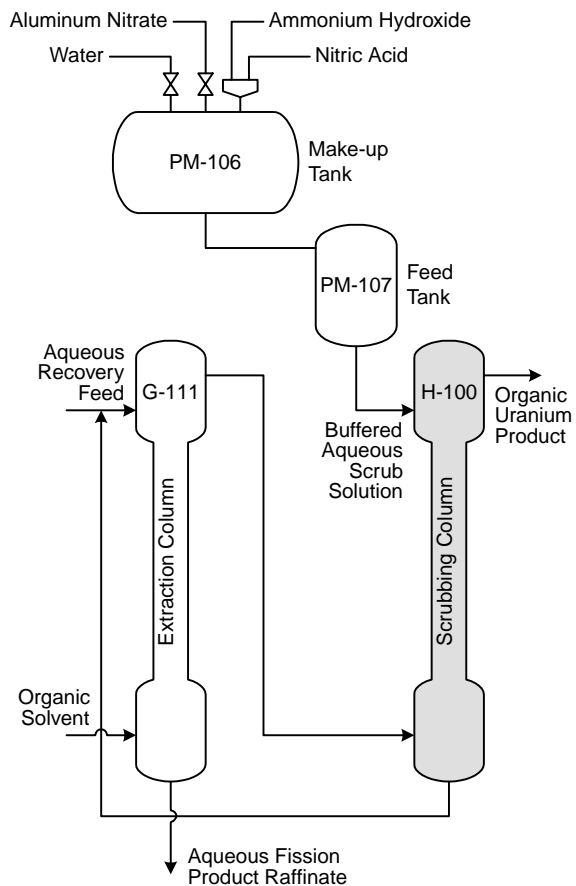
for the scrubbing column, H-100, had been leaking for about a month prior to the accident. Over time, this leak caused a dilution of the feed solution from 0.75 M to 0.08 M. The 13,400 ℓ make-up tank was equipped with a density alarm that would have indicated the discrepancy, but the alarm was inoperable. A density alarm was scheduled to be installed on the 3,000 ℓ process feed tank (PM-107) that was filled, as necessary, from the make-up tank, but this had not been done. The make-up tank was instrumented with a strip-chart recorder showing the solution level in the tank. However, the leak into the tank was so slow that the change in level would have not have been discernible unless several days worth of the chart was analyzed. To complicate matters, the chart recorder had run out of paper on 29 September and it was not replaced until after the accident. Furthermore, procedures that required the taking of samples from the feed tank, PM-107, to confirm the density, were not being followed.

Figure 27. First cycle extraction line equipment. The accident occurred in the lower disengagement section of the H-100 column.

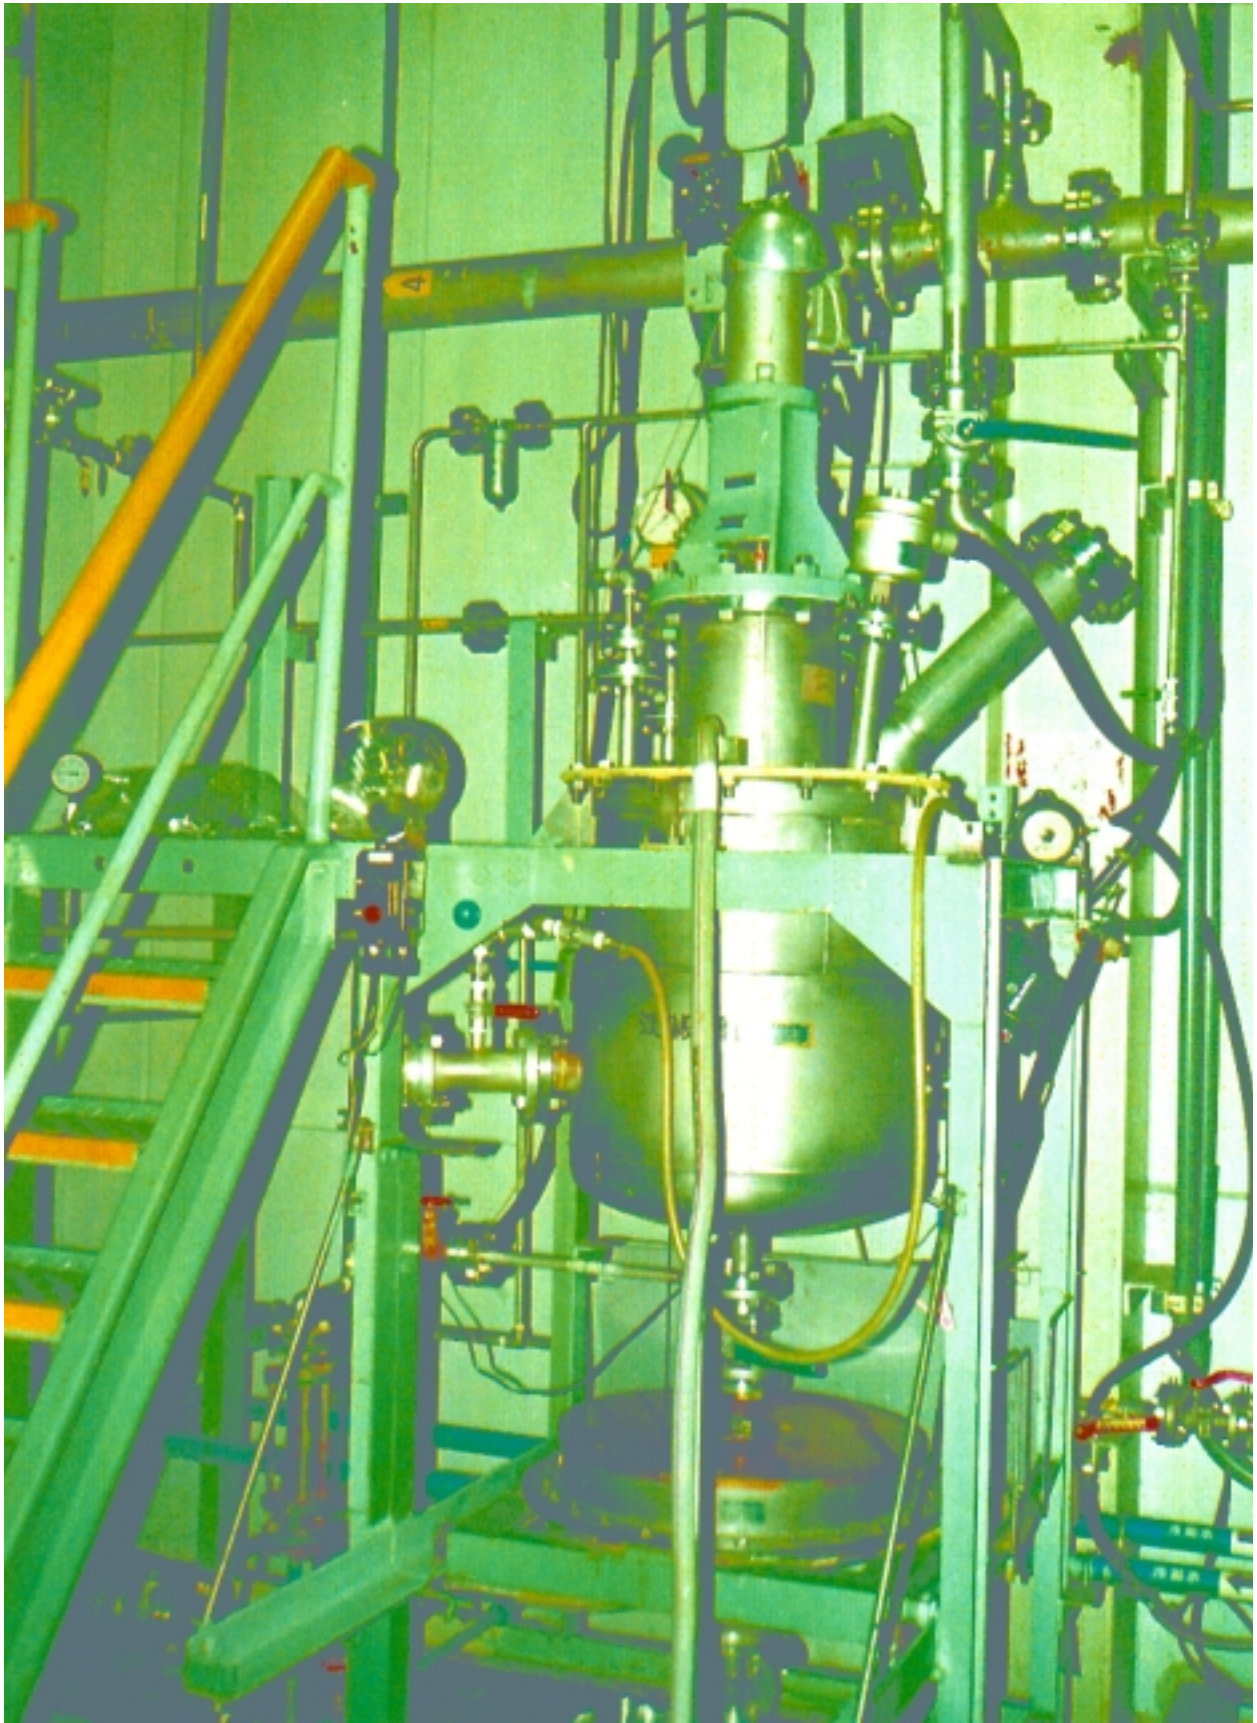
Figure 35. The precipitation vessel in which the process criticality accident occurred.
