NL-16-032

March 16, 2016

SUBJECT: Entergy Transmittal of Indian Point 2 ASME Section XI, IWL Concrete Containment Inspection In Accordance With the Parties' Approved Settlement of License Renewal Contention NYS-24
Indian Point Unit Number 2
Docket No. 50-247
License No. DPR-26

ENTERGY ENGINEERING REPORT IP-RPT-15-00029,
“IP2 ASME SECTION XI, IWL CONCRETE CONTAINMENT
INSPECTION FOR 2015”

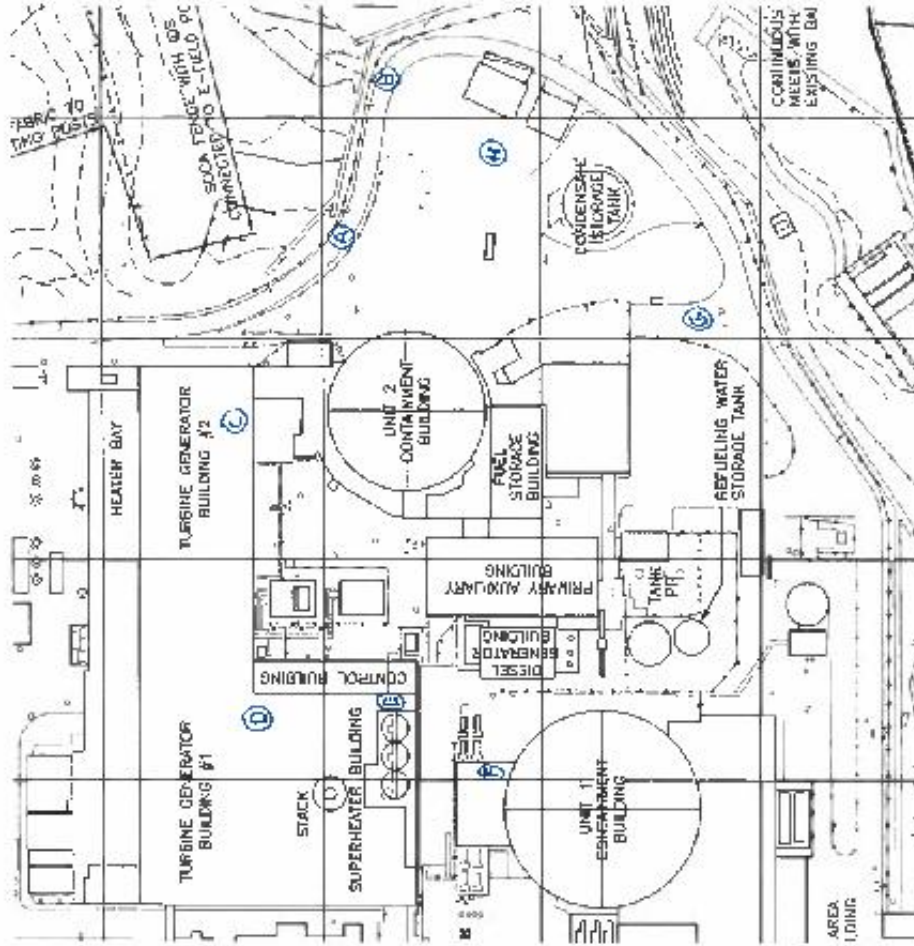
FIGURE 1

Vantage Points Used in Remote Visual Inspection		
Vantage Point	Description	Zones Examined
A	Along edge of road.	Zone 1 from El. 31' to El. 68'
B	Along edge of road.	Zone 1 from El. 68' to Dome
C	Edge of Turbine Building roof.	Zone 2 from El. 68' to Dome
D	Edge of Superheater Building upper roof.	Zone 3 from El. 68' to Dome
E	Edge of Superheater Building lower roof.	Zone 3 from El. 68' to El. 98'
F	Edge of NSB roof.	Zone 4 from El. 108' to Dome
G	Along edge of road	Zone 5 from El. 108' to Dome
H	On and north of condensate tank.	Zone 6 from El. 108' to Dome

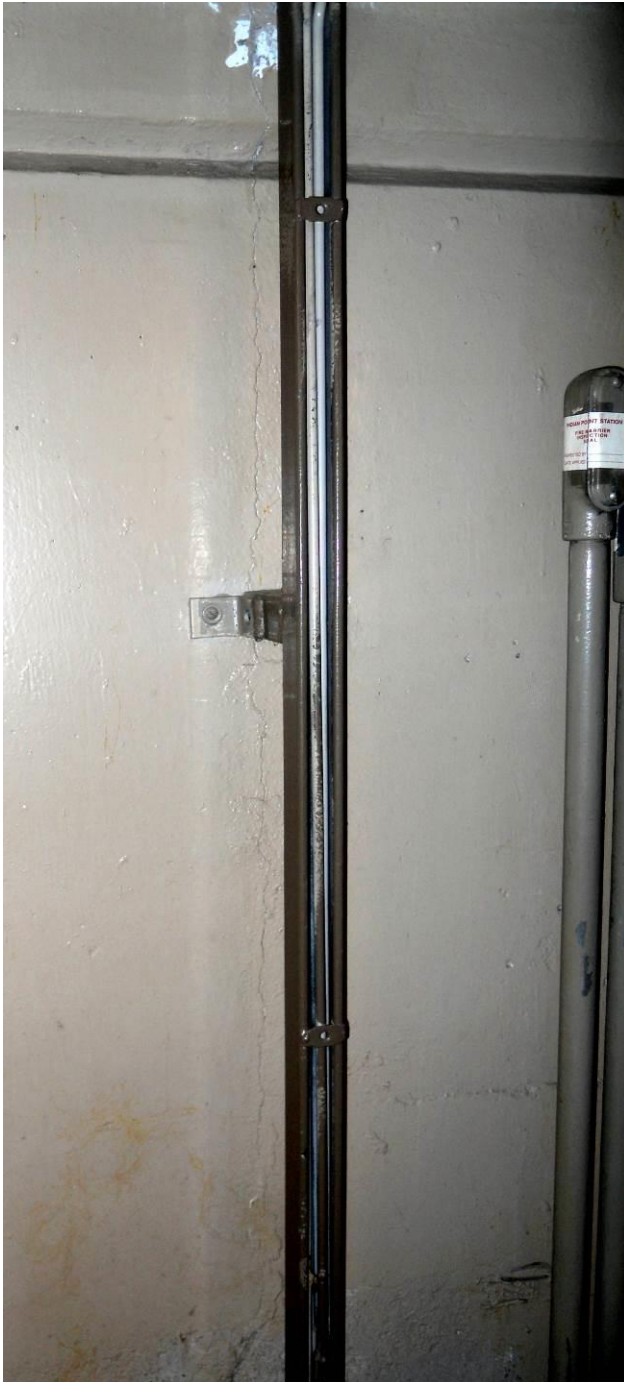
2015 Photo IWL-034-002 Photo Z2-002

No.	Comment	Initials
1	There are several pockets (8 total all less than 8" long) of unconsolidated concrete ("honeycomb") at the very bottom edge of the mat. These areas are due to lack of proper consolidation or loss of paste during original concrete placement and do not represent degradation. This area continues to be monitored with no changes since the baseline inspection. See photos Z2-001 through Z2-001E .	JK
2	Crack behind unistrut, 56" long & 1/16" wide, ends at ceiling and void below. In same location as item 1. No change since previous inspection. See photos Z2-002, Z2-002A, Z2-002B and Z2-002C .	JK
3	<p>There are a number of areas within this zone where the coating is flaking and peeling. There is no evidence that this is due to degradation of the concrete substrate. It is a coatings related issue and not containment degradation. No notable change since last inspection.</p> <ul style="list-style-type: none"> - Two areas flaking/peeling in main room. See photos Z2-003, Z2-003A, Z2-003B, Z2-004, and Z2-004A. - 9" x 7" area behind PCV-1310-B, Aux. Feed Pump 22 St. Supply, peeling due to heat damage. See photos Z2-005 and Z2-005A. - South corner 36" x 18" flaking/peeling. See photos Z2-006 and Z2-006A. - 	JK

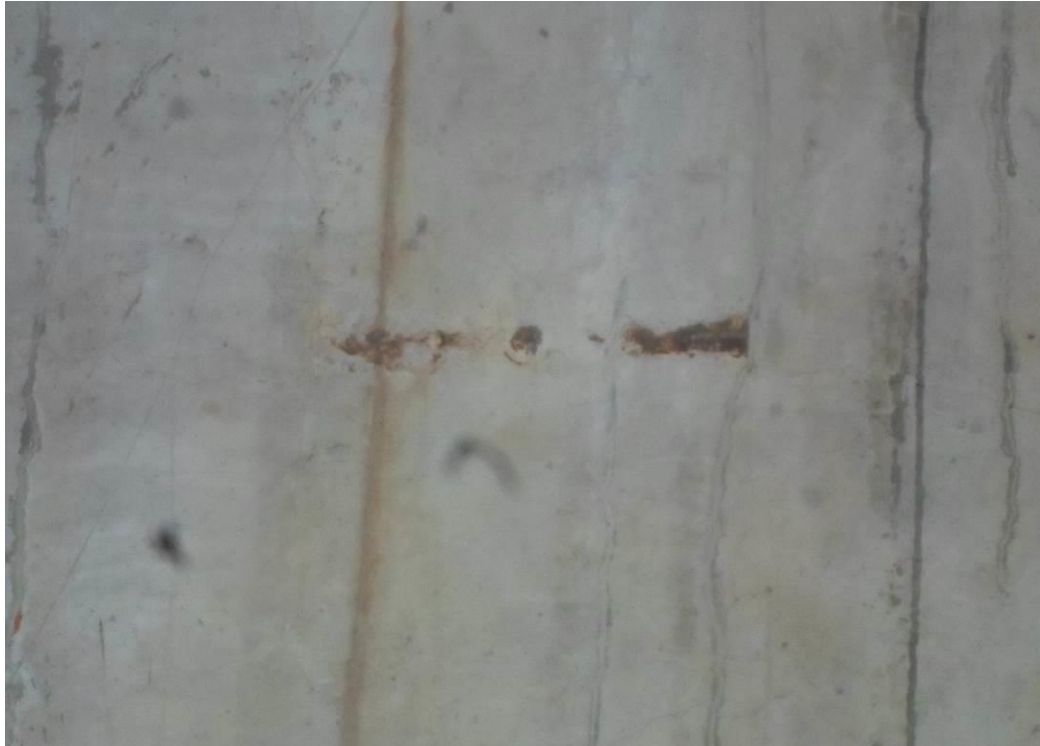
Photo Z3-007

8.	Epoxy injection tubes near Pipe Penetration wall up to ~6'. See photo Z3-006 .	JK
9.	Cut anchors in top corner behind column. Slight corrosion is evident but no streaking or staining of the concrete. See photo Z3-007 .	JK

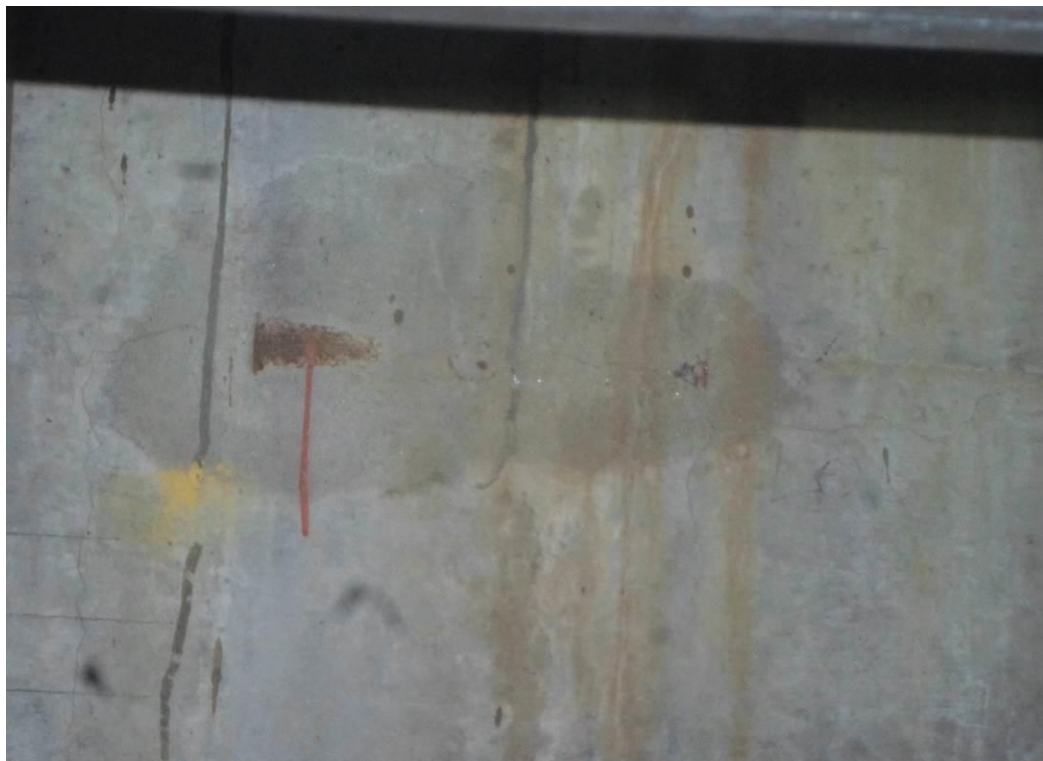
Photo Z3-008

10.	Next to containment area cage, tight vertical crack intersecting horizontal joint with minor separation (<1/16")	JK
11.	Two partially exposed cadwelds near left side due to lack of cover. No spalling. See photos Z3-008 and Z3-008A .	JK

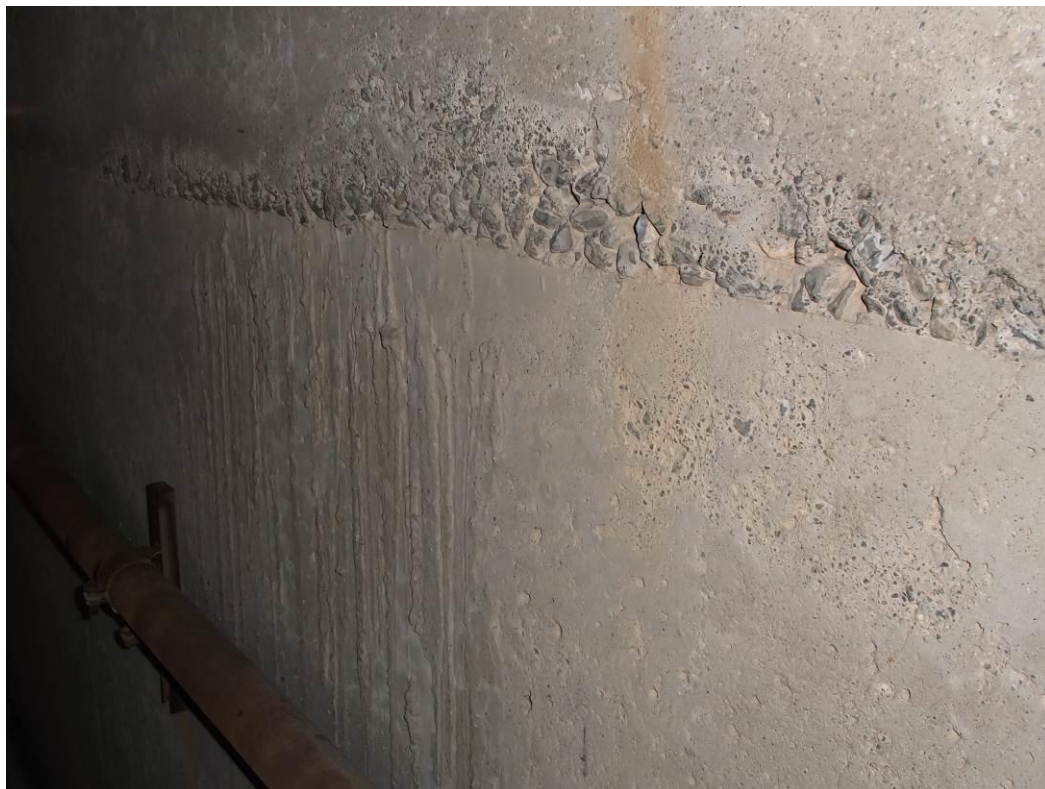
Photo Z5-001

No.	Comment	Initials
1	Three sets of two popouts (approx. 2" dia.) behind the duct (approx. El. 97', El. 102' and El. 107') possibly from unfilled form ties or drilled holes. See photo Z5-001.	<i>AWD 9-28-15</i>
2	Exposed aggregate due to loss of matrix from initial vibration. Cement paste streaks due to improper form work installation is visible. Rust stains appear from surface mounted steel. No change since 2005 inspection. See photos Z5-002, Z5-002A, Z5-002B and Z5-002C.	<i>AWD 9-28-15</i>
3	An additional 10' of inspected elevation (El. 78' – 88') was added to this component and pertain to comment 2 above.	<i>AWD 9-28-15</i>
4	Drop-in anchors were installed to allow scaffold to be built for painting of the vent stack. See sample photos Z5-002A and Z5-002B.	<i>AWD 9-28-15</i>
