ACCESSION NBR: 8104070395 DOC. DATE: 81/04/02 NOTARIZED: YES DOCKET #
 FACIL: 50-250 Turkey Point Plant, Unit 3, Florida Power and Light Co. 05000250
 AUTH. NAME: UHRIG, R. E. AUTHOR AFFILIATION: Florida Power & Light Co.
 RECIP. NAME: RECIPIENT AFFILIATION:

SUBJECT: Application to amend License DPR-31 requesting permission to return facility to power operation for six equivalent full power months. Class III amend fee encl.

Re: Turkey Point Unit 3
Docket No. 50-250
Steam Generator Inspections

TURKEY POINT 3 STEAM GENERATOR
INSPECTION PROGRAM
March, 1981

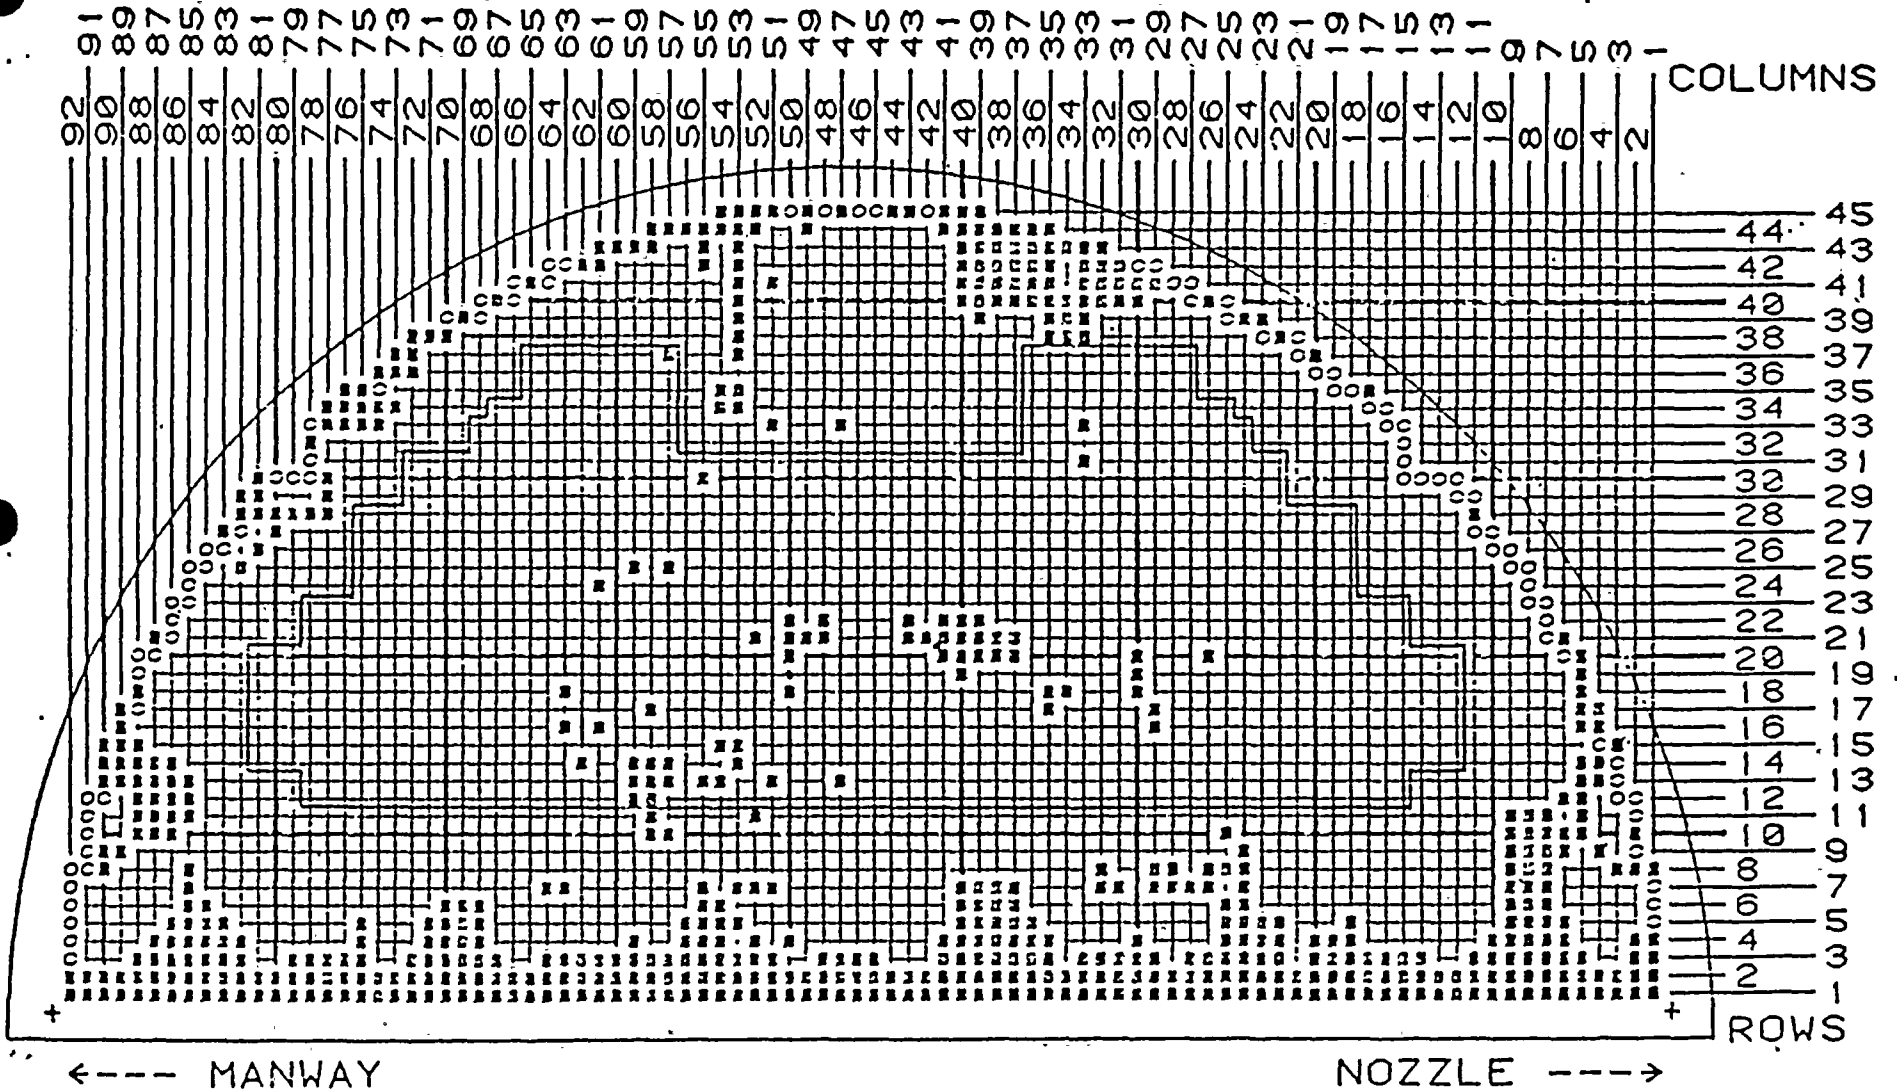
GAUGE ALL TUBES OUTSIDE BOUNDED AREA, OCTOBER, 1980

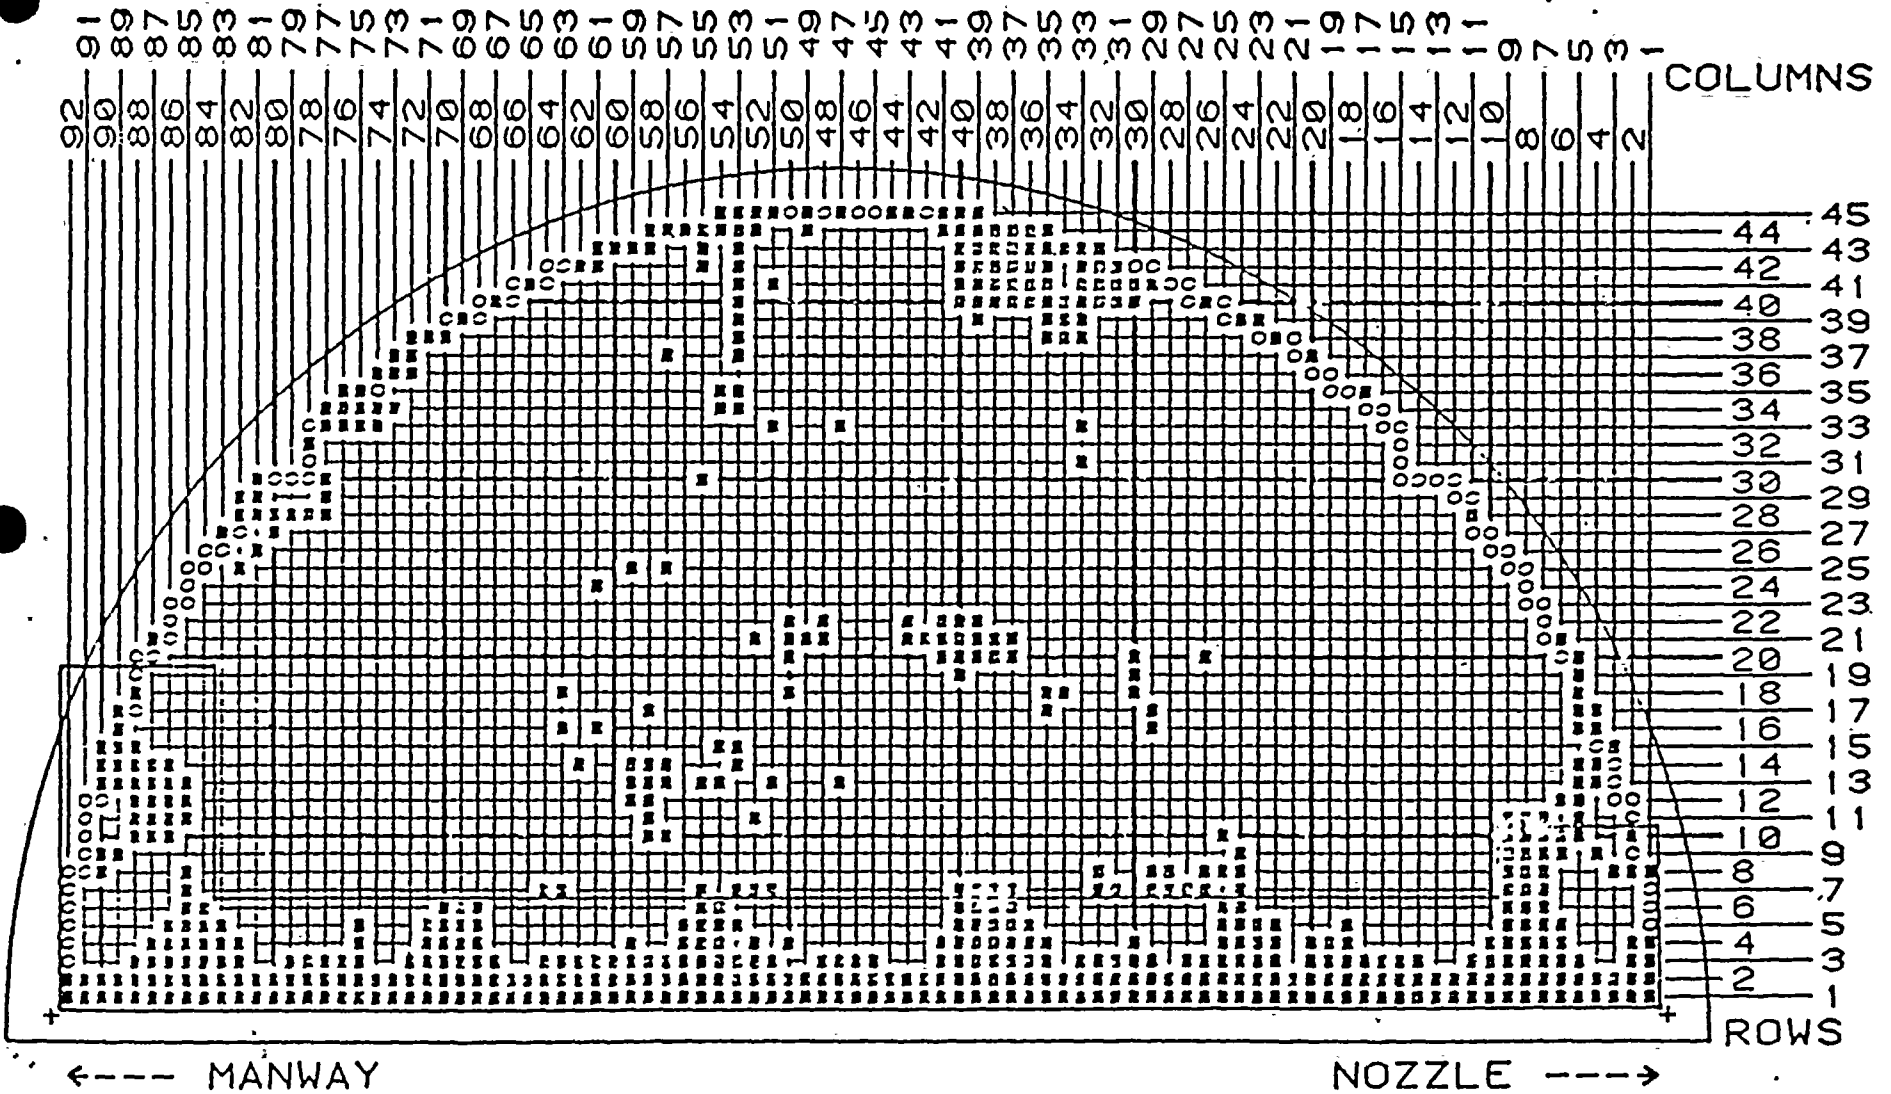
FIGURE 2

GAUGING PROGRAM (TYPICAL) OUTLET
GAUGE ALL TUBES WITHIN BOUNDED AREA
OCTOBER, 1980

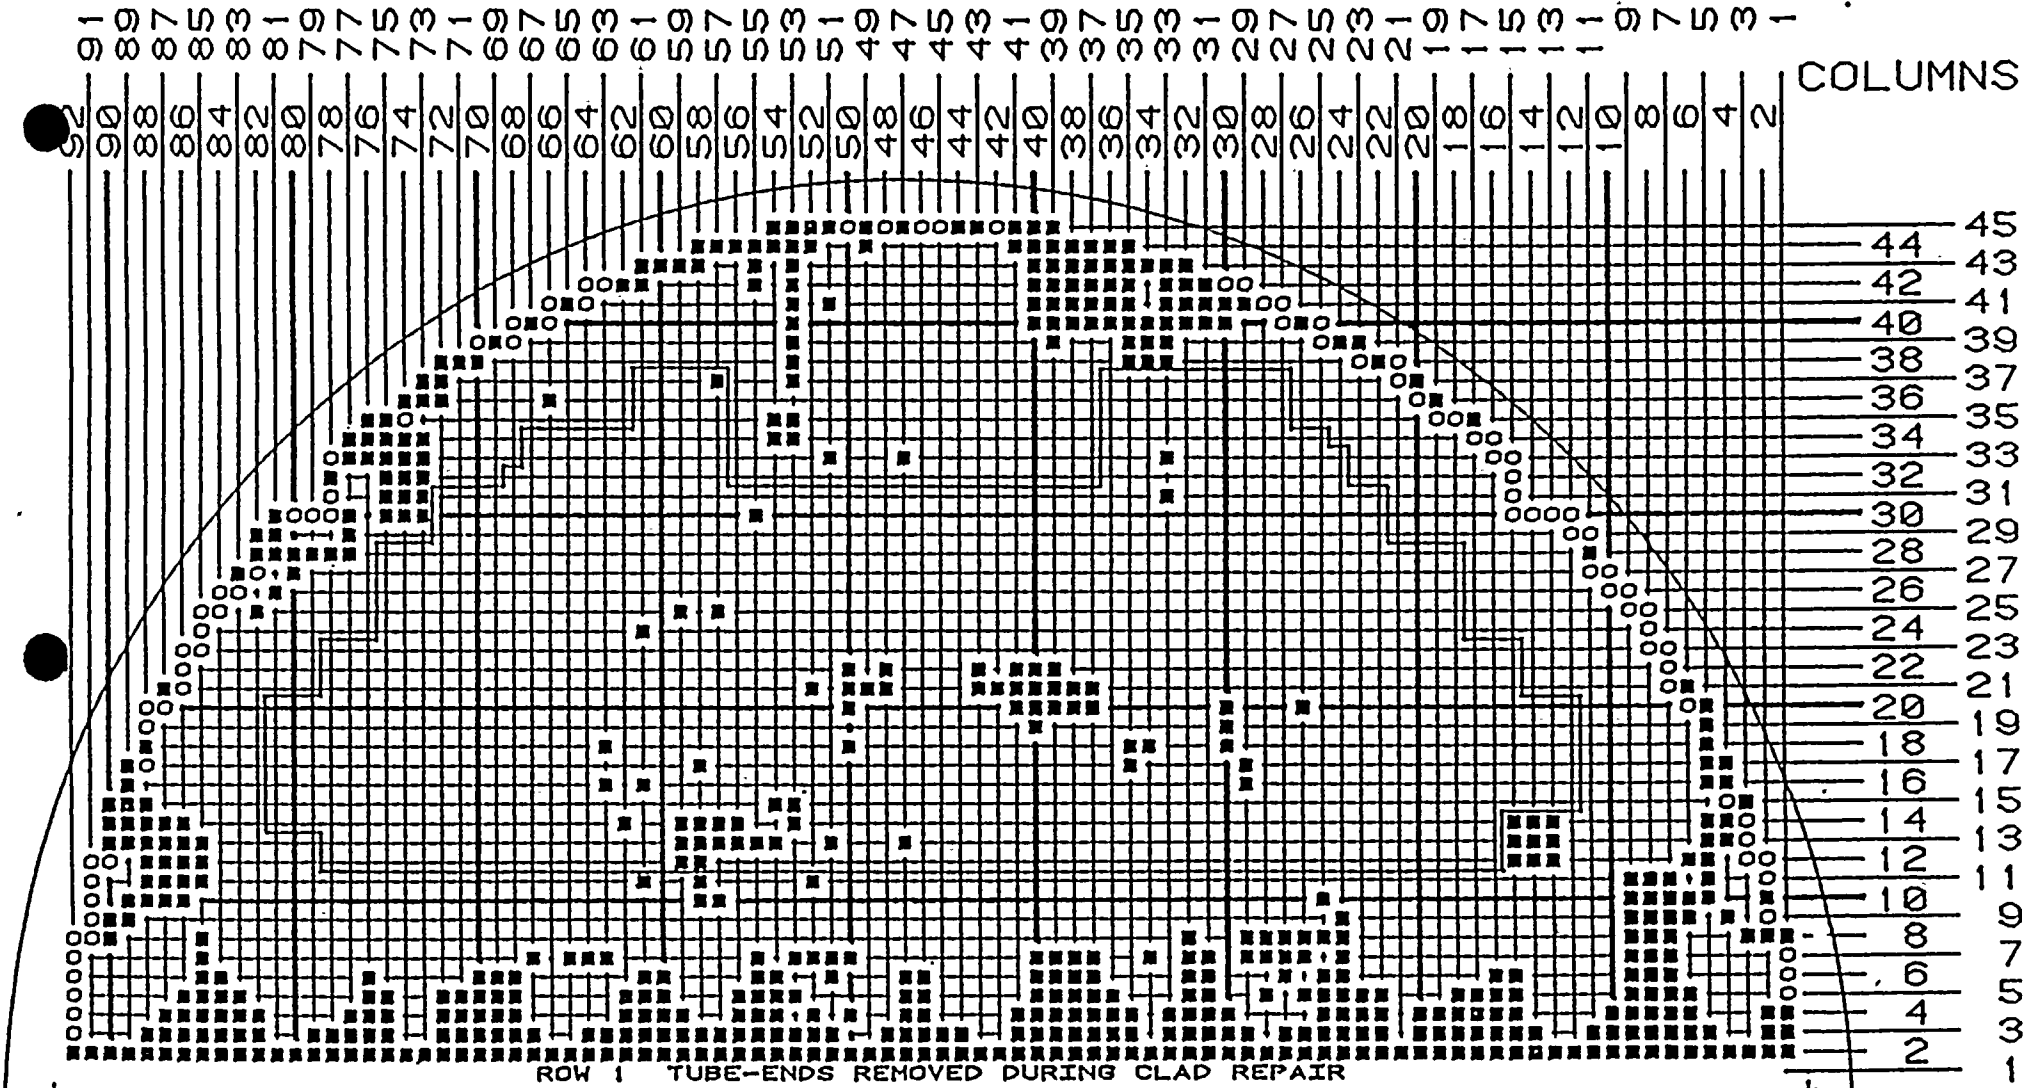
FIGURE 3

TURKEY POINT UNIT #3
STEAM GENERATOR A - HOT LEG
GAUGING PROGRAM

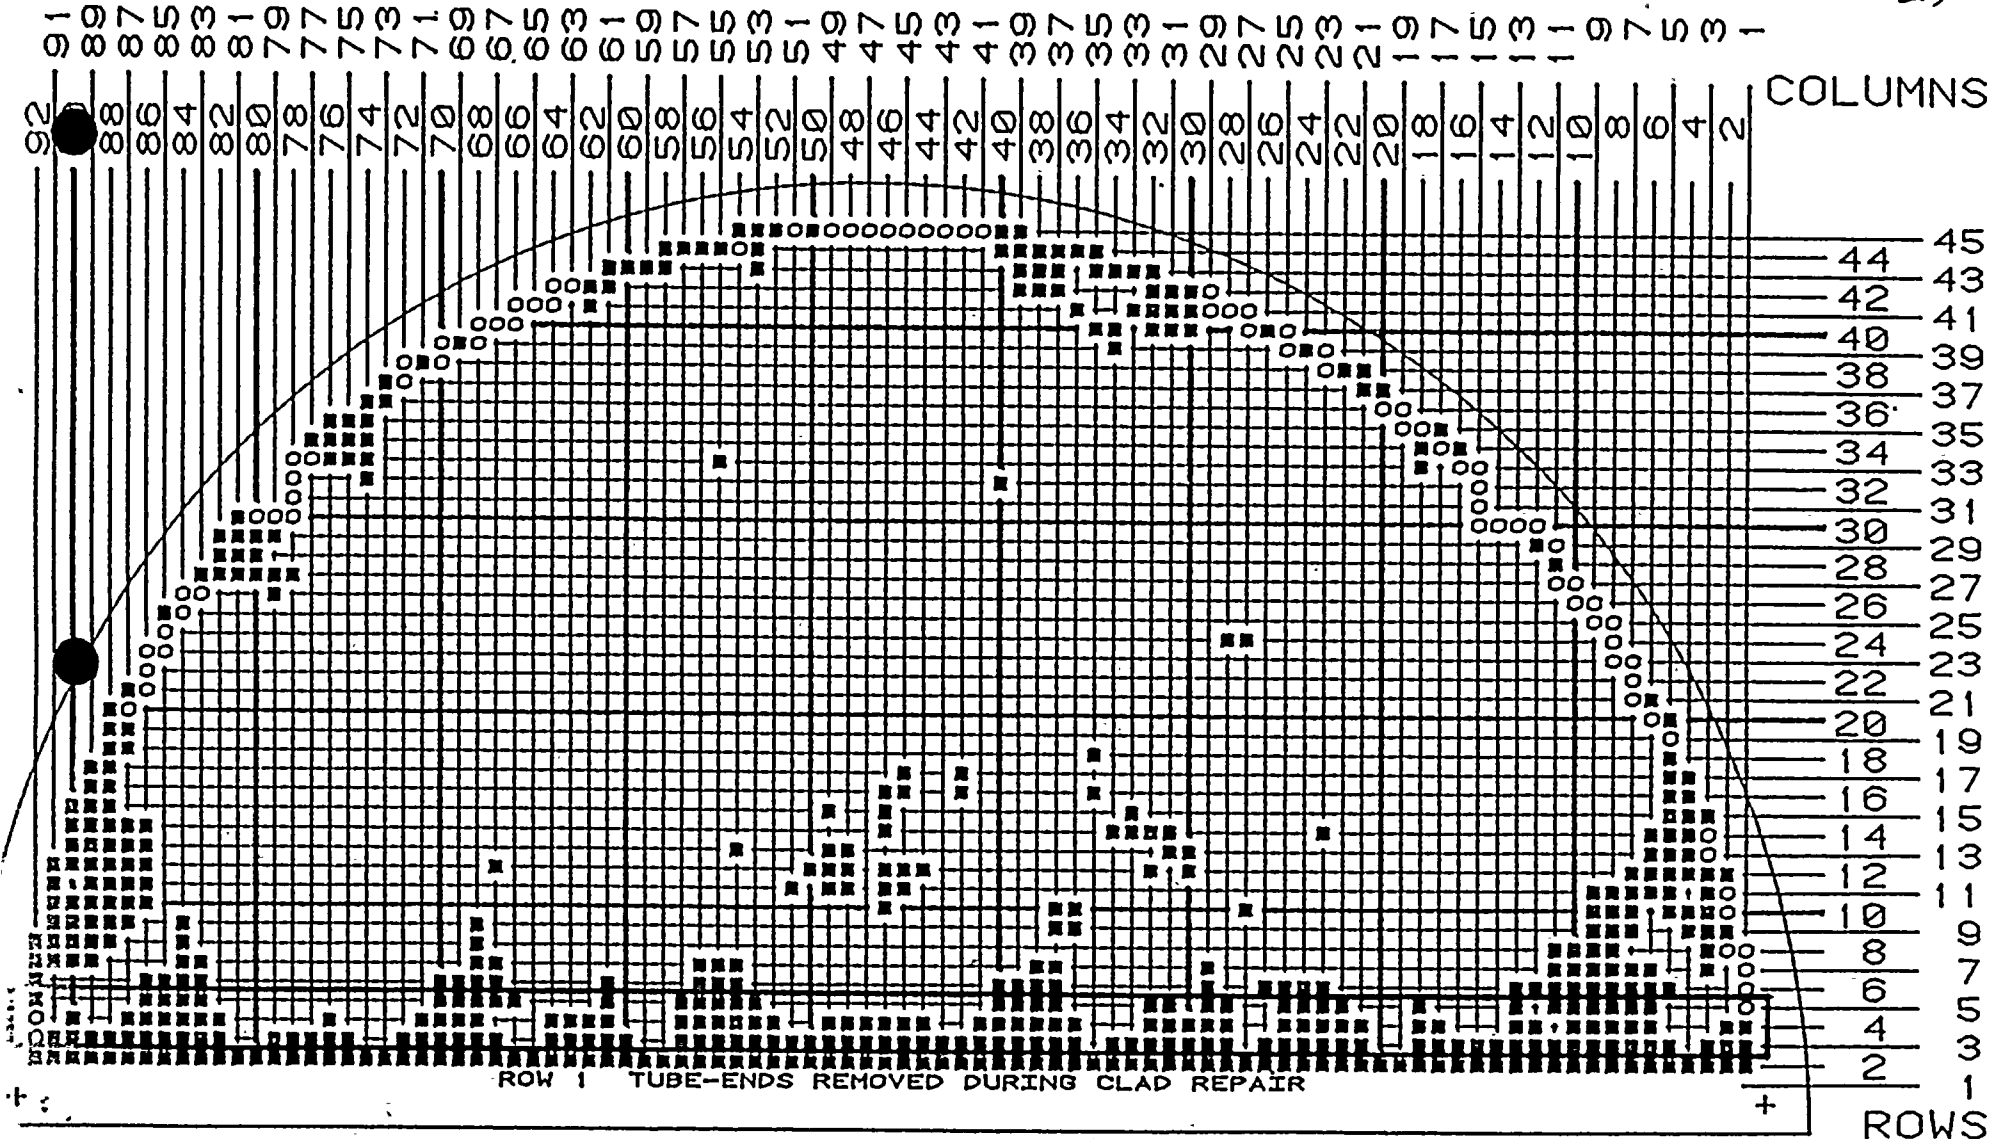
FIGURE 9

The U-bends of unplugged tubes in rows 3 thru 5 in steam generator C were examined at 100 kHz. No indications were noted in these small radius U-bends.

←--- MANWAY Tight Radius U-Bend Program - Test Blocked-IN NOZZLE ---→
 Area through U-Bend with .610 BF and 540 BF
 102 Tubes.

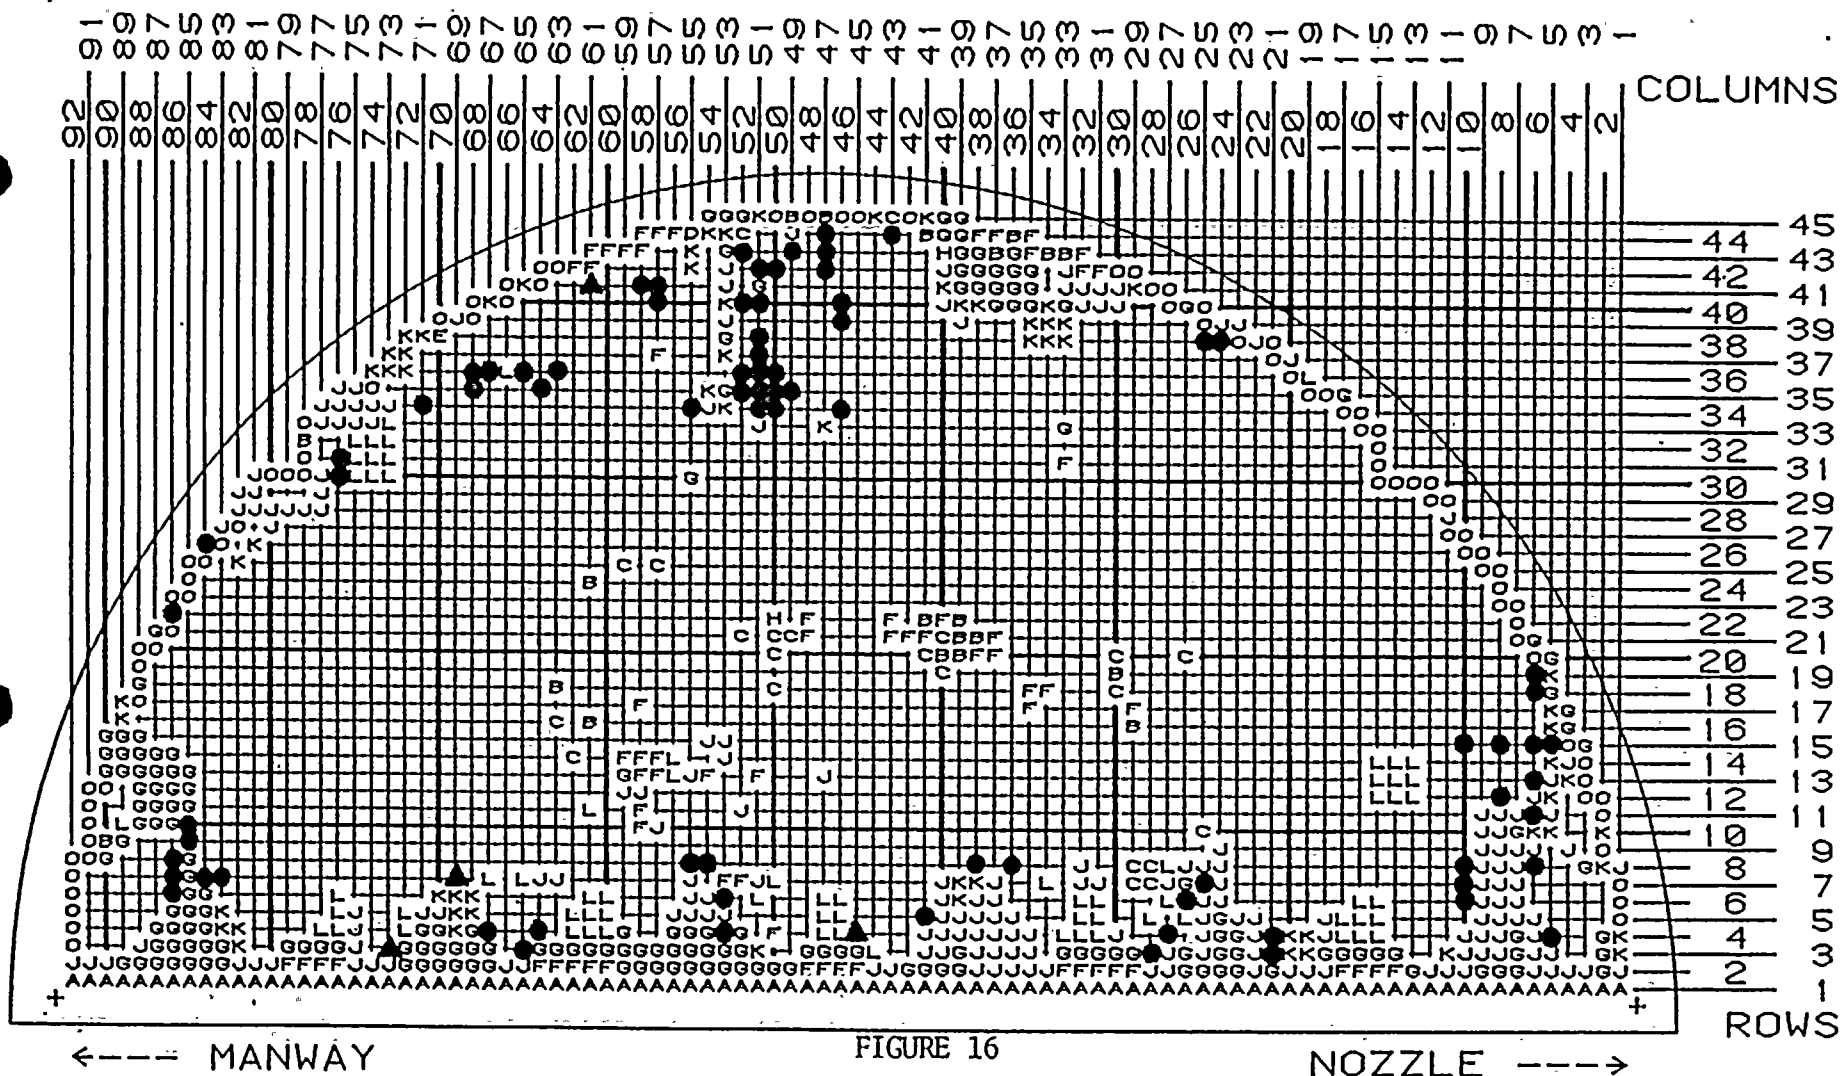
FIGURE 16
TURKEY POINT UNIT #3
GAUGING RESULTS, MARCH, 1981
STEAM GENERATOR A - HOT LEG

RESTRICTED TUBES	NO. OF TUBES
X = .540 Probe	None
▲ = .610 Probe	4
● = .650 Probe	78

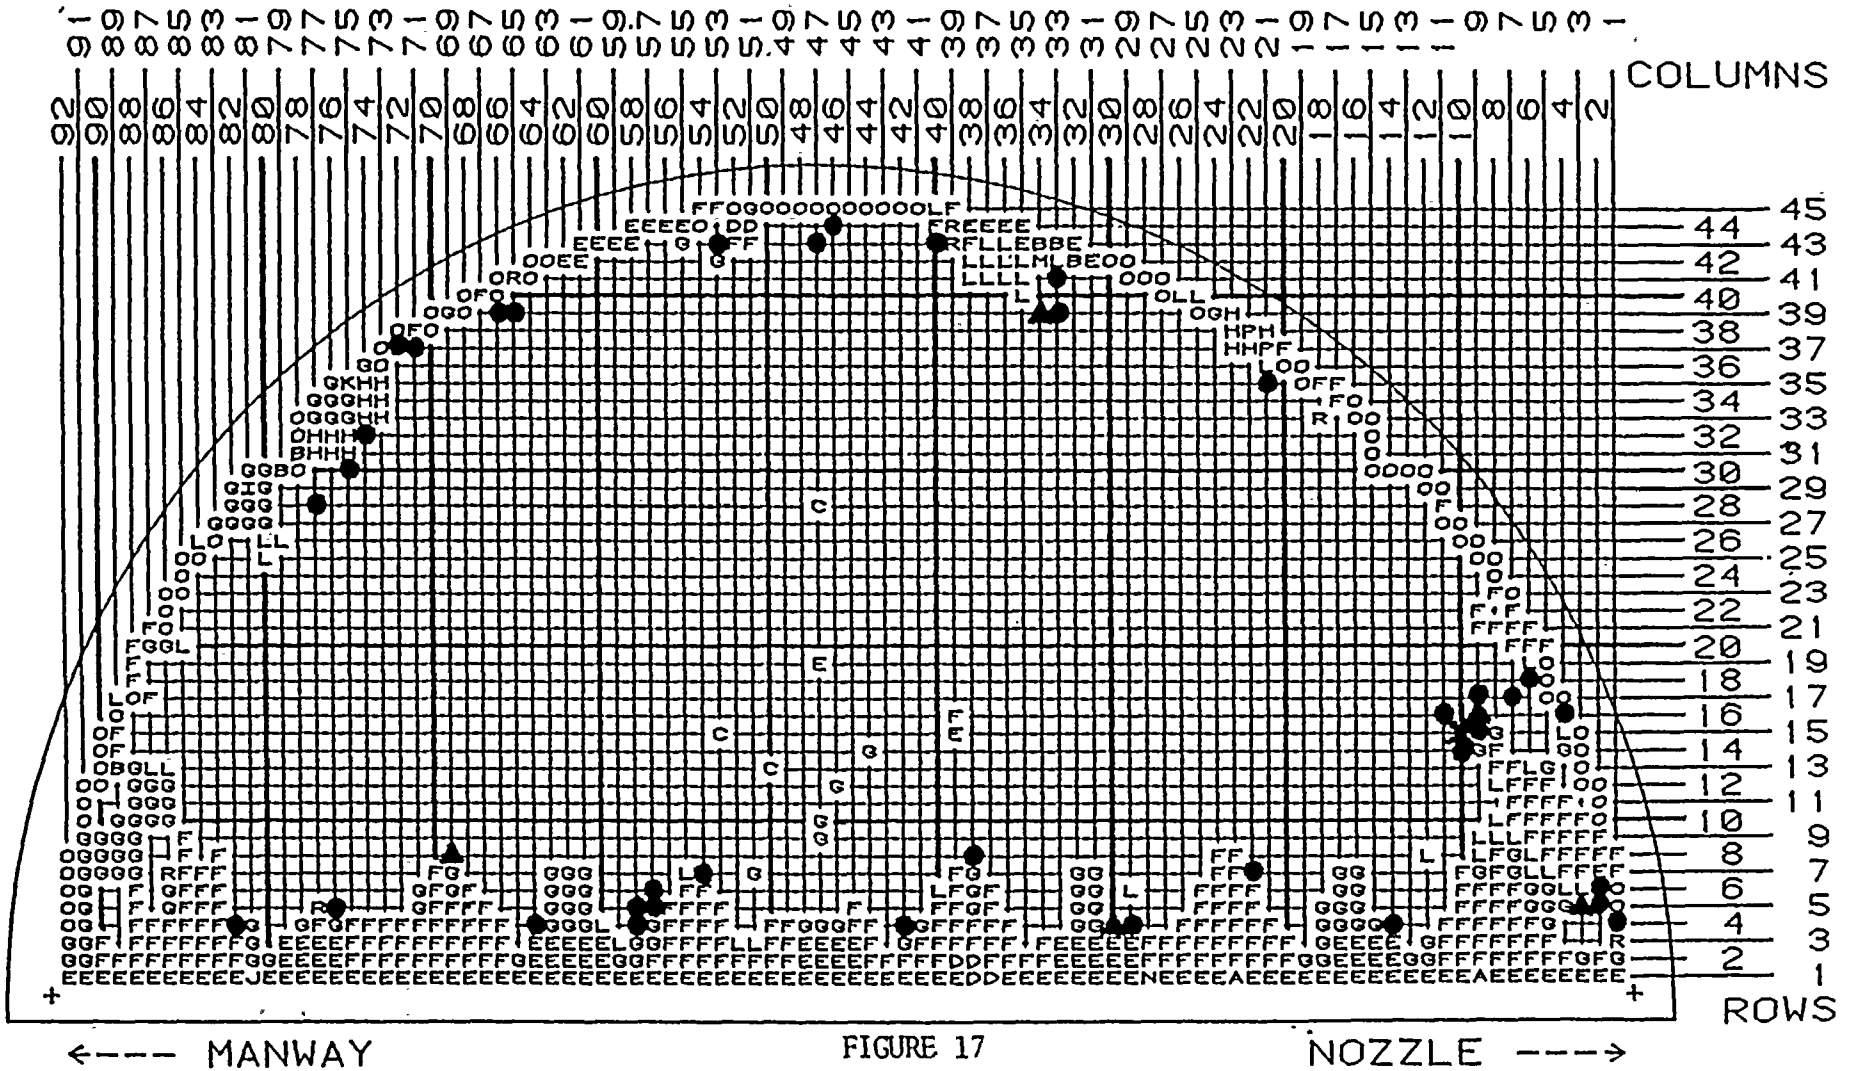
FIGURE 17
 TURKEY POINT UNIT #3
 GAUGING RESULTS, MARCH, 1981
 STEAM GENERATOR B - HOT LEG

RESTRICTED TUBES	NO. OF TUBES
X = .540 Probe	1
▲ = .610 Probe	5
● = .650 Probe	37

1. All tubes which do not pass the 0.540 inch probe will be plugged. Only one such tube (steam generator B; R 15-C10) was observed in this inspection.
2. Additionally, for in excess of ten (10) months operation, two (2) tubes beyond (i.e., higher row numbers) any tube in columns 1-92 in the tubelane region which did not pass the 0.540 inch probe will be plugged. (Calculation of the progression of the 17-1/2% strain contour, as determined from finite element plots through 24 EFPM after closure, results in predicted advancement of this contour by 1.9 tube rows for a 10 month operating period. Given the conservatism of this approach, plugging two additional tubes beyond observed 540 mil restrictions provides adequate margin. This criterion was not applicable in this inspection.)

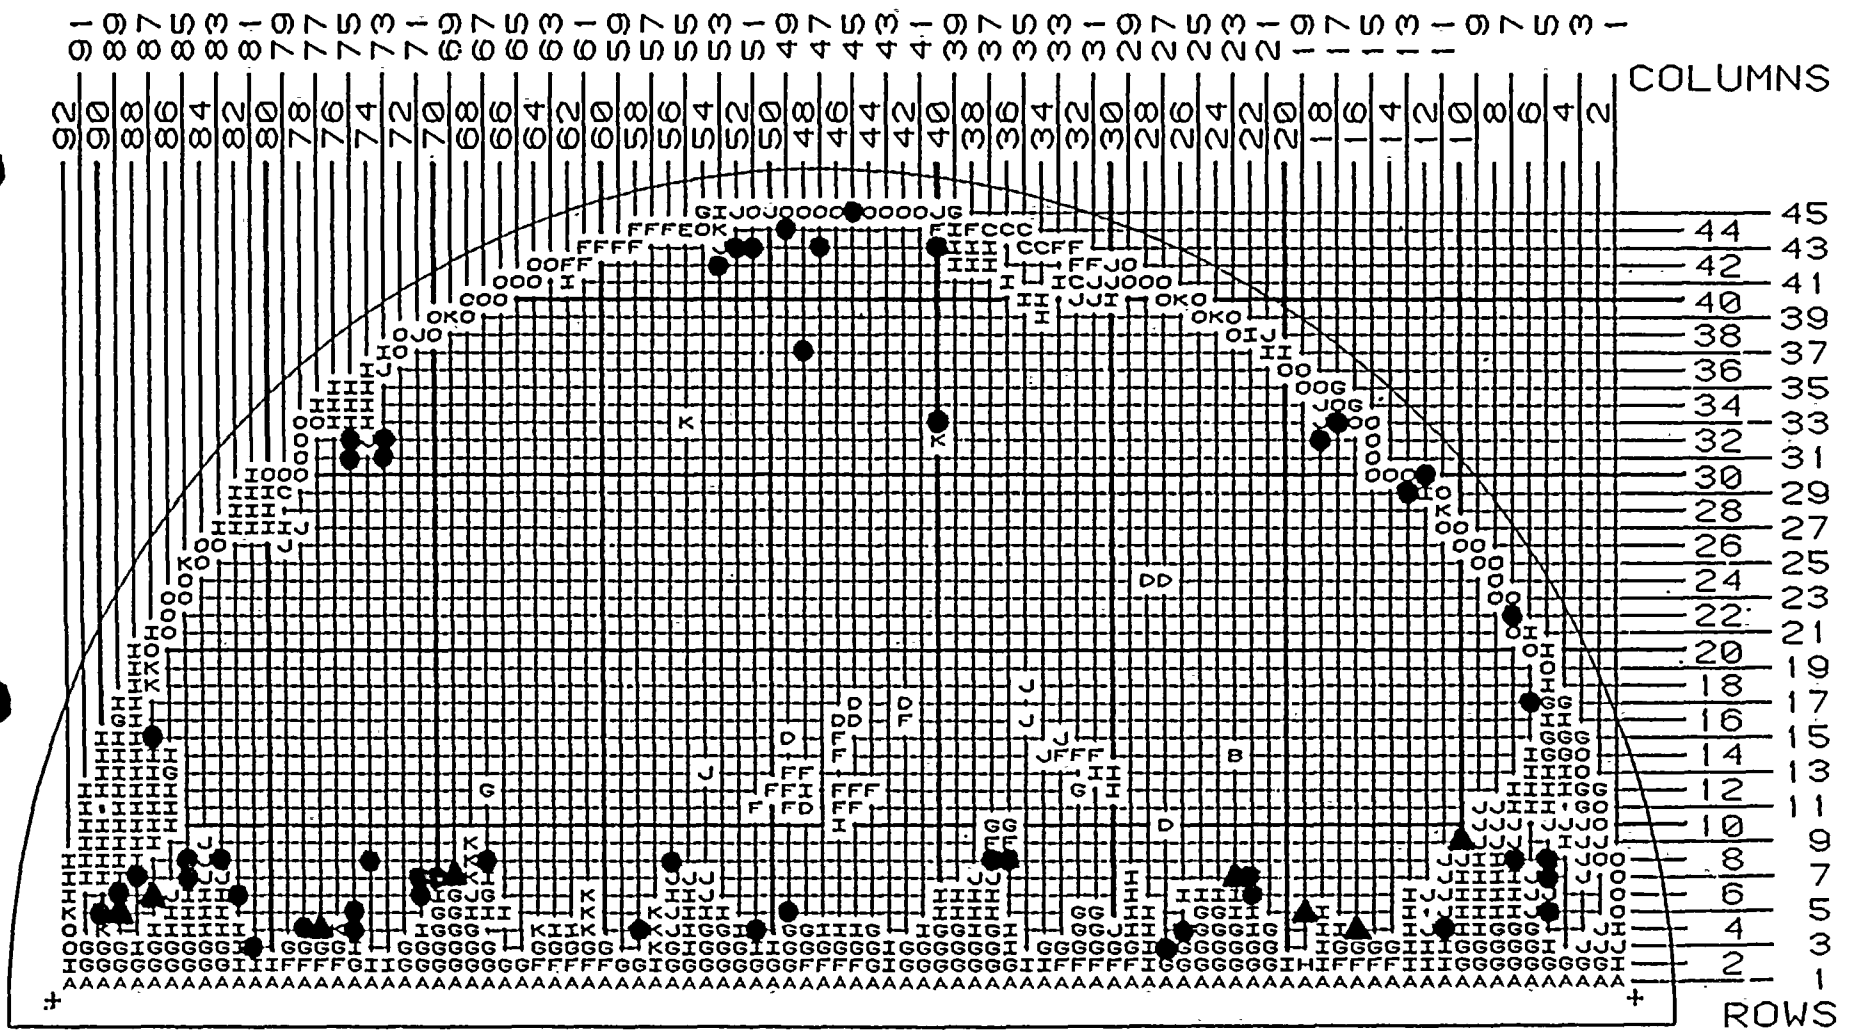
FIGURE 18
 TURKEY POINT UNIT #3
 STEAM GENERATOR C - HOT LEG
 GAUGING RESULTS - MARCH, 1981

RESTRICTED TUBES	NO. OF TUBES
X = .540 Probe	None
▲ = .610 Probe	8
● = .650 Probe	51

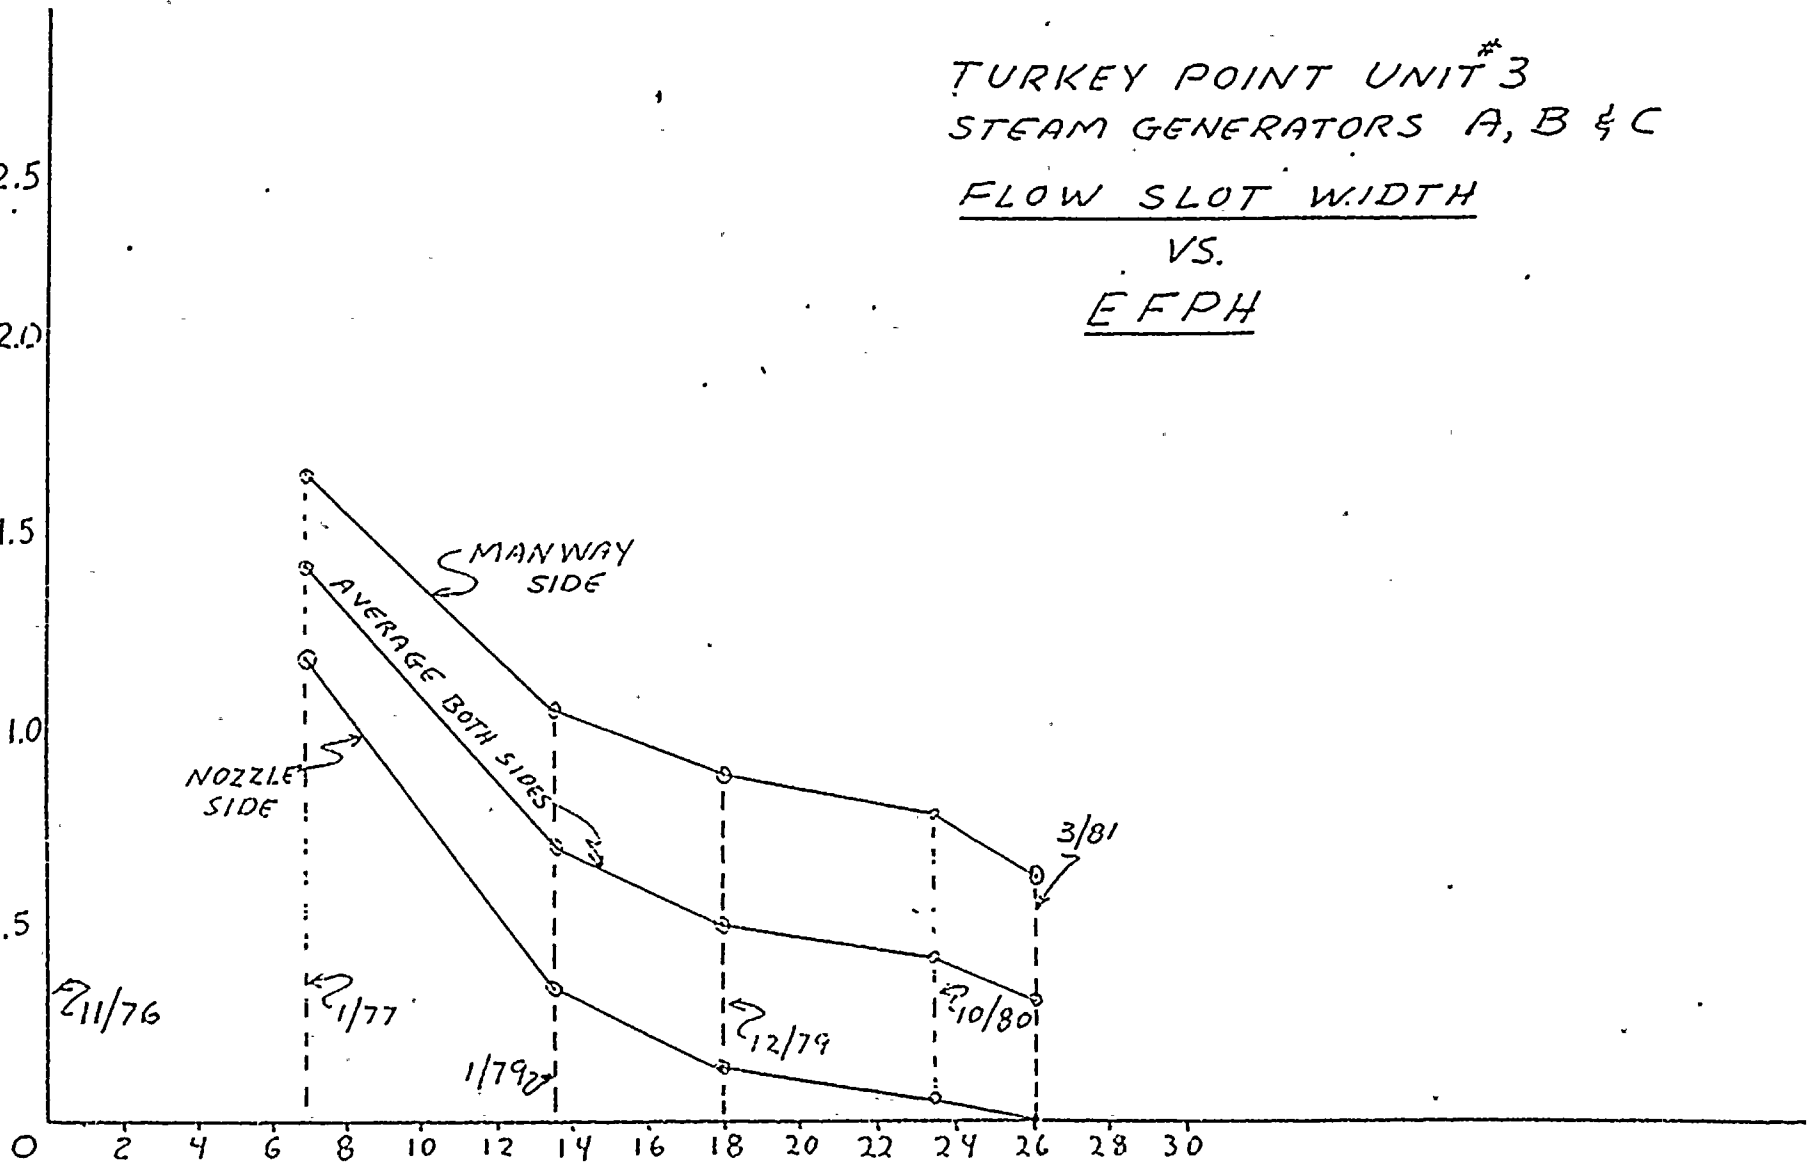
TURKEY POINT UNIT #3
STEAM GENERATORS A, B & C
FLOW SLOT WIDTH
VS.
EFPH

The results of the flow slot measurements are provided by Figure 23.

AVERAGE FLOW SLOT MINIMUM WIDTH IN INCHES
(BASED ON FIRST SUPPORT PLATE DATA)
