HANGER REPORT

Midland Plant Units 1 and 2

August 9, 1982

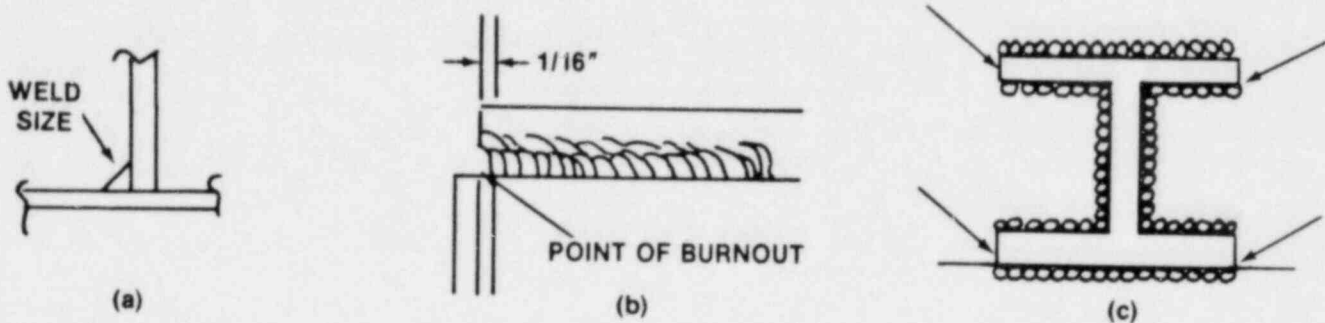
3A - Component Supports Other Than Anchors:

Undersize welds include: a) weld size which is either entirely or partially less than specified in the drawing, b) undercut (burnout), and c) noncontinuous weldment.

<u>Hanger No.</u>	<u>No. of Occurrences</u>	<u>Ref: CPCo NCR</u>
1-610-4-27, Rev 4(b)	1	M-01-9-2-007
2-604-3-18, Rev 1(c)	1	M-01-9-2-007
2-611-7-33, Rev 1(a)	1	M-01-9-2-010
2-611-6-5, Rev 3(a)	2	M-01-5-2-014
2-613-4-19, Rev 3(a)	1	M-01-5-2-014
2-619-6-11, Rev 3(a)	1	M-01-5-2-014
1-612-2-2, Rev 1(a)	1	M-01-5-2-014

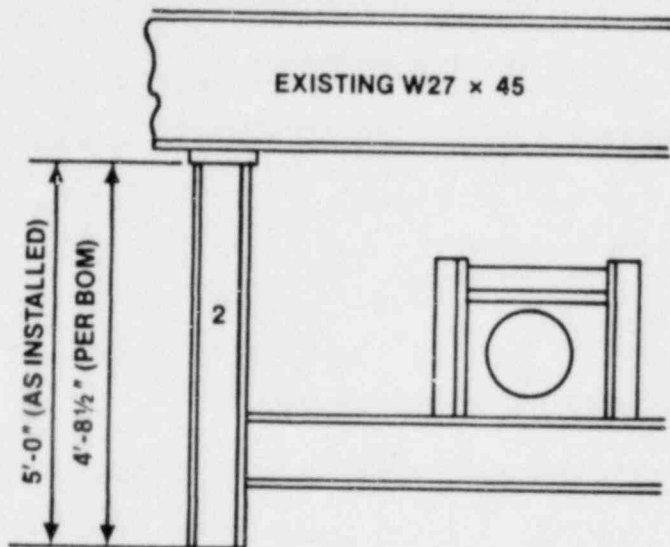
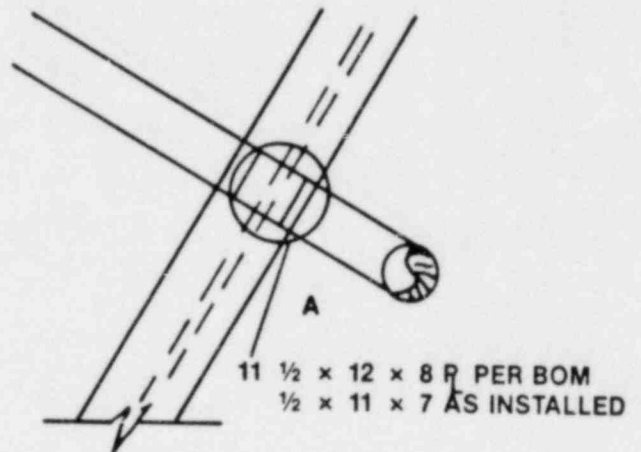
Component dimensions are not in accordance with the dimensions listed on the bill of materials.

<u>Hanger No.</u>	<u>No. of Occurrences</u>	<u>Ref: CPCo NCR</u>
1-616-10-22, Rev 4	1	M-01-9-2-007
FSK-M-2HBC-216-5-H3, Rev 0	1	M-01-9-2-010
2-604-16-15, Rev 0/F1	2	M-01-9-2-010
2-619-1-19, Rev 1	1	M-01-9-2-010
FSK-M-2HBC-219-1-H1, Rev 0	1	M-01-9-2-010
FSK-M-2HBC-144-1-H8, Rev 1	1	M-01-5-2-014
2-619-6-11, Rev 3	2	M-01-5-2-014
FSK-M-2GCB-22-1-H3, Rev 0	1	M-01-5-2-014

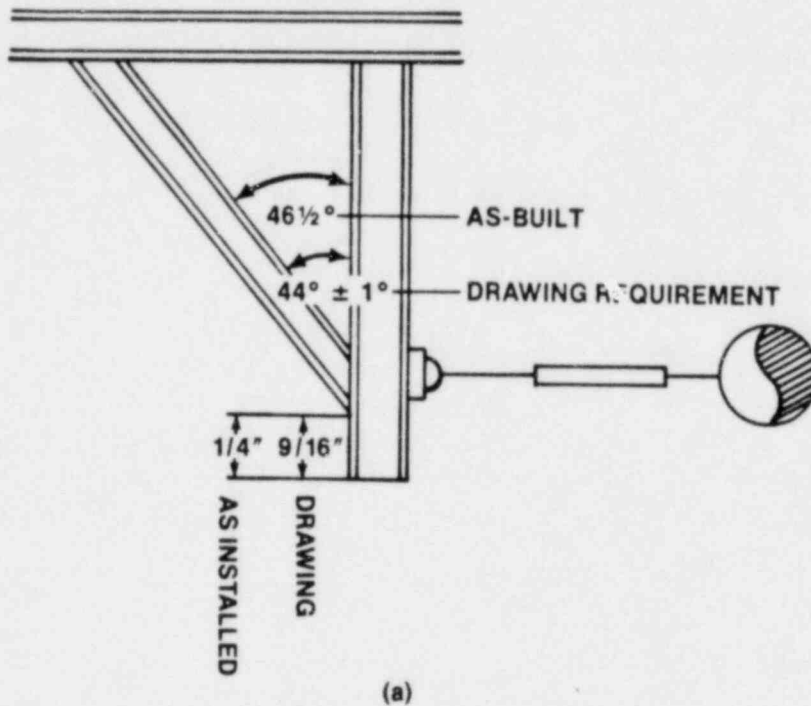
5A - Component Supports Other Than Anchors:

Angular and linear dimensions are not in accordance with the drawing.

<u>Hanger No.</u>	<u>No. of Occurrences</u>	<u>Ref: CCo NCR</u>
2-611-6-5, Rev 3	1	M-01-5-2-014
1-619-14-4, Rev 2	1	M-01-9-2-007
1-610-4-27, Rev 4	1	M-01-9-2-007
1-616-10-22, Rev 4	1	M-01-9-2-007
1-612-2-3, Rev 1	1	M-01-9-2-007
FSK-M-1HBC-219-1-H1, Rev 2	1	M-01-9-2-007
2-616-8-2, Rev 7	1	M-01-9-2-010

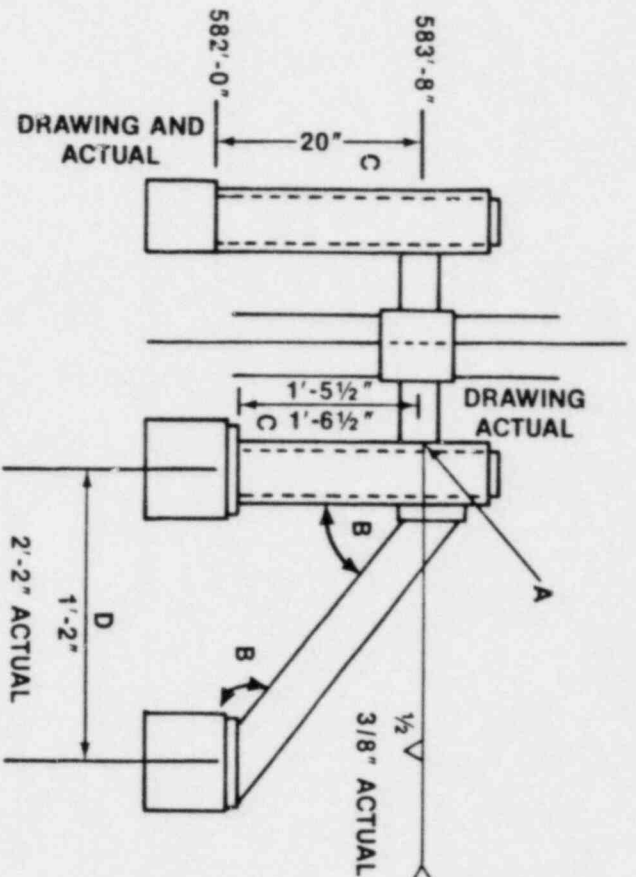
5B - Anchors:

<u>Hanger No.</u>	<u>No. of Occurrences</u>	<u>Ref: CPCO NCR</u>
1-616-6-28, Rev 1	2	M-01-9-2-007

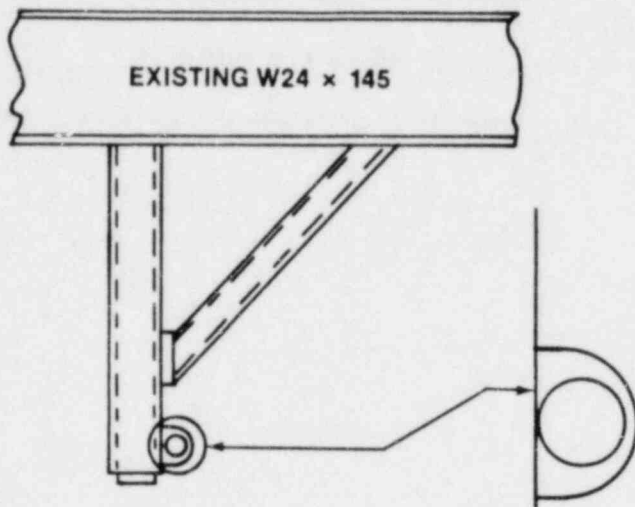
ZERO CLEARANCE
(a)

Clearances between pipe and support (strap, u-bolt, box) do not conform to the drawing/specification tolerances, e.g., zero clearance, excessive clearance.

<u>Hanger No.</u>	<u>No. of Occurrences</u>	<u>Ref: CPCo NCR</u>
2-604-16-15, Rev 0/F1(a)	1	M-01-9-2-010
2-657-43-6, Rev 1(b)	1	M-01-9-2-010
2-619-6-11, Rev 3(a)	1	M-01-5-2-014
FSK-M-1HBC-144-1-H3, Rev 1(b)	1	M-01-5-2-017
1-648-7-58, Rev 1/F1(b)	1	M-01-5-2-017
1-657-37-9, Rev 2(a)	1	M-01-5-2-017
FSK-M-0HBC-142-1-H1, Rev 4(b)	1	M-01-5-2-017

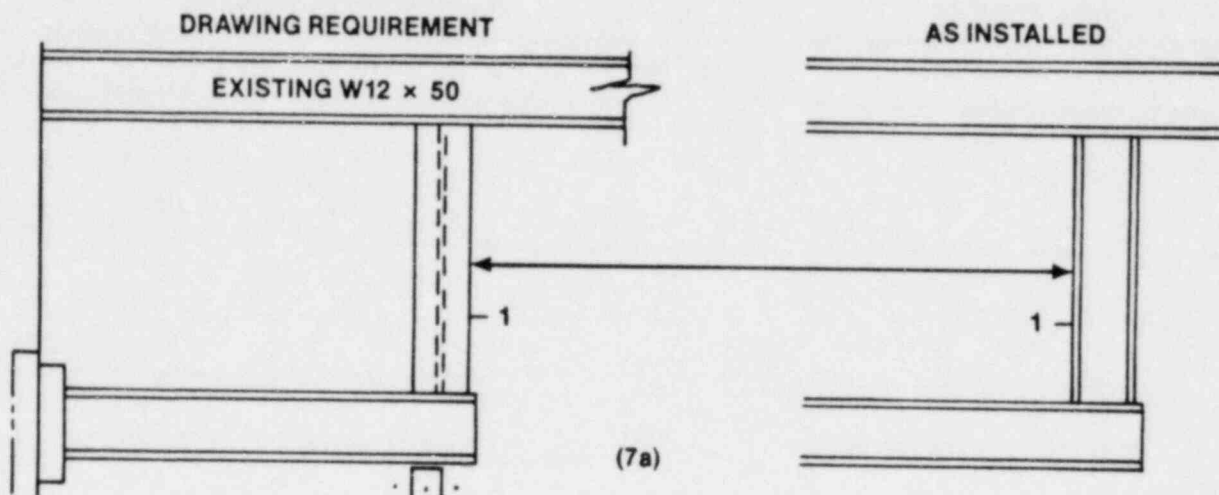
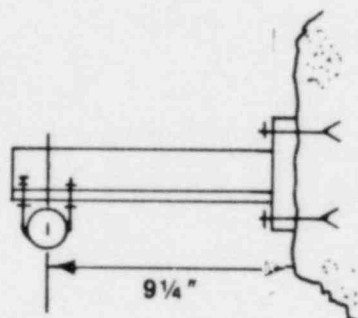
(7b)

Support member rotated ___ degrees from design sketch.

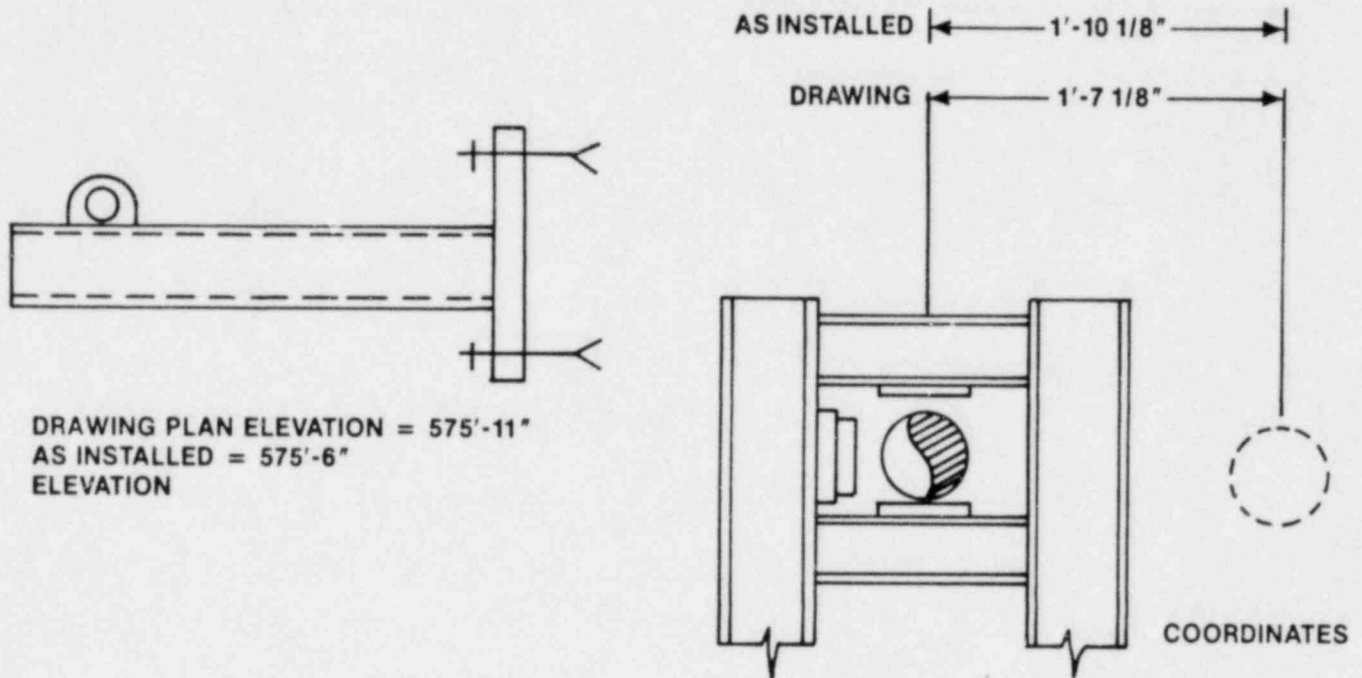
Hangers are not installed in accordance with the elevation and coordinates specified in the drawings. For example:

<u>Hanger No.</u>	<u>No. of Occurrences</u>	<u>Ref: CCo NCR</u>
FSK-M-2HBC-217-1-H2, Rev 1	1	M-01-9-2-010
1-612-2-2, Rev 1	1	M-01-5-2-014
2-619-6-11, Rev 3	1	M-01-5-2-014
1-612-3-12, Rev 1	1	M-01-5-2-014
2-619-1-20, Rev 1	1	M-01-5-2-014

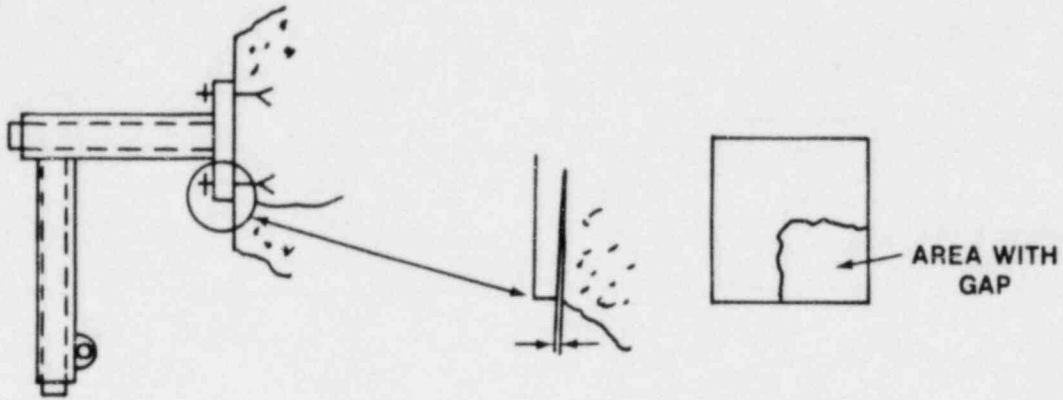
Lower right-hand corner of baseplate exceeds gap tolerance.

<u>Hanger No.</u>	<u>No. of Occurrences</u>	<u>Ref: CCo NCR</u>
FSK-M-2HBC-216-5-H3, Rev 0	1	M-01-9-2-010

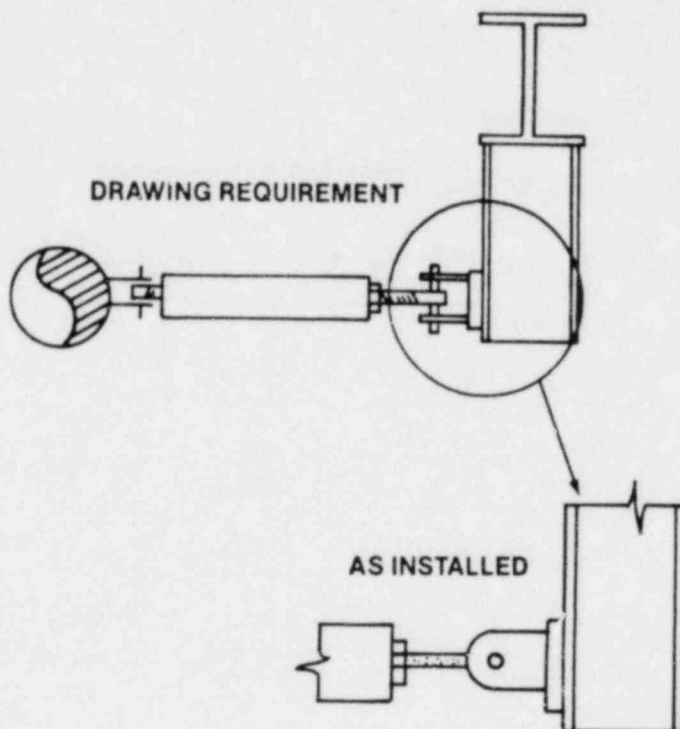
Clevis rotated 90 degrees from drawing configuration.

<u>Hanger No.</u>	<u>No. of Occurrences</u>	<u>Ref: CCo NCR</u>
2-604-2-35, Rev 1	1	M-01-9-2-010
2-619-2-19, Rev 1	1	M-01-5-2-014

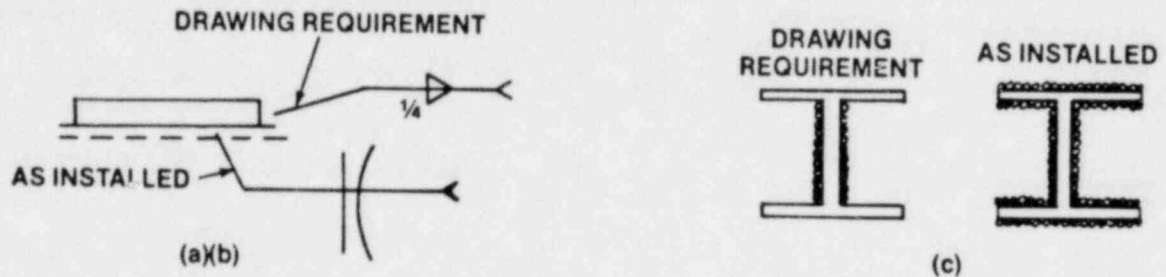
Field welds do not conform to drawing requirements, e.g., a, b) welds located at the ends instead of at the sides, c) weld configuration is not as shown on the drawing.

<u>Hanger No.</u>	<u>No. of Occurrences</u>	<u>Ref: CPCo NCR</u>
0-618-1-6, Rev 0(b)	1	M-01-5-2-017
2-617-8-5, Rev 2(c)	1	M-01-9-2-007
FSK-M-2HBC-219-1-H1, Rev 0(a)	1	M-01-9-2-010

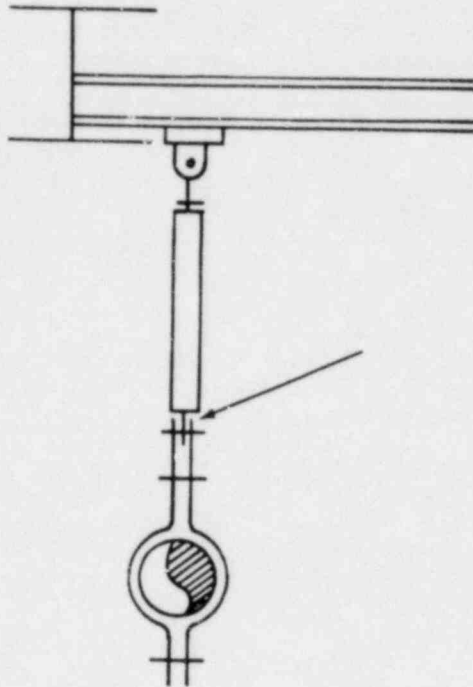
At sight holes of support rod, no threads are visible. Thread engagement (at the lower end only) was 1 inch, instead of 1-1/2 inch.

<u>Hanger No.</u>	<u>No. of Occurrences</u>	<u>Ref: CPCo NCR</u>
1-616-8-2, Rev 7	1	M-01-9-2-010

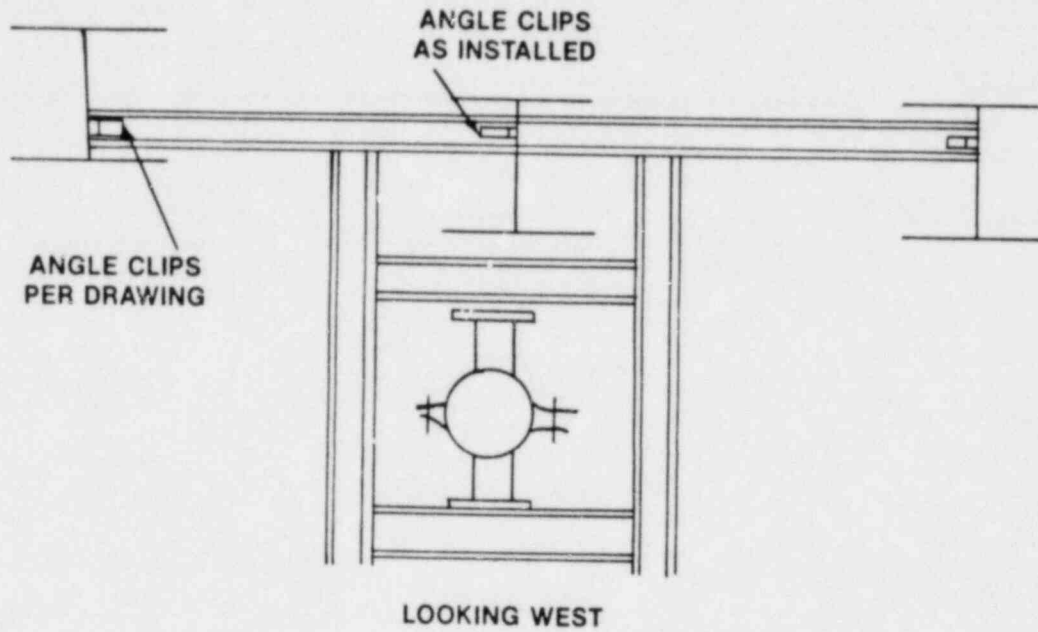
Hanger No.
0-617-7-13, Rev 0

Angle clips are in wrong location.
