DOCKET NO. 50-301  
REPORT OF STEAM GENERATOR TUBE INSPECTION  
POINT BEACH NUCLEAR PLANT, UNIT NO. 2

EXAMINATION OF POINT BEACH UNIT #2

STEAM GENERATOR TUBE SAMPLE

SG A R15-073 HL

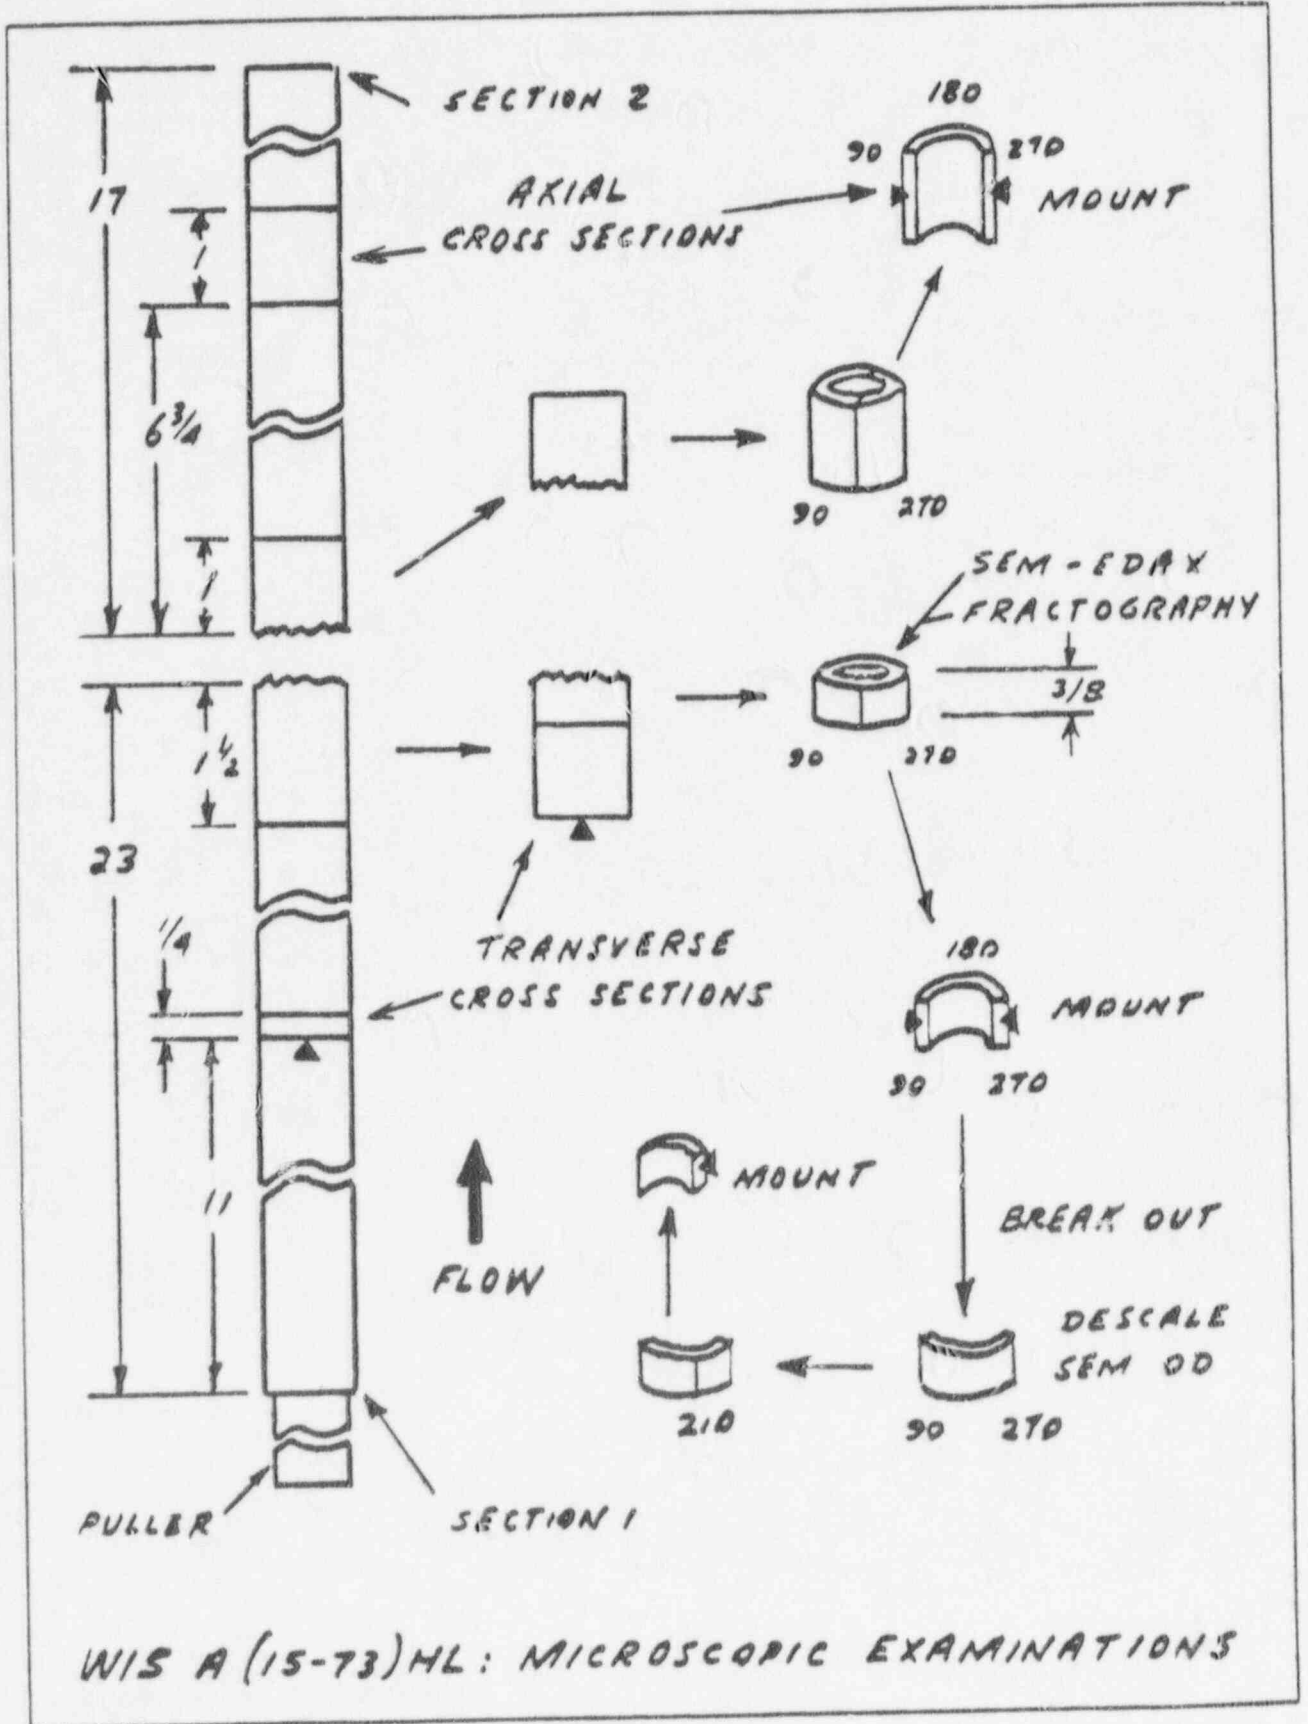
Figure 1

Figure 2 shows the as-received appearance of the 1-1/2 in. of tubing which extended from the fracture downward. The sectioning in this region and photomicrographs of the fracture edge appear in Figures 3-5 for axial planes located at 90° and 270°. (The zero degree orientation reportedly faced the divider plate.) The third plane, located at about 210° (and prepared after descaling and SEM examination) is shown in Figures 6-8.

A(15-73), Upper End of Section I, at Fracture, 4 Rotations ( $0^{\circ}$ ,  $90^{\circ}$ , etc.)

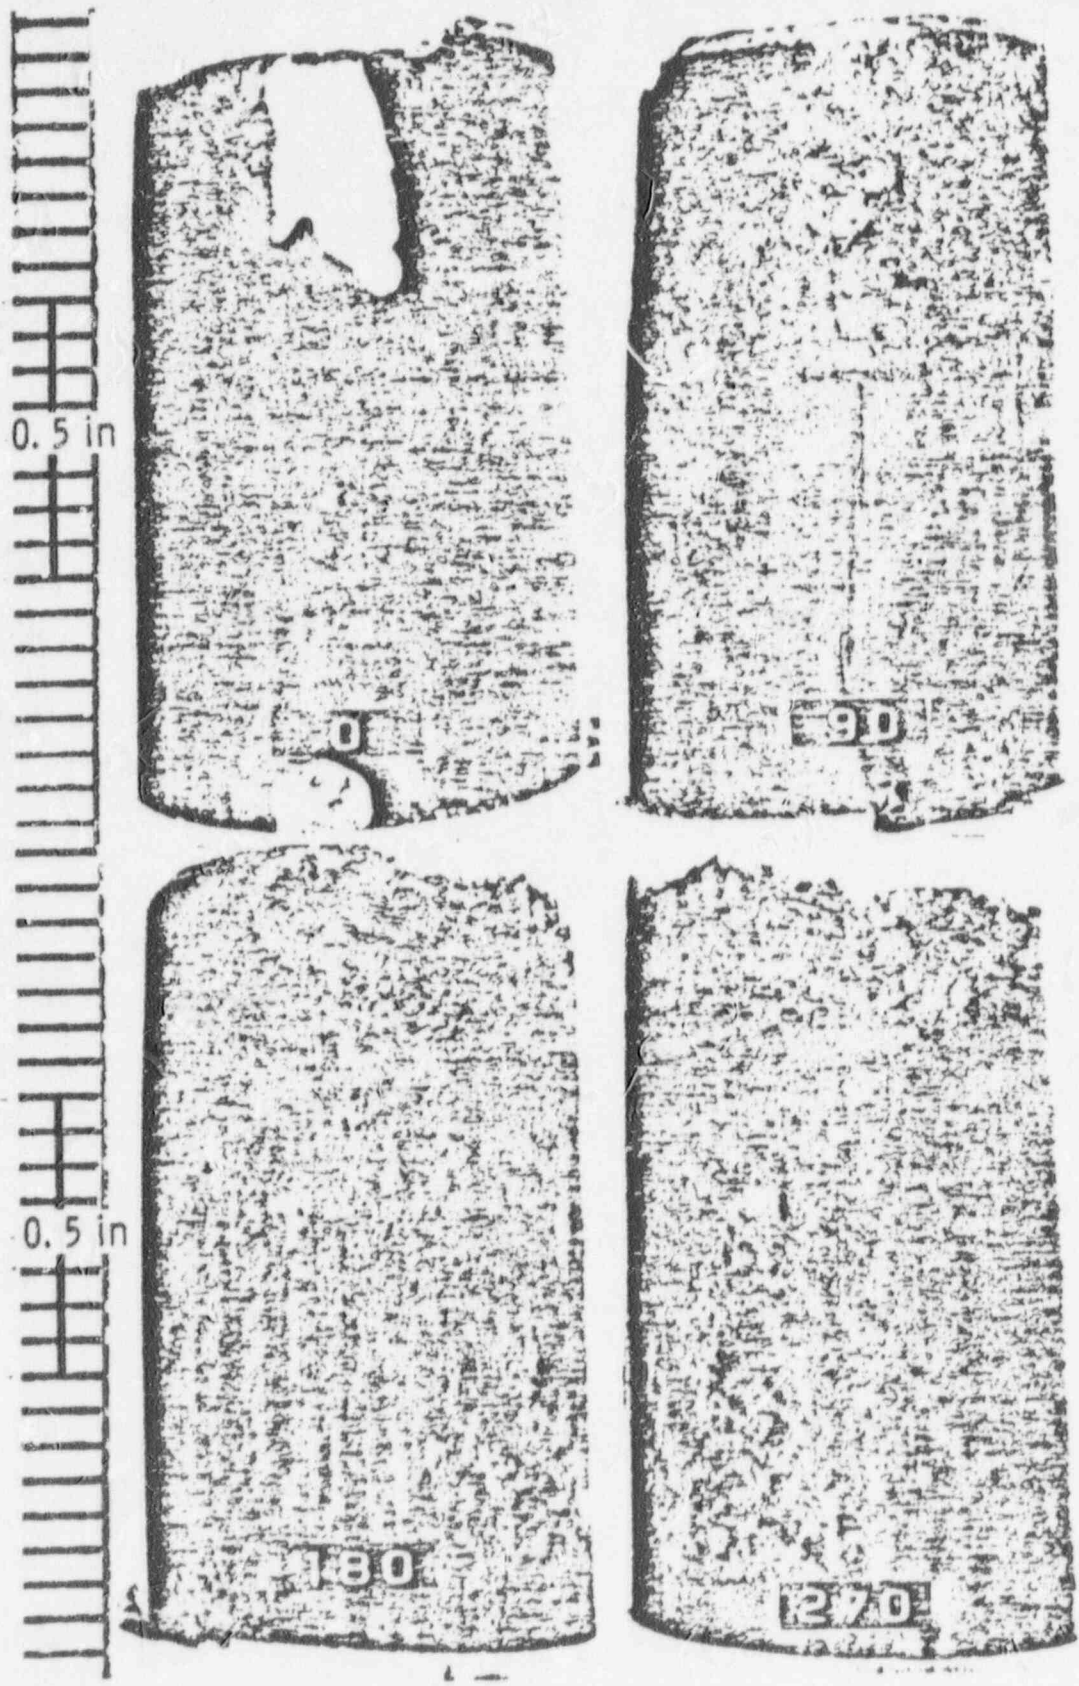
Figure 2

The deepest penetrations by intergranular attack (IGA) at the fracture edge were noted in the 270° micro (Figure 3) at 0.016 in., and in the 210° micro (Figure 7) as 0.010-0.012 in. The "necking" at the fracture requires these

A (15-73), Section 1, Double Axial Cross  
 Section (90° and 270°) through Fracture. Depth of IGS Measures  
 0.016 in. (to Center of Field "AA") on the 270° Side)

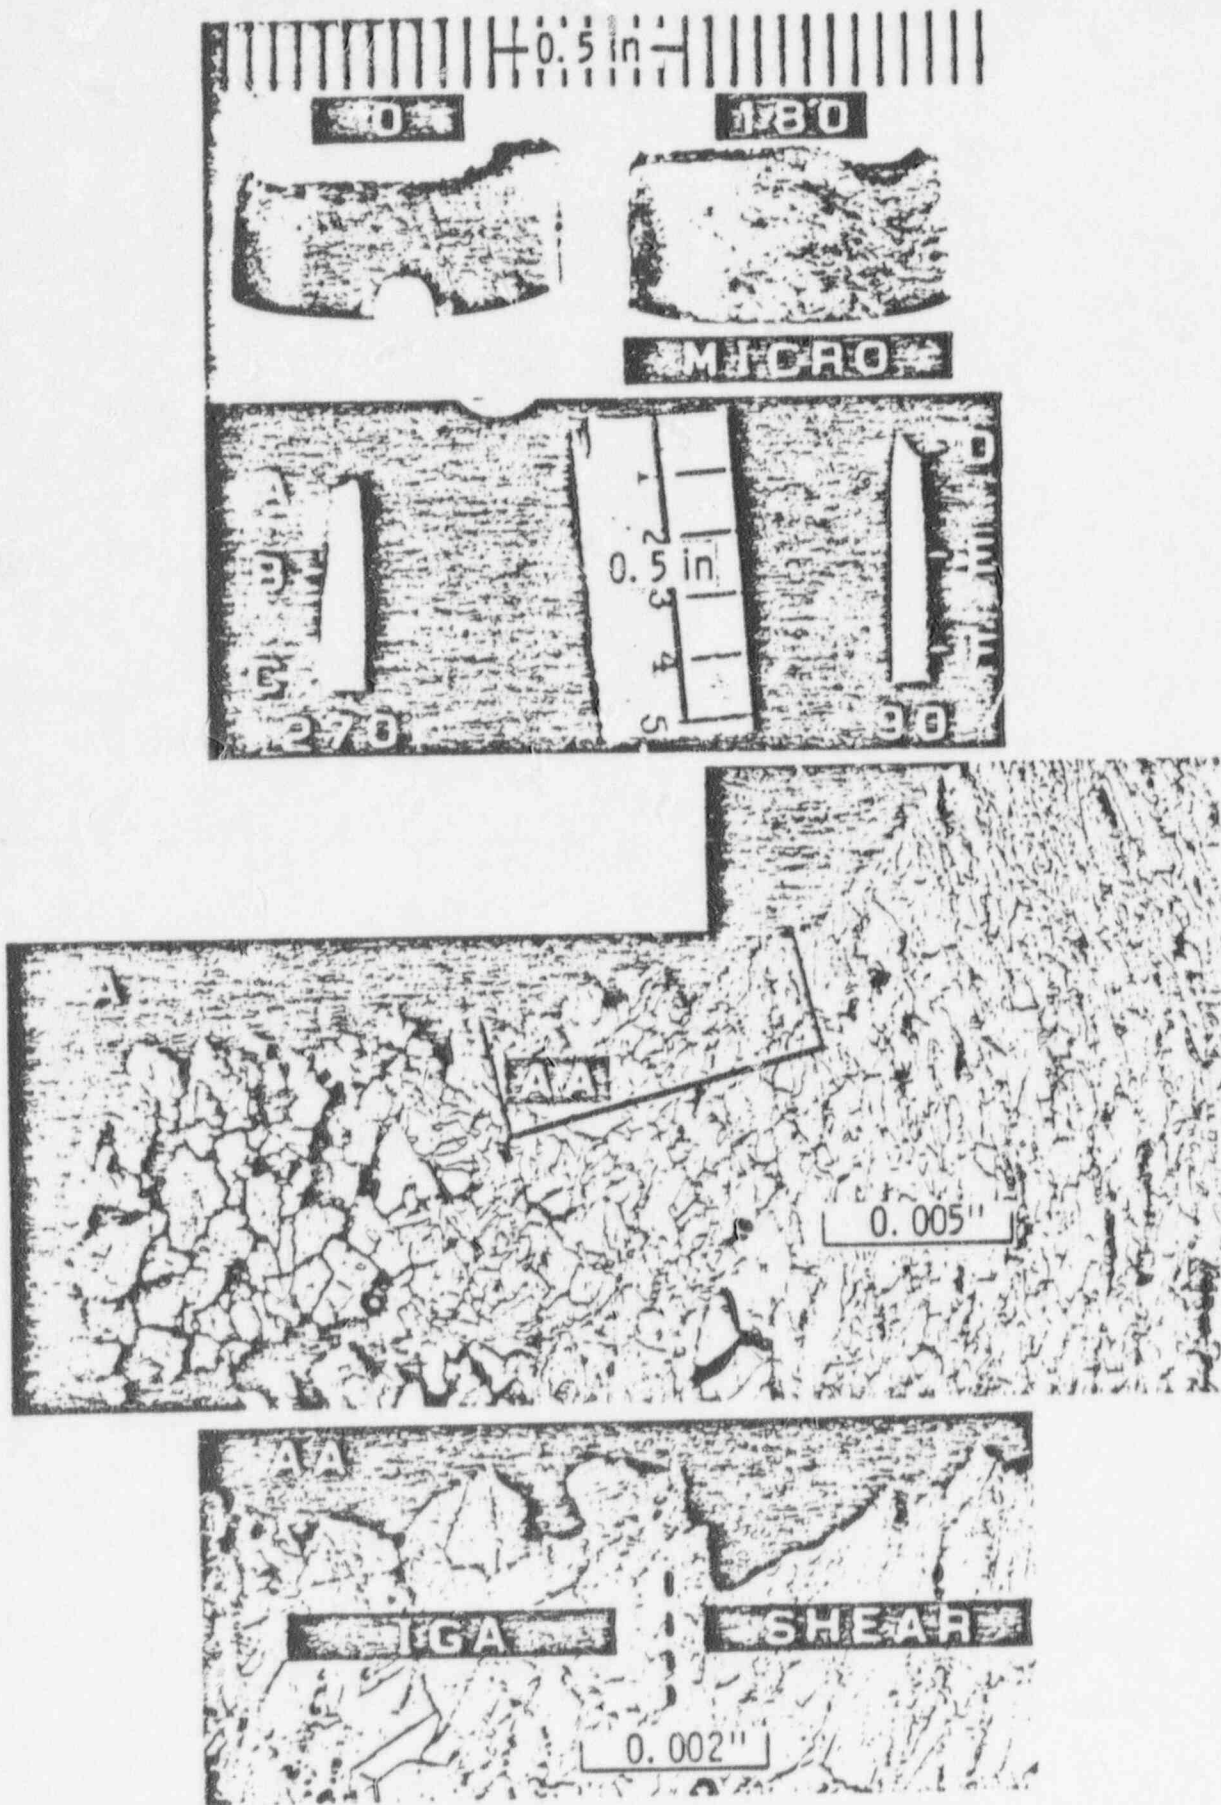
A (15-73), Continuation of Axial  
Metallography, on 270° Side, Sec-  
tion 1, Figure 3

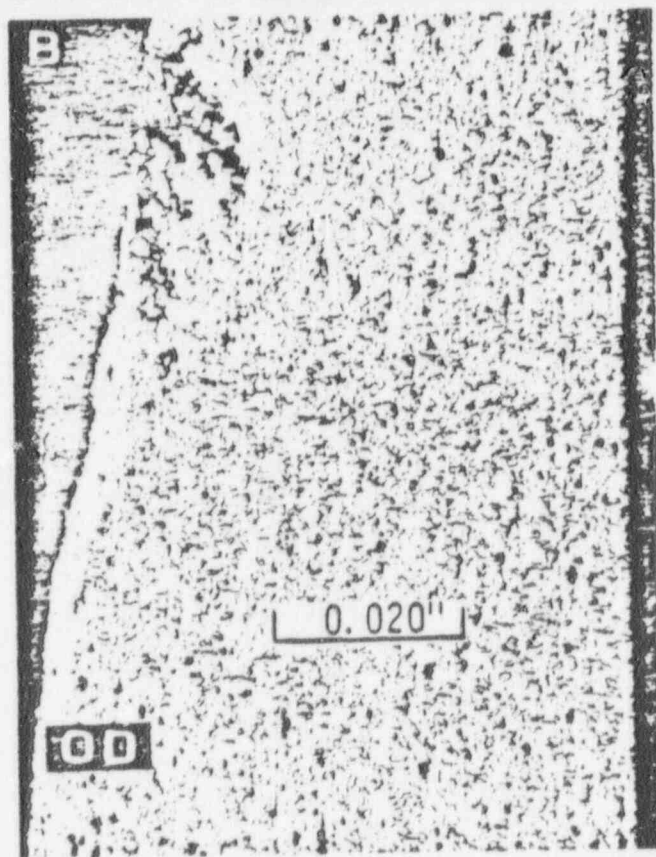
Figure 4

A (15-73), Continuation of Axial Metallography, Section 1, Figure 3

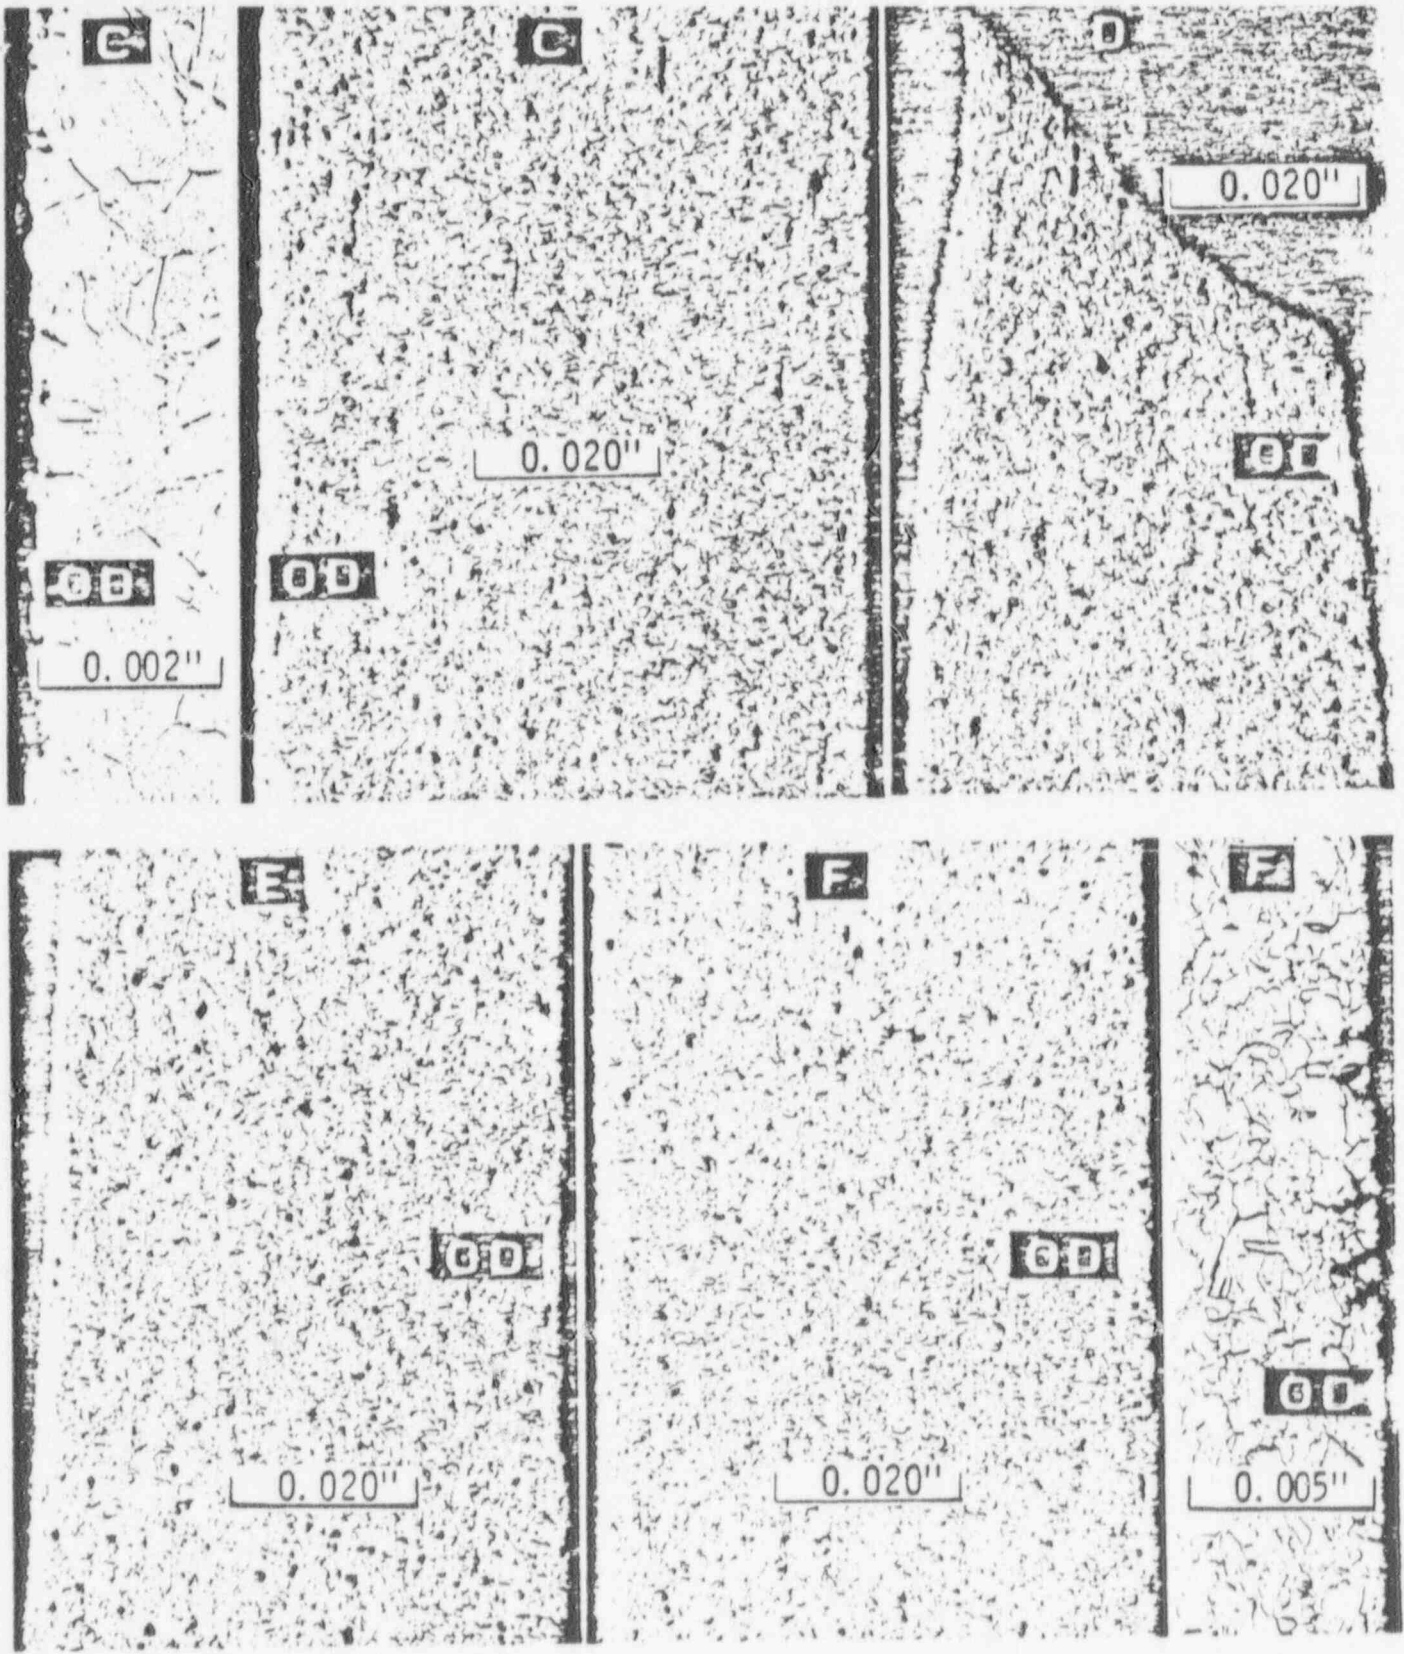
Figure 5

A (15-73), Upper End of Section 1,  
Broken Out of Mount, Descaled, and  
Renovated as an Axial Section at  
approx. 210°

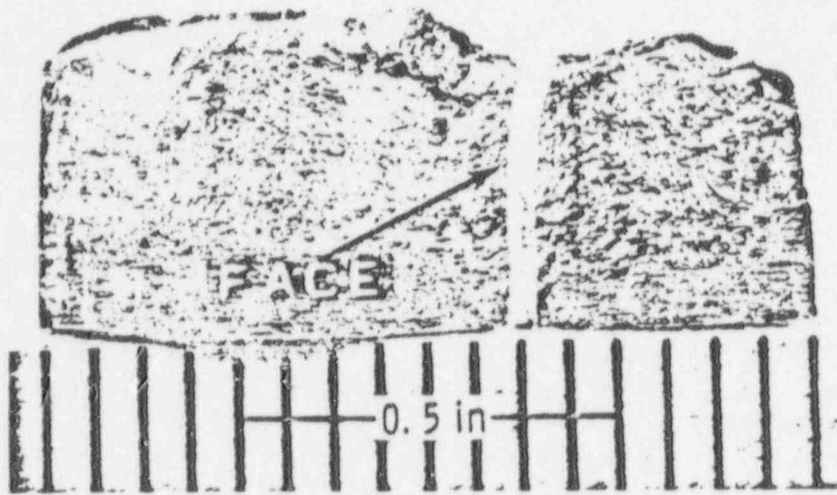
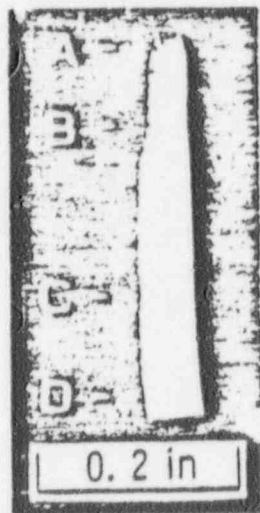
Figure 6

A (15-73), Section 1, Axial Cross Section  
Through Fracture, approx.  $210^{\circ}$  Orientation.  
Depth of IGA Measures 0.010-0.012 in.  
(Measurement is complicated by necking  
down of tube at fracture)

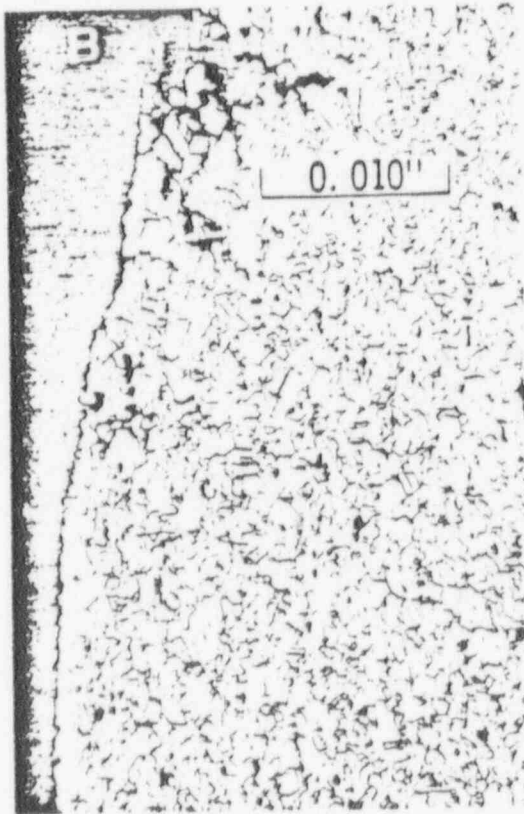
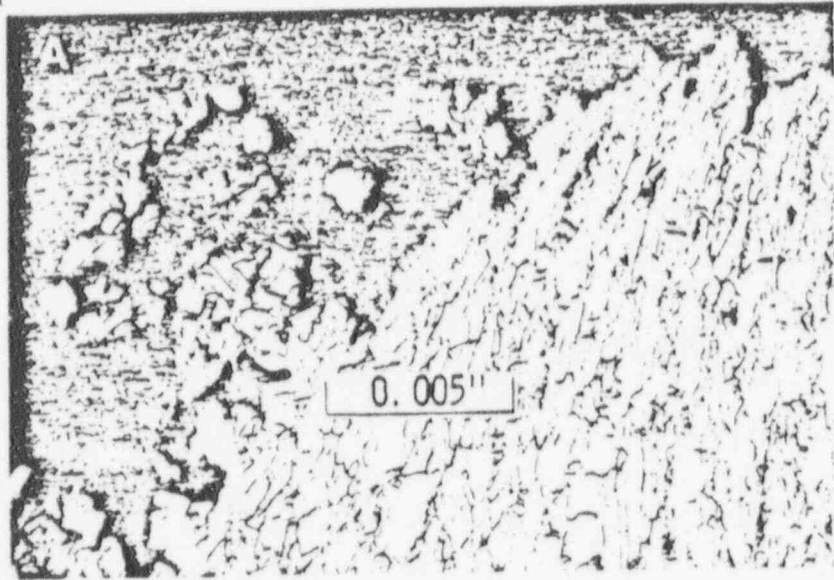
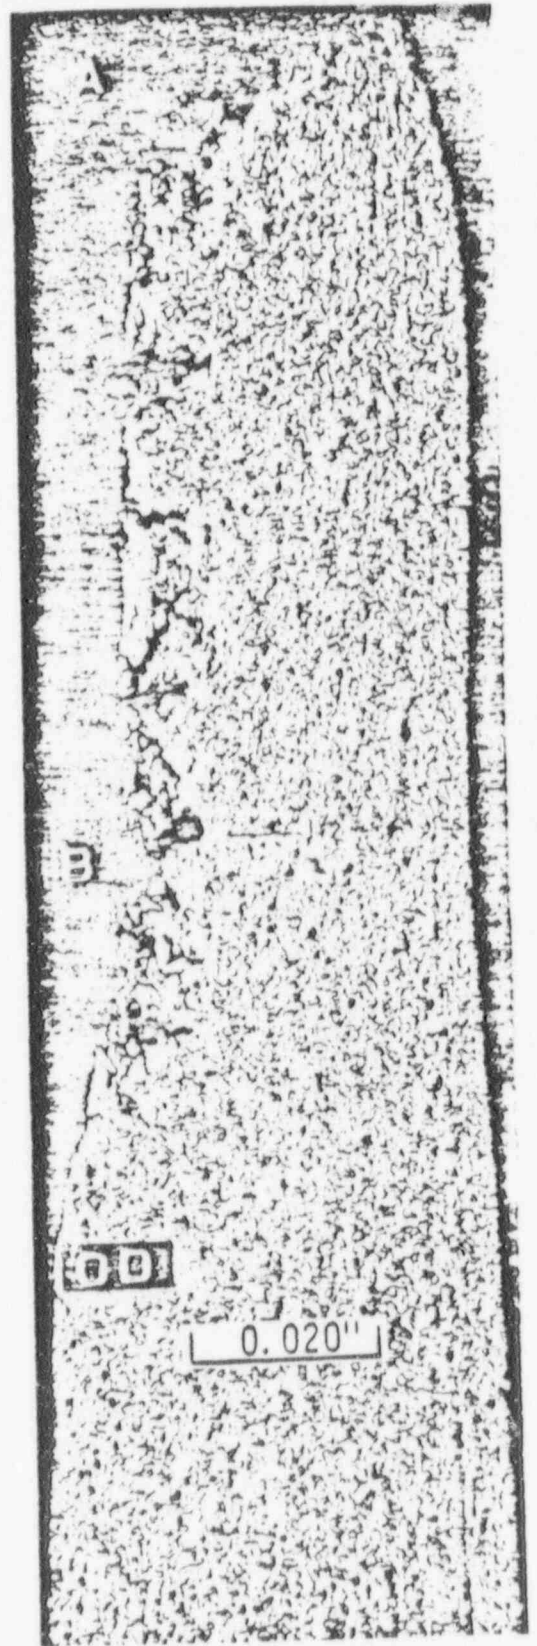
A (15-73), Continuation of Axial  
Metallography of Figure 7

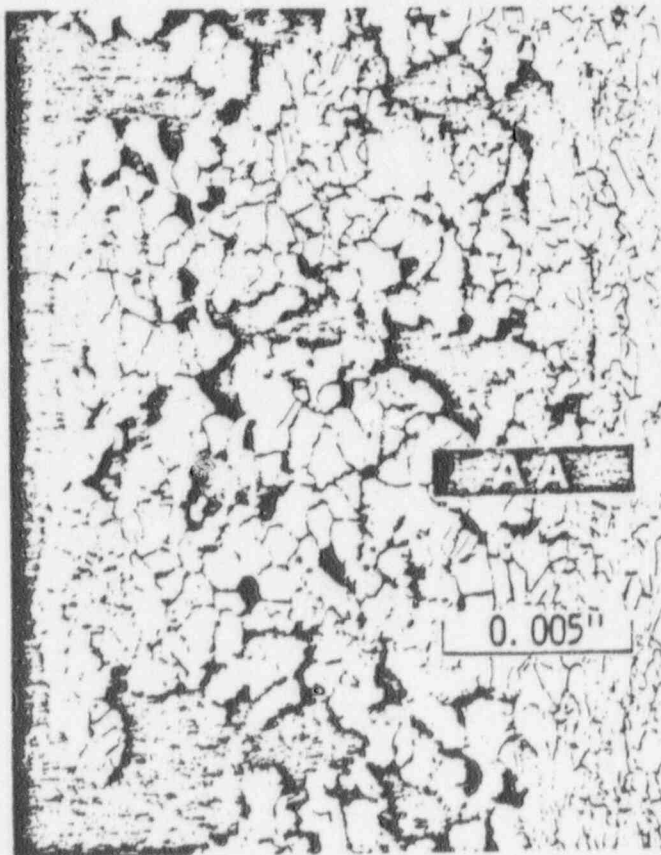
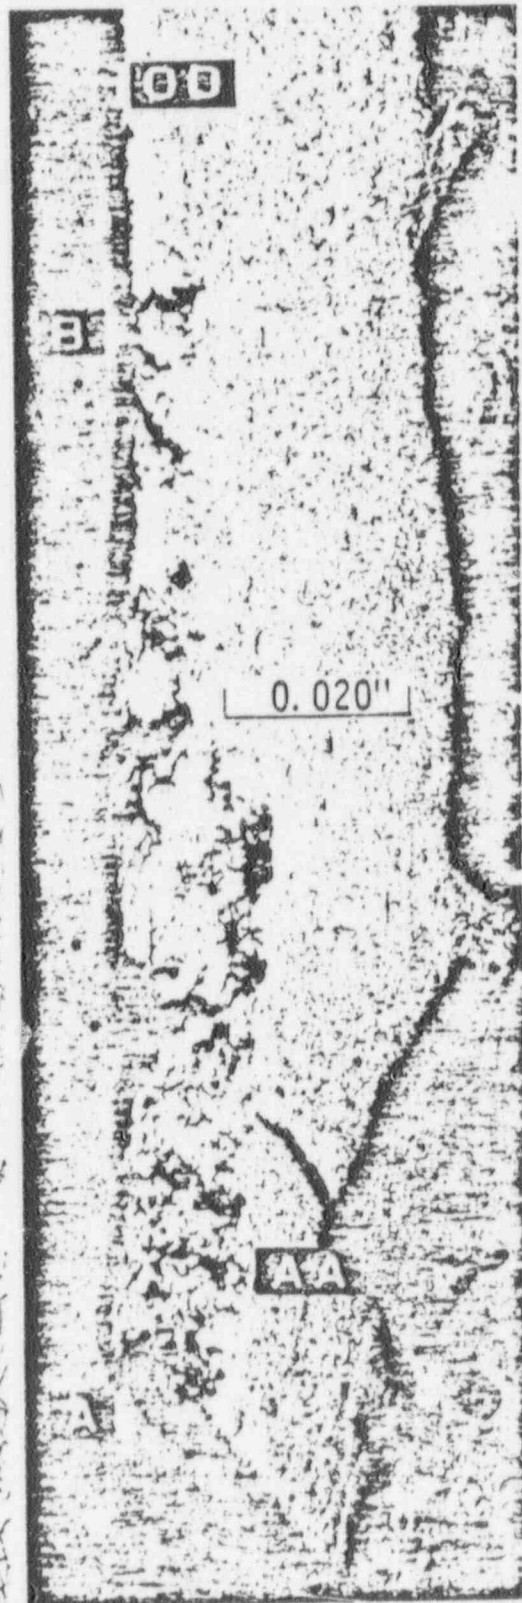
Figure 11

A (15-73), Continuation of Axial  
Metallography of Figures 10 & 11

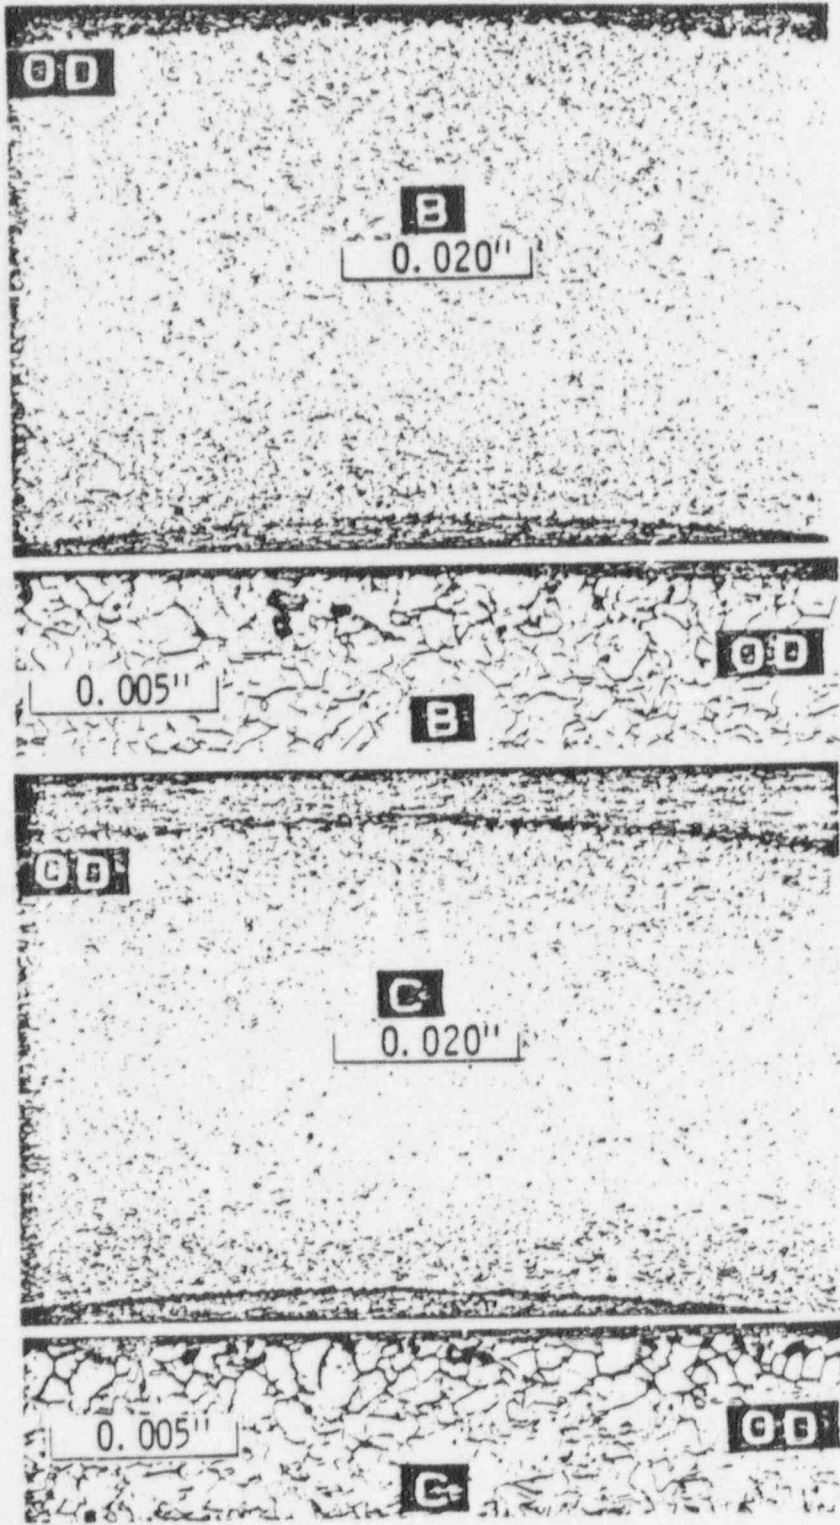
Figure 24

A (15-73), 1-1/2 in. below Fracture,  
Transverse Cross Section.

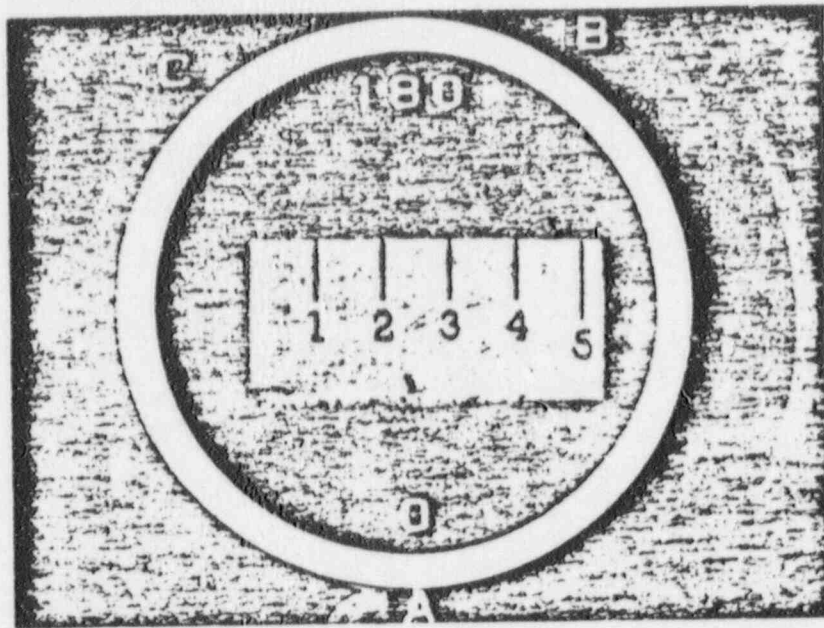
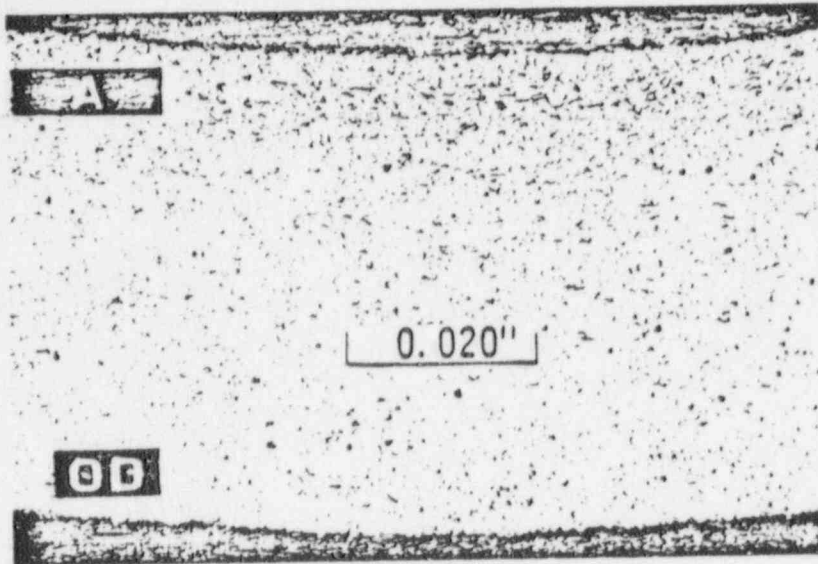
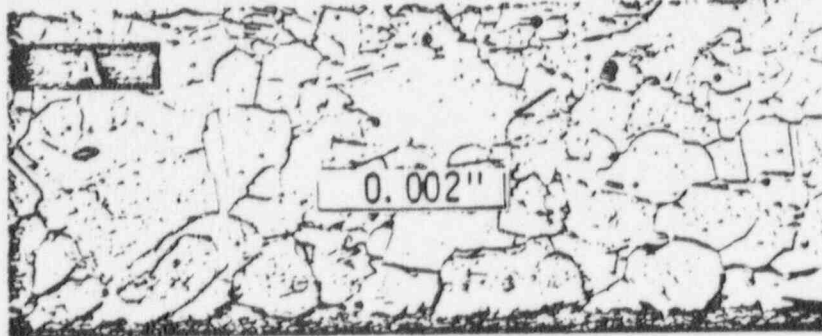
Figure 25

A (15-73), 1-1/2 in. below Fracture Areas B  
& C of Figure 25. The OD conditions at B  
represents intergranular penetrations of  
about 1 grain in depth (approx. 0.006 in.  
or 0.6 mil)

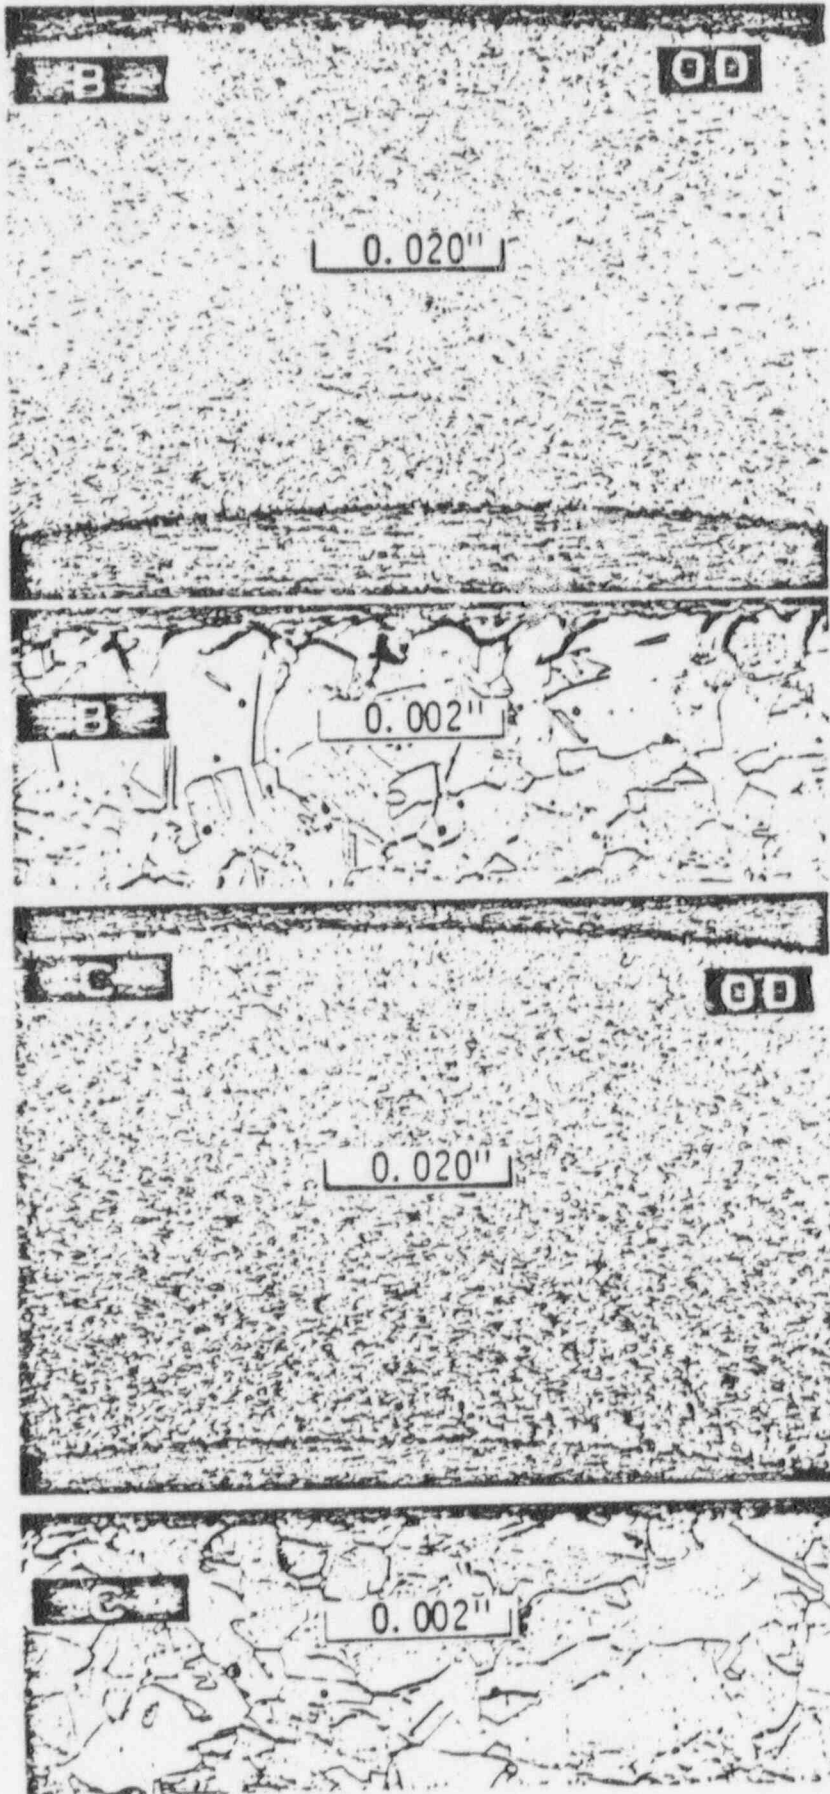
Figure 26

A (15-73), Double Axial Cross Section, 1 in. long, centered at 7-1/4 in. above the fracture. "Chatter marks" from tube removal equipment were present on ID surface.

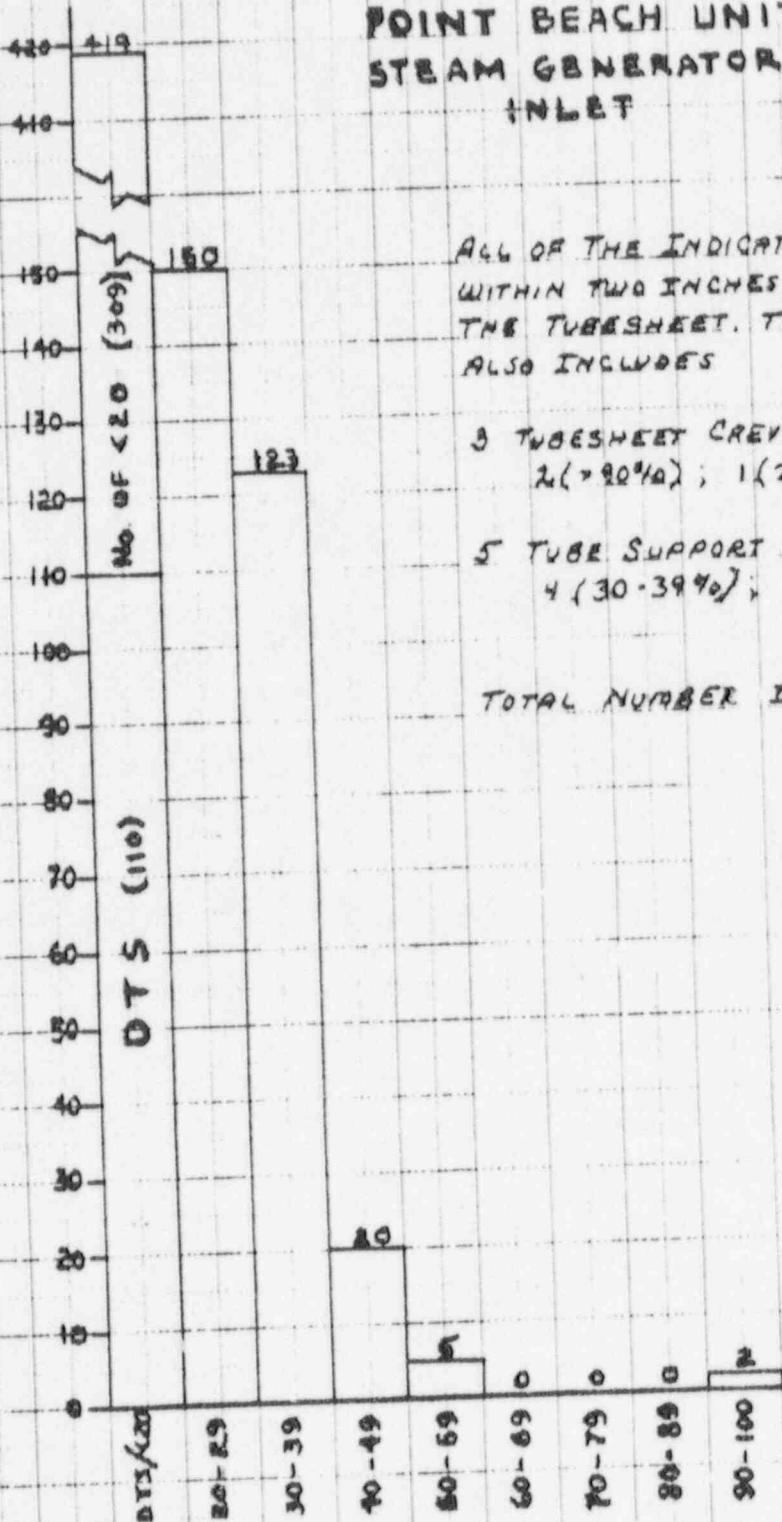
FIGURE 1

DISTRIBUTION OF ALL EDDY CURRENT INDICATIONS REPORTED AT THE APRIL 1981 INSPECTION

ALL OF THE INDICATIONS ARE REPORTED WITHIN TWO INCHES FROM THE TOP OF THE TUBESHEET. THIS DISTRIBUTION ALSO INCLUDES

TOTAL NUMBER INDICATIONS = 719

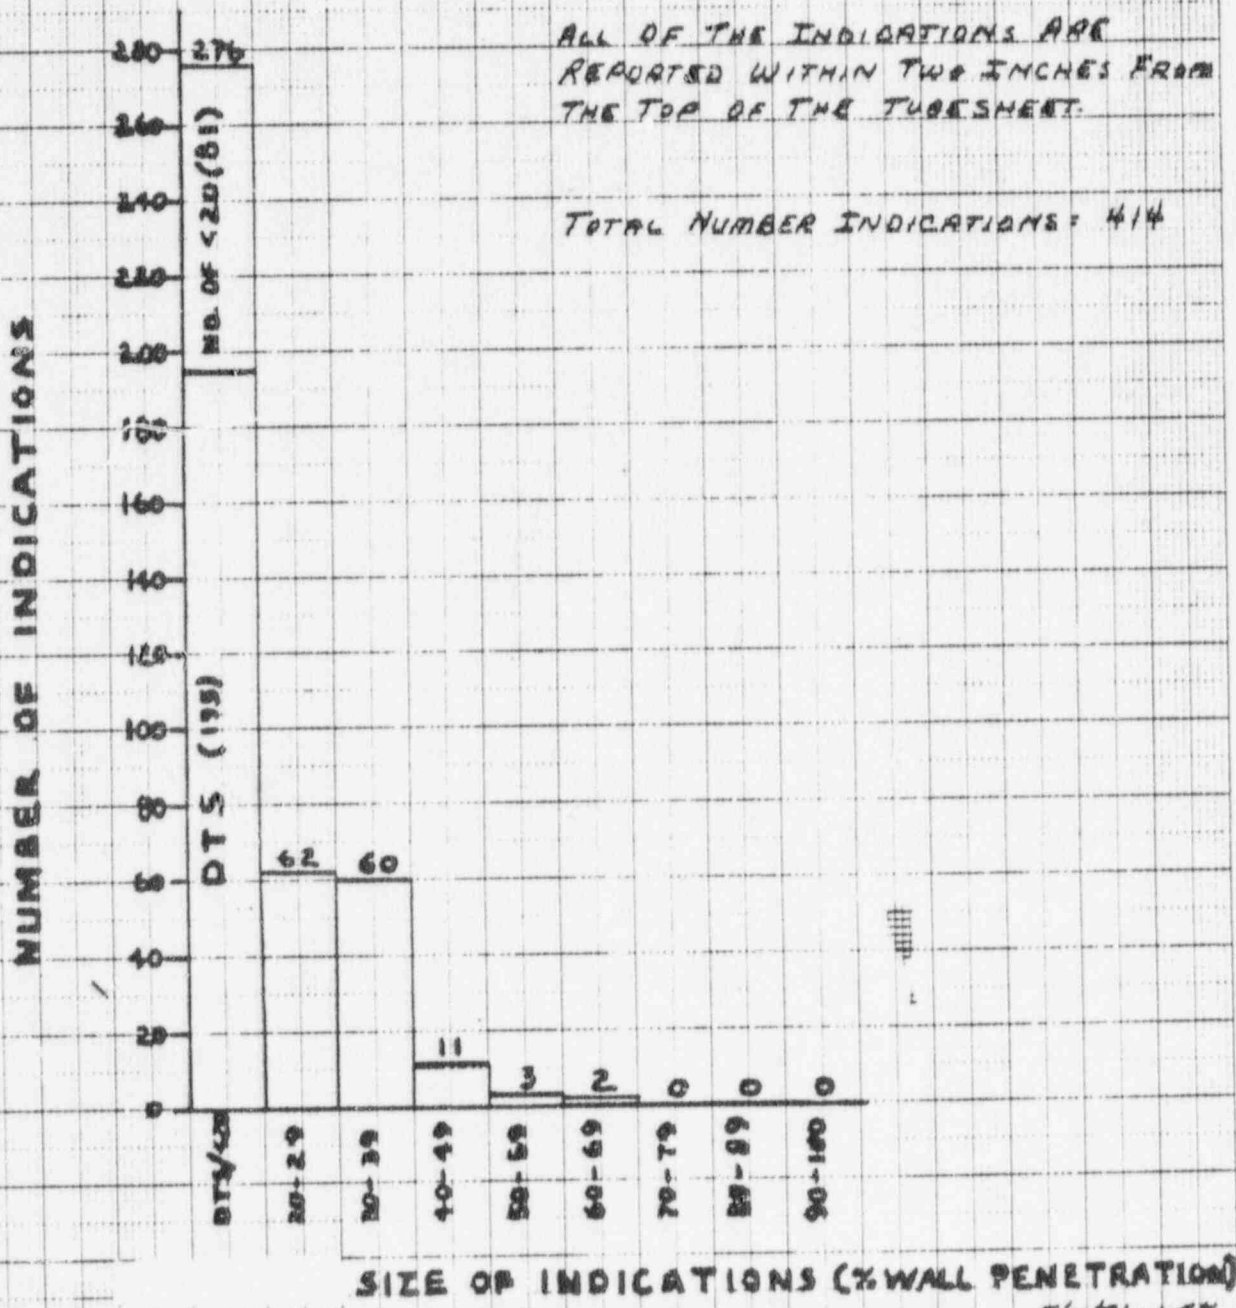
FIGURE 2

DISTRIBUTION OF % EDDY CURRENT INDICATIONS REPORTED AT THE APRIL 1981 INSPECTION

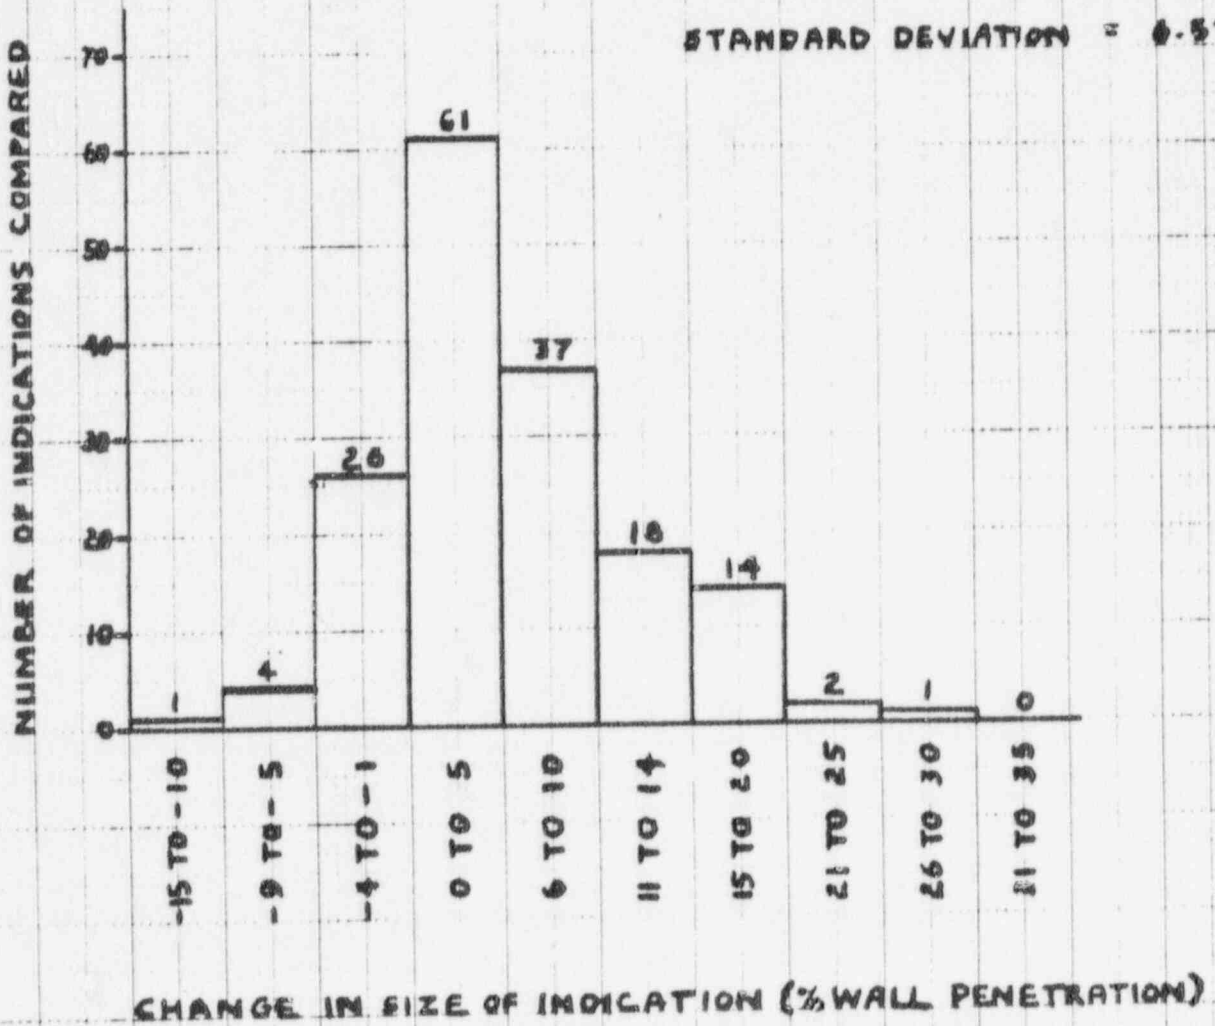
FIGURE 3

DISTRIBUTION OF THE CHANGE IN SIZE OF INDICATIONS REPORTED AS 220% AT THE TOP OF THE TUBESHEET IN BOTH MARCH 1980 AND APRIL 1981

NUMBER OF INDICATIONS  
COMPARED = 164  
MEAN CHANGE IN SIZE = 5.5%  
STANDARD DEVIATION = 6.5%

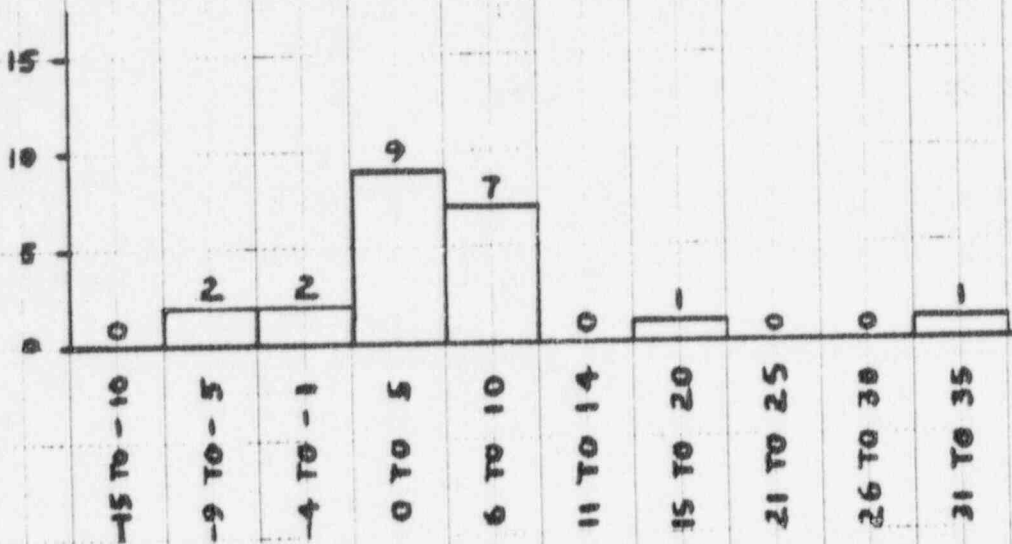
FIGURE 4

DISTRIBUTION OF THE CHANGE IN SIZE OF INDICATIONS REPORTED AS  $\geq 20\%$  AT THE TOP OF THE TUBESHEET IN BOTH MARCH 1980 AND APRIL 1981

NUMBER OF INDICATIONS COMPARED = 22  
MEAN CHANGE IN SIZE = 4.9%  
STANDARD DEVIATION = 7.9%
