**JIA - 96-351**

**RESPONSE TO FREEDOM OF INFORMATION ACT (FOIA) REQUEST**

6.	6/17/93	Rod Control System - Failed Components Status - (2 pgs)
7.	6/16/93	NRC Inspection Question/Response Tracking Form - (5 pgs)
8.	6/16/93	Rod Control System - Failed Components Status (15 pgs)

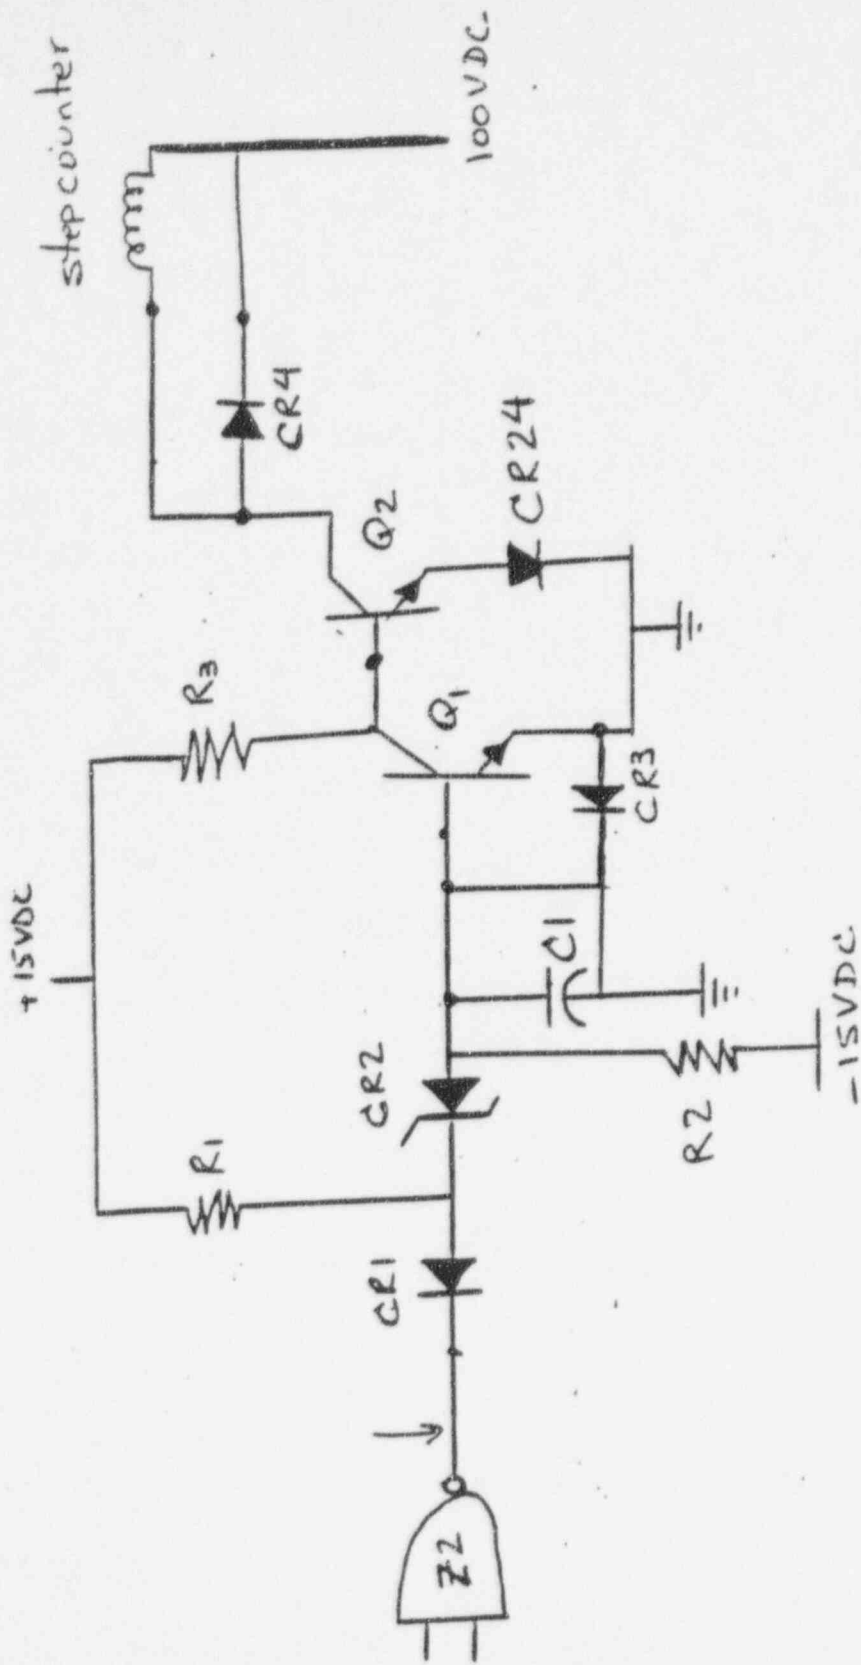
Fig 1

100VDC was shorted to -15VDC through  
circuit components failures (Fig 1)

In order for 100VDC short to -15VDC through compo  
failures on relay driver cards be a valid assumption  
the following components need to be failed as short  
Q<sub>2</sub> transistor having collector to base shorted  
and Q<sub>1</sub> transistor - at the same time must have  
collector to base shorted too. when such eve  
takes place, the R<sub>2</sub> resistor at the -15VDC wa  
limit the current flow to -15VDC from 100V

Based on event scenario and recorded information, possibility of 100VDC & -15VDC short circuited through any parts of the circuits is extremely low and indications are hard to miss. Therefore there must be an external element to 100VDC and -15VDC short circuit theory.

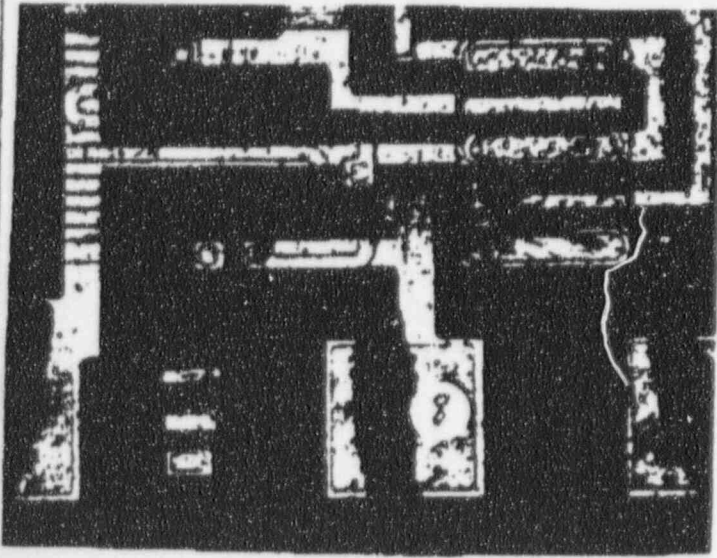
FIG. 2  
S/N 12 Pad 8  
ELECTRICAL OVERSTRESS

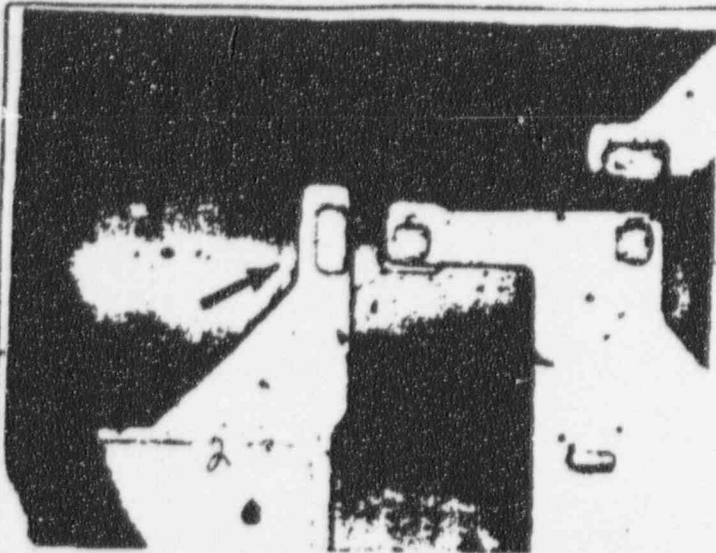
FIG. 4  
S/N 11 PAD 2

INDICATIONS OF ELECTRICAL  
OVERSTRESS DUE TO ESD

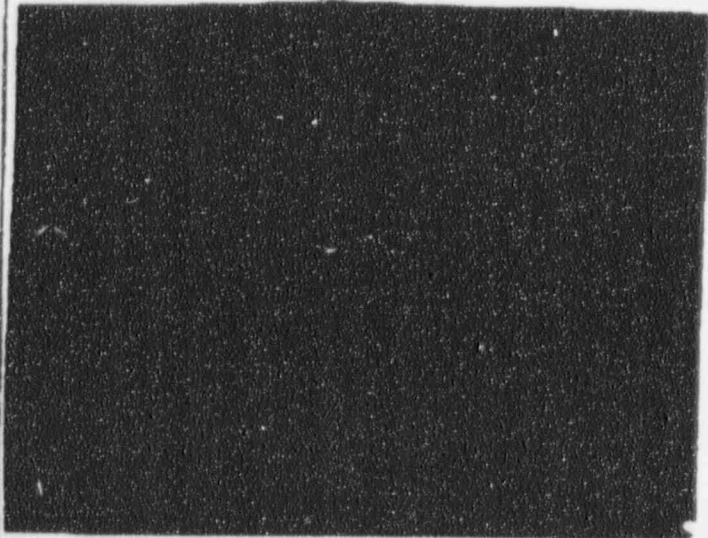
FIG. 5  
S/N 11 PAD 2

AFTER REMOVAL OF THE  
GLASSIVATION AND METAL,  
THE OVERSTRESS IS SEEN  
MORE CLEARLY

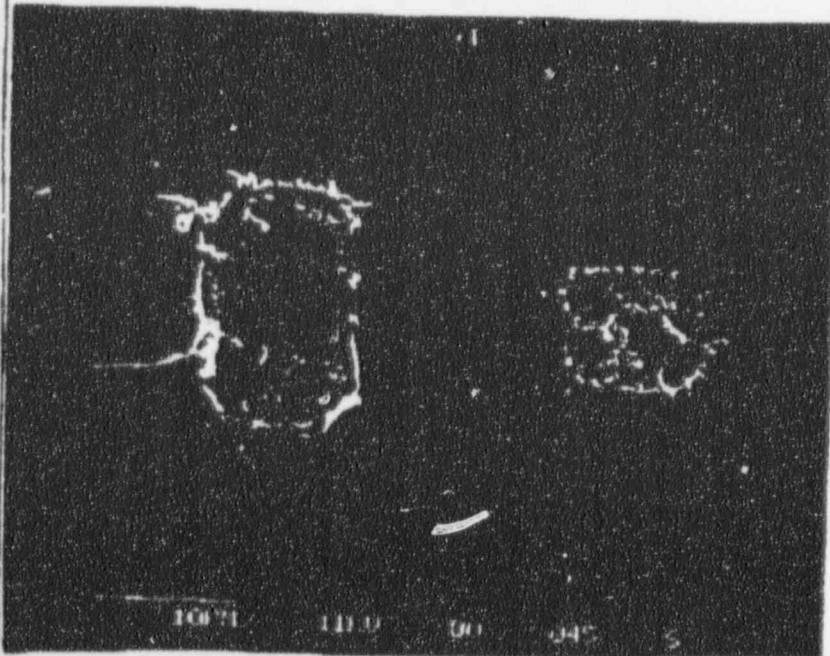
FIG. 6  
S/N 11

AFTER DEPROCESSING  
TO SILICON, SEM  
EXAMINATION SHOWS  
THE OVERSTRESS.

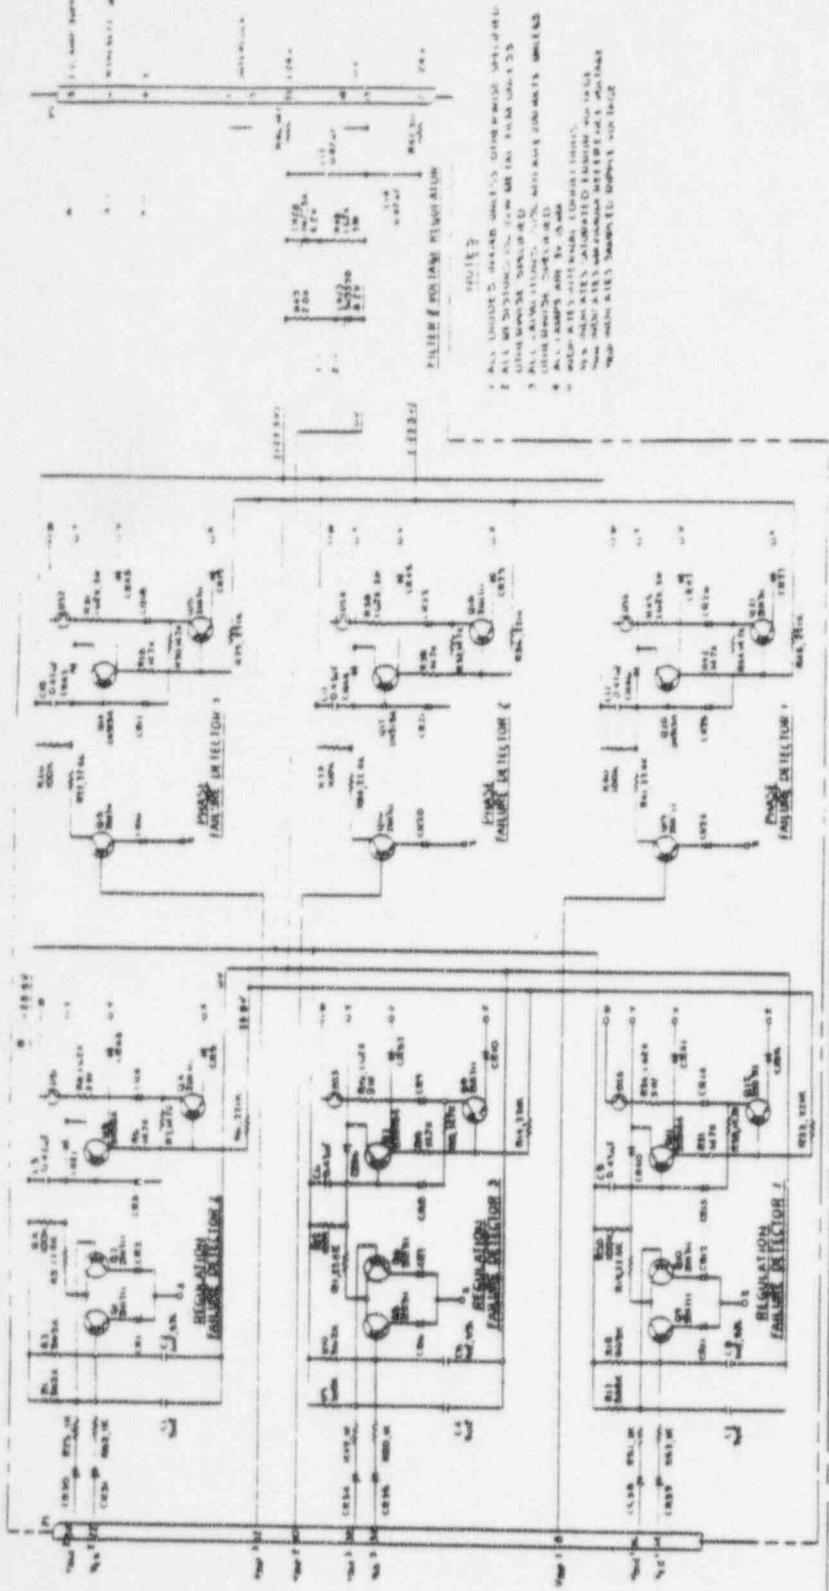
2 PIN 6 OF MATING ELCO CONNECTOR IS WIRED TO PIN 26 OF SIGNALING PROCESS CARD SHOWN BELOW. JUMPING OF PIN 5 AND 6 ON FAILURE DETECT CARD APPLIES +24VDC DIRECTLY TO THE COLLECTOR OF Q9 ON THE SIGNALING PROCESS CARD.

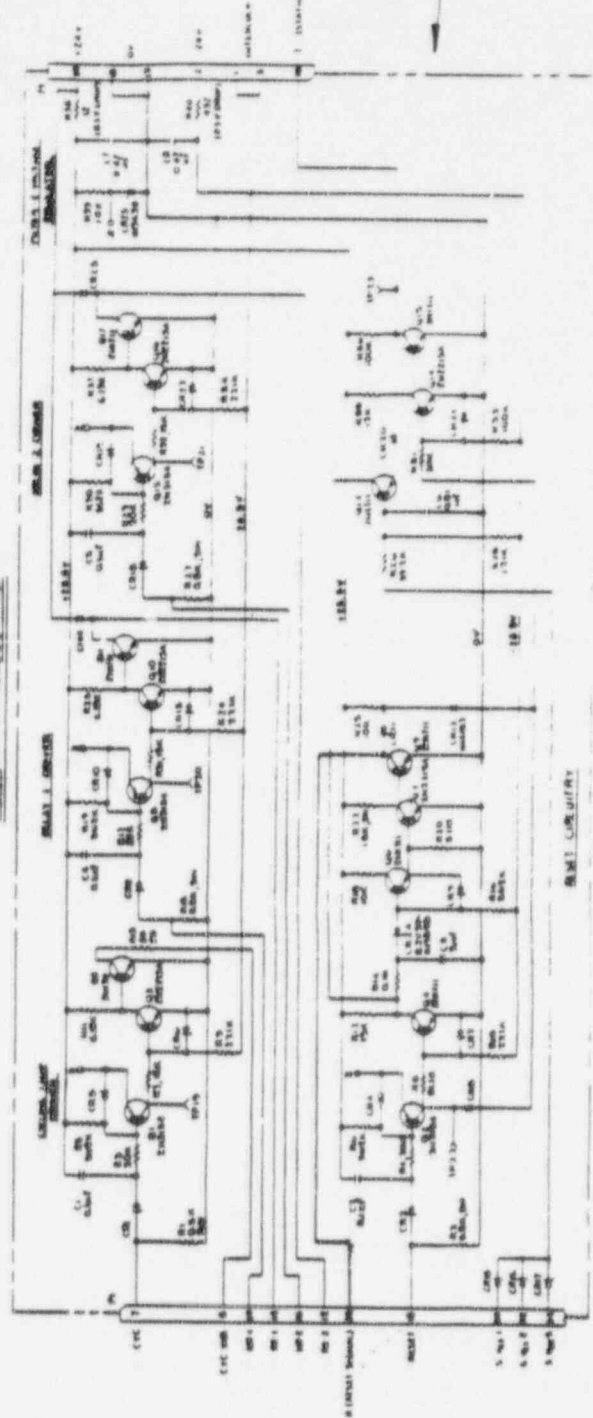
SIGNALING PROCESS CARD

FAILED Q9 LOCATED ON THIS CARD

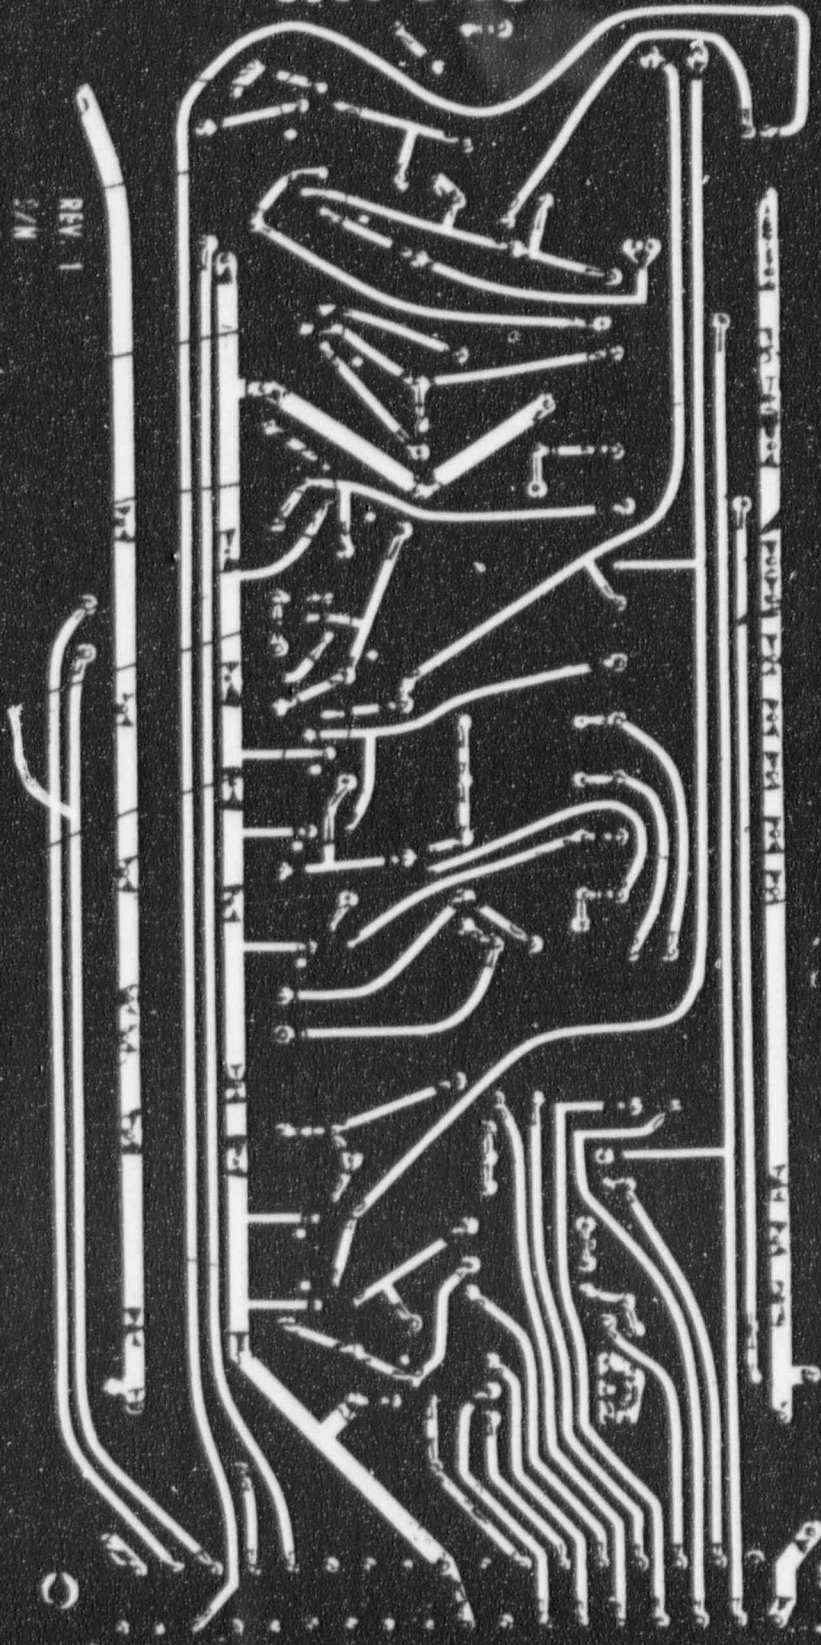
SHORTING OF TWO TRACES  
 DESCRIBED IN TEXT JUMPERS  
 +24VDC TO THE ANODE OF CR27  
 (WHICH IS THE JUNCTION OF CR25, CR26, & CR27)
