CSX Train Derailment with Hazardous Materials
Release
Hyndman, Pennsylvania
August 2, 2017

Accident Report
NTSB/RAR-20/04
PB2020-101012

Railroad Accident Report

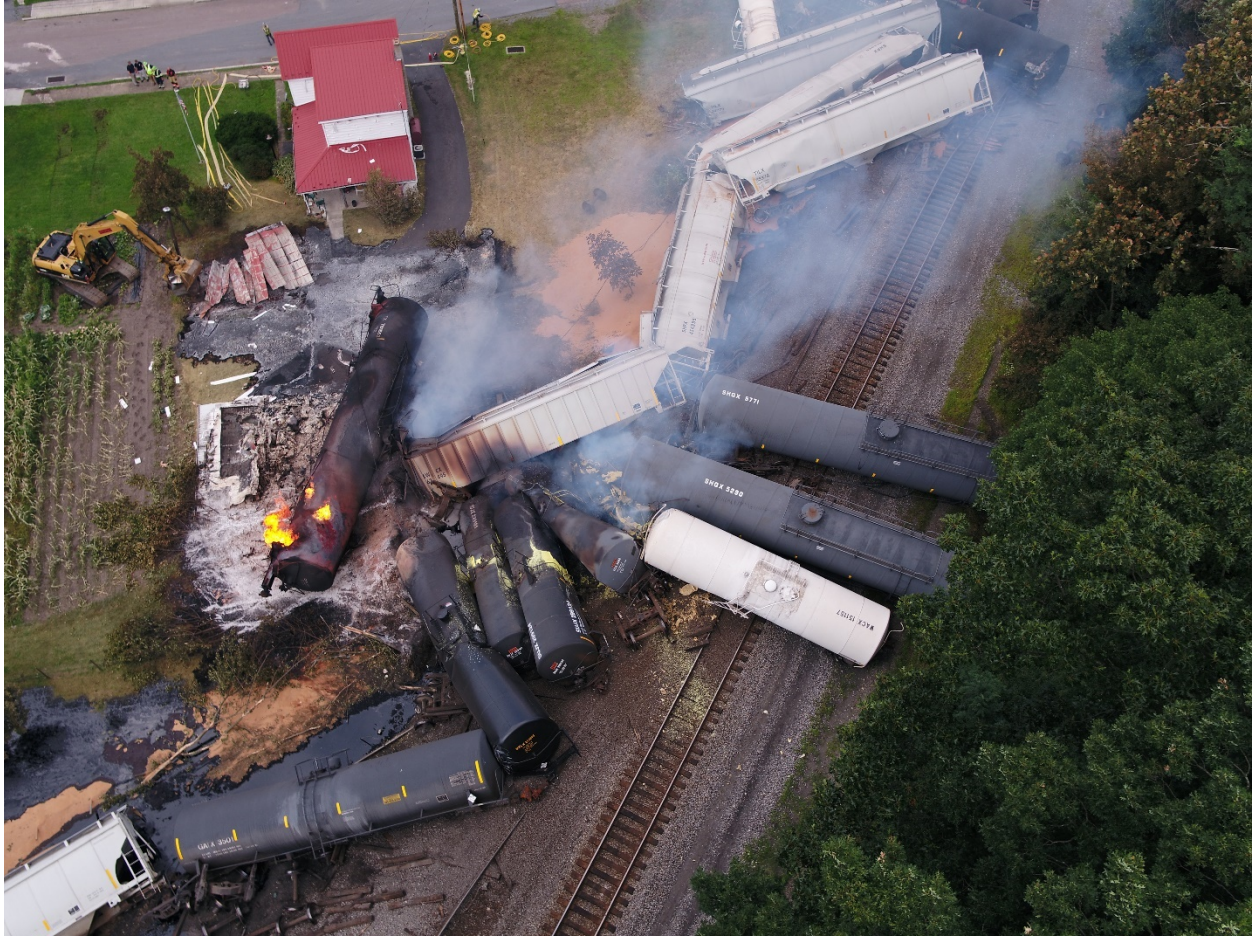
Figure 2. Overhead view of derailment of CSX freight train Q38831. (Courtesy of CSX.)

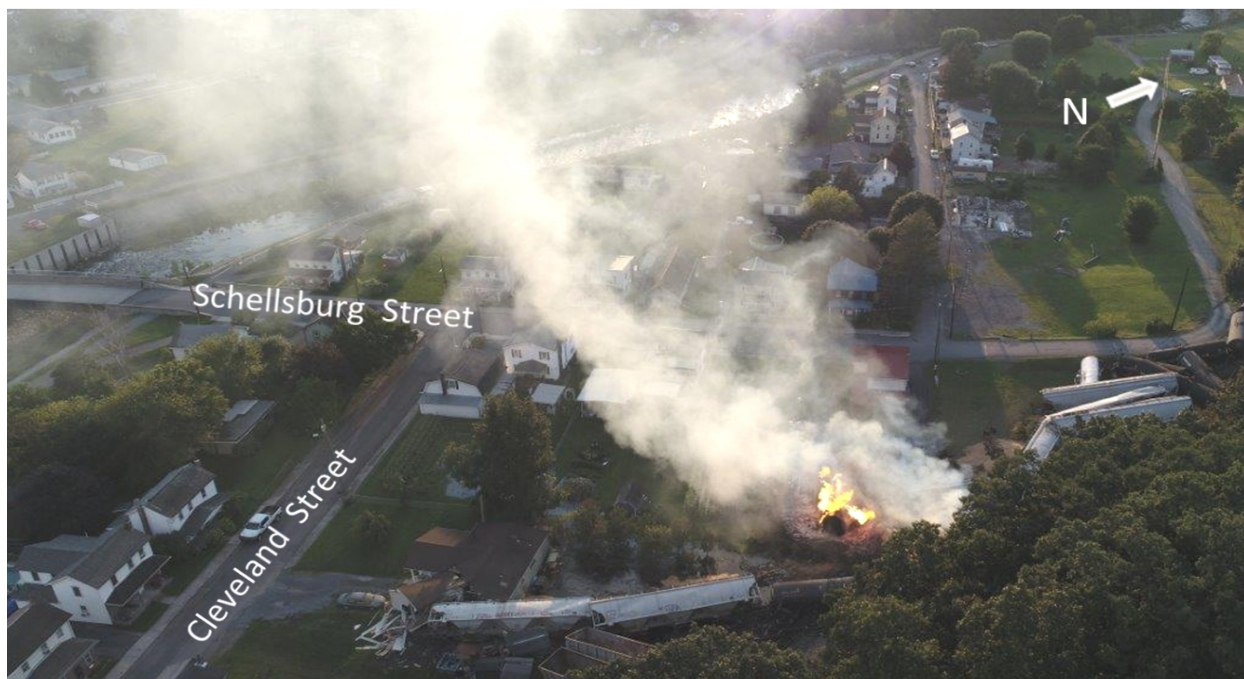
At 9:50 a.m., the CSX operations section chief participated in a state police helicopter overflight of the incident scene and confirmed that molten sulfur and asphalt had been released.¹⁸ Fire was seen issuing from several locations on the propane tank car, giving the appearance of multiple tank punctures. (See figure 3 for accident scene.)

Figure 3. Accident scene August 2, 2017, 7:45 p.m. (Courtesy of CSX.)

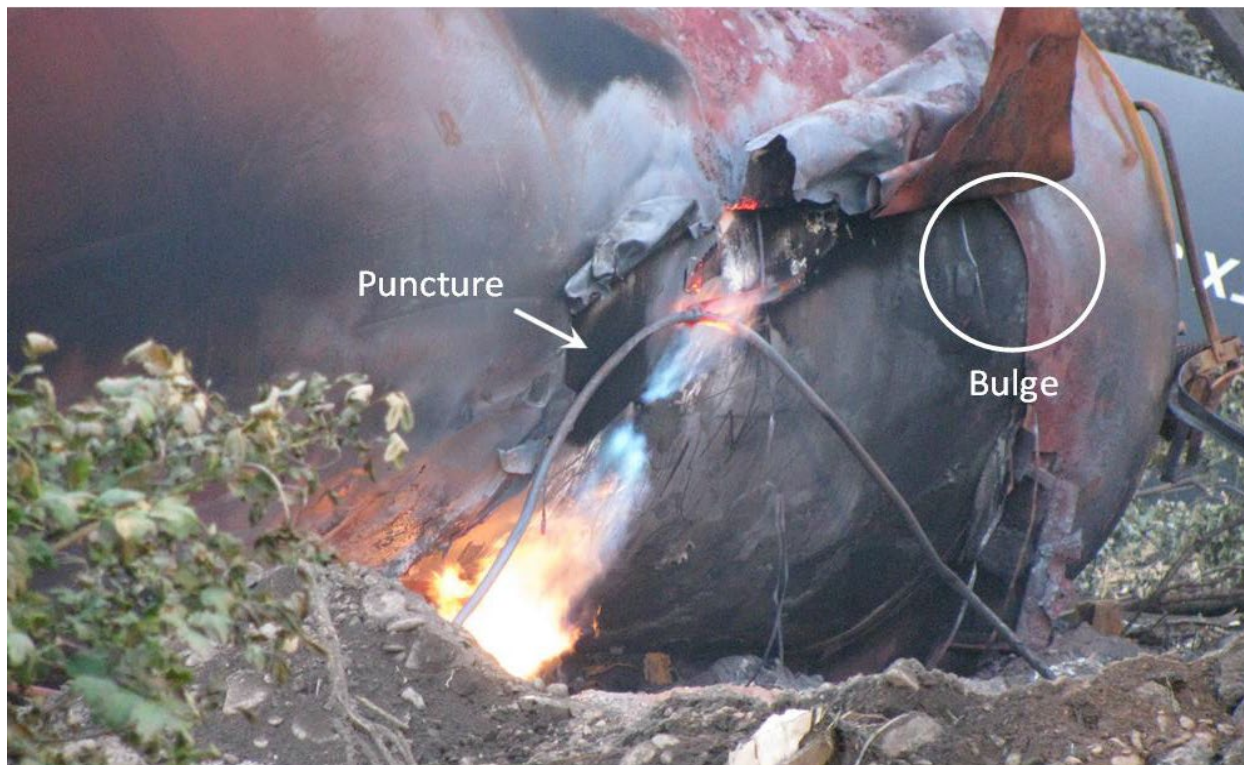
By the evening of August 3, the pressure in the propane tank car decreased as indicated by diminishing flame size. A hazardous materials team consisting of CSX and contractor personnel measured the pressure in CBTX 781553, finding about 28 psig, confirming that the pressure was considerably lower than the vapor pressure of propane under normal transportation conditions of 138 psi at 77°F. Therefore, although the tank car was not yet empty, its internal pressure had significantly reduced to the point that CSX was less concerned about the potential for further loss in tank integrity. The shell puncture became evident when CSX contractors peeled the jacket back to determine the nature of shell damage and to search for a frost line suggestive of any remaining liquid level.¹⁹ The frost line ranged from about 6 inches to 15 inches high, indicating that an estimated 2,000 to 3,000 gallons of liquid was still inside the tank. The most significant finding was the lack of a shell crack or buckled tank wall indicative of compromised structural integrity; however, the tank shell had been punctured in one location. The CSX operations section chief said

he noticed what appeared to be a bulge in the tank shell adjacent to the puncture. He said that by the time the shell bulge was discovered, there was almost no vapor pressure or product left in the car. Figure 4 shows the puncture covered by a square of magnetic patching material and the visible edge of the shell bulge under the exposed jacket.

Figure 4. The shell bulge and puncture site. (Courtesy of CSX.)

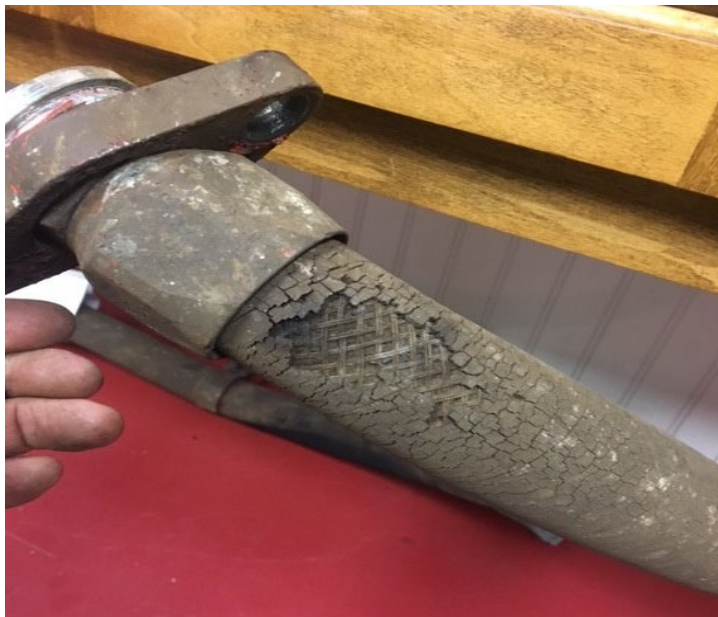
205.6. (See figure 5.) According to one of the mechanics who replaced the defective hose prior to the derailment, the hose that attached from the angle behind the angle cock to the train line was kinked and leaking.²⁹ The mechanic stated that the hose was “basically falling apart. You could see the internal threads.... I guess it was an older hose.”

Investigators inspected the damaged hose that was removed and found no visible signs of kinking. The hose was fitted with a coupling on one end and a pipe nipple and cap on the other. The hose was then pressurized to identify the location of the leak. The hose leaked at one end just behind the hose clamp and flange fitting. After returning the damaged hose to the Cumberland, Maryland, terminal for further testing, investigators attached the hose to the rear of a 67-car freight train. Leakage, measured by a pressure drop over time, on the train before attaching the hose at the rear was 2 psi over a span of 3 minutes in compliance with FRA minimum safety standards. After attaching and aligning air into the leaking hose, the pressure drop increased by 1 psi (to a 3-psi drop) within 3 minutes, which was within the federal threshold.³⁰

Figure 5. Close-up view of defective intermediate air brake hose removed from car LW 62114.

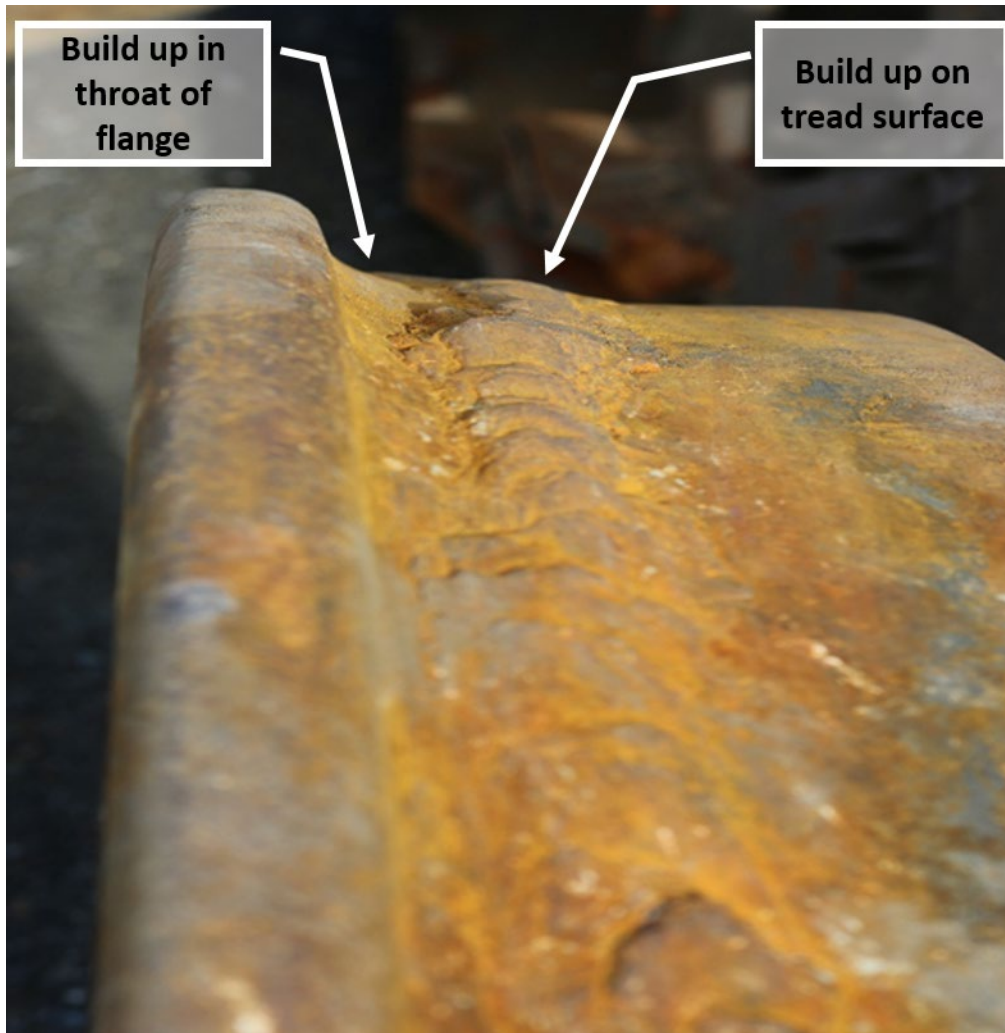
- [The application of hand brakes on empty rail cars toward the front of the consist caused the wheels of those cars to overheat and build up tread.](#)

A rail car truck assembly with damage consistent with being derailed was discovered between the point of derailment (POD) and the location of the general pile-up. It was identified as the truck assembly from FWTX 620111 (35th car). The truck assembly was discovered 600 feet away from the resting location of FWTX 620111. There were several indications that this truck assembly had derailed prior to the general pileup. These included gouges on the bottom of the side frame (consistent with impact with the rails), damage to the inside vertical surfaces of the side frame (where the wheel made contact) and damage to the tread of the wheels (consistent with contact with the roadbed). This truck assembly was from the leading end (in the direction of movement) of FWTX 620111 on the train at the time of derailment. All the wheels of FWTX 620111 showed signs of overheating. The 1st and 3rd axles (in the direction of movement) had a reddish-brown discoloration on both the front and back of the rim, which extended more than 4 inches into the plate. These wheels also had extensive tread buildup, especially along the throat of the flange as can be seen in figure 6.

Figure 6. Closeup of wheel tread surface showing tread buildup on wheel of the 35th car.

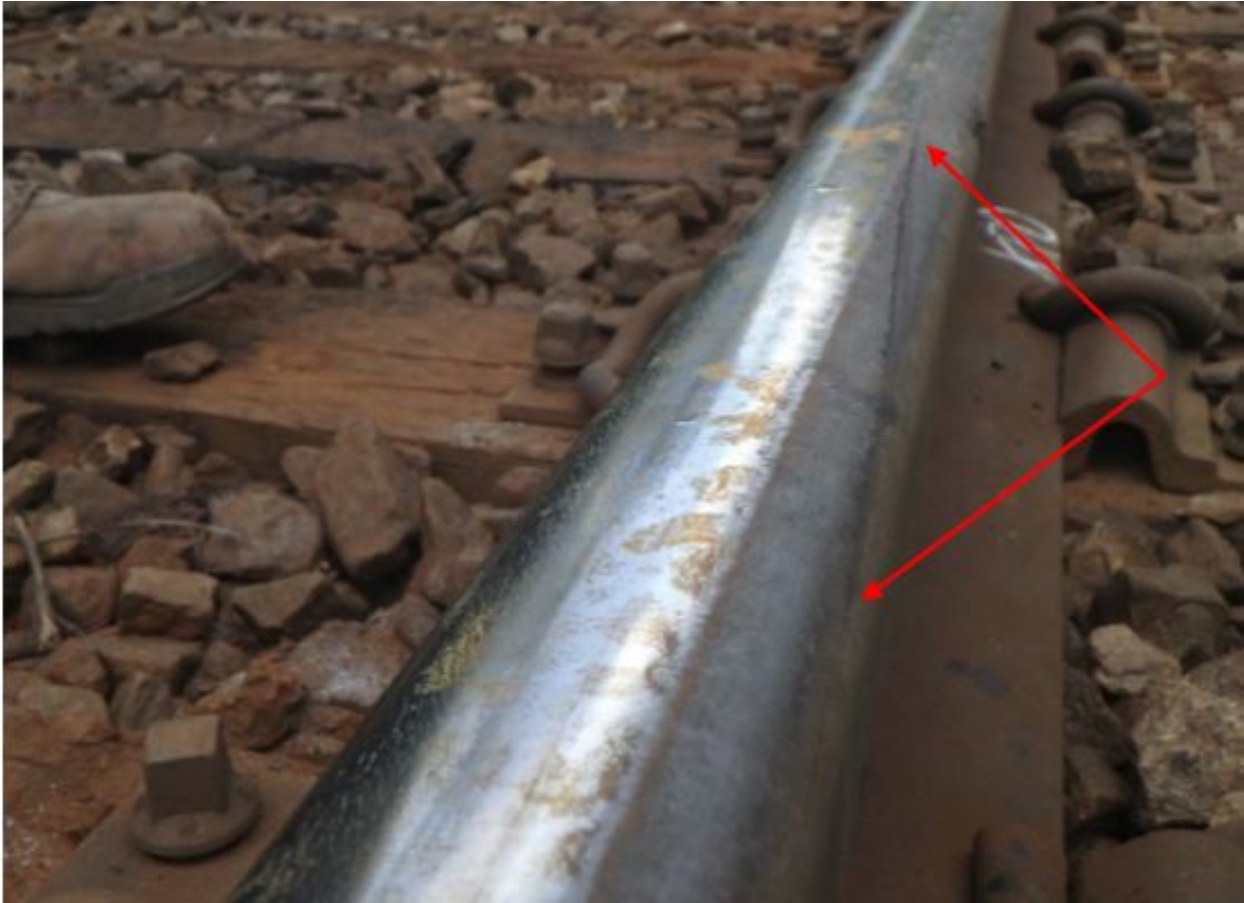
Figure 8. Flange mark at point of departure of FWTX 620111 (35th car).

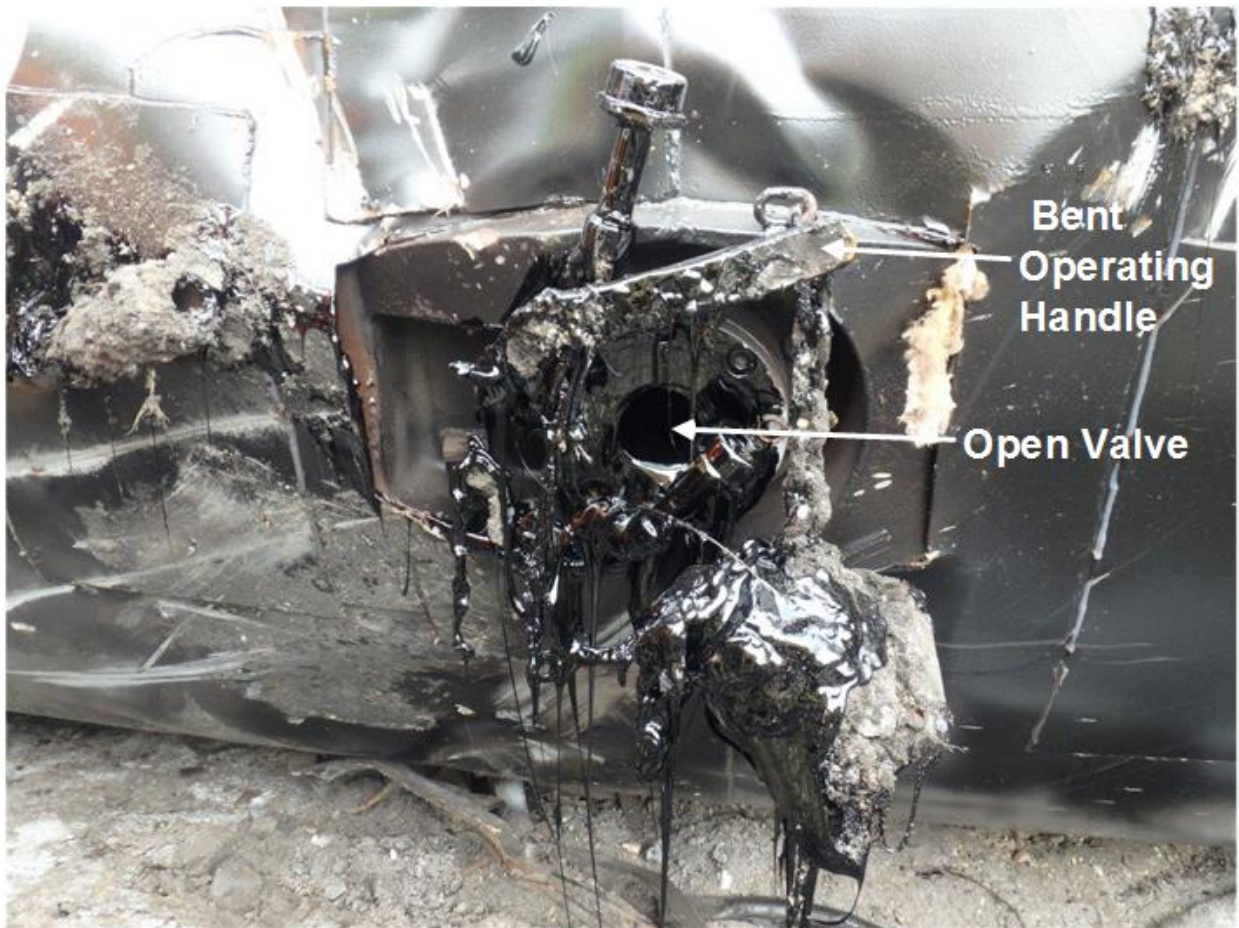
The derailment left the tank car with a missing bottom outlet valve nozzle, a bent operating handle, and the ball valve in the completely open position as shown in figure 10. Most of the asphalt released through this open ball valve. The left side of the shell was also crushed with significant loss in tank volume. The entire load of about 23,000 gallons of asphalt released and pooled on the two residential properties north of Cleveland Street in Hyndman.

Figure 10. UTLX643949 open bottom outlet valve.

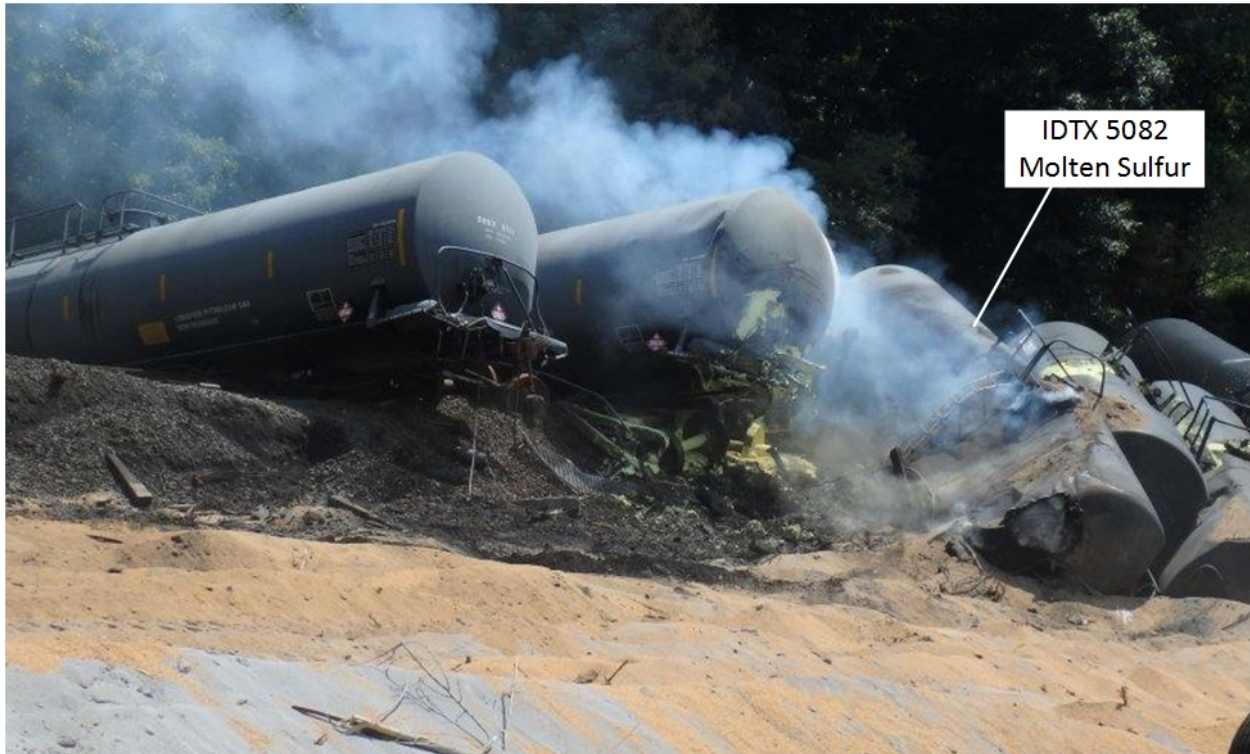
Most of the 13,000 gallons of molten sulfur product contained in tank car IDTX5082 released and ignited. (See figure 11.) The tank car sustained a 7-foot transverse shell tear in the right center of the car. The bottom of the car sustained a 32 x 18-inch puncture midway between the bottom outlet valve and the A end.

Figure 11. Burning molten sulfur released from tank car IDTX5082.

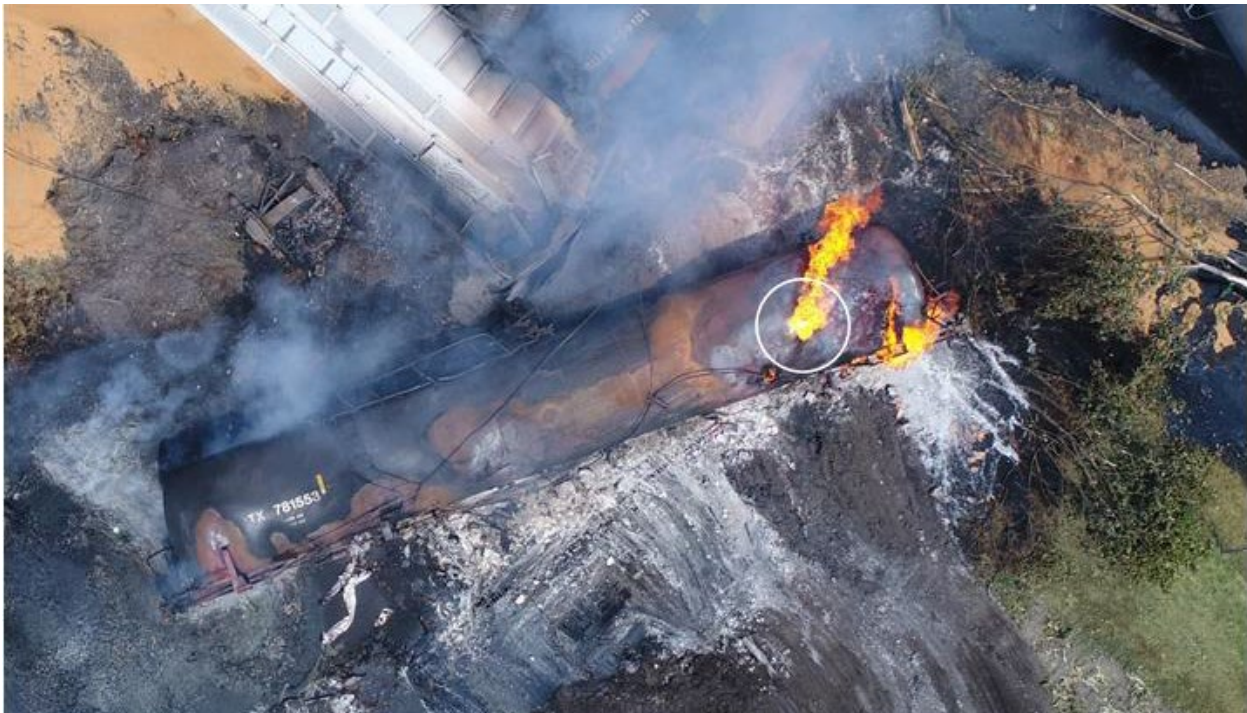
The A end of CBTX 781553 was leading in the eastbound train consist. The car came to rest with the A end facing east, parallel to and about 2 car lengths south of the track. The bottom of the car was in contact with a pool of burning molten sulfur released from tank car ITDX5082. The car was punctured and released burning propane, with torch fires escaping from holes and gaps in the jacket at several locations the length of the car. The most vigorous flame was observed at the right A end. (See figure 13.) As the postaccident emergency response actions progressed, the fire became restricted to the A end of the car. Aerial video and visual examination of the pressure relief device did not show any evidence that it had activated.

Figure 13. CBTX 781553 with puncture location circled, August 3, 2017, 2:46 p.m.

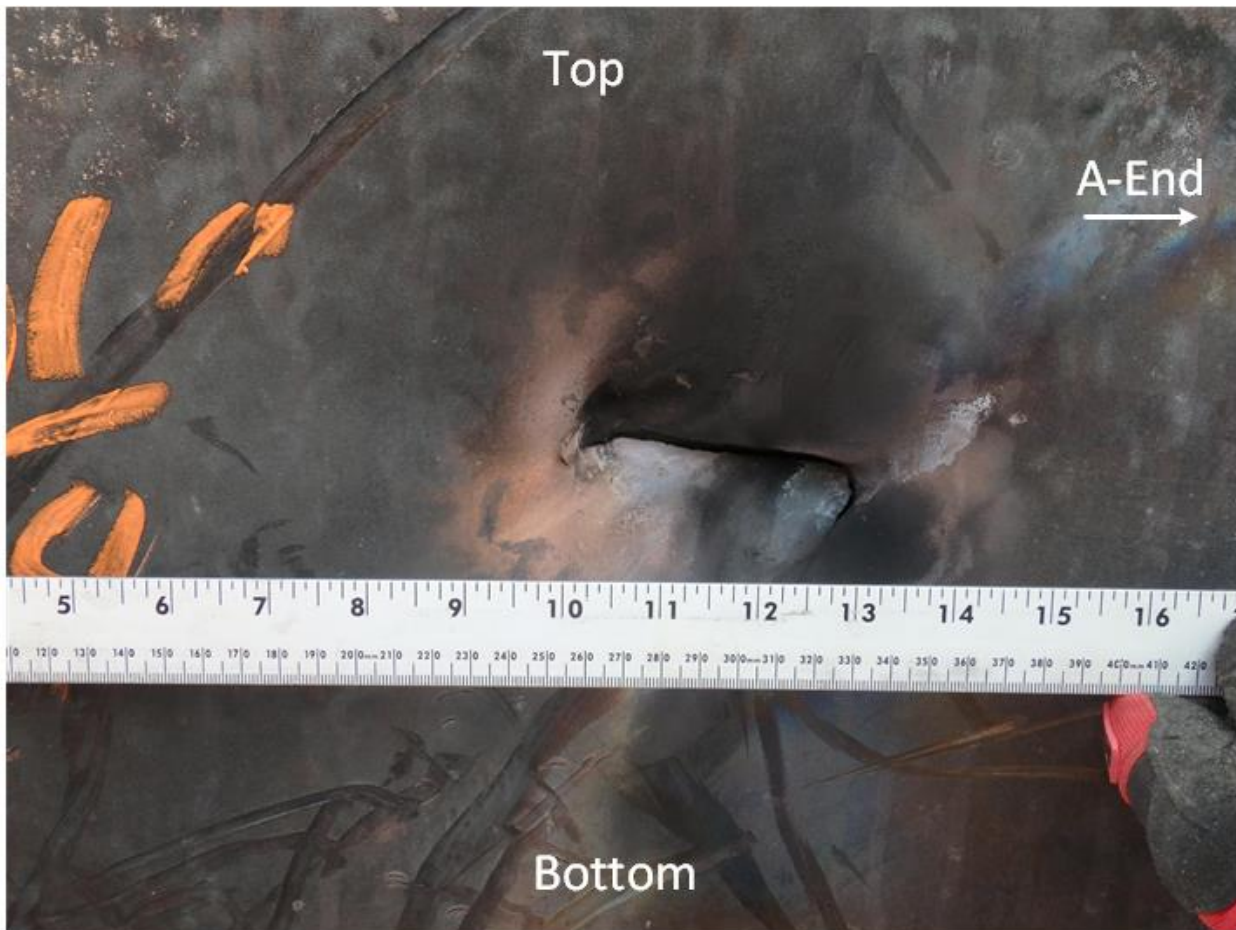
Investigators found a shell puncture at about the 3 o'clock position on the right side of the A end in the first barrel section. (See figures 14 and 15.) The puncture measured about 3.25 inches

in length and was oriented longitudinally. The puncture was within a dent measuring about 3.5 inches deep, with evidence of sliding contact in an upward direction. The shell fracture was isolated to the impact area and did not show any visual evidence of brittle propagation. Ultrasonic gauge thickness measurements of the tank shell in this region found thinning from 0.630 inch in a nearby unaffected area to 0.537 inch at the top edge of the puncture.

Figure 14. Tank Car CBTX 781553 puncture in exterior surface, August 4, 2017.

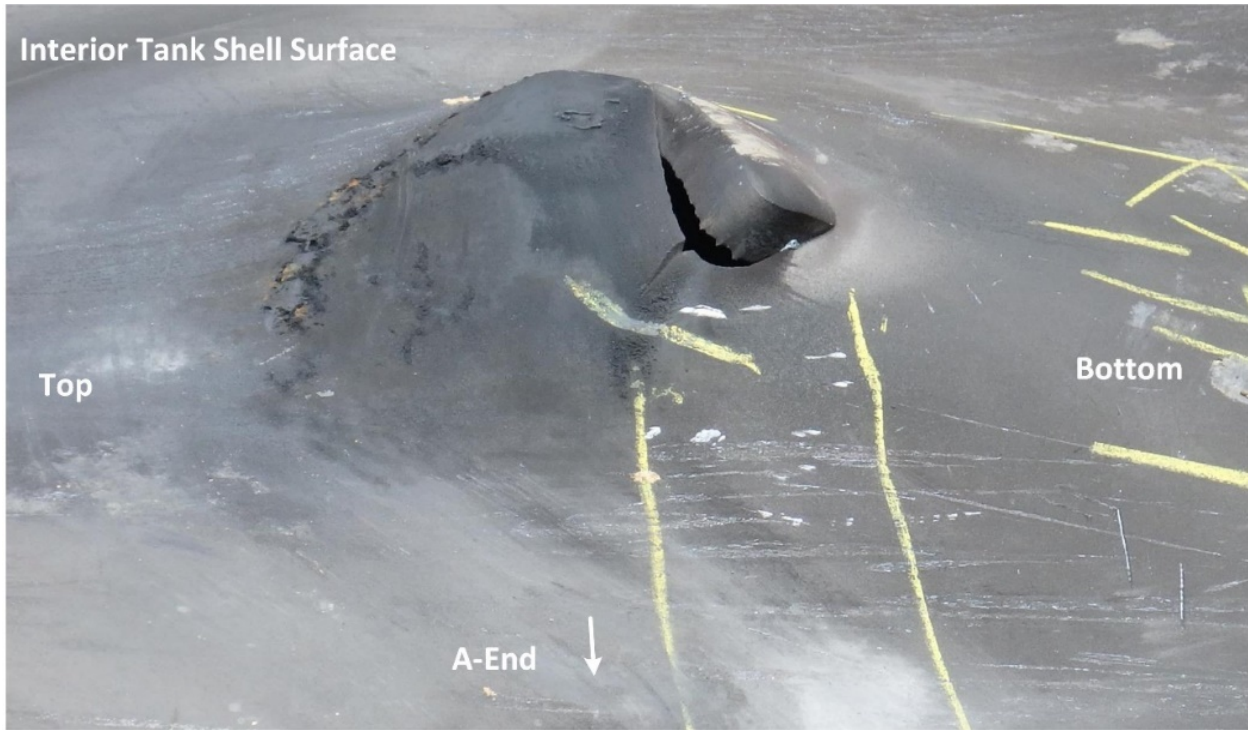
Investigators removed a section of the punctured tank shell plate 1 to examine the interior surface of the puncture as shown in figure 15. Penetration into the shell became deeper toward the A end. At the A-end side of the puncture, the crack turned downward about 1/2 inch in the circumferential direction. Carbon was deposited on the interior shell surface above the breach.

Figure 15. CTBX 781553 interior surface of shell puncture, August 5, 2017.

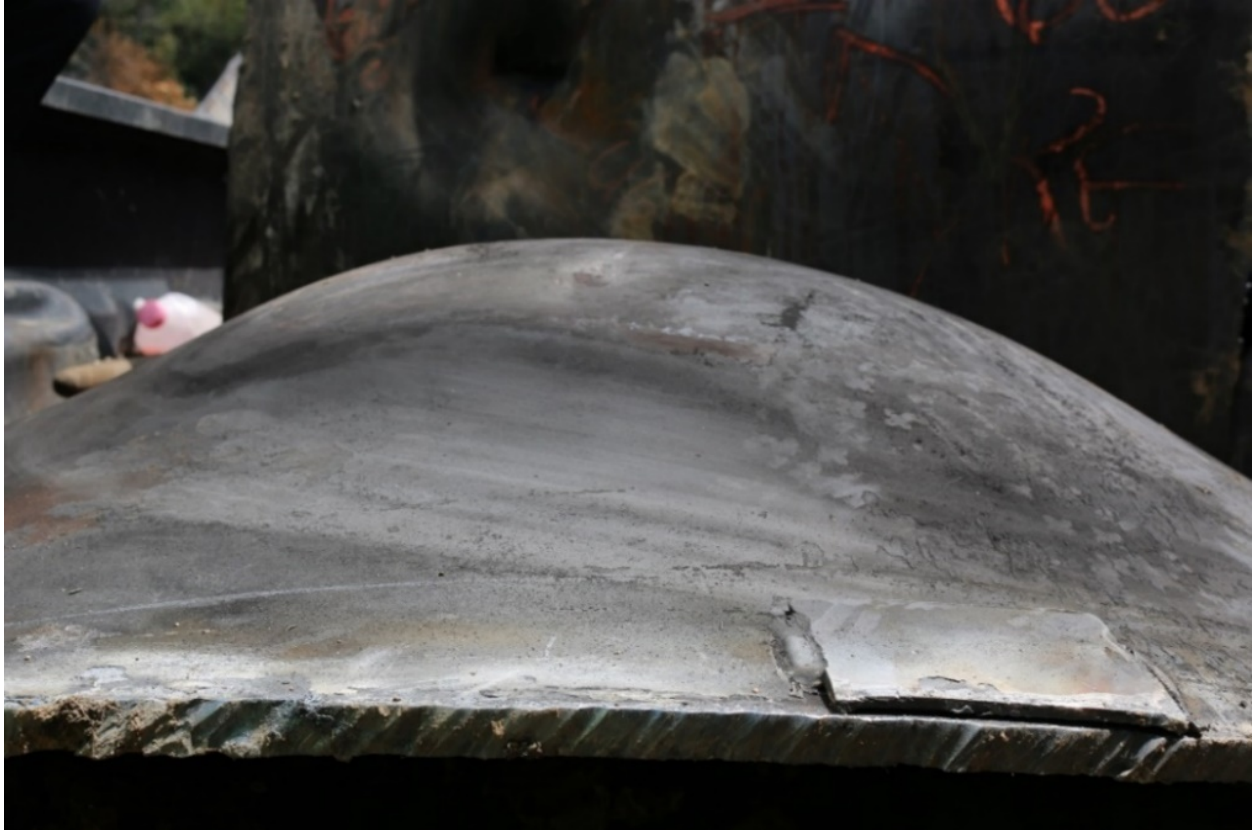
A shell bulge was observed closer to the A end, above the right-side body bolster in ring 1 of the tank shell. The bulge measured 27 inches in the longitudinal direction and 56 inches in the circumferential direction and protruded outward about 5 inches. (See figure 16.) Ultrasonic thickness measurements taken at about 2-inch intervals across the center of the bulge found that the shell thinned from 0.630 inches in a nearby unaffected area, to 0.436 inches at the thinnest location near the edge of the bulge. The Certificate of Construction reported a nominal shell thickness of 0.608 inches.⁴¹

Figure 16. CBTX 781553 tank shell coupon showing bulge profile, August 5, 2017.
