PRESERVATION PLAN

WASHINGTON & JEFFERSON COLLEGE

WASHINGTON & JEFFERSON
COLLEGE
WASHINGTON, PENNSYLVANIA

The purpose of this plan is to outline recommendations for the preservation, conservation and continued use of the historic landscape and buildings of Washington & Jefferson College.

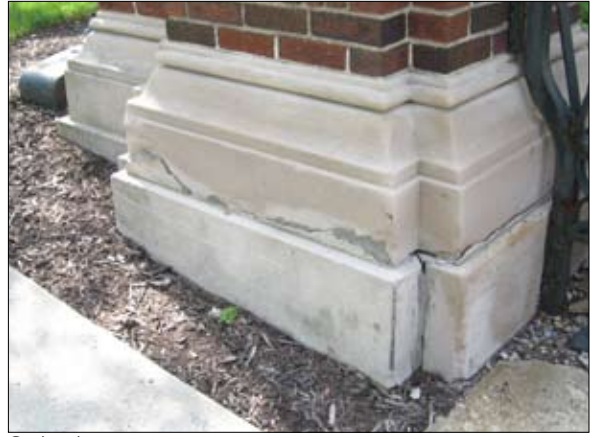
Gate damage.

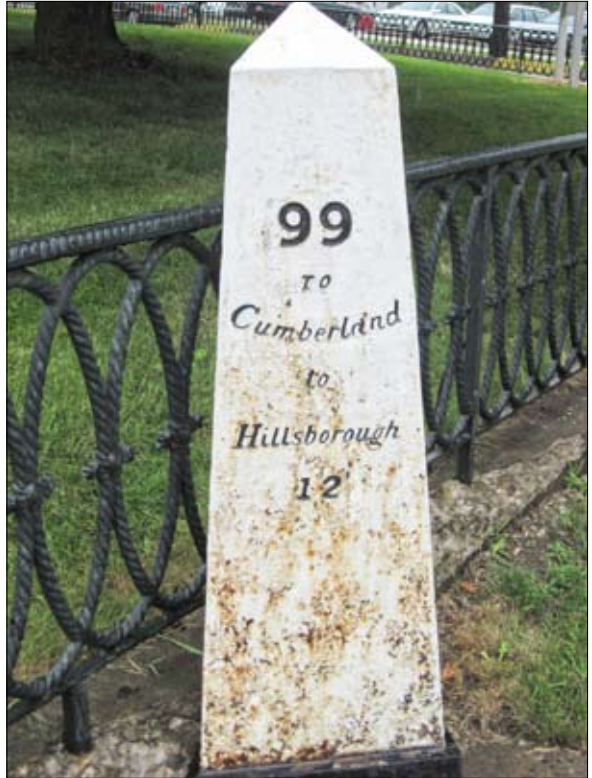
Reseat and level historic mile marker.

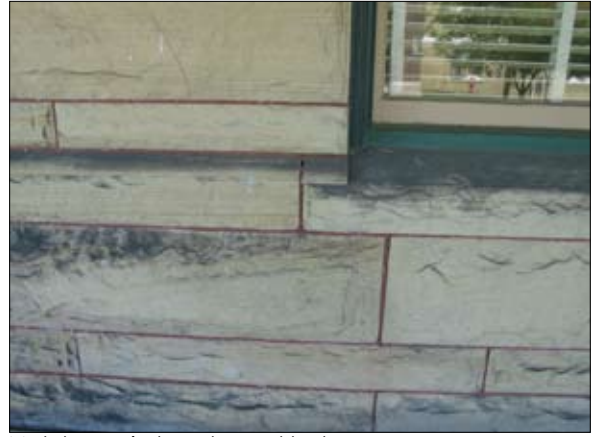
Match repairs to color and texture.

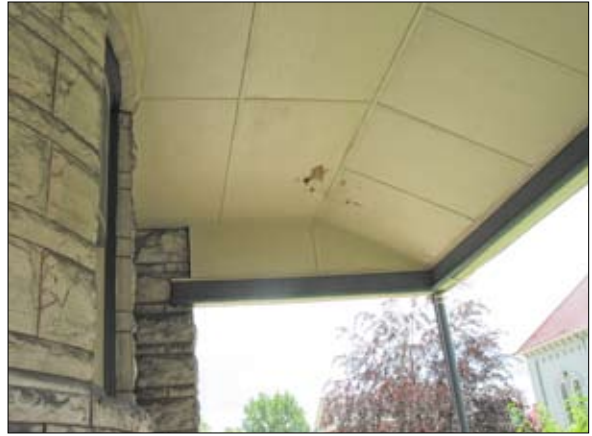
Check roof and flashings. Evidence of water leakage.

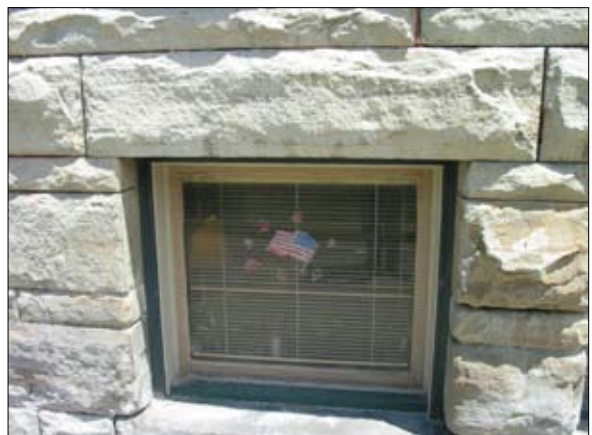
Scrape and prime wood windows as needed.

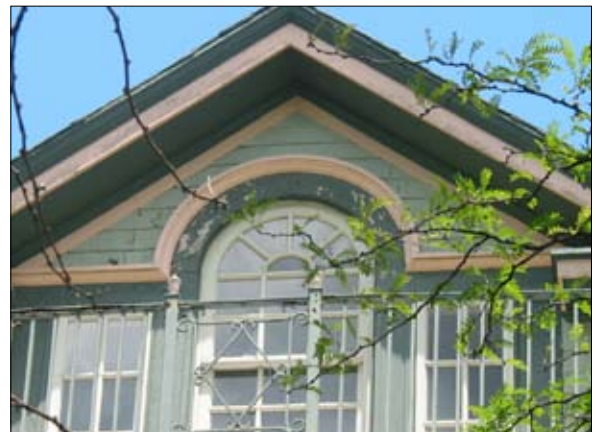
Scrape and prime wood trim as needed.

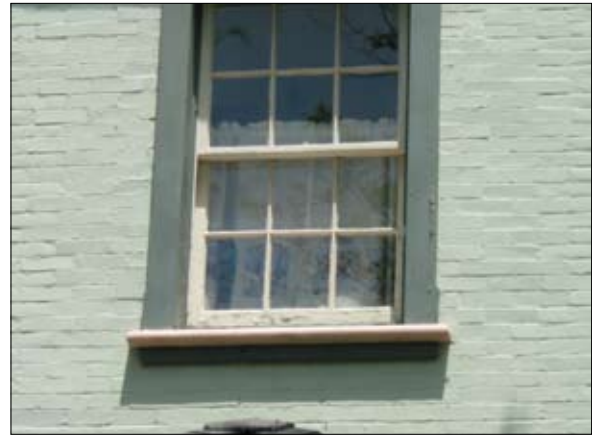
Repair joints to match.

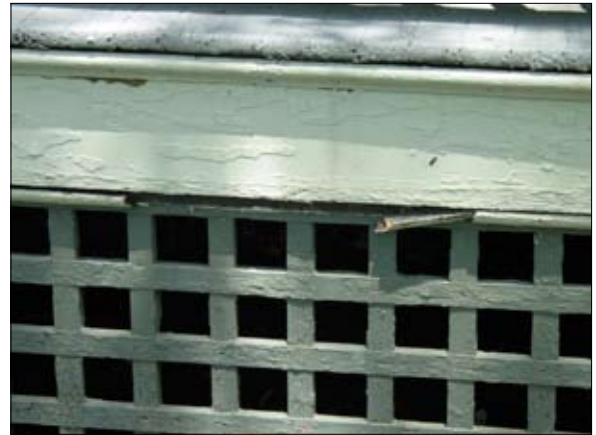
Repair or replace with similar materials.

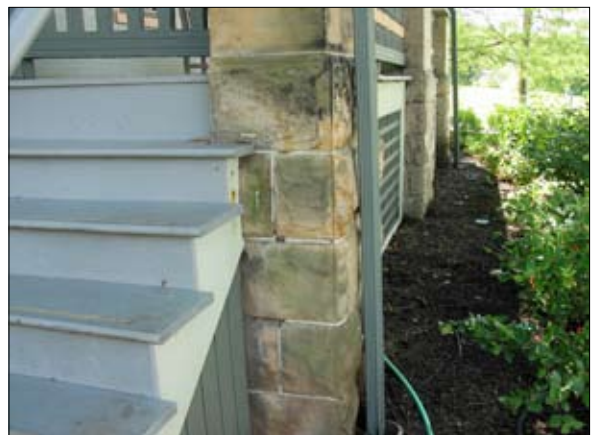
Repair masonry and joints to match original.

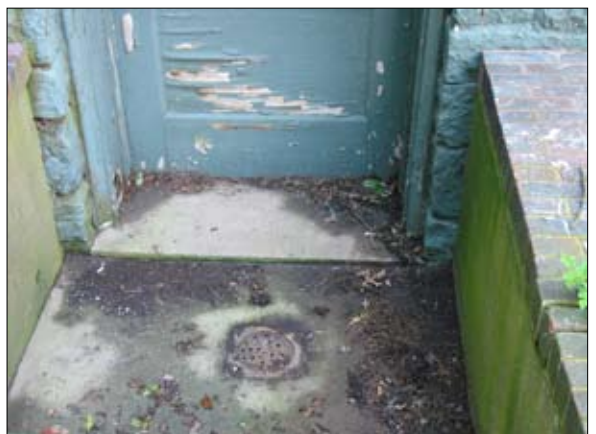
Keep drains free of leaves to prevent water damage.

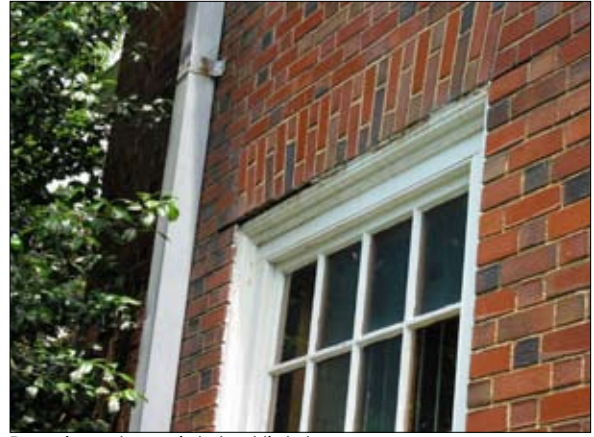
Repair and repaint steel lintels.

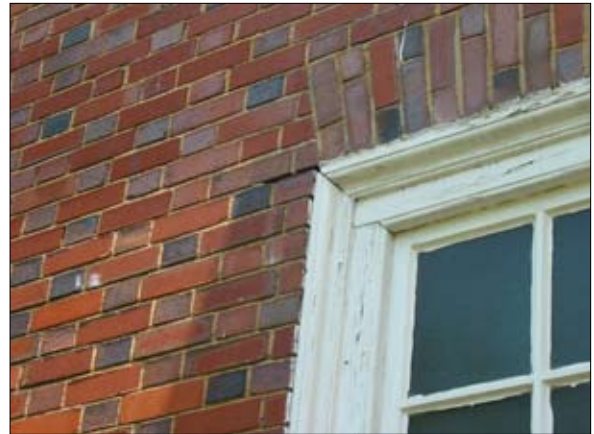
Match mortar repairs to existing color and texture.

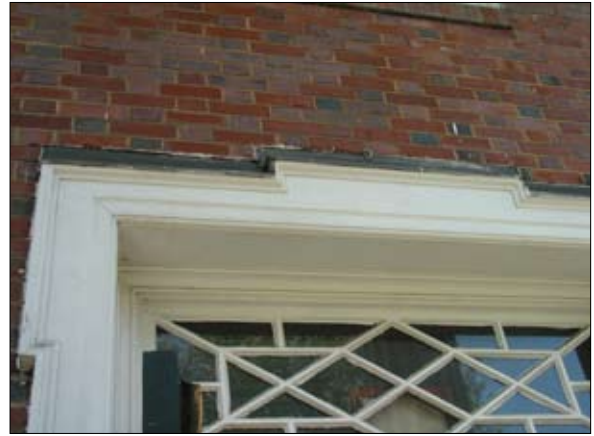
Recaulk fenestrations as needed.

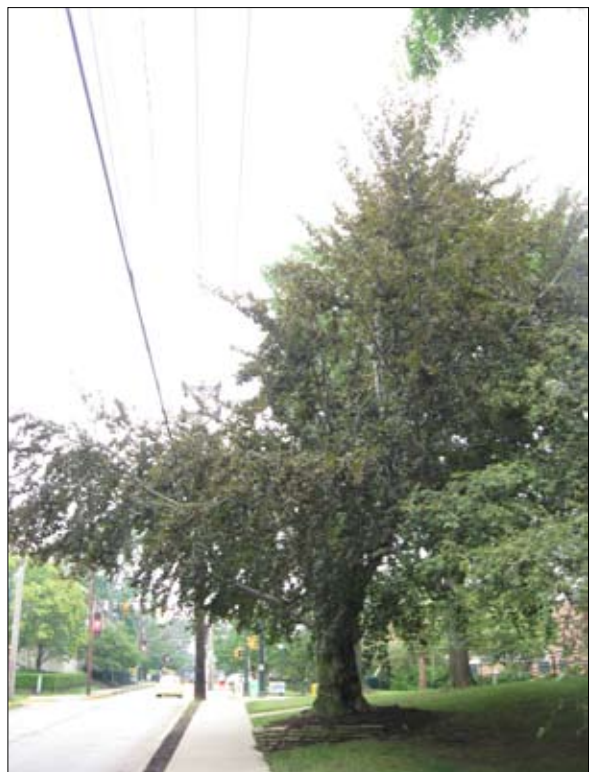
Beech has been brutalized by the utilities. Replace.

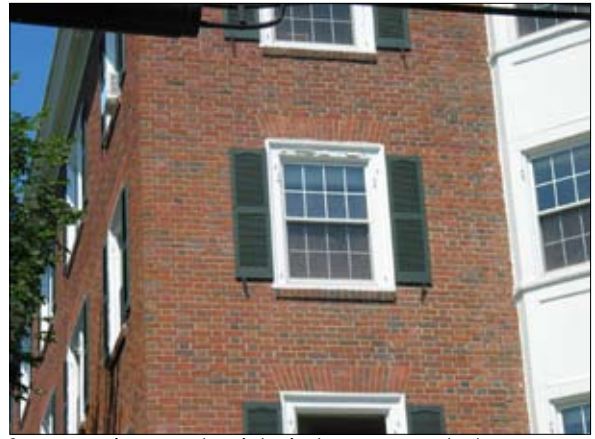
Scrape, prime, and paint windows as needed.

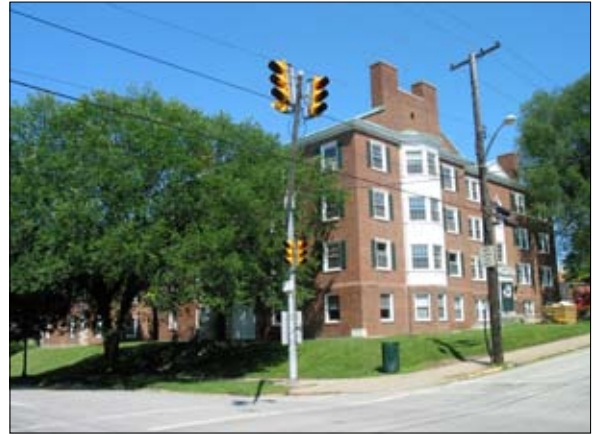
Prune trees back from buildings and roof lines.

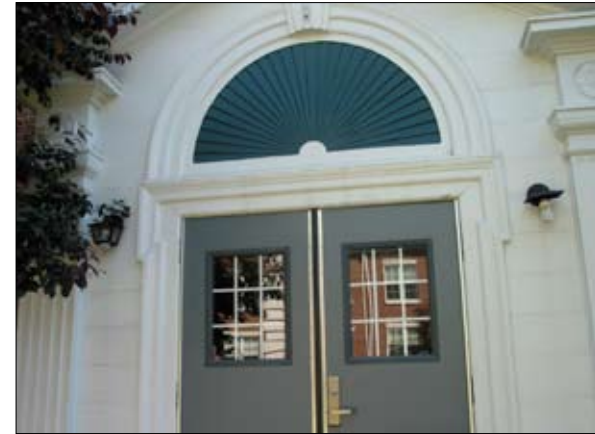
Replace modern fixture with appropriate period light.

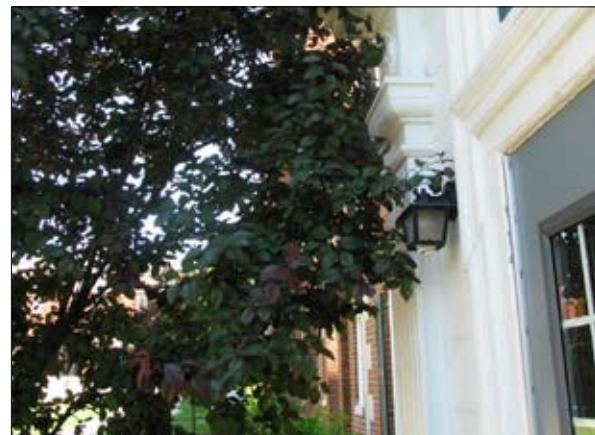
Prune trees away from building

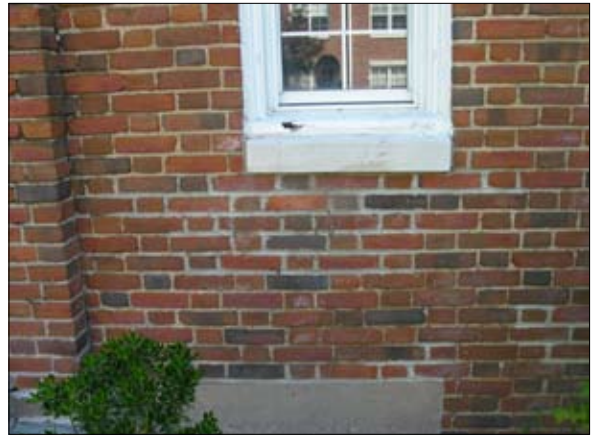
Bad repair. Match color and texture on repairs.

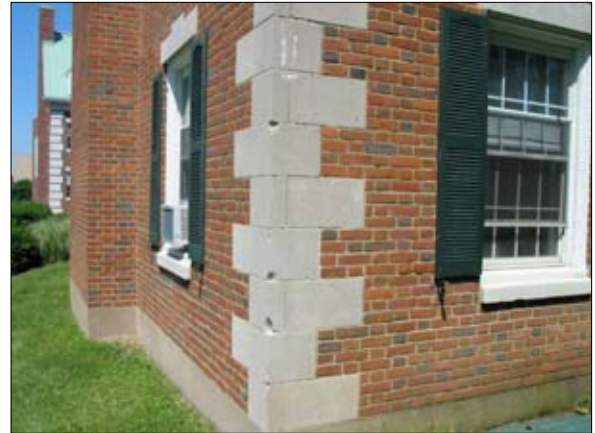
Repair damaged cornerstones.

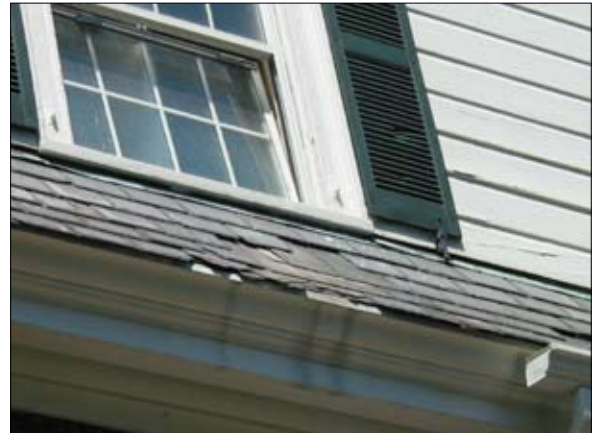
Repair broken or missing slate.

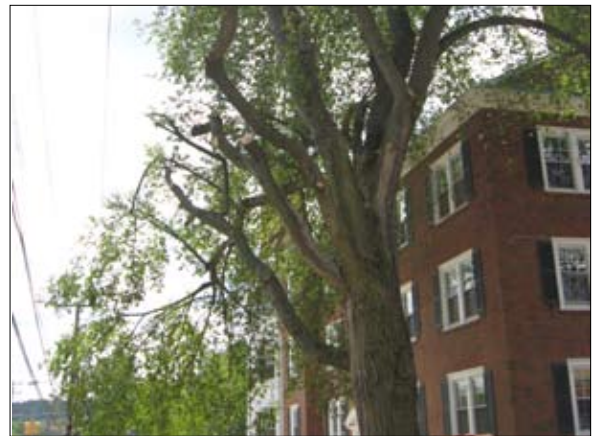
Improper pruning.

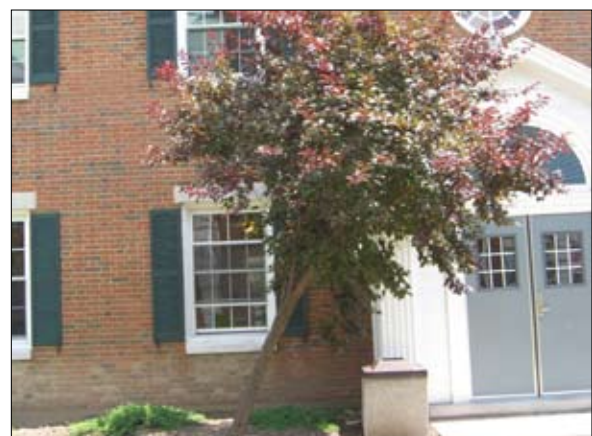
Tree leaning due to improper root development.

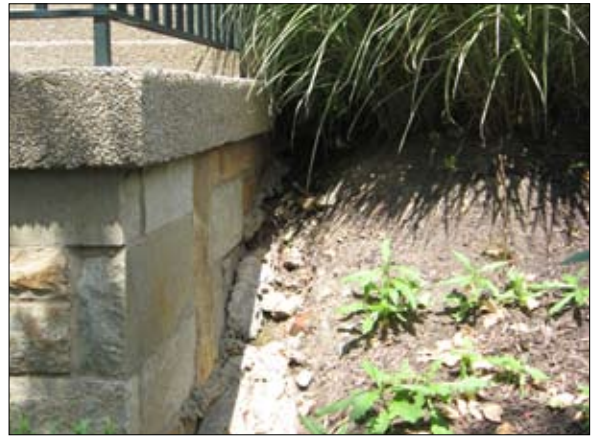
Correct erosion wash along East Beau St.

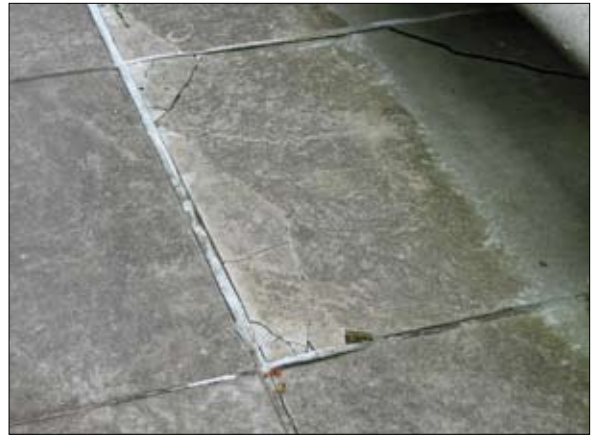
Replace or repair damaged stone pavers as needed.

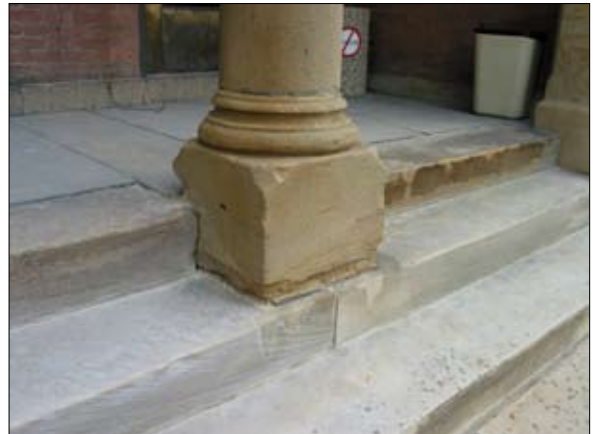
Repair damaged stone to match color and texture.

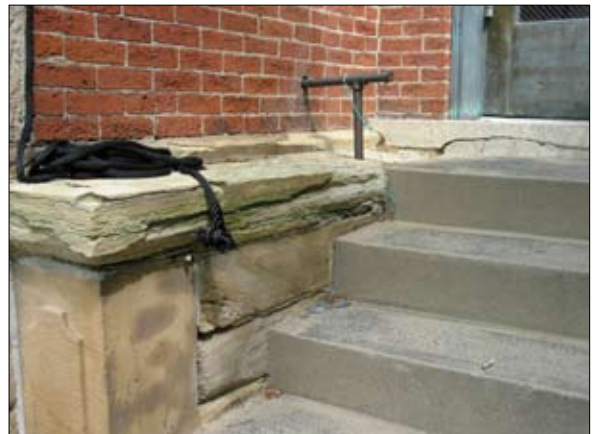
Repair damaged stone to match color and texture.

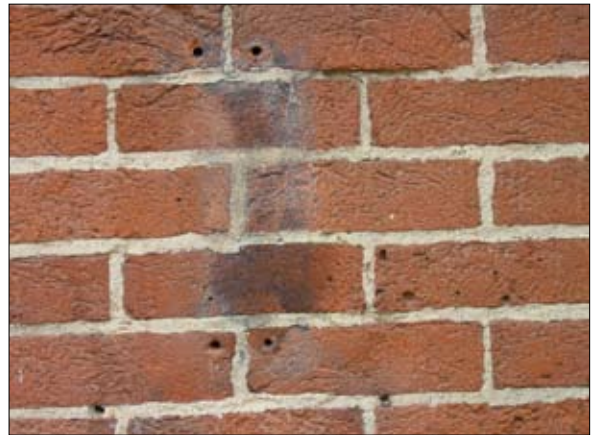
Fill holes in brick to match color and texture.

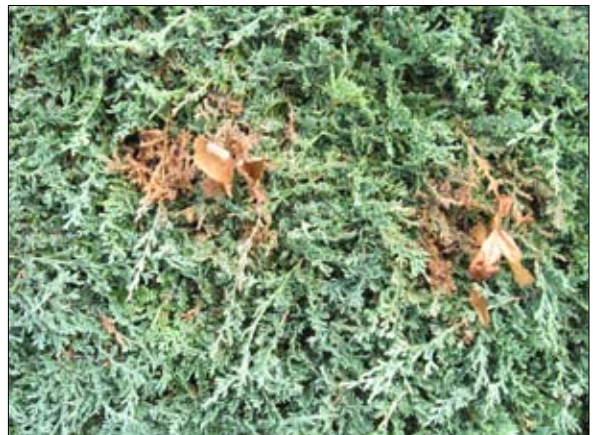
Be careful with herbicide overspray. Juniper damage.

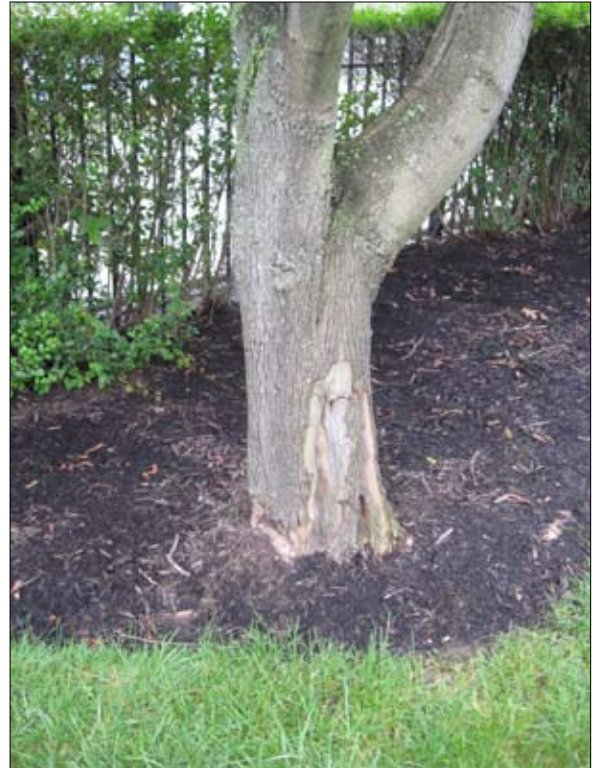
Replace this maple.

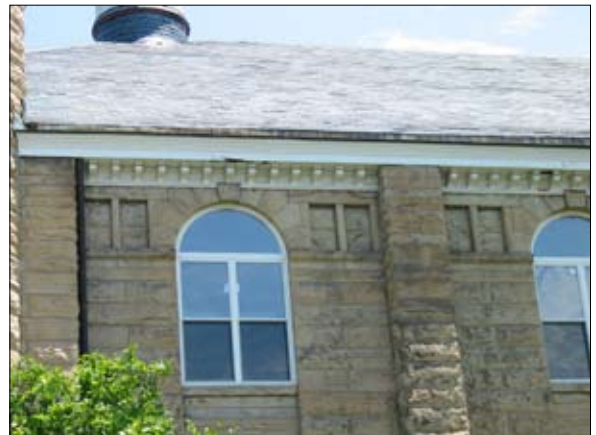
Repair soffit and facia boards as needed.

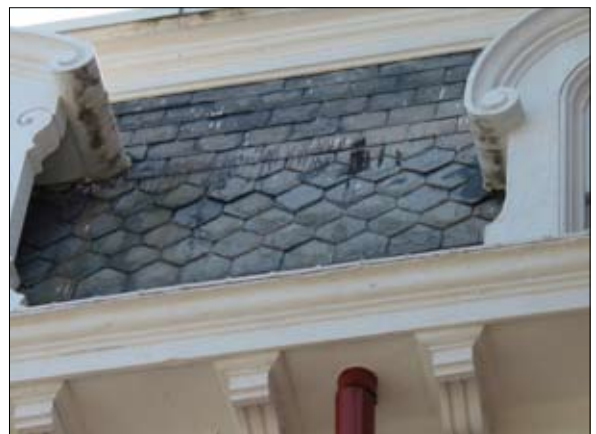
Repair slate, box gutters, downspouts as needed.

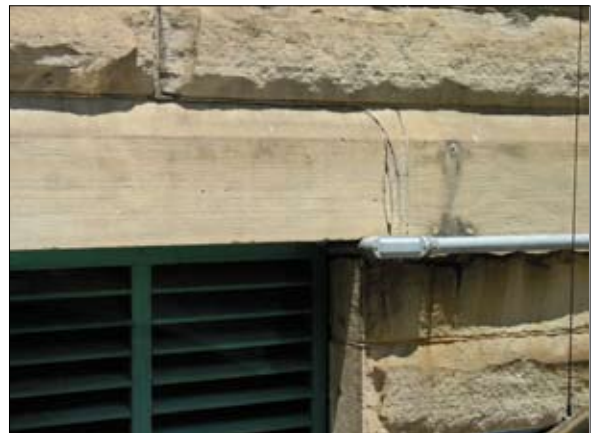
Remove abandoned hardware and repair.

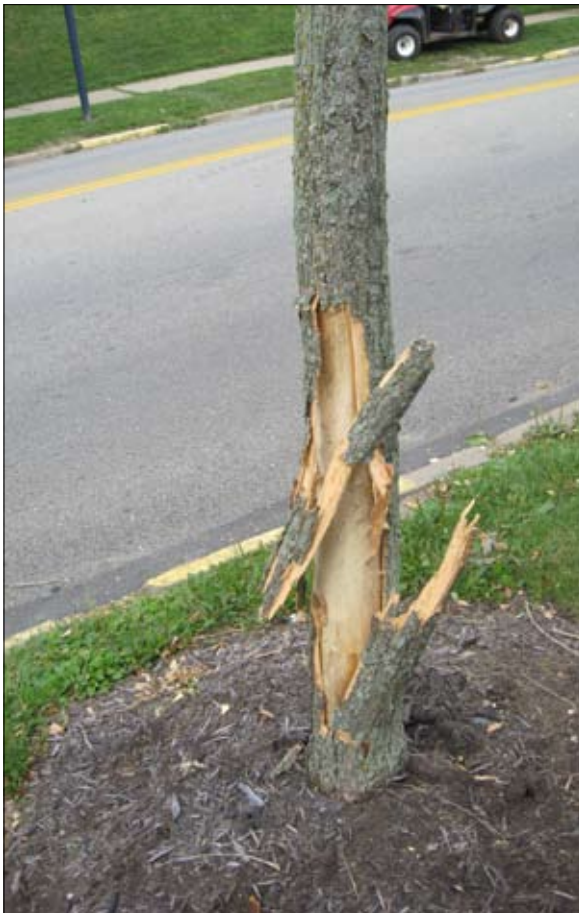
Scholar tree severely damaged. Replace if necessary.

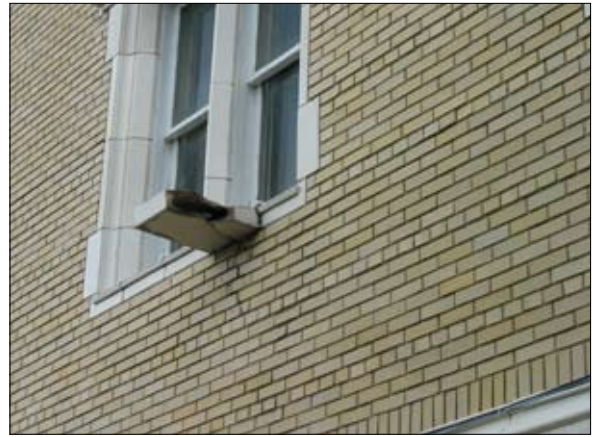
Repair window sills to match original.

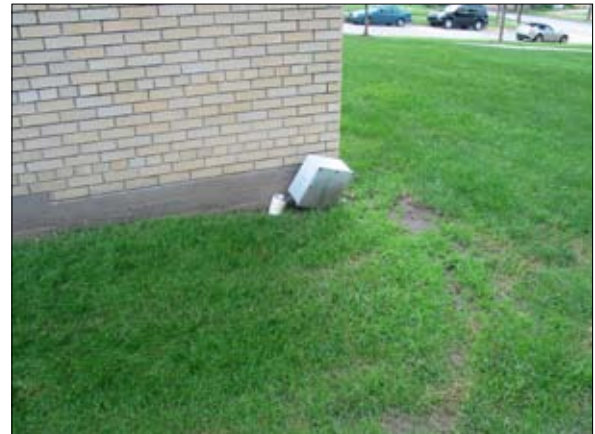
Reconnect junction box to prevent damage.

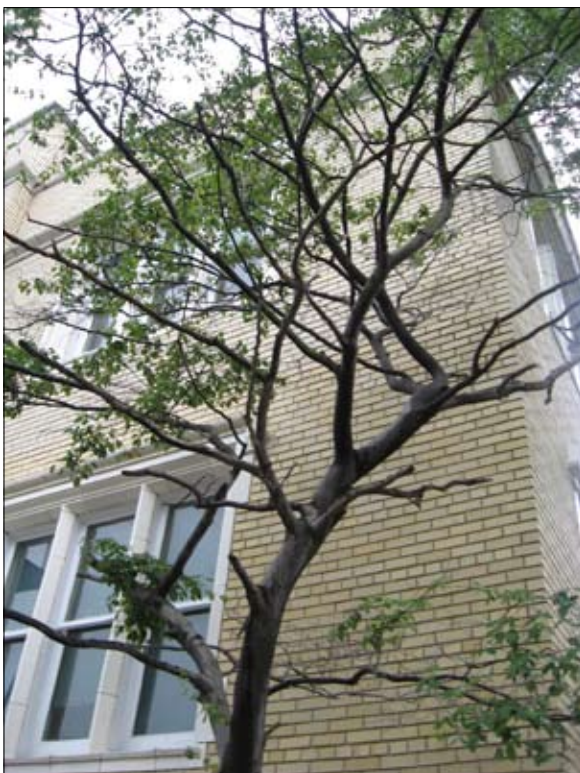
Replace dying serviceberry and add new plantings.

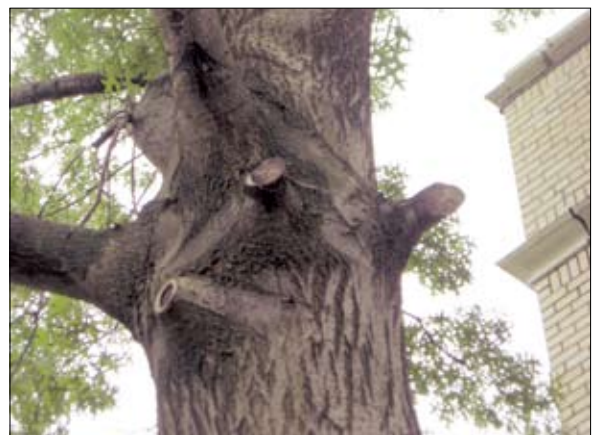
Prune off stubs to branch collar.
