Schadenspiegel

Special feature issue

Risk factor of earth

Risk factor of earth
Our habitat in motion

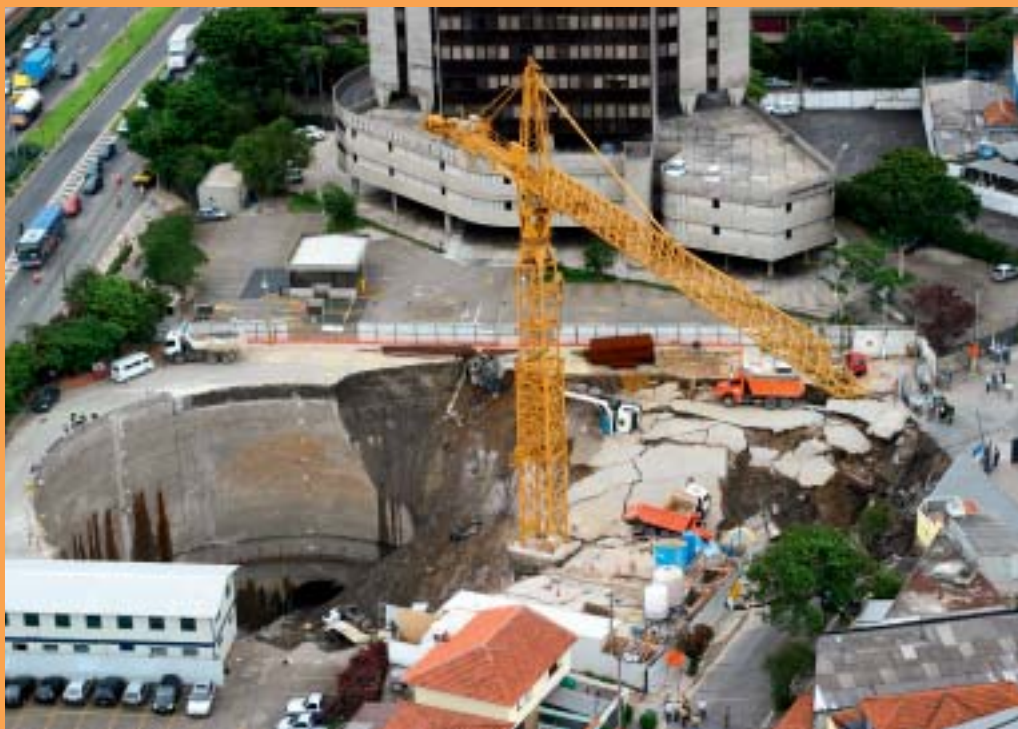
12 February 2007, São Paulo, Brazil: The launching shaft and parts of the running tunnels beyond collapsed during work on a new underground station.

São Paulo, Brazil, 12 January 2007: The launching shaft and parts of the running tunnels beyond it at the future subway station Pinheiros collapse during construction work on underground railway line 4, increasing the diameter of the shaft from 42 to 80 m. According to press reports, seven people are killed. No official statement has yet been made on the cause of loss – an investigating committee is conducting an inquiry.

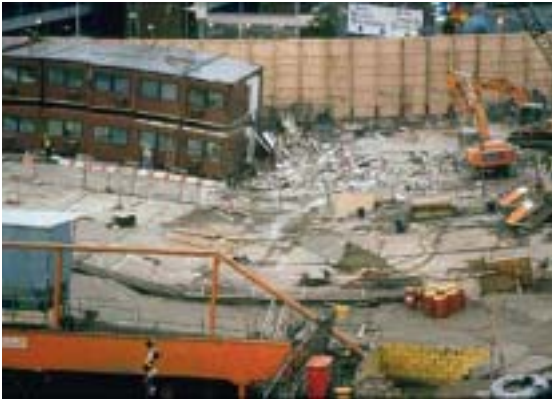
The Heathrow Express Link connects central London and Heathrow Airport. The running tunnels were driven with tunnel-boring machines (TBMs) whilst the two stations at the airport were to be built using the New Austrian Tunnelling Method, which involves the application of shotcrete. A number of trial tunnels had been driven successfully and a few tunnel sections subsequently constructed without any problems when, on 21 October 1994, disaster struck. At first, cracks were discovered in the shotcrete lining of one of the three headings, followed by large-scale concrete spalling and subsidence craters on the surface. These problems gradually spread to the other two headings. Finally, all three tunnels caved in one after the other, taking several buildings with them.

21 October 1994, London, UK: There was considerable surface subsidence in three of the headings for the Heathrow Express Link, finally leading to the tunnels caving in.

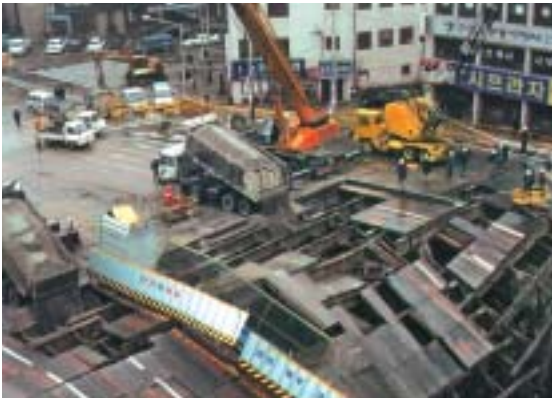
22 January 2000, Taegu, South Korea: Following the failure of a diaphragm wall, part of an underground station excavation pit caved in. The consequences? A whole section of road gave way and cracks formed in buildings.

A serious accident occurred on 22 January 2000 during the construction of an underground line in Taegu. Following the failure of a diaphragm wall, part of a station excavation pit caved in. The debris buried a local bus: three passengers were killed and the driver was seriously injured. There was considerable damage to neighbouring buildings.

The accident was found to have been caused by a load case that had not been considered in the design phase and was due to unforeseen soil conditions. Large variations in the water table set in motion the previously unexplored gravel and sand banks, triggering the load case which exceeded the design strength of the diaphragm wall.

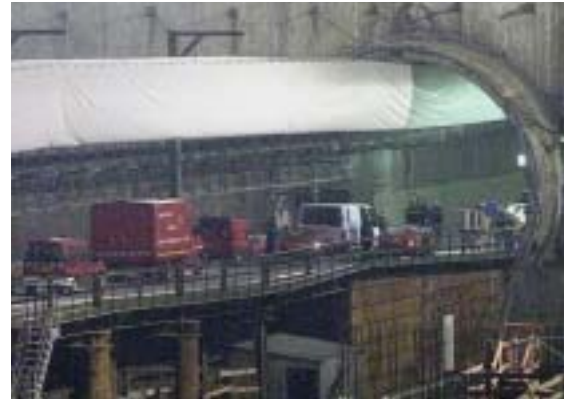
On 5 March 2002, one of these trains was on its way to the working face when it caught fire. The tank of the diesel locomotive was soon engulfed in flames, with the result that the train was automatically stopped. The crew attempted to extinguish the fire but could not prevent it from spreading to the spoil conveyor and the ventilation duct, the travelling formwork, and the tunnel's concrete lining. The dense smoke and intense heat blocked the way back to the portal, forcing the workers to take refuge in the TBM's compressed-air chamber. The TBM itself was not damaged by the fire, as it was protected by a sprinkler system at the end of the back-up train.

5 March 2002, Paris, France: Major operation for fire and rescue services in the Socatop Tunnel – a back-up train burst into flames and set fire to machinery and installations (including the ventilation duct).

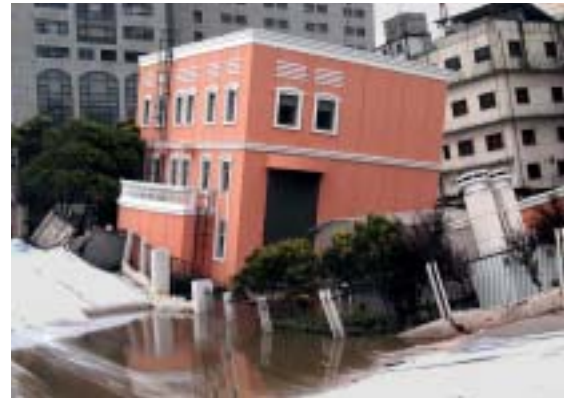
1 July 2003, Shanghai, People's Republic of China: Subsidence had a devastating effect on buildings after a massive influx of material and water into a cross passage under the Huangpu River.

high at that particular time of year. After the ground gave way, the tunnel tubes subsided a few metres and were flooded; the tunnel lining was fractured. The loss was found to have been caused by failure of the ground-freezing unit that had been installed to protect the excavation work for the cross passage.

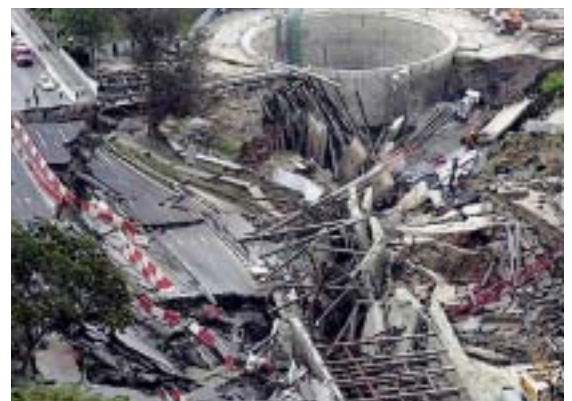
20 April 2004, Singapore: A retaining wall for the Circle Line collapsed, resulting in severe damage to the six-lane Nicoll Highway directly beside it.

On 20 April 2004, a construction pit was being excavated directly beside the six-lane Nicoll Highway when there was a disastrous collapse. The excavation pit, which was about 35 m deep at the time, collapsed along a length of over 100 m. Four construction workers were killed, the highway collapsed and had to be closed for several months while the damage was being repaired.

A number of causes were identified: use of an inappropriate soil simulation model which over-estimated the soil strength at the accident site and underestimated the forces on the retaining walls within the excavation; an error in the design of the strut-waler support system with the connections being under-designed; and deviations in actual construction, which further aggravated the under-designed conditions.

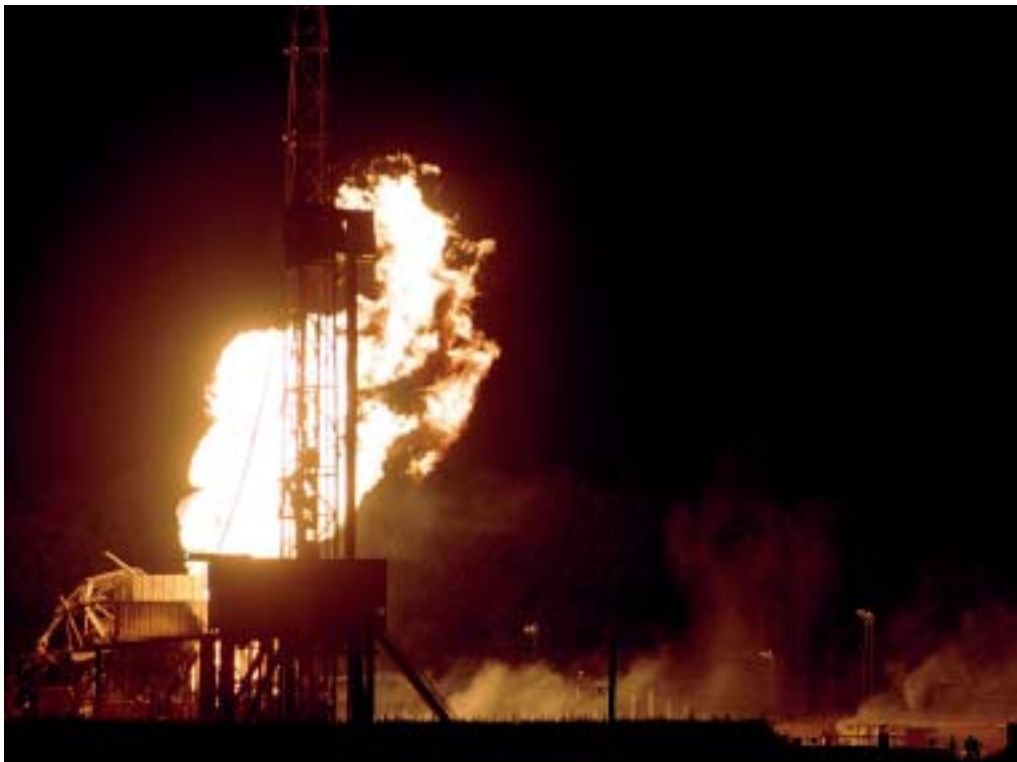
Blowout: The huge cloud of flaming gas could be seen from miles away.

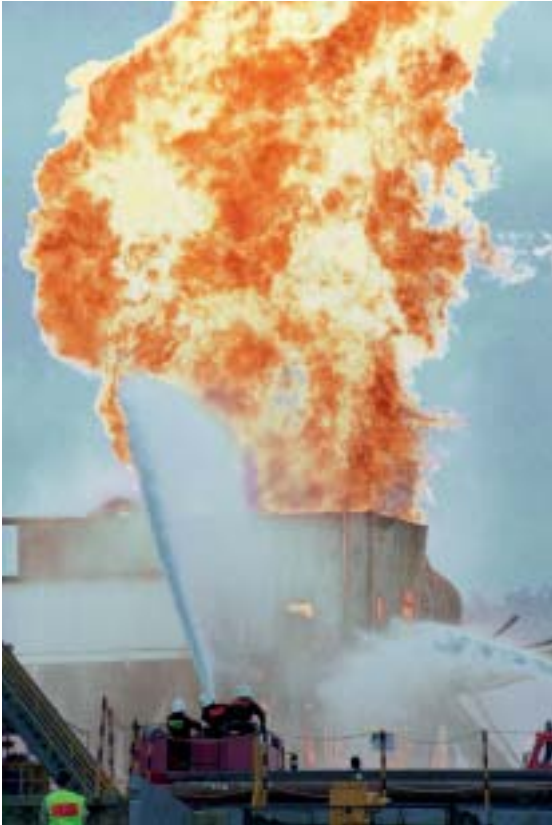
The situation is extremely dangerous. Extinguishing the conflagration and cooling the well are a tough challenge for the fire-fighting teams.

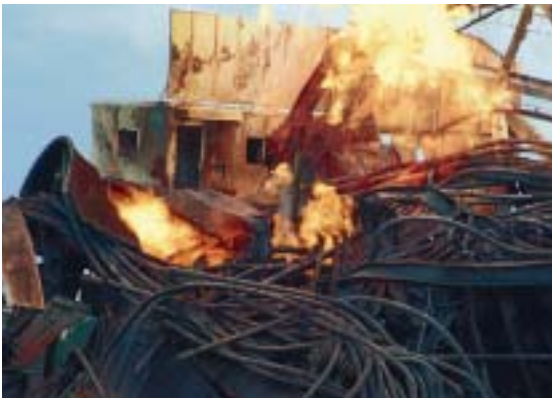
The rig collapses, gas continues to pour out, the heat is enormous. Some five tonnes of steel scrap has to be removed in order to gain access to the blowout preventer.

The uncontrolled gas escape may have been caused by a combination of factors: large gas losses and inadequate reserves of drilling fluid and water. In addition, the safety regulations were not properly observed when attempts were made to remedy the losses. When a “critical gas loss” situation had been reached, for example, the well bore was not closed with the preventer and the drill string was not withdrawn. This resulted in large volumes of gas escaping under high pressure and igniting – presumably on an electrical unit. In the final analysis, the explosion and fire were due to faulty performance since the work instructions had not been followed during drilling operations.

As the blowout preventer was blocked, it was not possible to inject water at first. It had to be cooled off before it could be removed using a crane. But hydrostatic pressure alone turned out to be insufficient to close the blowout preventer. Time was pressing because leaks seldom remain stable and are capable of eroding. One method of sealing leaks is to use rubber, rubber balls, or even golf balls as sealing elements in the gas stream. In this case, a mixture of water and rubber balls succeeded in stopping the escape of gas. A new blowout preventer was mounted. The emergency operation was successfully concluded within the space of two weeks.

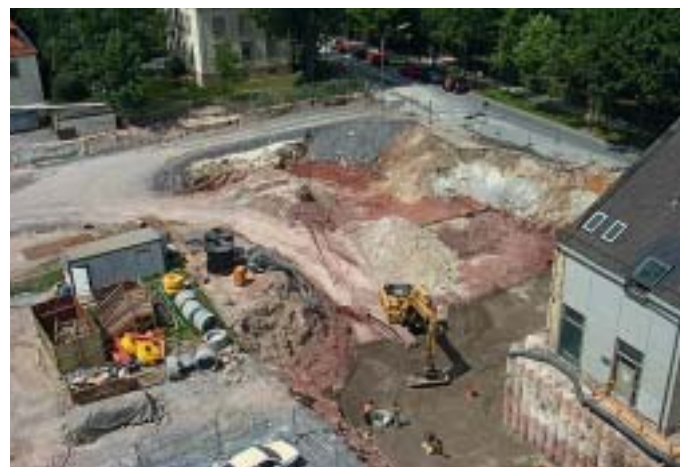
The remediation plan implemented in 2000 included a large-scale excavation of the soil down to a depth of 5 m – not the most favourable solution in either economic or ecological terms.

The excavation work was not completed until the autumn of 2001. Some 40,000 tonnes of soil had been excavated and replaced. Beneath the machine room, 2,700 cubic metres of heavily contaminated subsoil were encased by a bored pile wall. The open space was completely sealed to prevent any leaching of residual pollutants due to seeping precipitation. Since then, the groundwater runoff has been pumped off regularly, cleaned, and then discharged into the sewage system – an operation that will probably have to be repeated for a very long time to come.

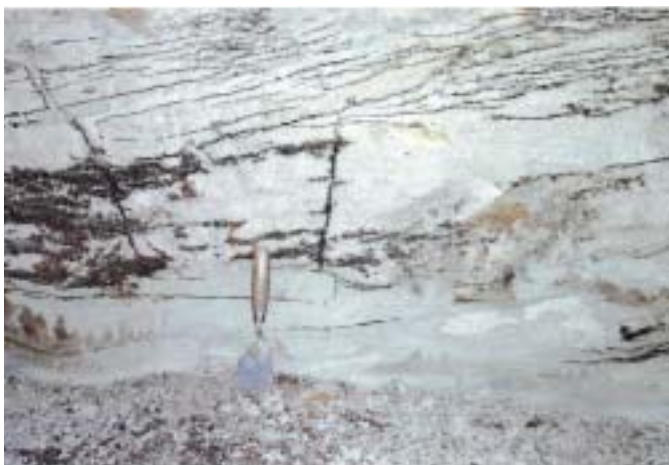
By the time the tar oil (black veins) was discovered to be bound in the sandstone, it was much too late. It was only when the ground was excavated that the tar oil began to flow.

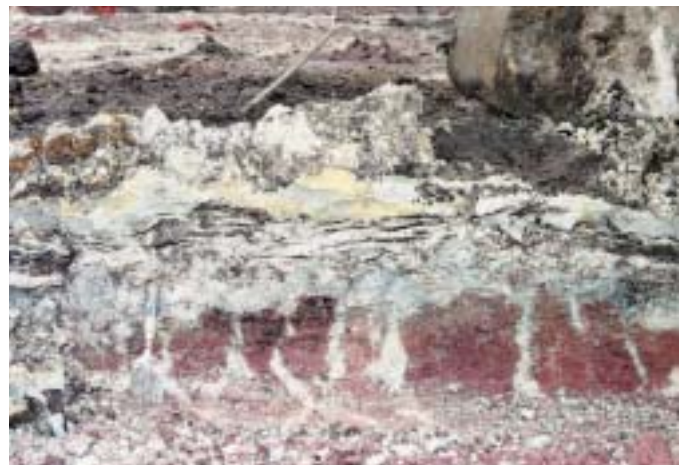
The profile section shows the tar oil contamination in the white sandstone. No-one had expected that the surface of the red mudstone (to the right of the trowel) would also be polluted.

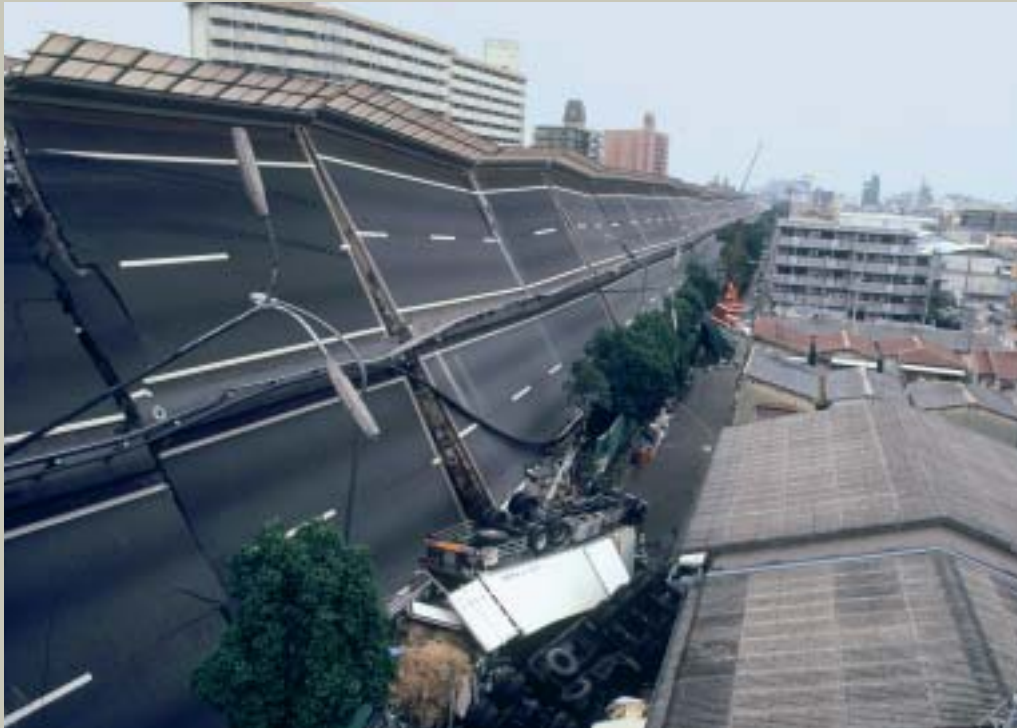
On 17 January 1995, a 500-m stretch of the elevated carriage-way tipped over on the Hanshin expressway in Kobe, Japan. The remarkable thing was that numerous multi-storey buildings in the immediate vicinity remained undamaged.

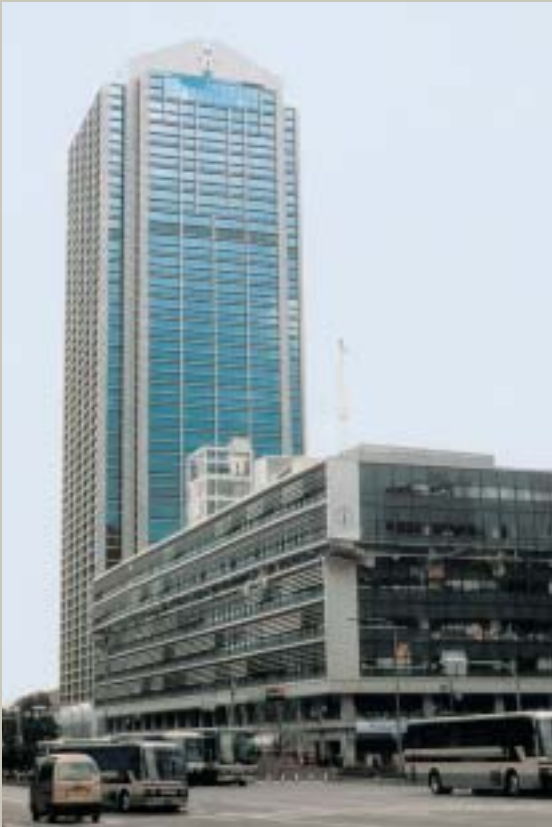
Kobe, Japan, 17 January 2005. The damage to the town hall was typical. The middle storey of the old town hall collapsed. The new high-rise building, erected in accordance with the current building regulations, stood firm.

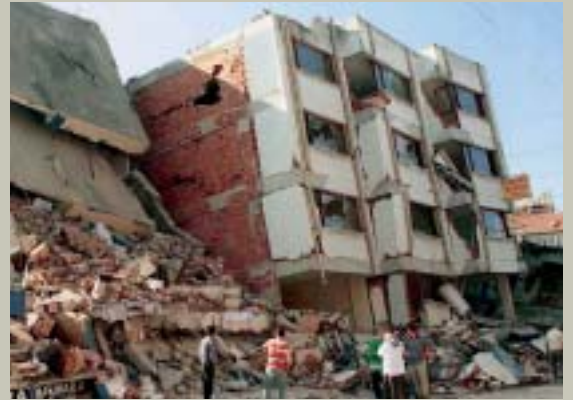
Izmit, Turkey, 17 August 1999. Multi-storey blocks of flats which had been built without adherence to the building regulations suffered the worst damage.

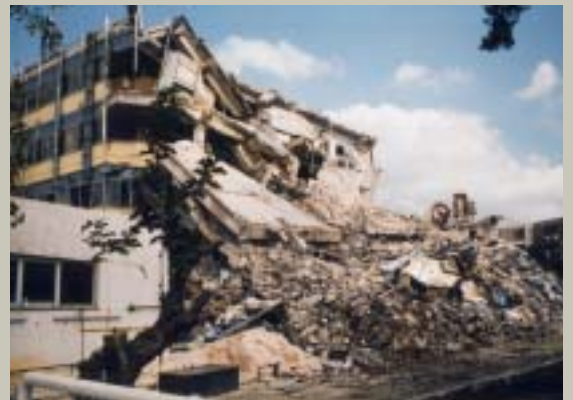
Athens, Greece, 7 September 1999. Here too, much of the damage could have been avoided by paying attention to good construction work and observing the regulations.

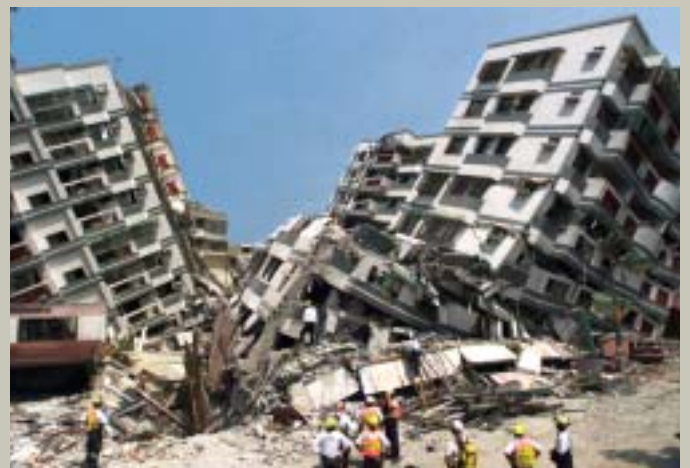
Chi-Chi, Taiwan, 21 September 1999. Numerous apartment blocks collapsed. But the losses caused by incessant power outages were much costlier than those due to structural damage.

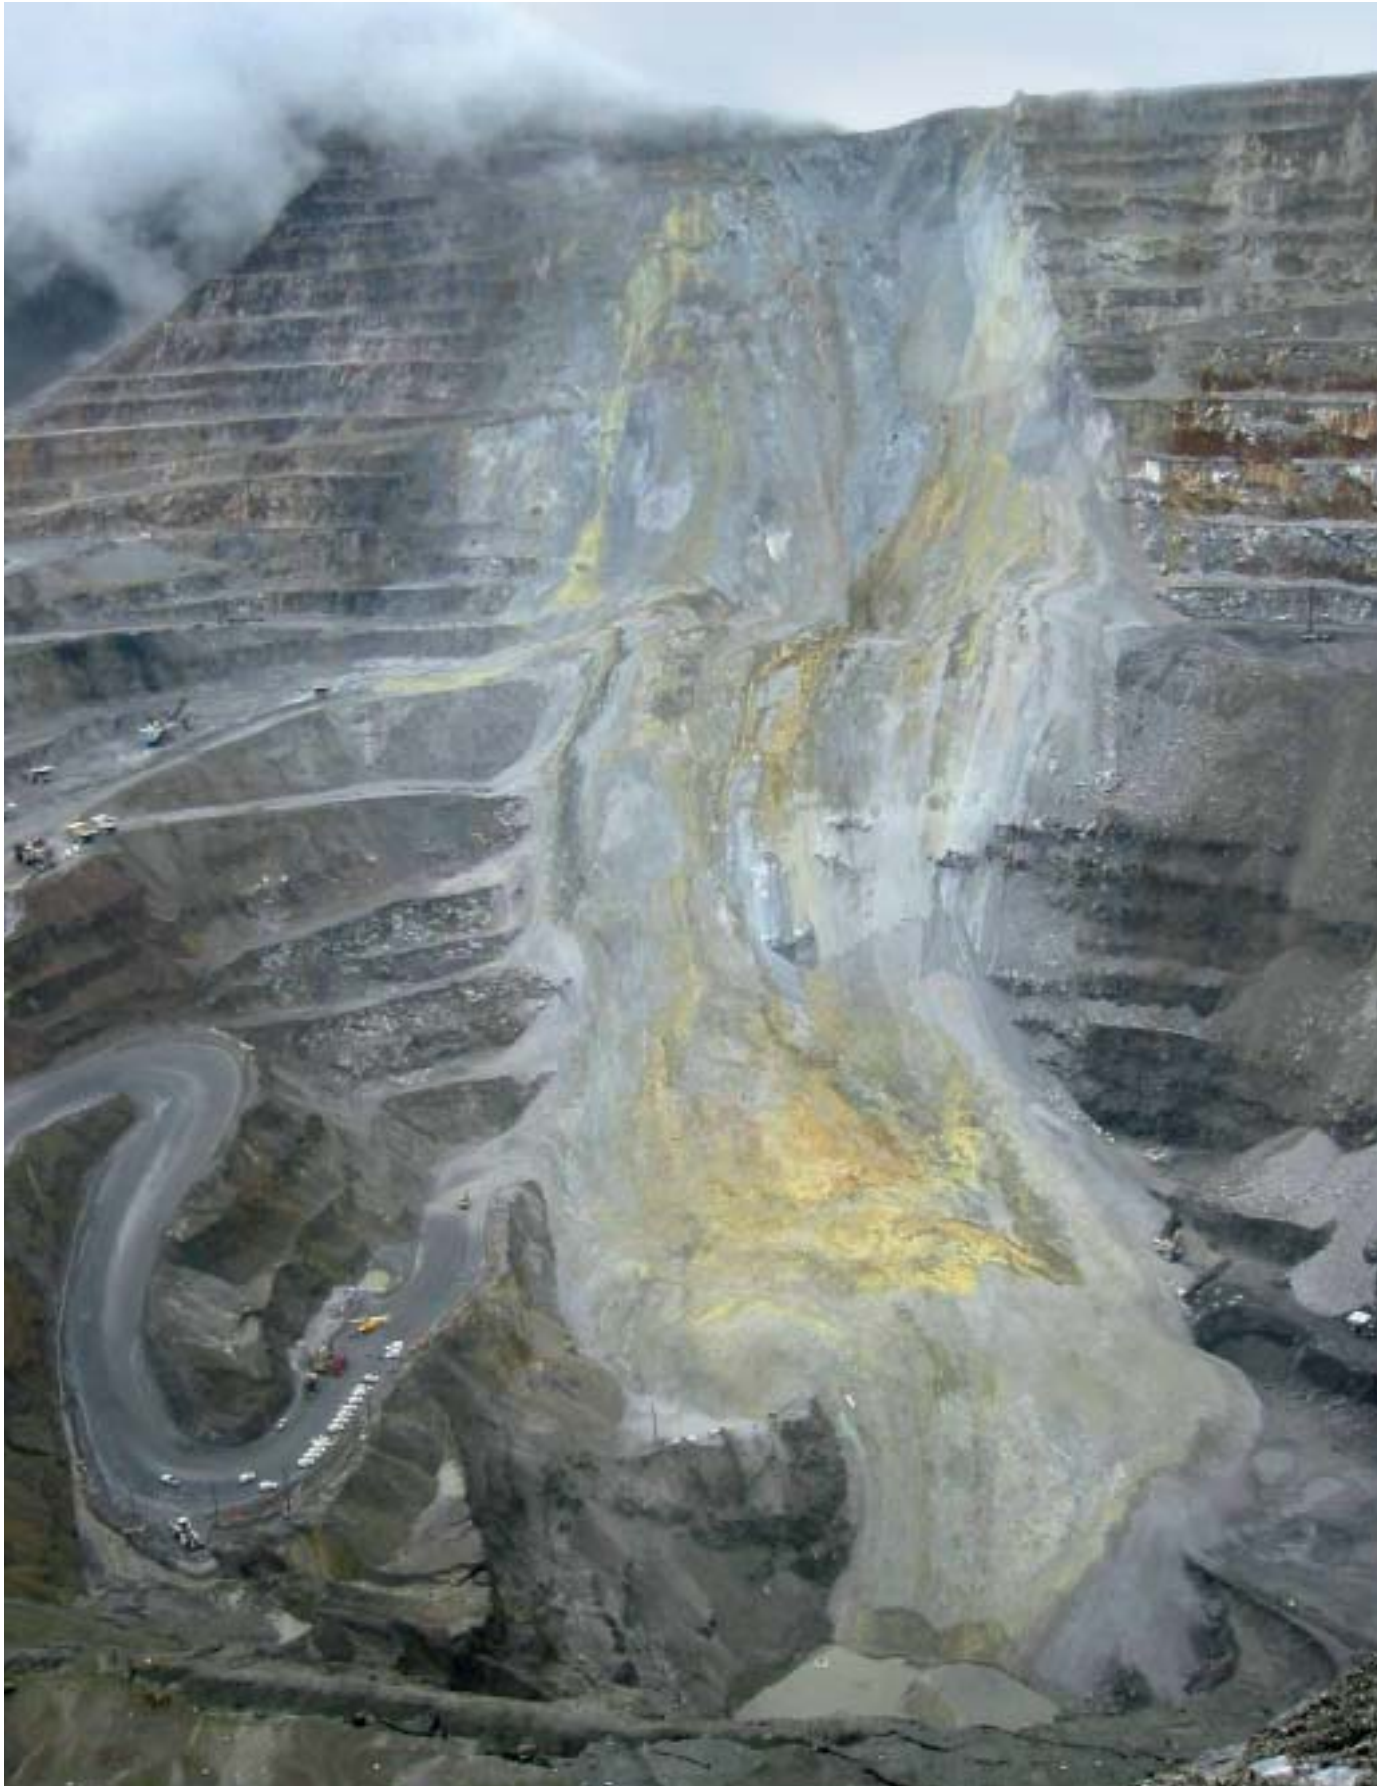
Ore stone slid over 450 m – the length of four-and-a-half football pitches – down to the floor of the mine. The destructive force of the material was immense.

The rock on the southern edge of the open pit was friable. The slope angles had originally been created with a safety factor to cater for these difficult geological conditions. As operations changed, however, and the competence of the rock deteriorated – which was not apparent from the outset – the slope angles became steeper, thus increasing the risk of a failure.

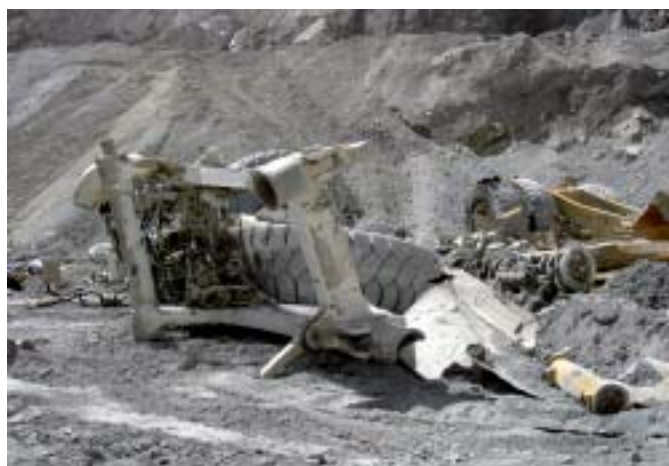
HDTs were at the mercy of the falling material. One of the colossal trucks – 5 m high and more than 10 m long – lies in ruins.

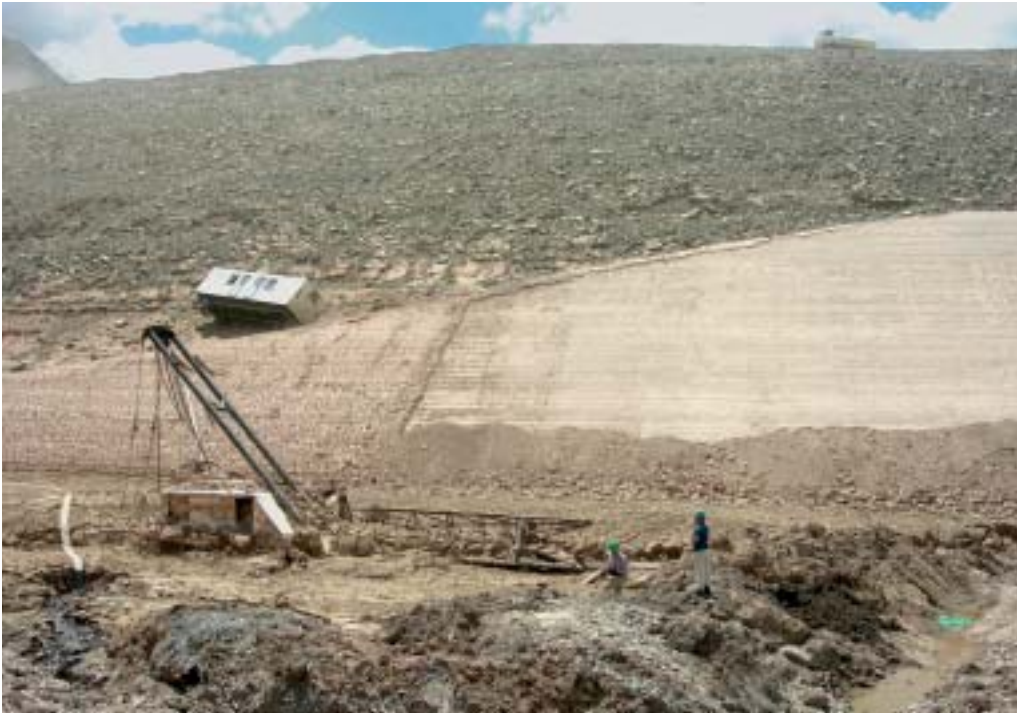
A still partially buried crane in front of the main dam. As the machines used in dam construction are technically sophisticated and expensive, the loss is enormous in most cases.

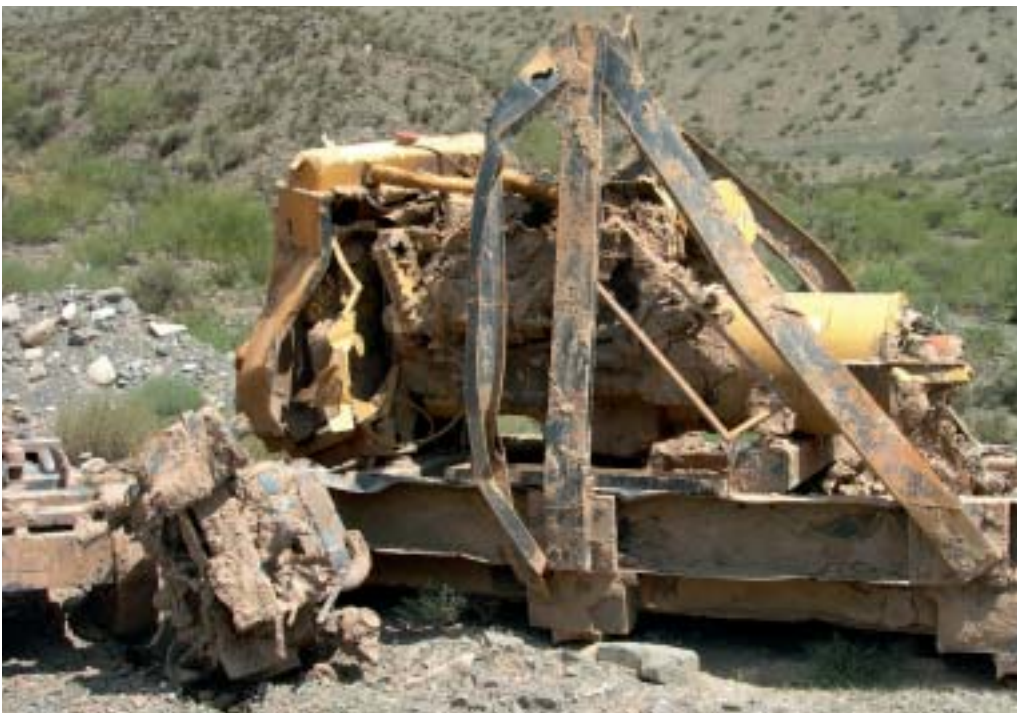
The remains of a diesel generator – completely deformed by the strong flow of water and debris.

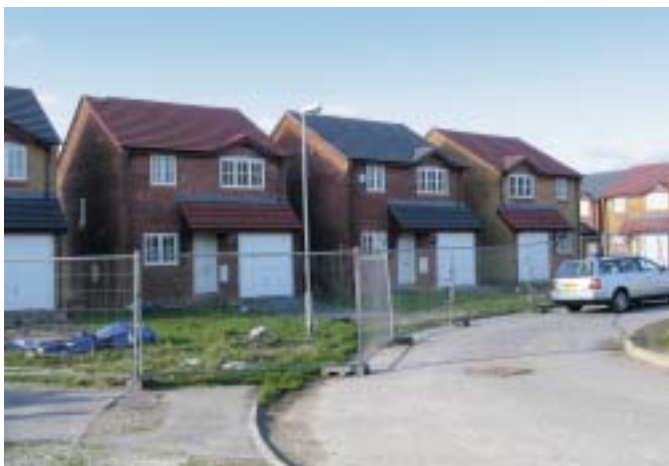
A fence protects the empty houses on the new housing estate. Massive damage occurred because the development plan for the peaty soil did not go far enough.

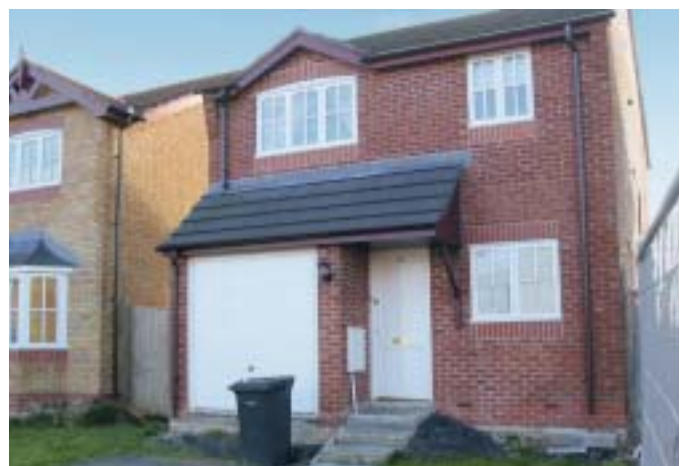
For around the houses, which stood on secure pile foundations, the ground was sinking. Drains, water pipes, gas pipes, and power lines were shifting, pipes were breaking open and cracking. On garage driveways, steps were appearing that could not be negotiated with "normal" cars. House entrances that were once level with the ground needed extra steps.

Phase 2 house, constructed on pile foundations. The surrounding ground became compacted, however, and subsided.

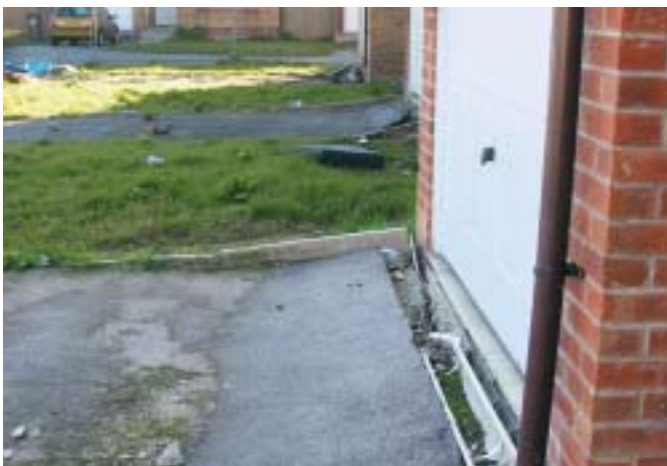
On garage driveways, steps appeared that could not be negotiated with "normal" cars.

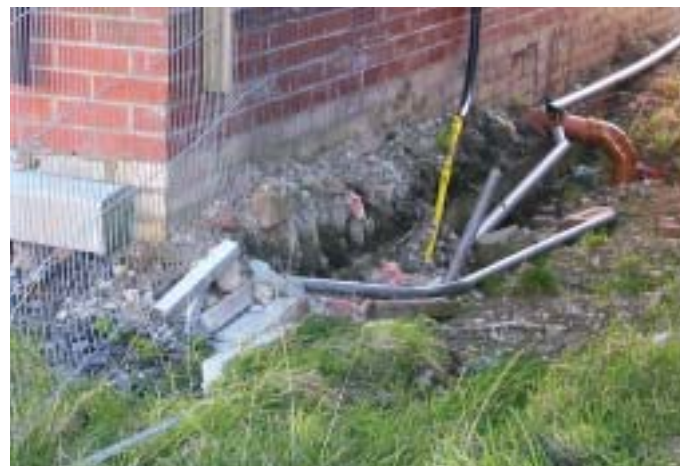
Drains, water pipes, gas pipes, and power lines shifted and cracked.

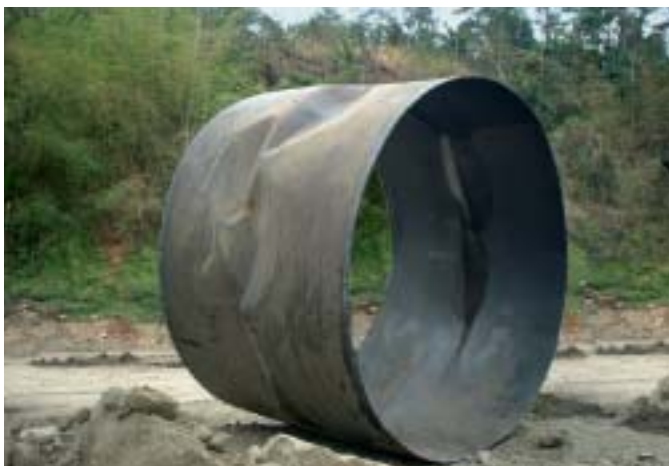
Initially, work progressed without difficulty. Backfilling of the pipe trench was more or less complete when an inspection revealed that the pipeline was deformed at various locations. Since the pipeline was due to be handed over, the deformations had to be examined and remedied as quickly as possible. In order to prevent the pipeline from collapsing, an independent consultant appointed by the construction company recommended the installation of internal steel reinforcements on the section of pipeline under the dam and the section near the riverbed crossing. Furthermore, a retention wall was recommended to be

Pipe segment distinctly deformed, unable to support the pressure of the backfill material.

- Damage to the 12.5-mm pipeline under the dam: deformation to be repaired by means of reinforcement
- Damage to the 9.5-mm pipeline and the trench running as far as the collapse: to be replaced with a stronger pipe
- Damage to the 12.5-mm pipeline and the trench in the bend area and crossing: to be replaced with a stronger pipe

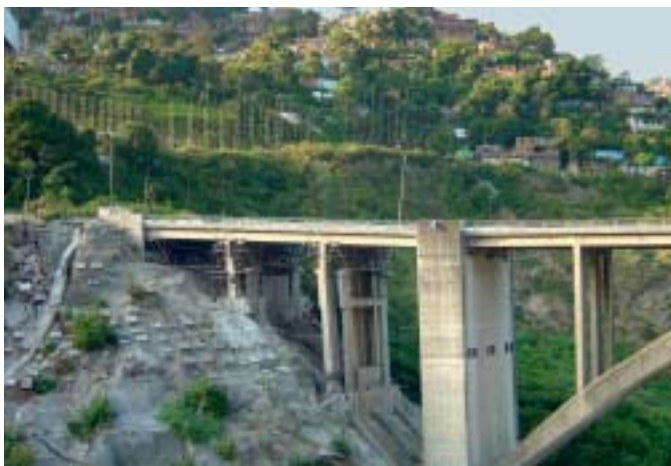
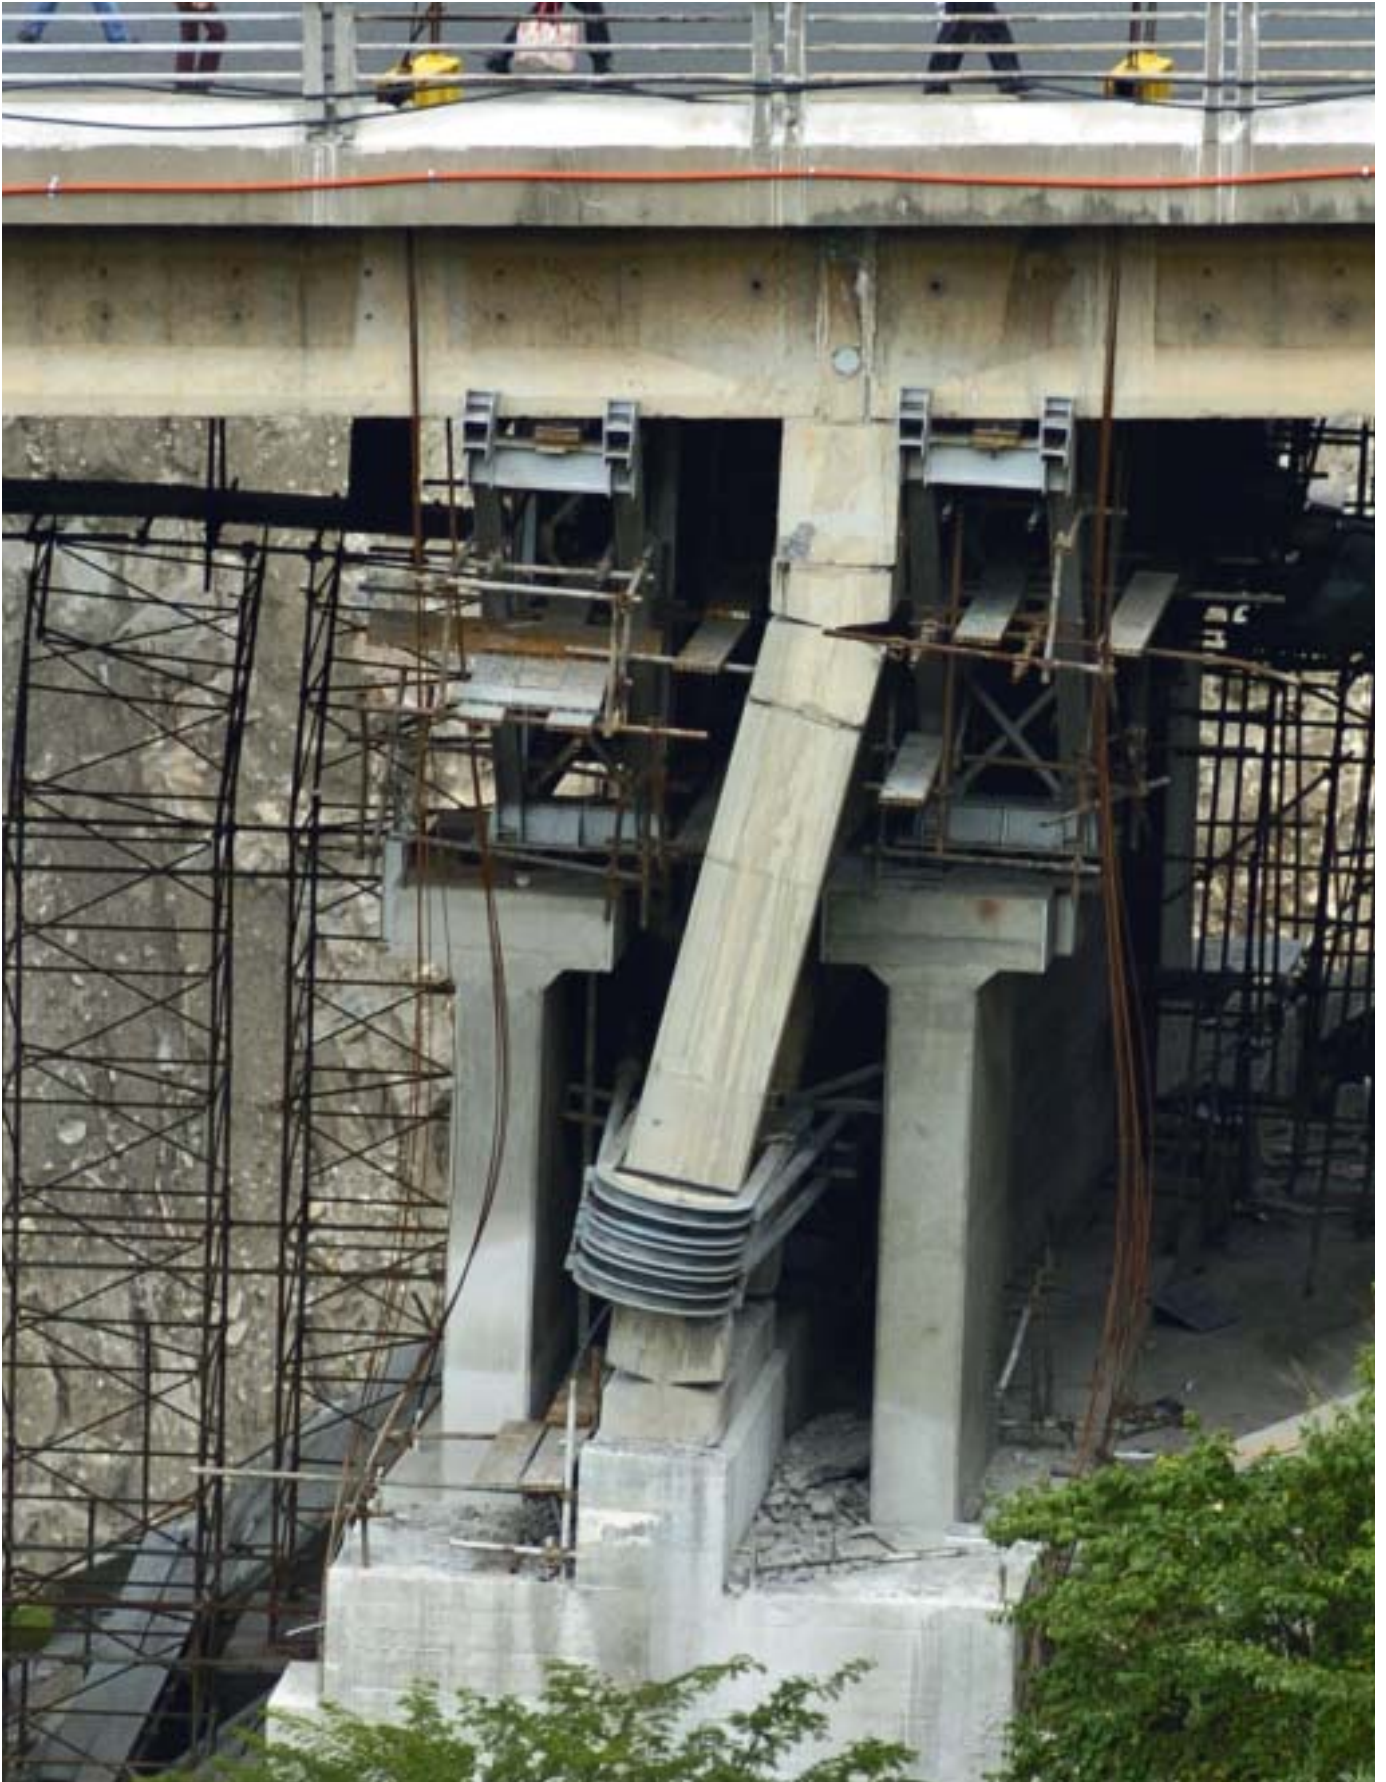
Viaducto Uno at the beginning of 2006: the piers were still supported by scaffolding ...

... but nothing could be done to avert the collapse.
