Section 19 Flood Investigation Report for Castle Point

ECC
600892
1
3.0

11 August 2022

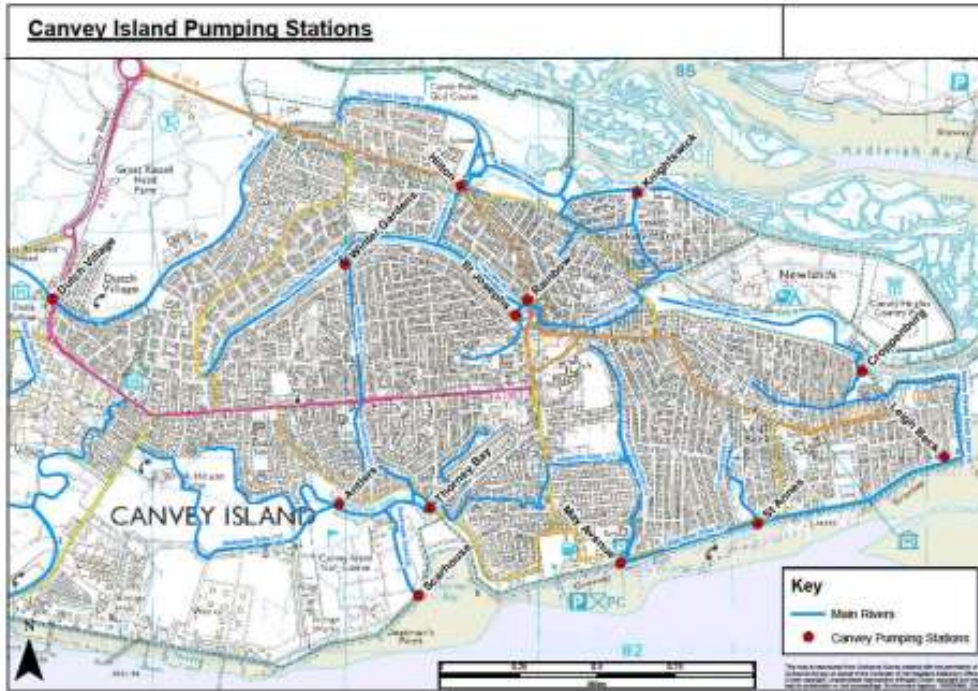
Figure 1.3 Map of Canvey Island Pumping Stations

There are 8 pumping stations around Canvey Island that are designed to pump flood water out and direct them to the sea, since the area is an identified hot spot for flooding, (Figure 1.3). Additionally, a further 5 pumping stations are located to stop the water from stagnating in dry weather. Water can be moved between North and South of the Island through dykes and this can be useful when a pumping station is overwhelmed with water or should it have a malfunction. There is the possibility that these can become blocked from errant material, and adversely impacting the watercourse. Further information on the drainage network in the area covering Benfleet and Hadleigh has not been made available by Anglian Water and has therefore not been possible to summarise here.

One of the eight pumps designed to transfer water around Canvey Island was temporarily out of action which may have exacerbated the flooding.

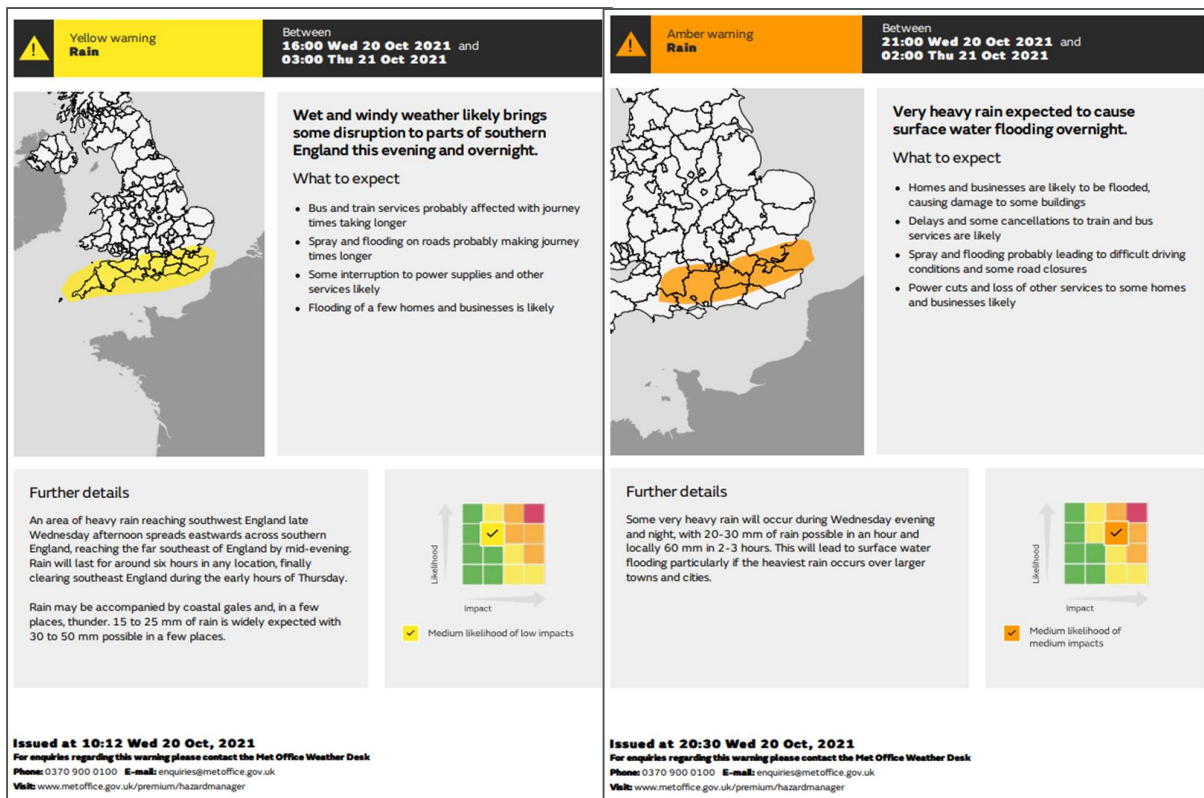
Figure 1.7 Met Office Flood Warning on the 20th October 2021

The Met Office is the UK's official weather service, with a responsibility for issuing weather warnings in advance of severe weather events. Extracts from the Met Office are shown below. Two warnings were issued on the 20th October 2021. The initial warning was issued at 10:12 and the second at 20:30. (Figure 1.7). The forecast on Wednesday morning was for 35mm of rainfall, but much higher rainfall was experienced. The amber warning on Thursday was more accurate, which anticipated 20-30mm in 1 hour over Benfleet and up to 60mm over 3 hours.

It can be seen from the statements that there would be a likelihood of very heavy rain with the potential to cause surface water flooding to homes and business to the South Essex area, as well as other areas in the South and South-East of England.

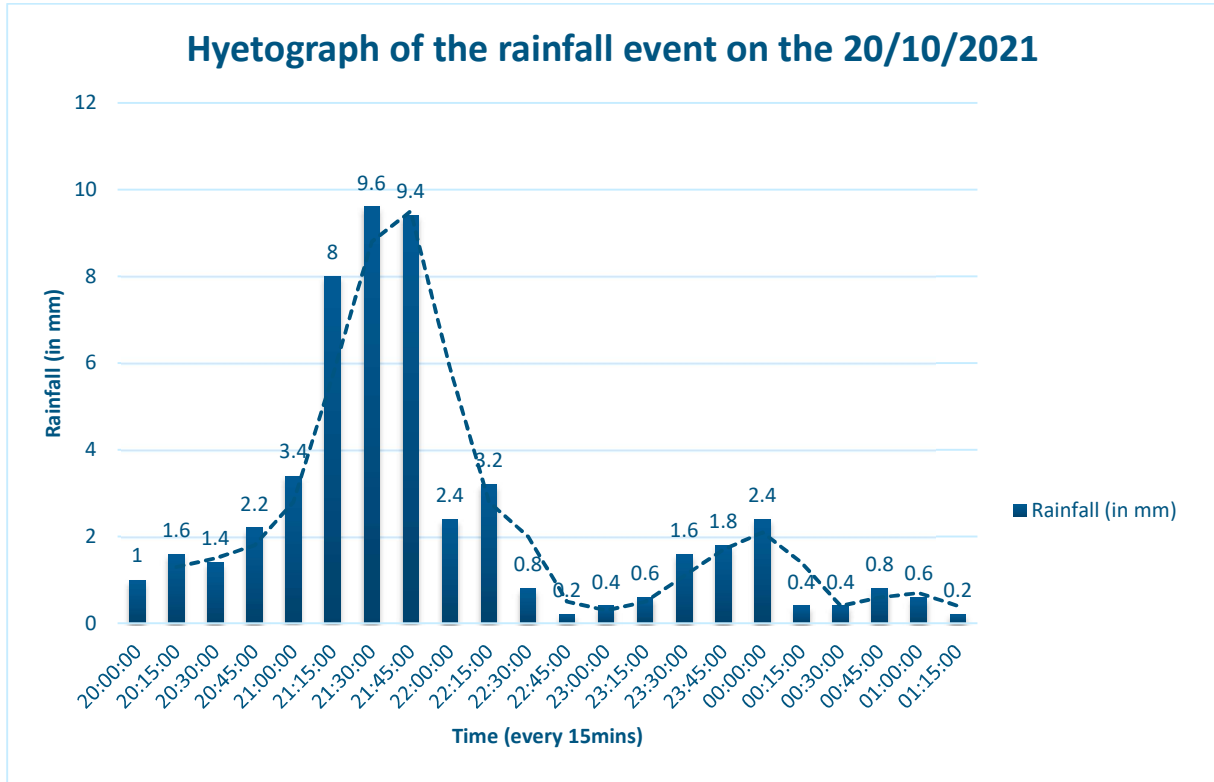
Figure 1.8 Hyetograph of the rainfall event on the 20/10/2021

The Benfleet barrier rainfall gauge captured 52.4mm of rainfall over the course of the rainfall event between 20:00 on the 20th October 2021 and 01:15 on the 21st October 2021. The hyetograph in Figure 1.8 indicates the depth of rainfall that occurred during the event, with each bar representing the depth of rainfall recorded by the rain gauge within a 15-minute interval. The hyetographs shows that the period of greatest intensity rain was between 21:30 and 21:45 on the 20th October when 9.6mm of rain fell in the 15 minute interval.

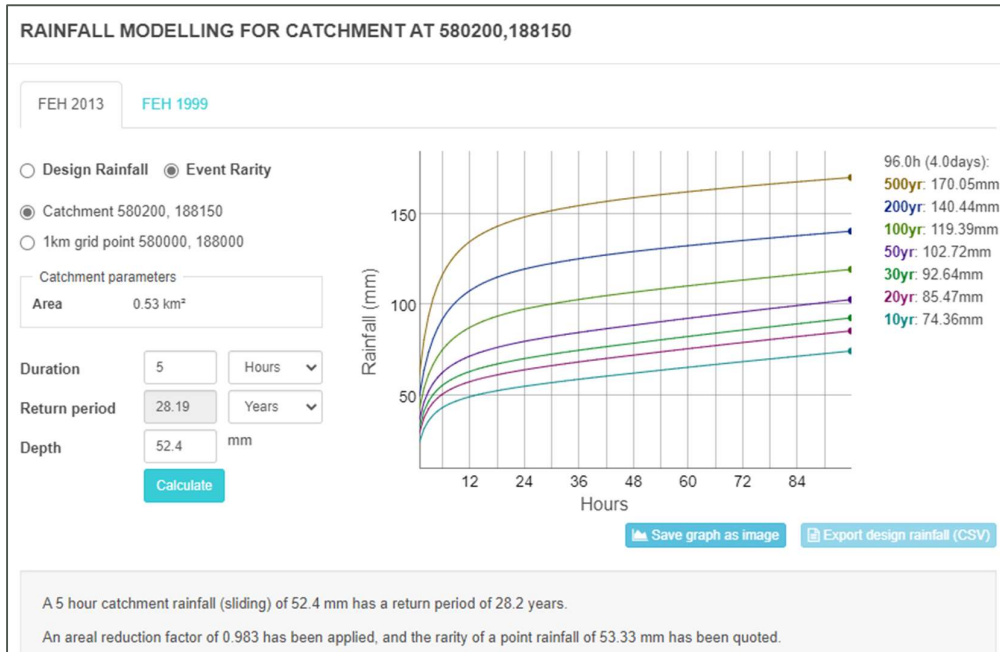
Figure 1.9 Return Period of the Rainfall event on the 20th October 2021 at Benfleet

The rainfall event on the 20th October 2021 corresponds to a Return Period (RP) of 28.2 years as described by the Flood Estimation Handbook method as implemented in the FEH Web Service (Figure 1.9).

The rainfall event on the 20th October 2021 was noted to be a 1 in 28-year event by the flood estimation handbook (FEH) method. The urban drainage system would typically be designed to manage rainfall intensities up to 1 in 30-year rainfall event for more recent drainage systems, with older systems potentially providing a lower standard of service, but this was exacerbated by the urban nature of the catchment, where local drainage assets may have insufficient capacity to manager surface water from recent storm events effectively as well as blocked drains and a failed pump.

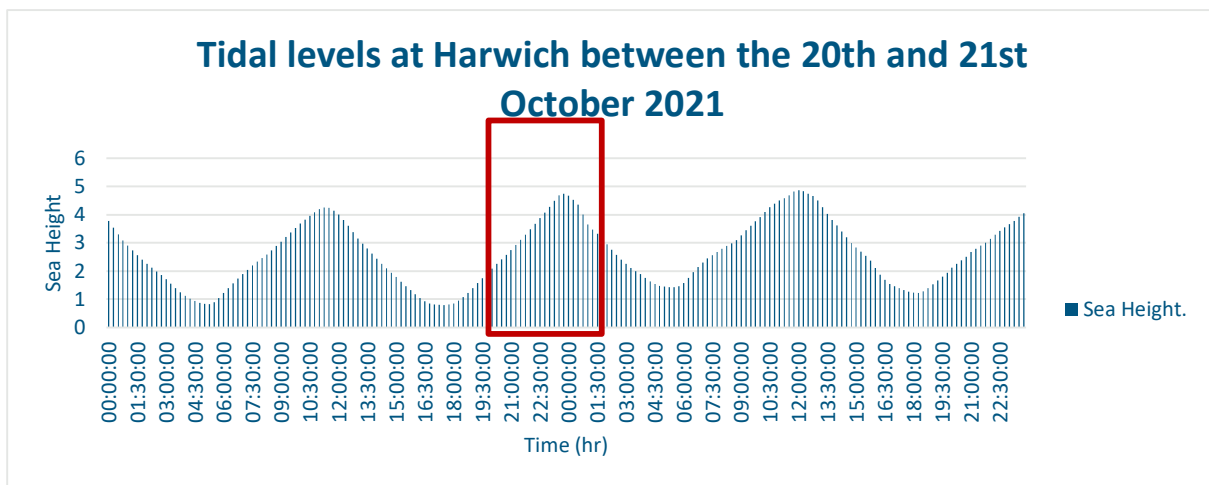
Figure 1.10 Graph of the tidal gauge data on the 20th October to 21st October 2021 at Harwich

BODC recorded tidal data from the two closest tidal gauges at Harwich and Sheerness show tidal highs of between 2.08m and 4.74m during the event. (Figure 1.10). *Contains public sector information licensed under the Open Government Licence v3.0.*

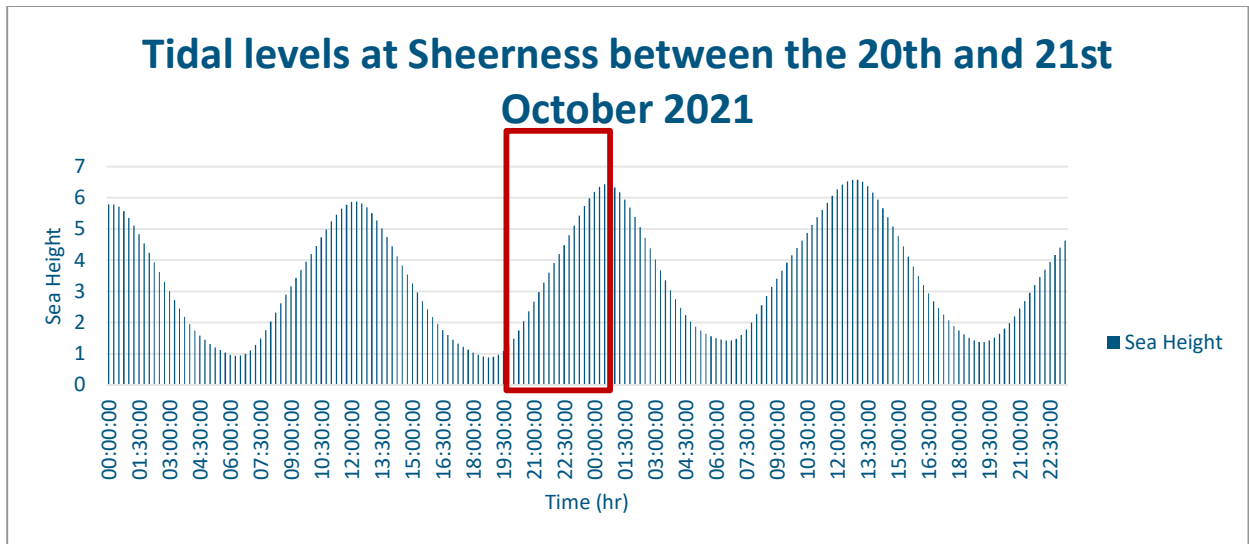
Figure 1.11 Graph of the tidal gauge data on the 20th of October to 21st October 2021 at Sheerness

BODC recorded tidal data from Sheerness gauge show tidal highs of between 1.47m and 6.42m during the event. (Figure 1.11)

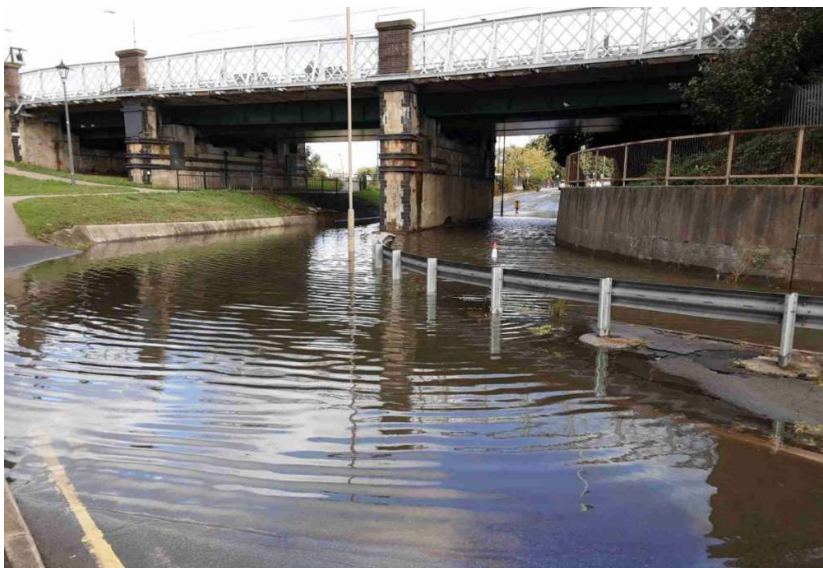
A list of identified properties have been compiled here (Table 1.3). This was created by cross-referencing locations reported to be flooded from Castle Point Borough Council, Essex Highways and ECC. Of particular importance is the underpass below Benfleet station as this road forms one of the main arteries in and out of Canvey Island (Figure 1.12). This is understood to have flooded due to failure of the pumping system, causing gridlock to the local area and buses were diverted for several hours.

Figure 1.12 Image of the flooding under the railway bridge at Benfleet Station

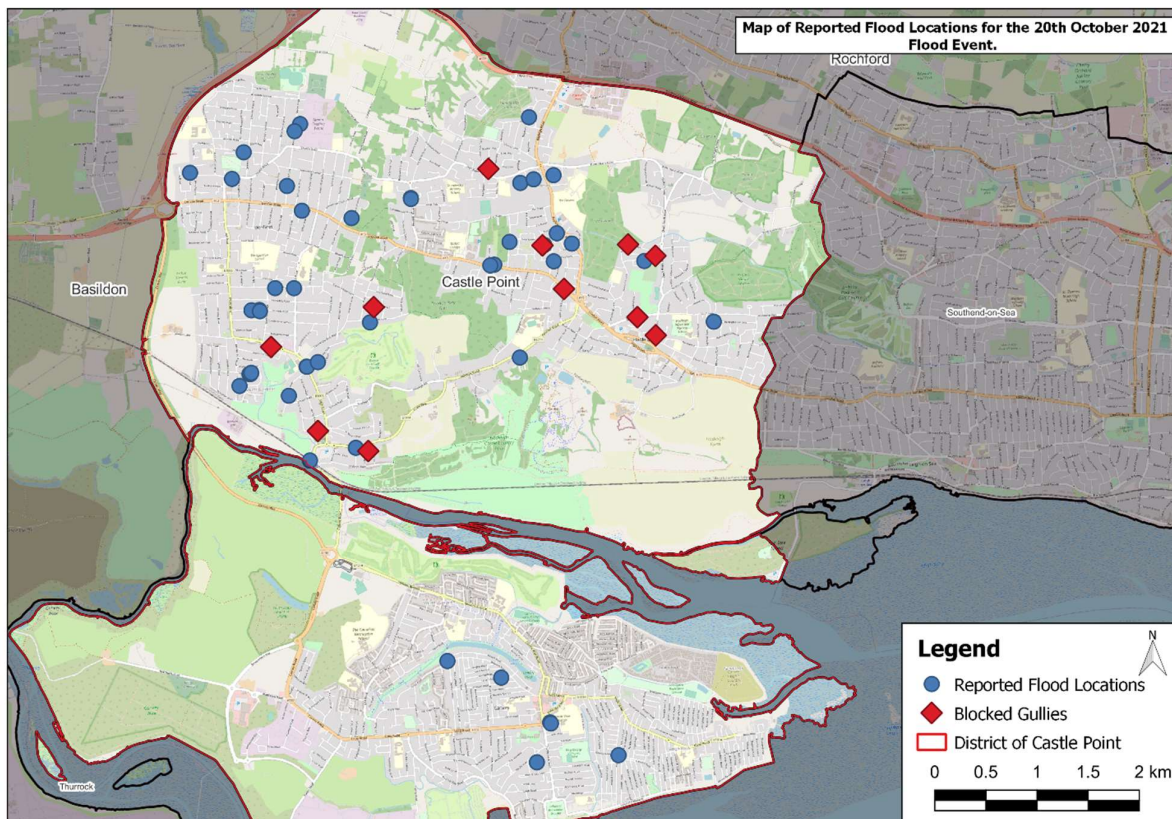
Figure 1.13 Map of Reported Flood Locations

The map of reported flood locations is not exhaustive of locations reported to have flooded, as some locations missed accurate geospatial information. Furthermore, there may be more flood locations, that have not been reported out of concern that the value of their property will decrease, or their insurance premium will rise. Blocked gullies were reported by both ECC and the Highway Agency and were verified independently in many cases by Highway Engineering Teams and Highway Asset Data Teams. Blocked gullies affected flooding on:

- Kiln Road,
- New Road,
- Rectory Road,
- Dalwood Gardens,
- Westwood Gardens,
- Fernlea Road,
- Eastleigh Road,
- Queensmere Road,
- Alderleys
- High Road,
- Hall Farm Close
