## Texas City Refinery Explosion Findings from the Independent Safety Review Panel

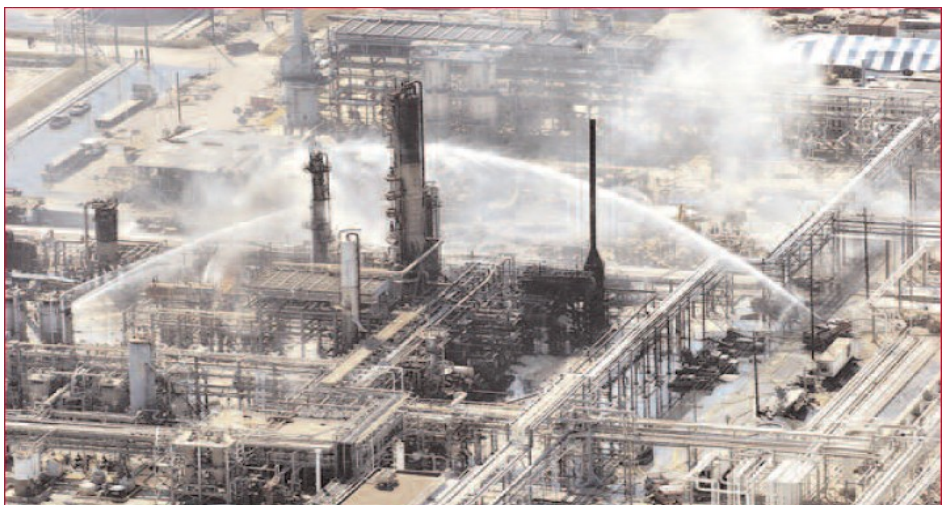
On March 23, 2005, the BP Texas City refinery experienced one of the most serious U.S. workplace disasters of the past two decades, resulting in 15 deaths, more than 170 injuries, and significant economic losses. During the start up of an isomerisation unit, the associated raffinate splitter tower was overfilled and overheated. A substantial volume of hydrocarbon liquid and vapour were forced into an adjacent blow-down stack, rapidly exceeding its capacity. Ignition of the resulting vapour cloud caused an explosion that extended to nearby temporary trailers.

Aftermath of the Texas City refinery explosion, 23rd March 2005
