NIST Response to the World Trade Center Disaster

**Federal Building and Fire Safety Investigation
of the World Trade Center Disaster**

Presentation to the Subcommittee on Disaster Reduction

World Trade Center 7

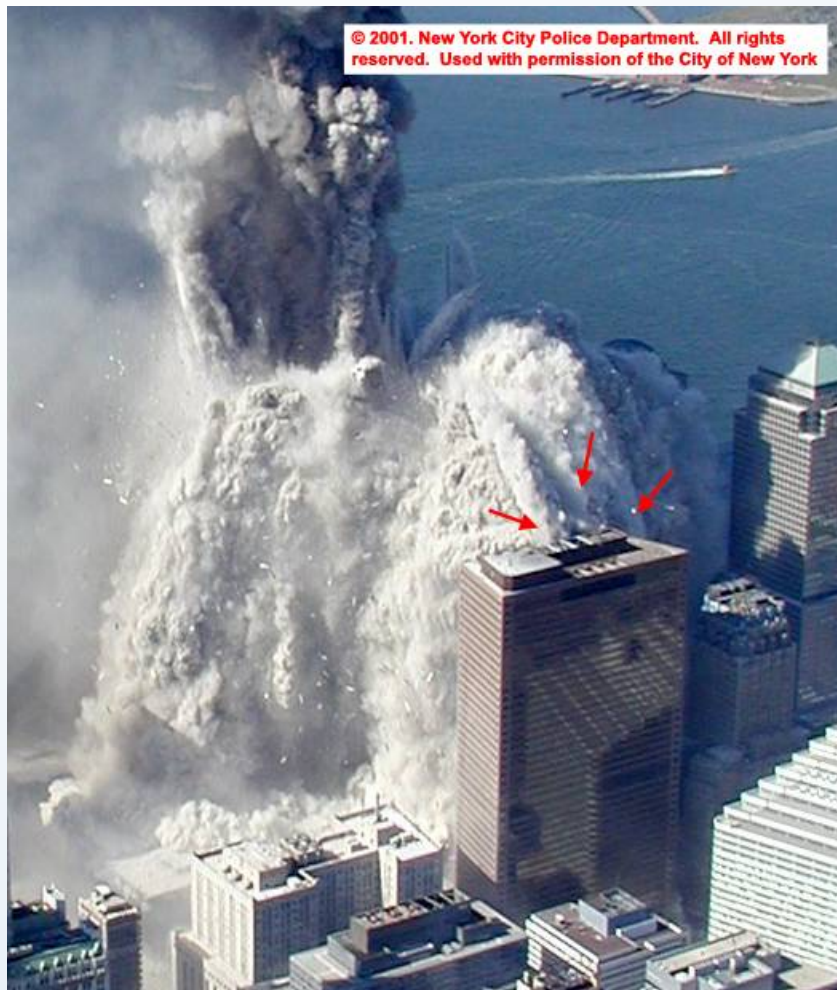
1. Initial Damage Due to Collapse of Towers

- Collapse of WTC 2 did not cause any structural damage or start any fires in WTC 7.
- Collapse of WTC 1 damaged seven exterior columns on the lower floors of the south and west faces and initiated fires on 10 floors between Floors 7 and 30.
- Aerial photograph shot $14 \text{ s} \pm 0.5 \text{ s}$ after WTC 1 began to collapse.
- Arrows mark arcs formed by debris that seemed to be ejected outwards from the debris cloud

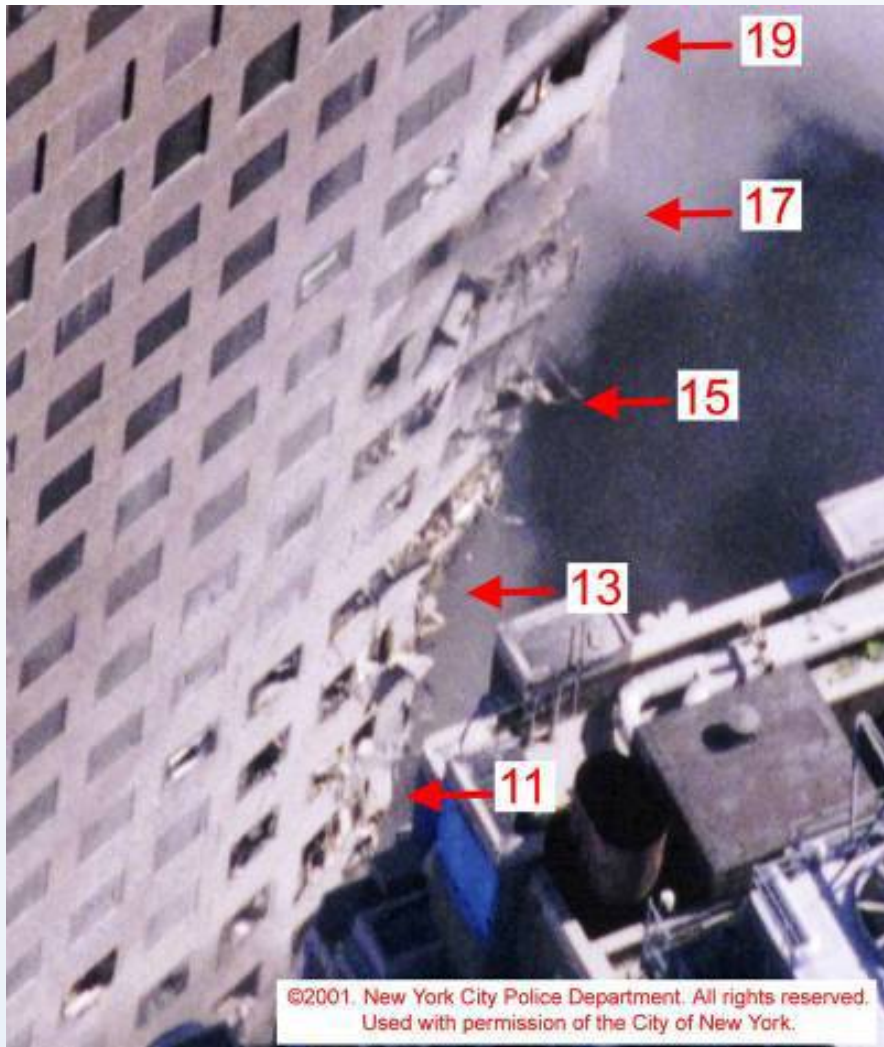
Debris Impact Damage to WTC 7

- Enlargement of a photograph showing part of the west face of WTC 7.
- Arrows and floor numbers have been added for the corresponding rows of windows.

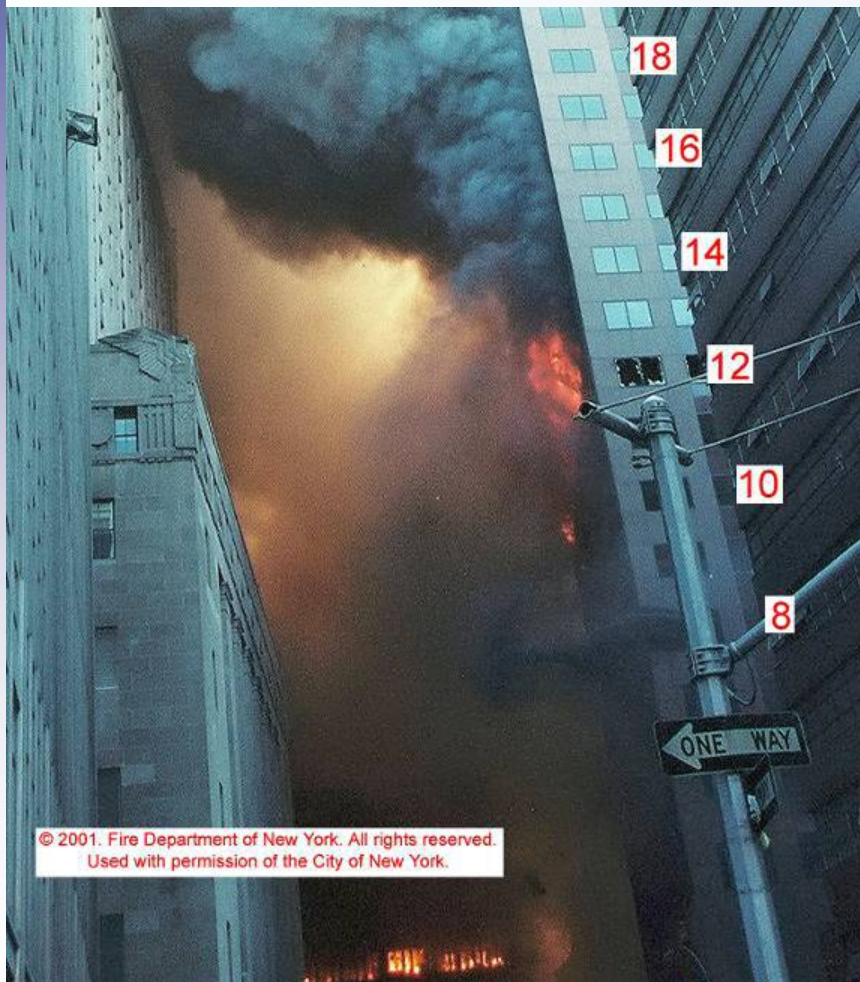
- Fires on the lower floors (Floors 7 to 9 and 11 to 13) grew and spread since they were not extinguished either by the automatic sprinkler system or by FDNY because water was not available.
- Fires were generally concentrated on the east and north sides of the northeast region beginning at about 3 p.m. to 4 p.m.
- The local fires on the upper floors (Floors 19, 22, 29, and 30) were not observed after approximately 1 p.m.
- Cropped photograph showing east edge of the north face and oblique view of east face of WTC 7.
- It was likely taken between 3:20 p.m. and 3:40 p.m.

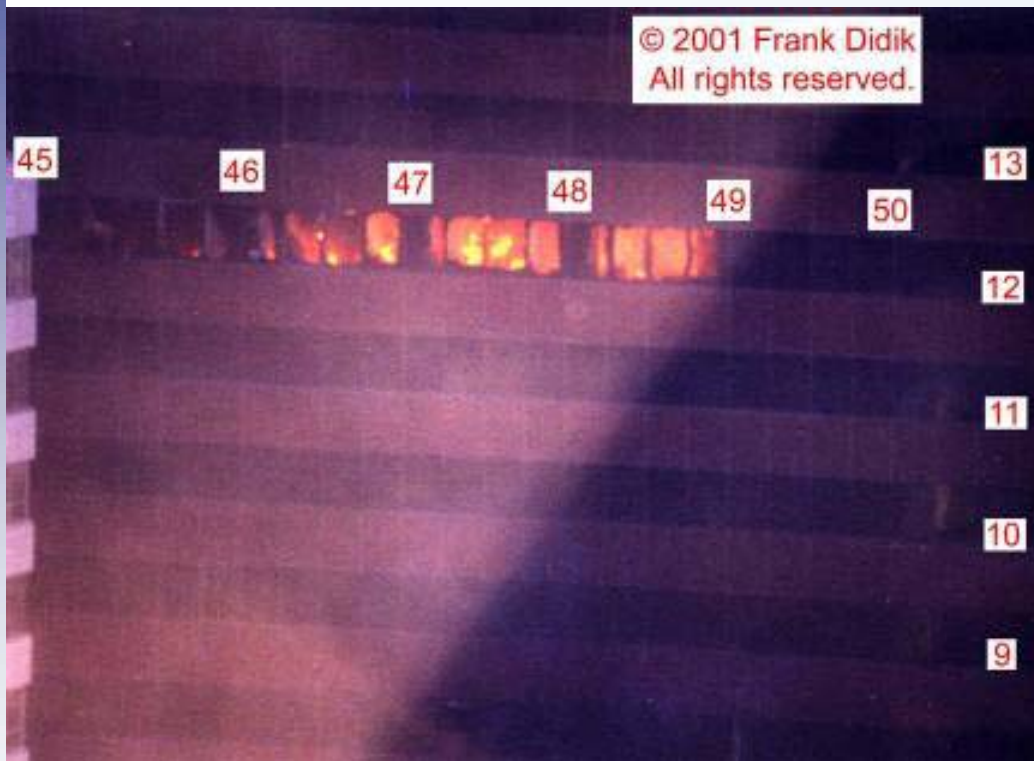
- Cropped photograph of north face of WTC 7 taken between 3:11:15 p.m. and 3:16:51 p.m.

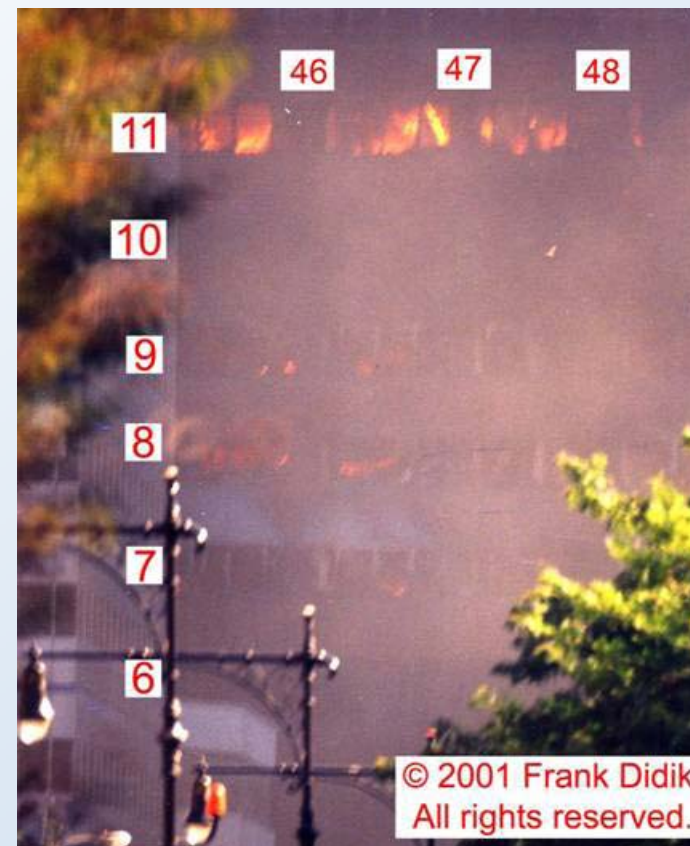
- Cropped photograph showing part of north face of WTC 7 at 4:39 p.m. \pm 120 s.

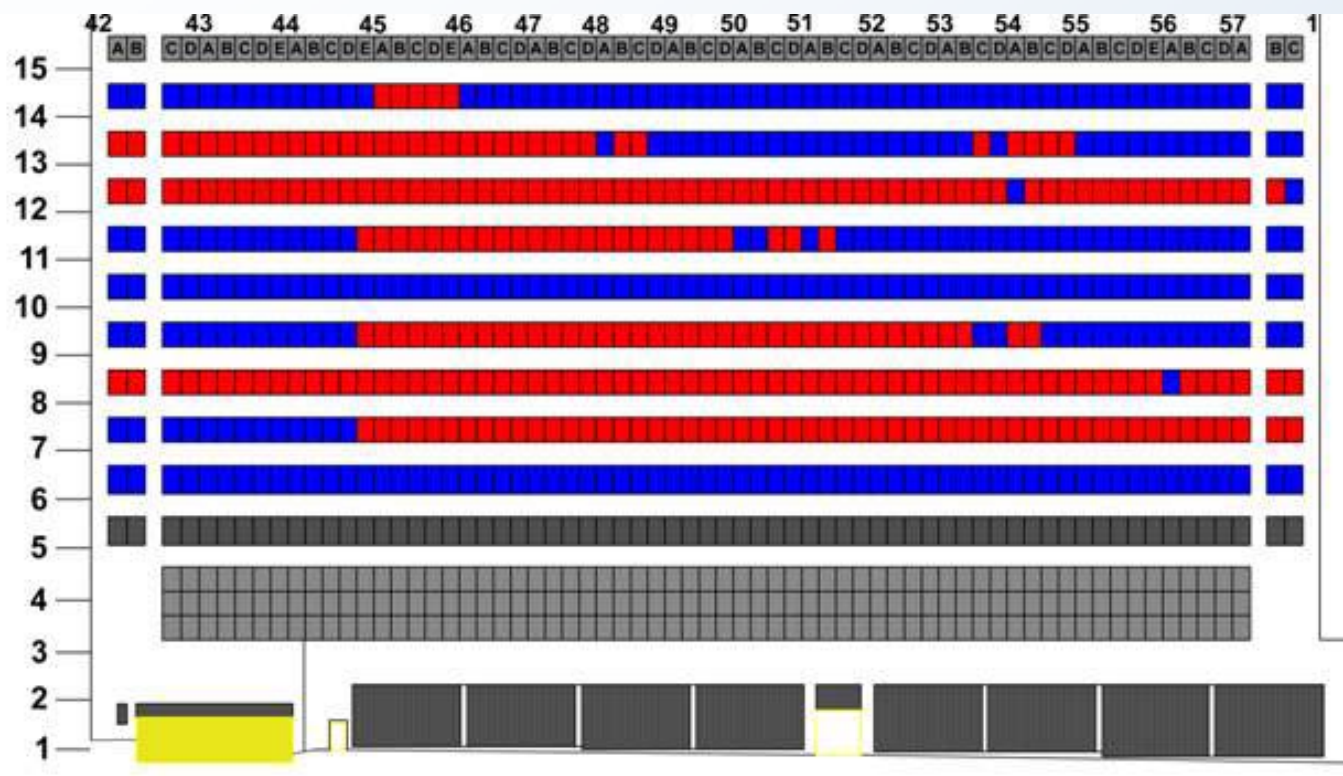
- Façade map showing where windows were broken and/or fire was observed during period when fire first appeared shortly before 3:00 p.m. until building collapsed at 5:20:52 p.m.
- Red represents windows where glass was broken out and/or fire was observed through window. Remaining windows are colored blue indicating that no direct evidence was observed for fires at these locations.

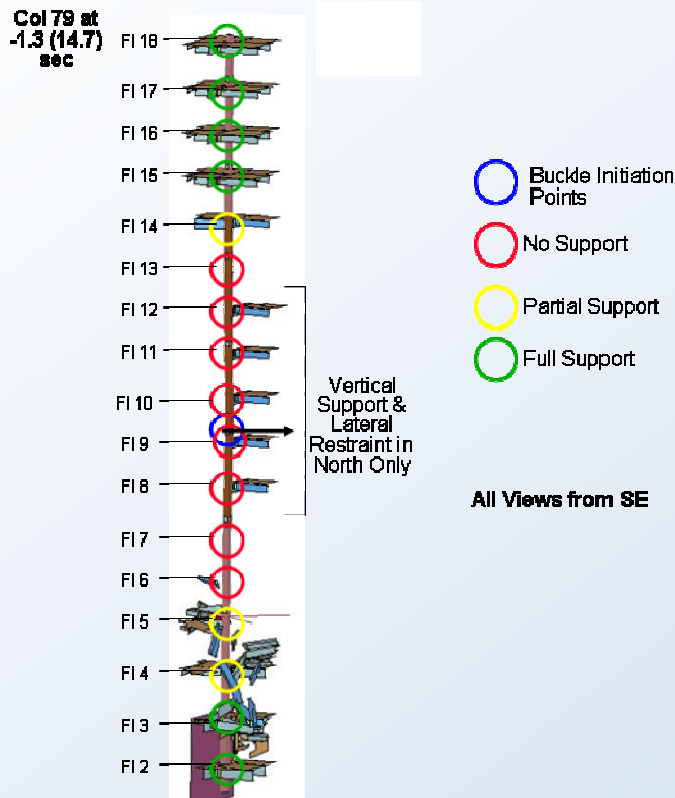
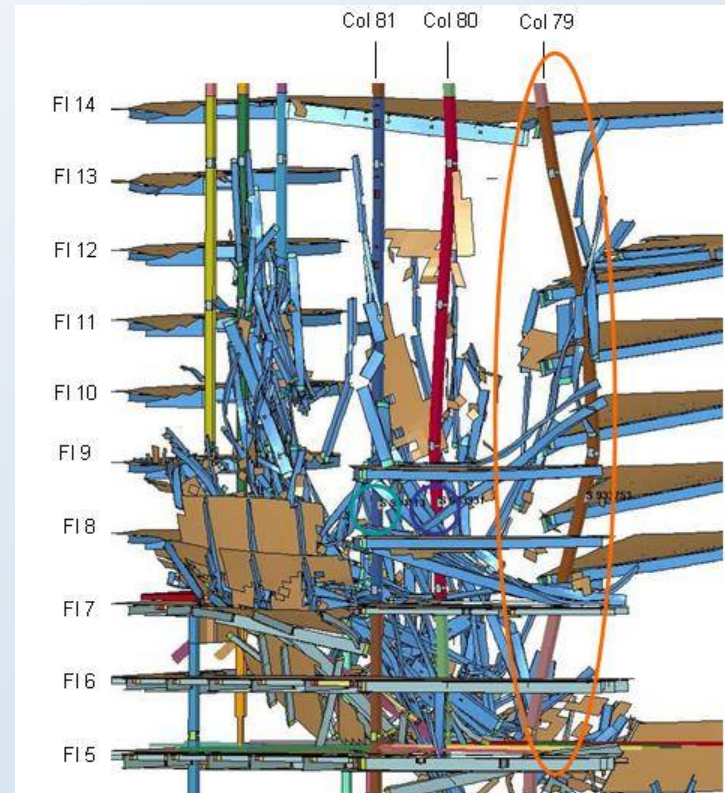
Initial Local Failure for Collapse Initiation

- Fire-induced thermal expansion of the floor system surrounding Column 79 led to collapse of Floor 13 that triggered a cascade of floor failures.
- This, in turn, led to loss of lateral support to Column 79 over nine stories, resulting in the buckling failure of Column 79.

- **The probable collapse sequence that caused the global collapse of WTC 7 was initiated by the buckling of Column 79, which was unsupported over nine stories, after local fire-induced damage led to a cascade of floor failures.**

- More robust connections and framing systems to better resist the effects of thermal expansion on the structural system.
- Structural systems expressly designed to prevent progressive collapse. **The current model building codes do not require that buildings be designed to resist progressive collapse.**

- Better thermal insulation (i.e., reduced conductivity and/or increased thickness) to limit heating of structural steel and to minimize both thermal expansion and weakening effects. **Insulation has been used to protect steel strength, but it could be used to maintain a lower temperature in the steel framing to limit thermal expansion.**

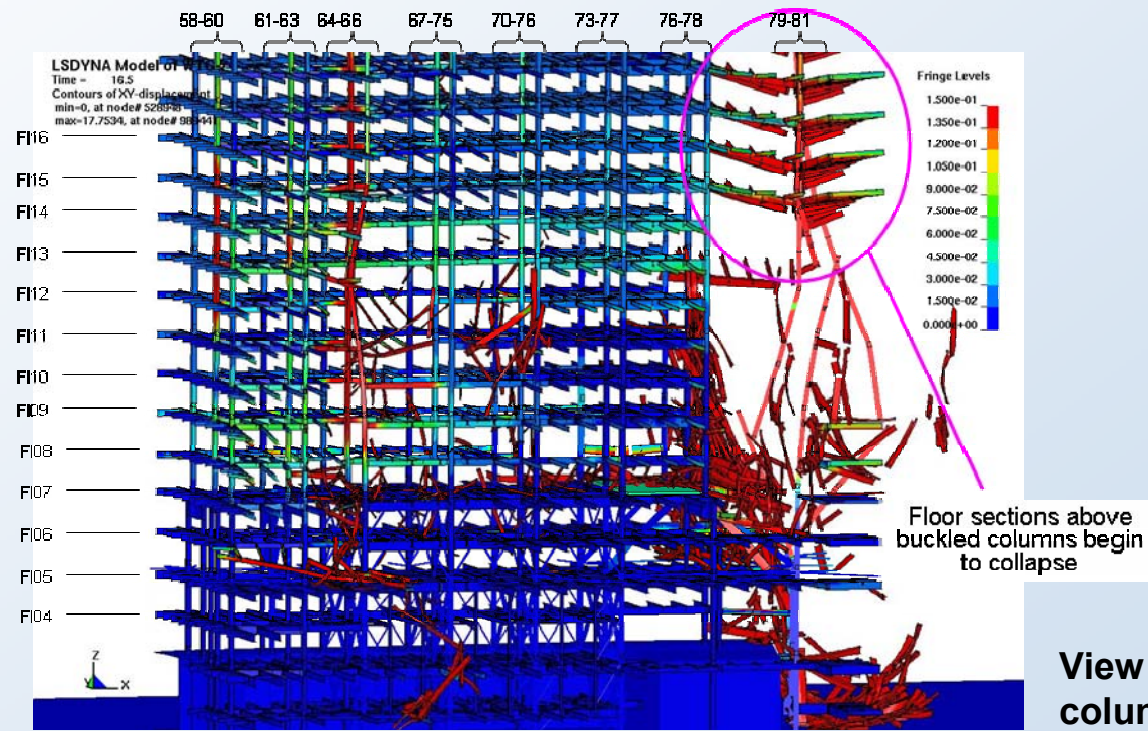
Vertical Progression of Failure

- Buckling of Column 79 (the collapse initiation event) triggered a vertical progression of floor system failures to the east penthouse and subsequent cascading failure of the adjacent interior columns on the east side of the building (i.e., Columns 80 and 81).
- Vertical progression of floor system failures spread to include the entire east region all the way to the top of the building.

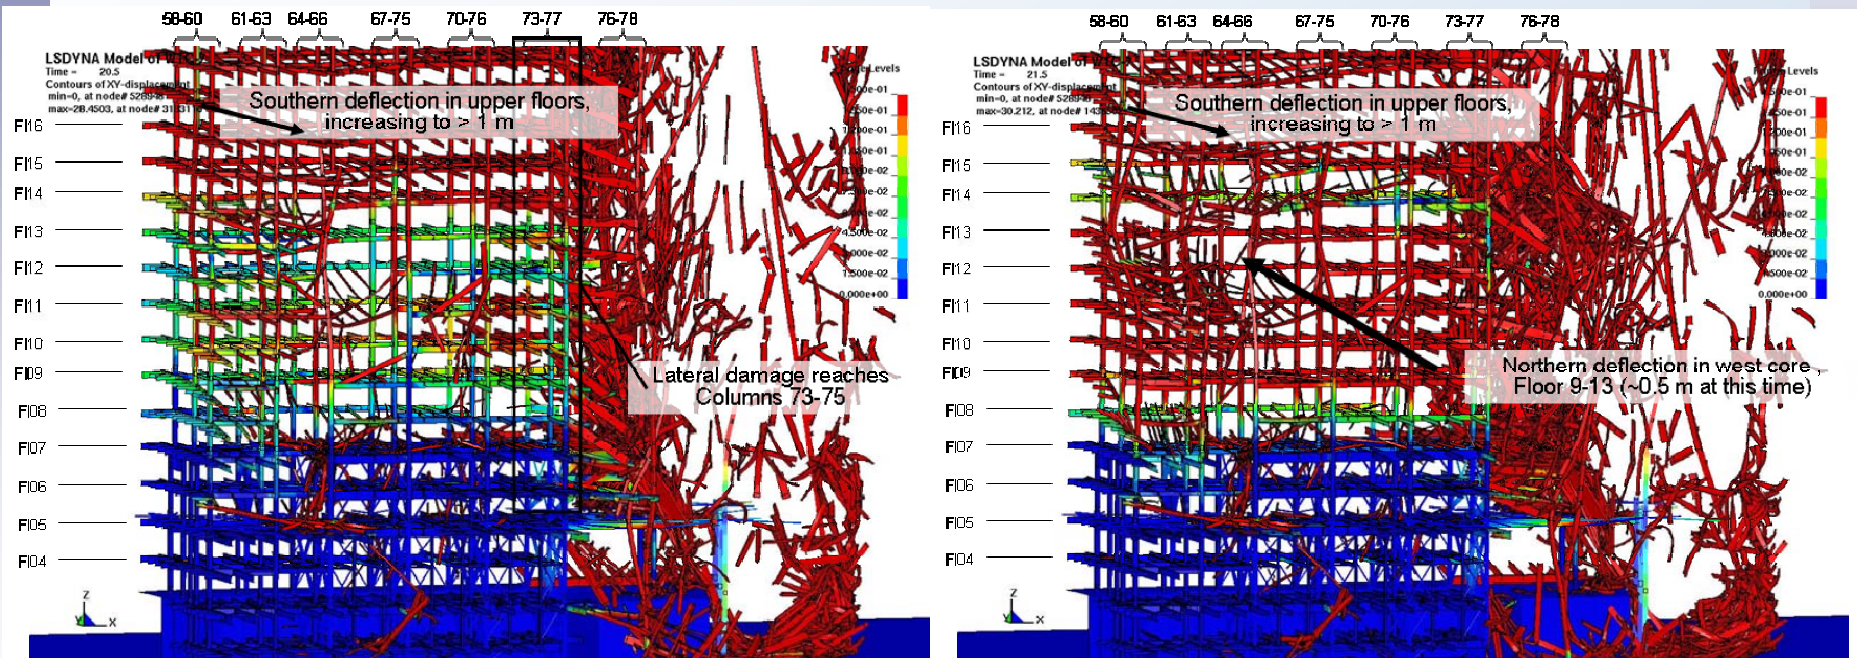
Horizontal Progression of Failure

The interior columns buckled in succession from east to west in the lower floors due to

- loss of lateral support from floor system failures
- forces exerted by falling debris
- load redistributed from other buckled columns.

Failure progresses to the third line of interior columns from the east at 4.5 s following collapse initiation.

Buckling of all interior columns at 6.5 s following collapse initiation.

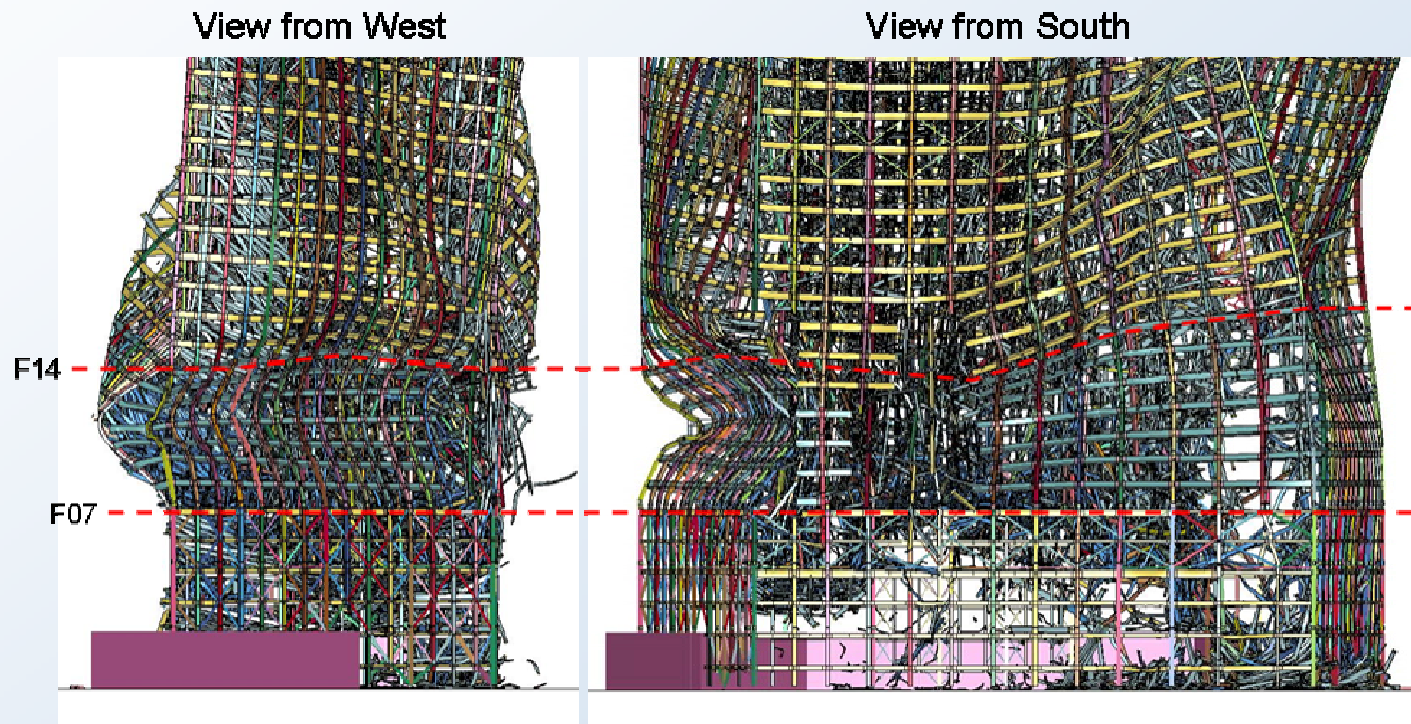
- The exterior columns buckled at the lower floors (between Floors 7 and 14) due to load redistribution to the exterior columns from the downward movement of the building core.
- The entire building above the buckled-column region then moved downward in a single unit, as observed, completing the global collapse sequence.

Buckling of lower exterior columns.
