SEISMIC RESPONSE OF BNZ BUILDING IN WELLINGTON FOLLOWING THE 2016 KAIKOURA EARTHQUAKE

Umair Siddiqui, Will Parker, Robert Davey, Simon Therkleson¹

[¹WSP Opus International Consultants]

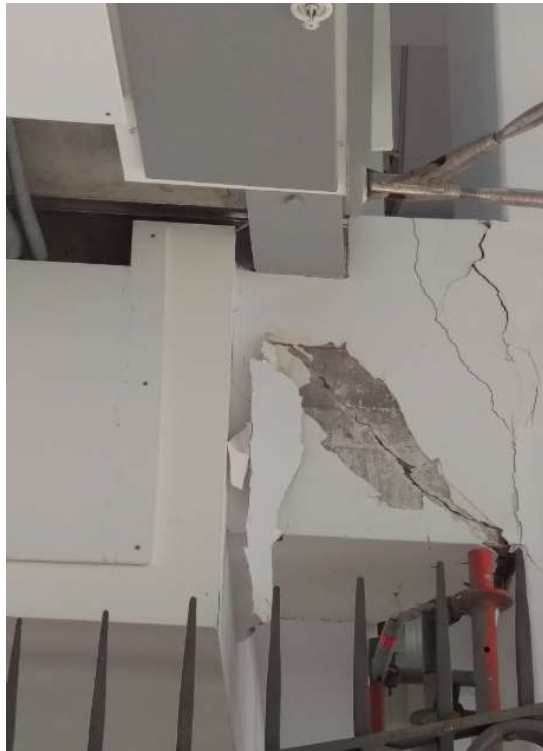
Pier 2 L1 Grids 6 and V beam

Figure 7. Cracking and spalling in the concrete beams

The damage observation on the plastic hinging zone indicated that the beams have suffered large cracks (0.5-3mm residual crackwidth) on both bottom and top of beams. At the top of the beams, cracking is sparsely distributed over a shorter distance (~200-250mm) with fewer cracks. At the bottom of the beam, the cracking pattern is usually well distributed within ~500mm plastic hinging zone. Moreover, the beams were surveyed at the column supports and at midspan along grids 4, 6, 9 and 11 at Level 2 and were found that relative to the average level at the supports for each beam, the midspan sag measurements range from 8mm to 29.5mm. The sagging measured is consistent with the behaviour expected for these gravity load-dominated beams. This is consistent with the behaviour of uni-directional plastic hinge region under in-cycle deformations or the so-called '*Ratcheting*' of the member have occurred in the plastic hinge zones of the beam.

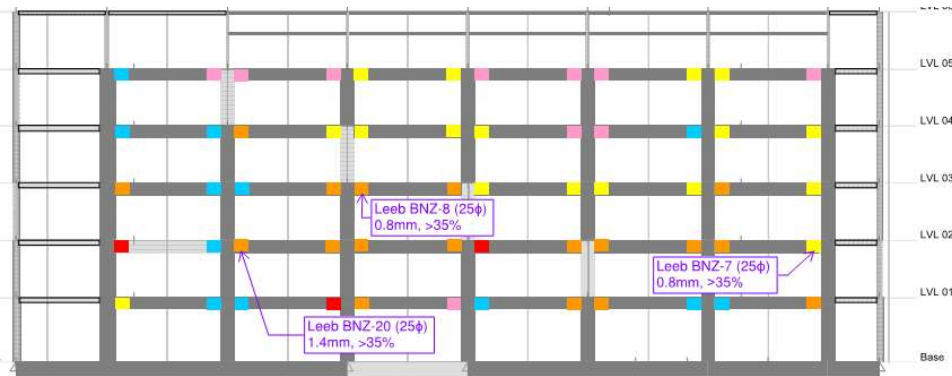
Pier 1 – Grid 4

- The average frame elongations per bay in transverse frames were 6.0mm, 10.8mm and 2.8mm in piers P1, P2 and P3 respectively. The transverse frames in pier P2 have undergone up to 100mm plan extension.

Figure 8. Transverse frame beams (worst damaged) maximum residual crackwidth and reinforcement testing results

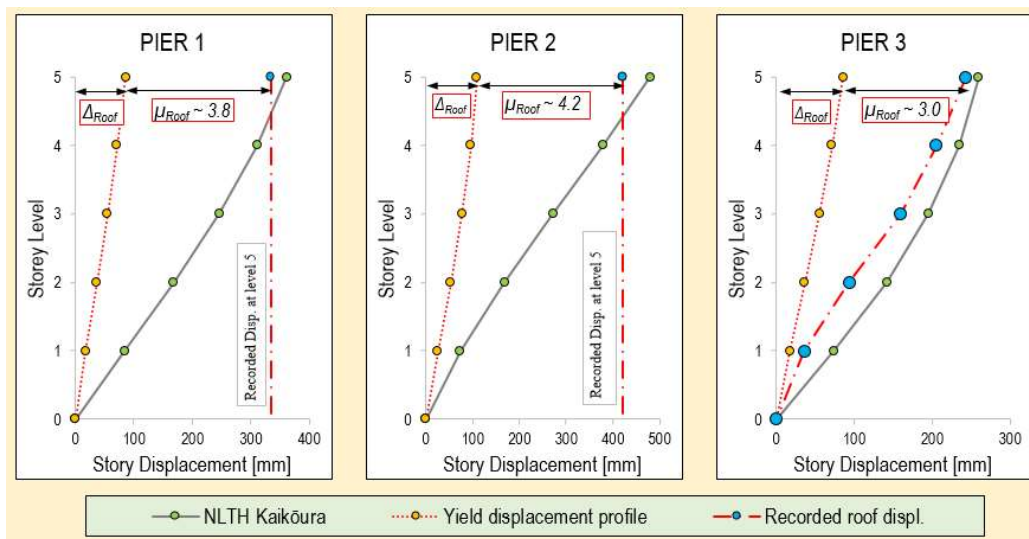
Figure 12 plots the peak recorded displacements for the three piers from accelerometer records on the building. Also shown are the estimated yield displacement profile from a pushover analysis, and the peak displacements from the ETABS non-linear 3D time history analysis using recorded Kaikōura accelerometer records. The peak roof displacement ductility demands during Kaikōura earthquake ranged between 3.0 and 4.2 for the three piers in the transverse direction frames where most damage was observed. The ductility demands for lower storeys is expected to be higher where most of the plastic deformations took place.

Figure 12. Ductility demands at roof level in each pier in transverse (EW) direction ([6])

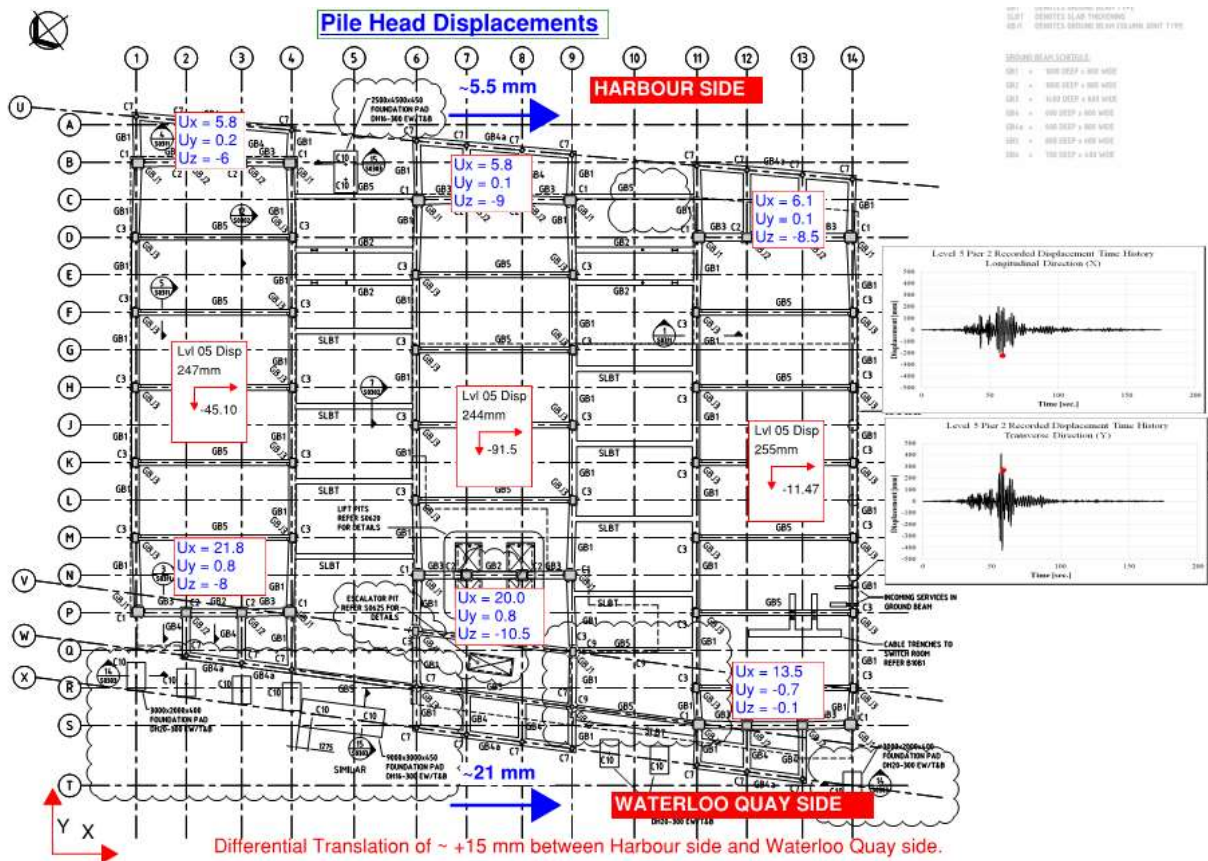
The building response observed from the instrumental records at Level-5 in Pier 3 showed larger displacements on the Waterloo Quay side compared to Harbour-side frames in the longitudinal direction. Figure 14 presents this torsional response at foundation level through pile head displacements variability in longitudinal direction across the entire building footprint. It shows the relationship between the foundation response of each pier and the superstructure peak displacements. The time at which the displacements have been taken from the numerical model is based on the instance of peak displacement in each direction from the records as well as from the analytical model in Pier 2 (being the governing pier in terms of total sway).

The foundation displacements (UX) shows a slight trend of differential lateral displacement among harbour and waterloo quay frames. As expected, the piles grounded in the softer (non-remediation) zone of soil, all waterloo quay side frames, undergoes more lateral displacement compared with ones within the remedial zone i.e. harbour side frames. The difference is about 15-20 mm given the nominal values of lateral stiffness of piles, which is expected to vary depending on the sensitivity of the soil parameters.

Figure 14. Pile head displacements at the instance of peak recorded roof (level 5) displacements in longitudinal direction

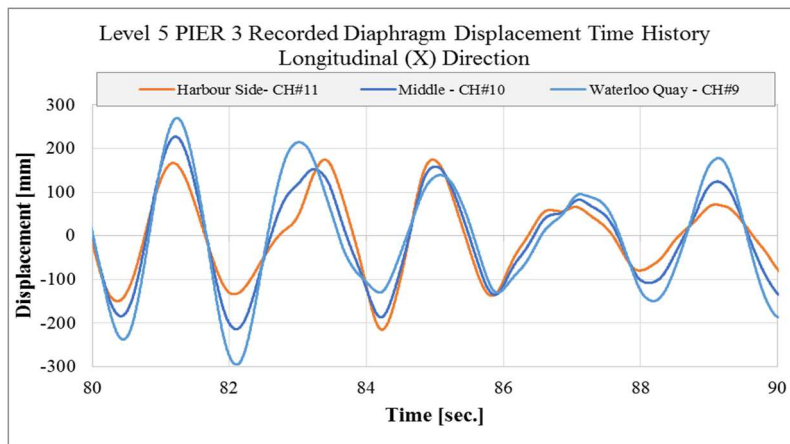
The evidence of foundation torsional response are also supported by the accelerometer records. Figure 15 presents the recorded displacements (w.r.t. ground) on the top storey slab (Level 5) in Pier 3 in the longitudinal (N-S) direction. The displacement time-histories indicate a clear trend of larger floor slab displacement near the Waterloo Quay end as compared to the Harbour side end with differential displacements of about 100 mm at some peak instances between the two ends of floor slab. It is interesting to note the accumulation of differential displacement as we move to the upper levels, with the differential displacements on floor diaphragm amplified from 15mm at the base to 100mm at the top floor level.

Figure 15. Recorded diaphragm displacements on Pier 3 at roof level in longitudinal direction

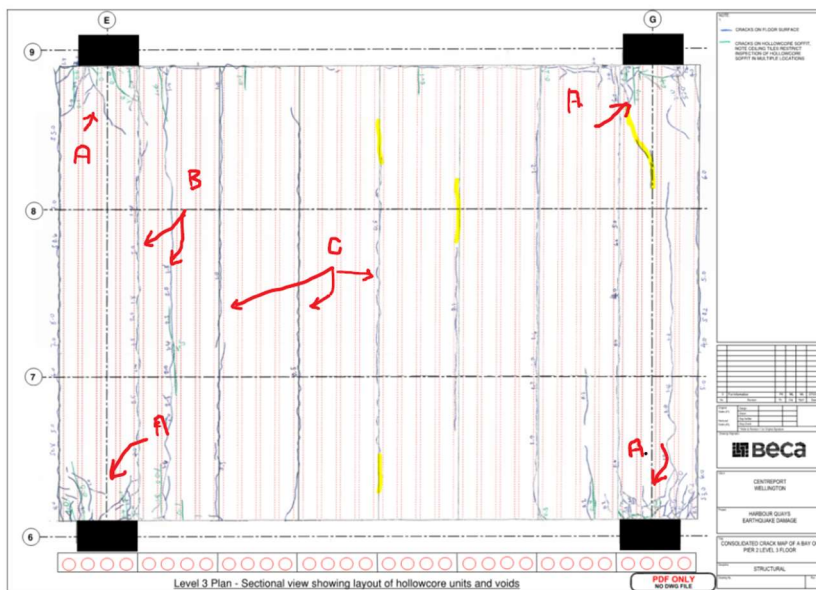
Figure 22. Pier 2 Level 3 floor slab (part) crack maps

Figure 22 (part of the crack mapping undertaken by Beca) illustrates the effects of frame elongation/deformation. As the beams elongate next to the columns, the floor gets significantly stretched next to the column, forming many cracks (labelled A in the figure). This elongation also stretches the whole floor resulting in cracks that run the full length of the floor unit. This is exacerbated near the column due to the high rotations in the plastic hinge zone of the supporting beam. The floor units are deep and therefore stiff but brittle – there is no

reinforcement across the unit. This longitudinal crack is observed in both the cast-in-place topping and top and bottom flanges of the unit (labelled B).

Other cracks form in the topping immediately above where units meet side-to-side (labelled C). It was noted that these cracks are originally formed by shrinkage of the cast-in-place concrete, but the crack had widened during the earthquake. Similarly, new cracks will form at these locations because of future earthquakes. When a building is being displaced by a major earthquake, the floor plates are stretched “dilates”, compressed and racked (going rhomboidal in shape). The concrete of the topping is the weakest at the line where the units meet, hence it is common to have many full length cracks forming at these locations all over the floor plate. This was widely observed in the BNZ building.

Figure 3: Beam elongation forming a large number of cracks at the beam to column junctions (A), longitudinal cracks in the topping and units below (B) and cracks in the topping where the sides of the units meet (C).³
