SINGLE

POINT

OF

FAILURE

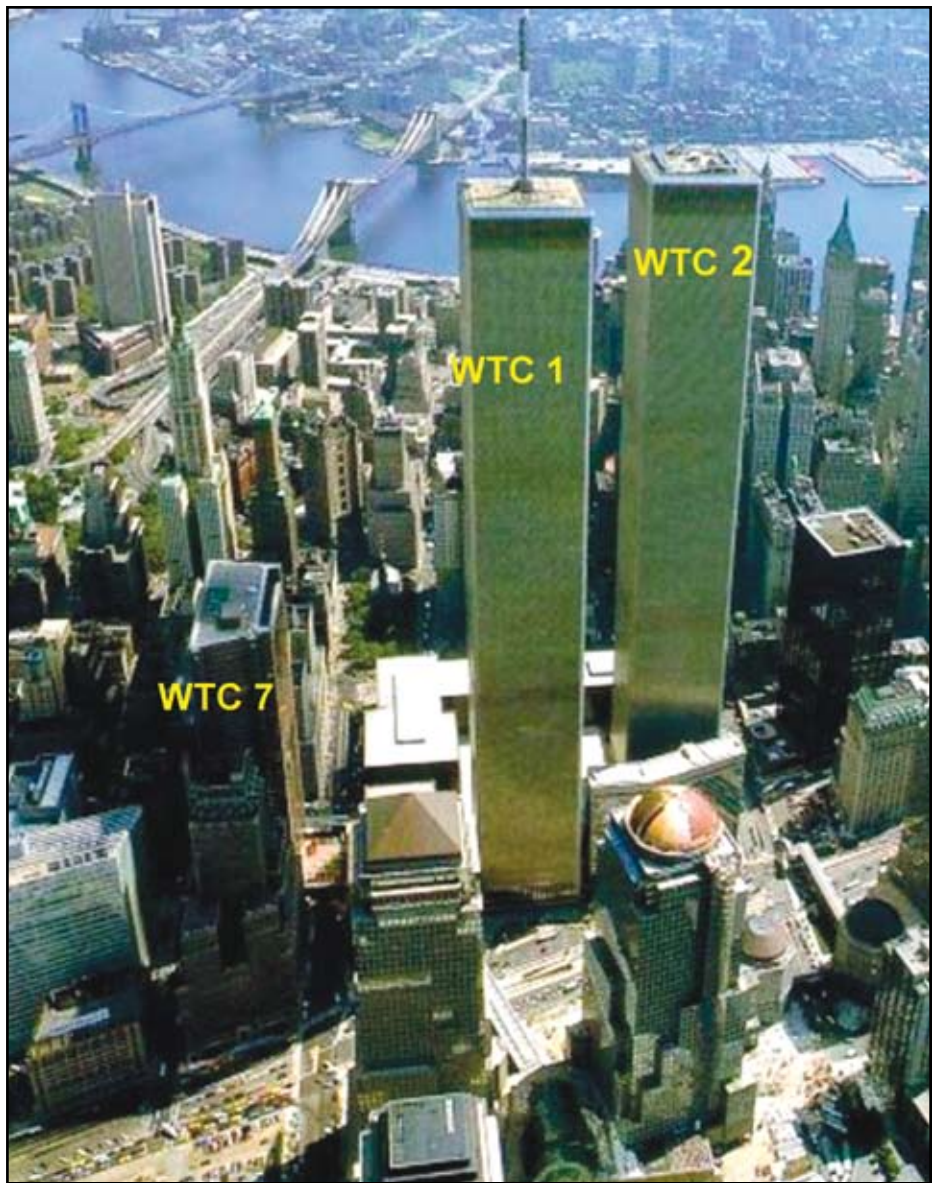
World Trade Center 7, on the north side of the World Trade Center Complex. The collapse of WTC 1 sent flaming debris into the southern face of WTC 7 and initiated a chain of events that would eventually lead to collapse.

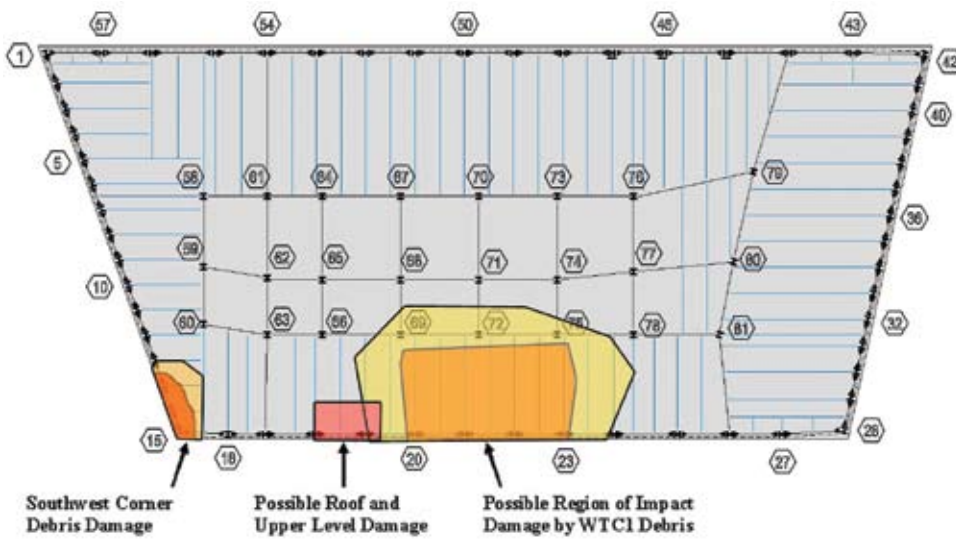
The failure of WTC 1 and WTC 2 sent flaming debris into the southern face of WTC 7. This impact and fire damage initiated a sequence that would lead to global collapse. Eyewitness observations by building occupants, NYPD, FDNY and bystanders indicated that the damage was located on the south face between floors 8 and 18, and that there was a fully involved fire on the south side of floor 7, which included the transfer elements. From 3:00 to 5:00 PM, fires were still burning in the building, which may explain why it took several hours for it to collapse. The continued heat of the fire weakened steel structural components until they failed at 5:21 PM, nearly seven hours after the collapse of WTC 1 and WTC 2.

Possible extent of debris damage from collapse of WTC 1 and WTC 2.

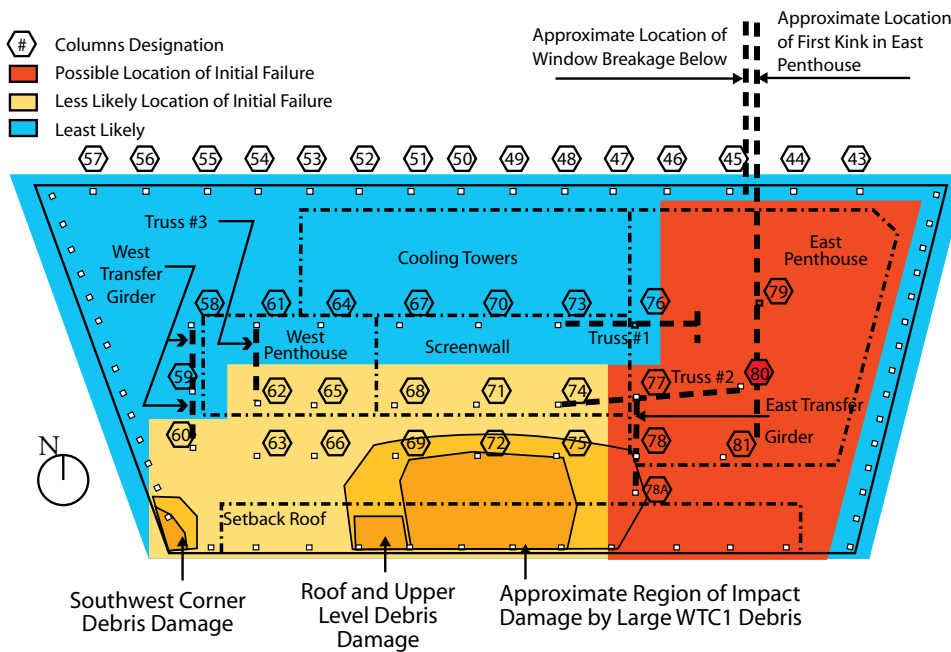
The sequence of final collapse can be interpreted using knowledge of the building’s framing from existing plans. For instance, the observed collapse of the east penthouse may signify a failure in a line of columns on the east side of the building (columns 76-81). In particular, interior

Locations of the collapsed penthouses and the kink in relation to the structural columns.

columns 79, 80 and 81 were located directly below the east penthouse and supported relatively large tributary areas.

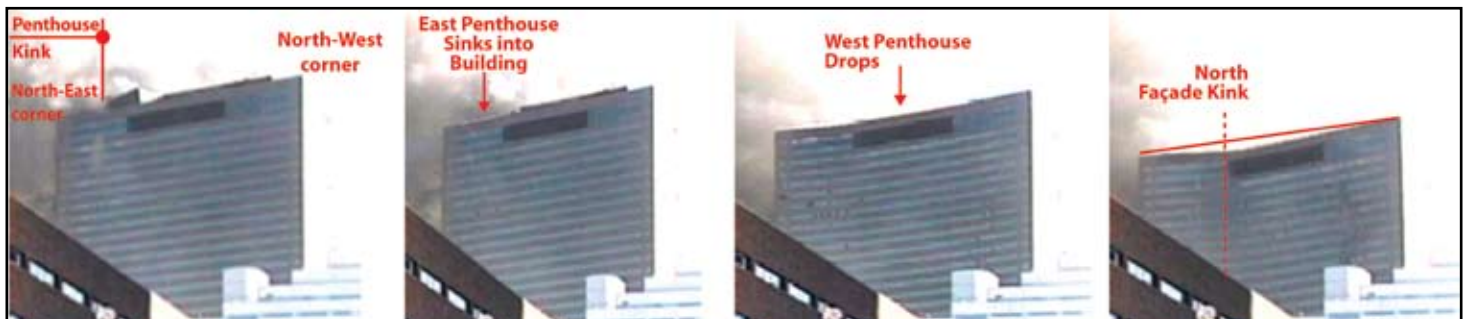
during the collapse. As seen in the photos, a kink develops in the east penthouse before it falls into the building. The west penthouse then fails, followed by a kink in the entire façade of the building. Total collapse follows.

This sequence of events, with roof elements sinking into a building with an intact façade, suggests an interior failure. An interior failure would explain the appearance of a “controlled” collapse with a relatively small debris field, as seen with WTC 7.

- 3) The sinking of the west penthouse, as well as the shifting of a clear kink from the east penthouse towards the middle of the structure, indicates that the collapse then progressed horizontally, as the localized failure of the eastern columns was distributed to the other columns through the transfer elements at floors 5 through 7.

Start of the final collapse sequence (7.7 seconds elapsed). Note that the kink in the east penthouse in the first photo "shifts" towards the middle of the building in the fourth photo, indicating horizontal progression of the collapse.

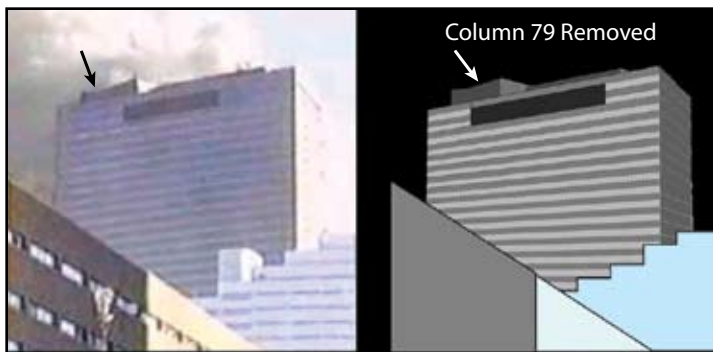
A kinematic model was created to test the final collapse hypothesis and isolate the structural elements that may have contributed to each phase of the failure. It was this testing that isolated one column, 79, as the critical structural component whose failure led to global collapse. A collapse mechanism analysis performed for the removal of column 79 produced a deformed shape with a kink in the roof of the east penthouse, as captured in actual videos and photos taken that day.

On the left, a video still showing the kink in the east penthouse. On the right, the kink is recreated when column 79 is removed (simulating a failure).

significant, should have caused no more than local failure of structural components. That is, buildings should be designed to survive a local failure, due to blast, fire, impact, etc. but prevent the progression of a collapse throughout the structure.■
