THURBER ENGINEERING LTD.

File: 23705

**CITY OF SURREY DRAINAGE MAINTENANCE ACCESS UPGRADES
GEOTECHNICAL RECOMMENDATIONS**

FIELD REVIEW REPORT NO.: 1

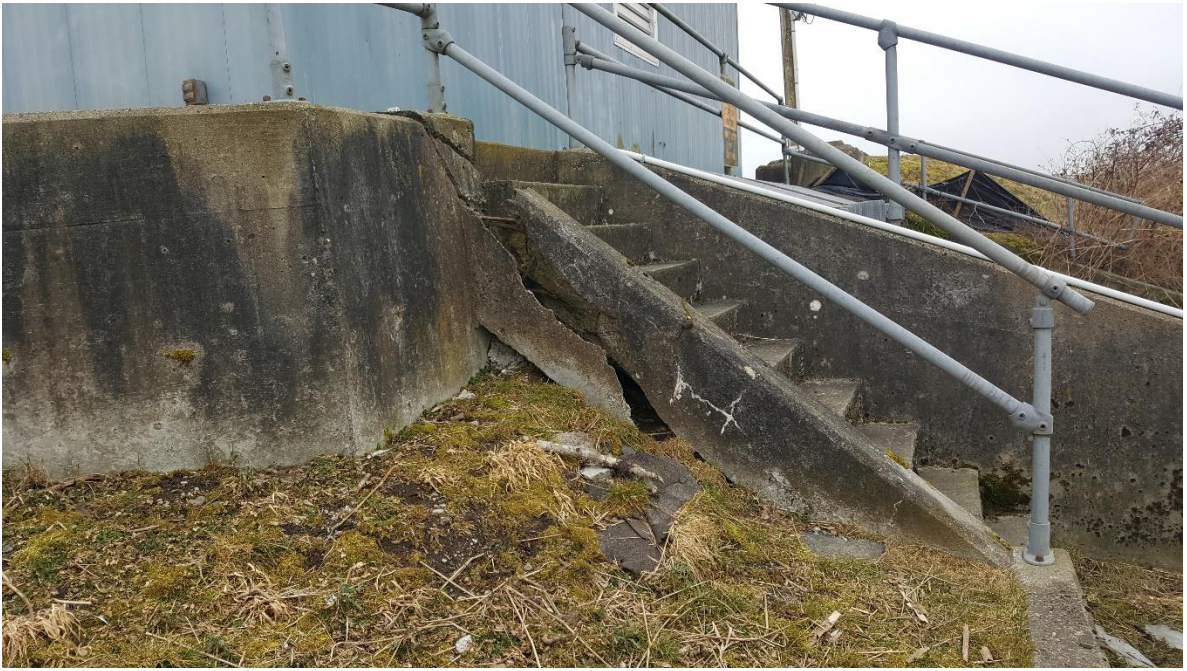
Photo 1 – Failure in north stair stringer for Erikson Pump Station.

- The distress features appear consistent with the effects of long term settlement. No features suggest an obvious stability concern about the dike.

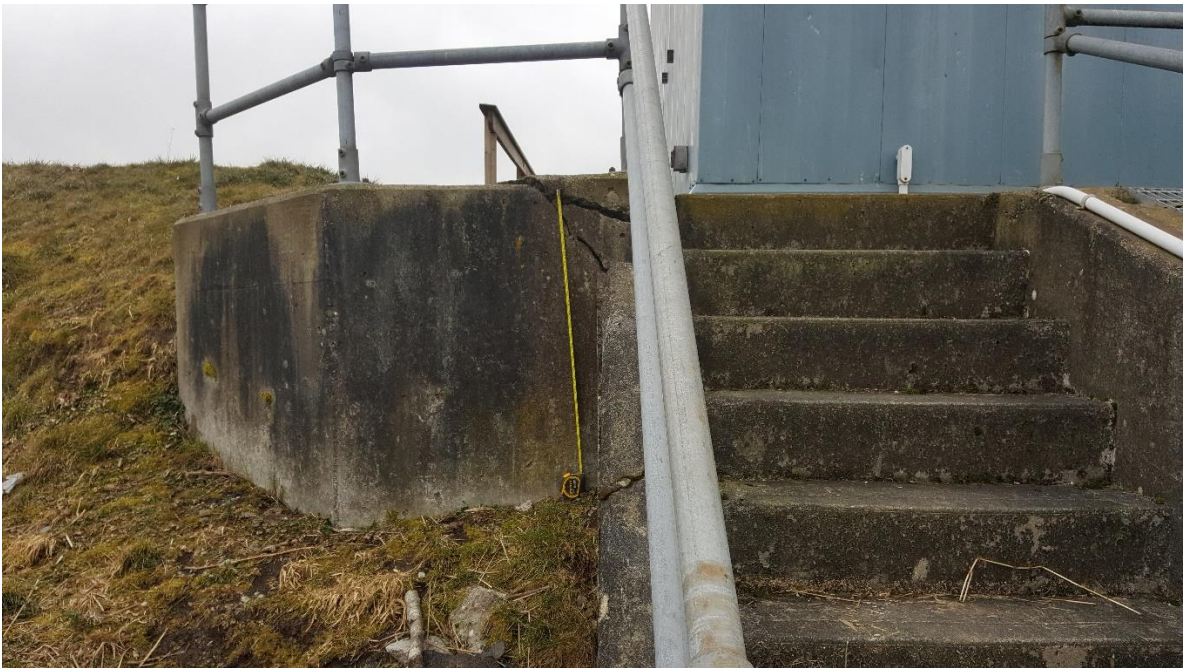
Photo 2 – Sloping of retaining wall for Erikson Pump Station.

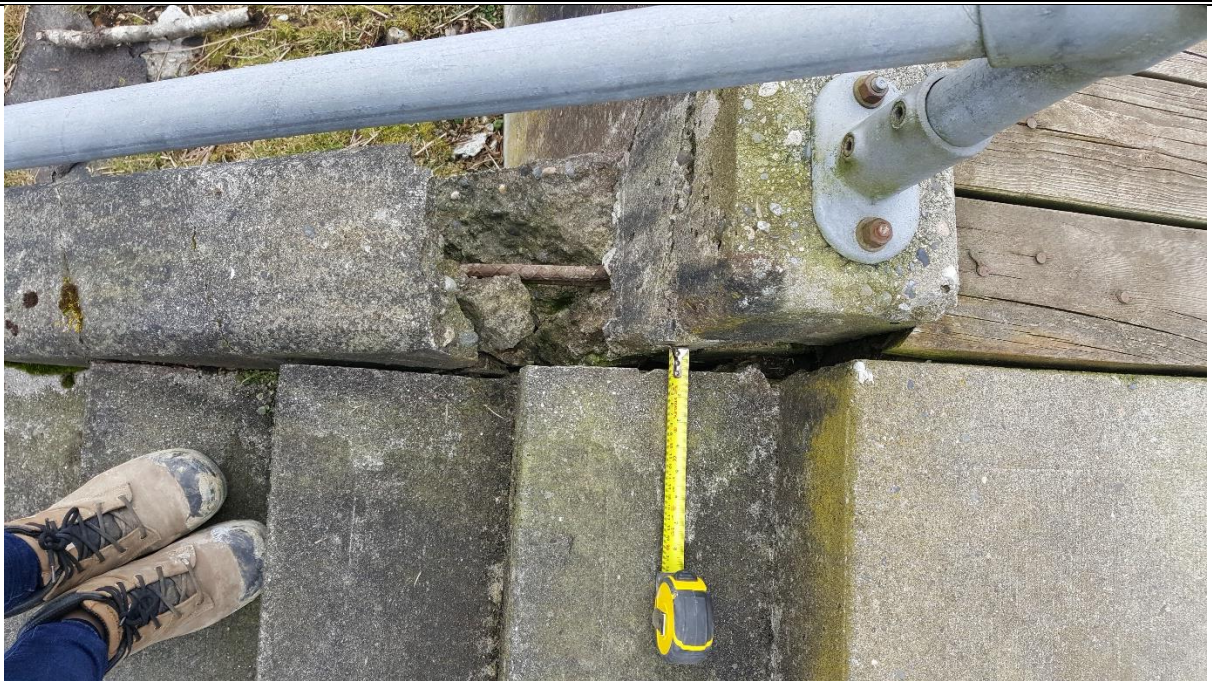
Photo 3 – Gap between the stairs and retaining wall for Erikson Pump Station.

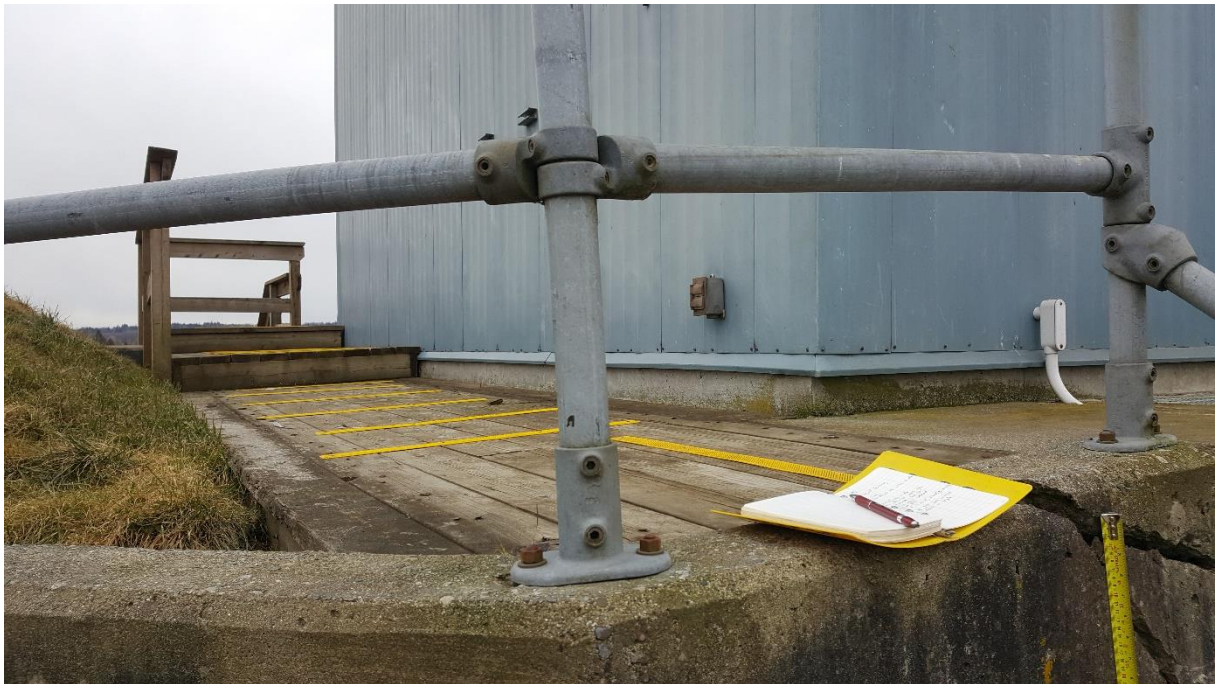
Photo 4 – Wooden platform at the top of the retaining wall for Erikson Pump Station.

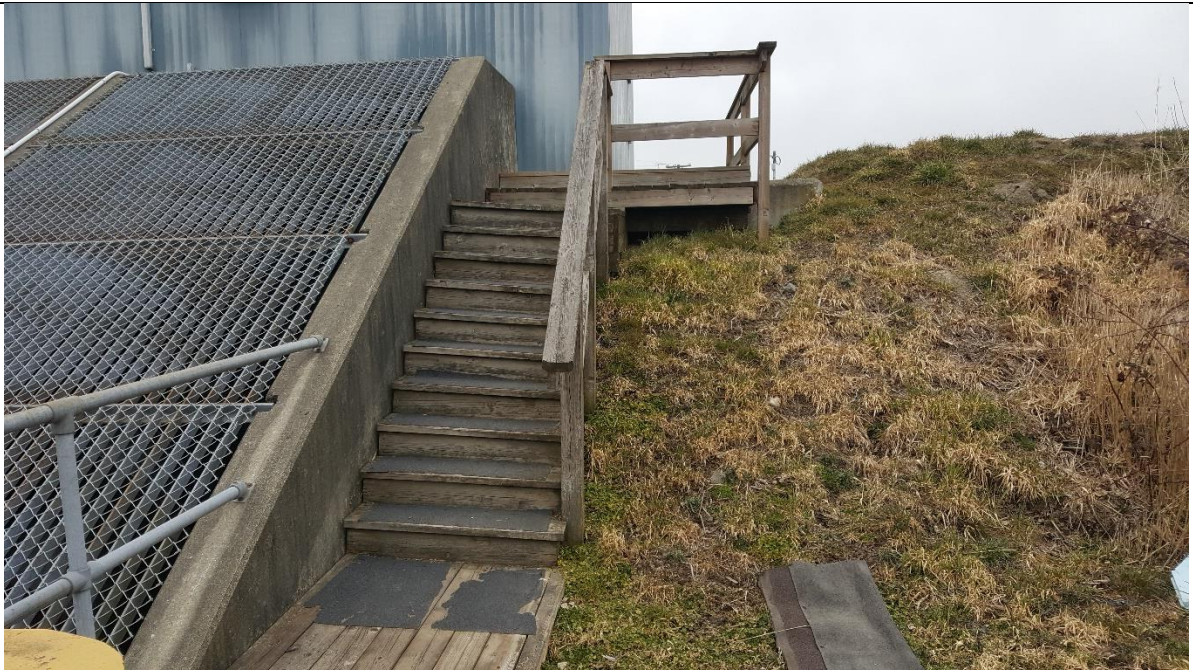
Photo 5 – South Stairs for Erikson Pump Station.

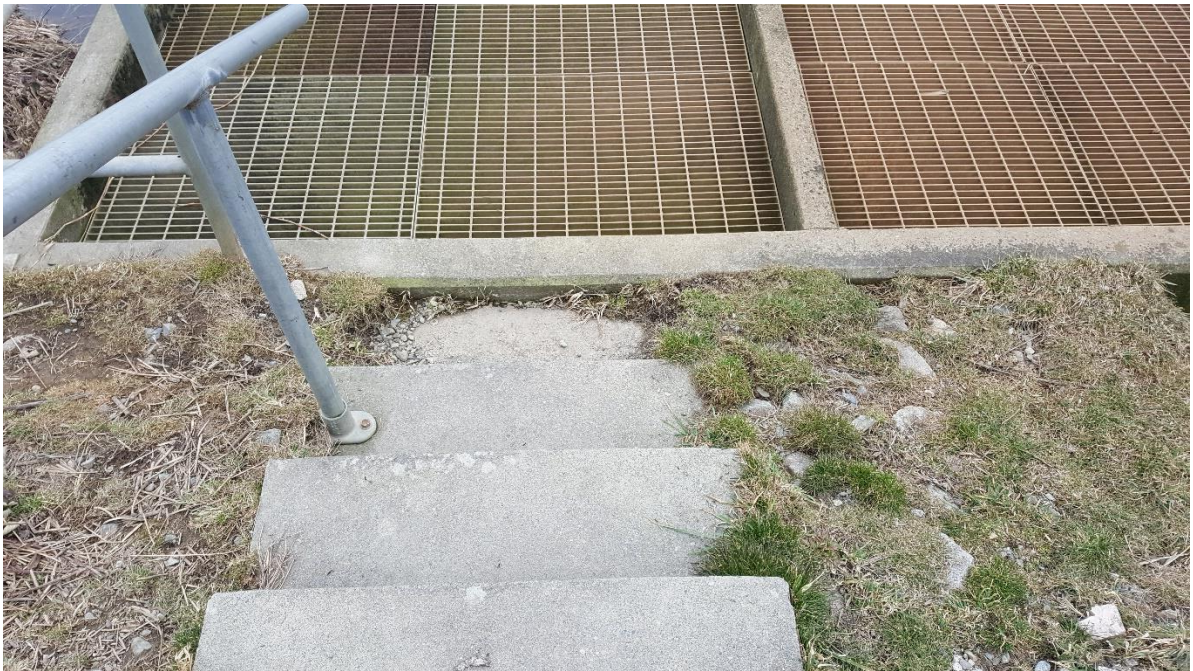
Photo 6 – Cloverdale pump station south stairs.

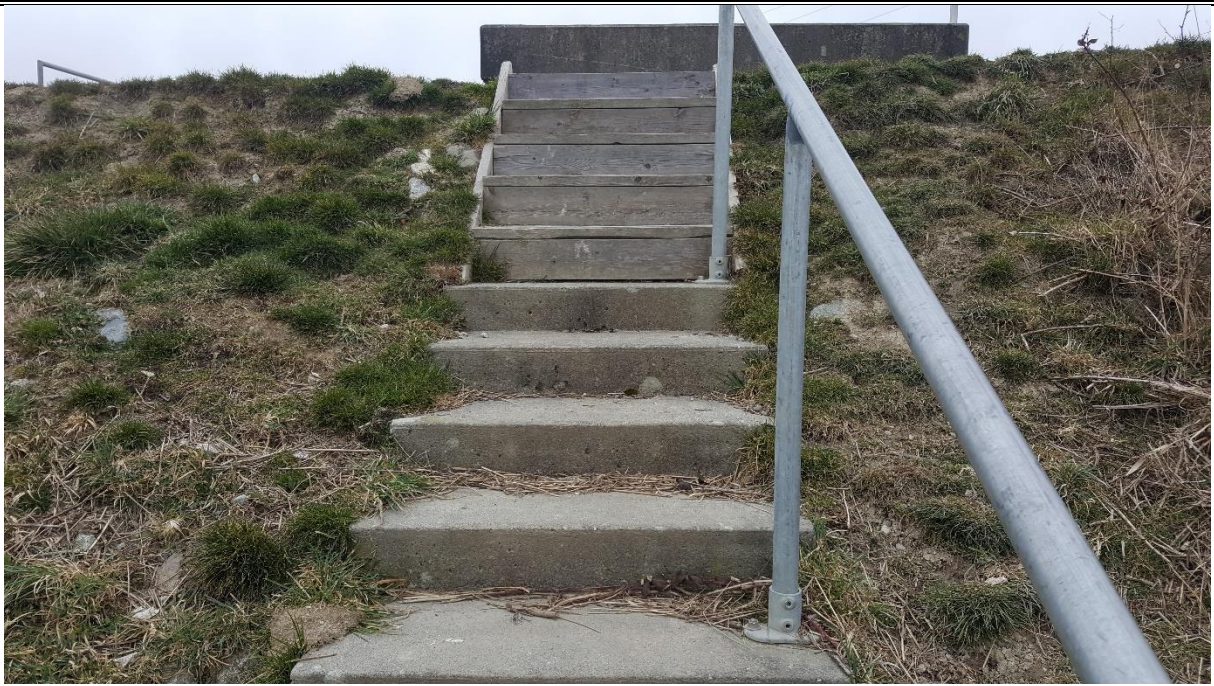
Photo 7 – South Stairs for Cloverdale Pump Station.

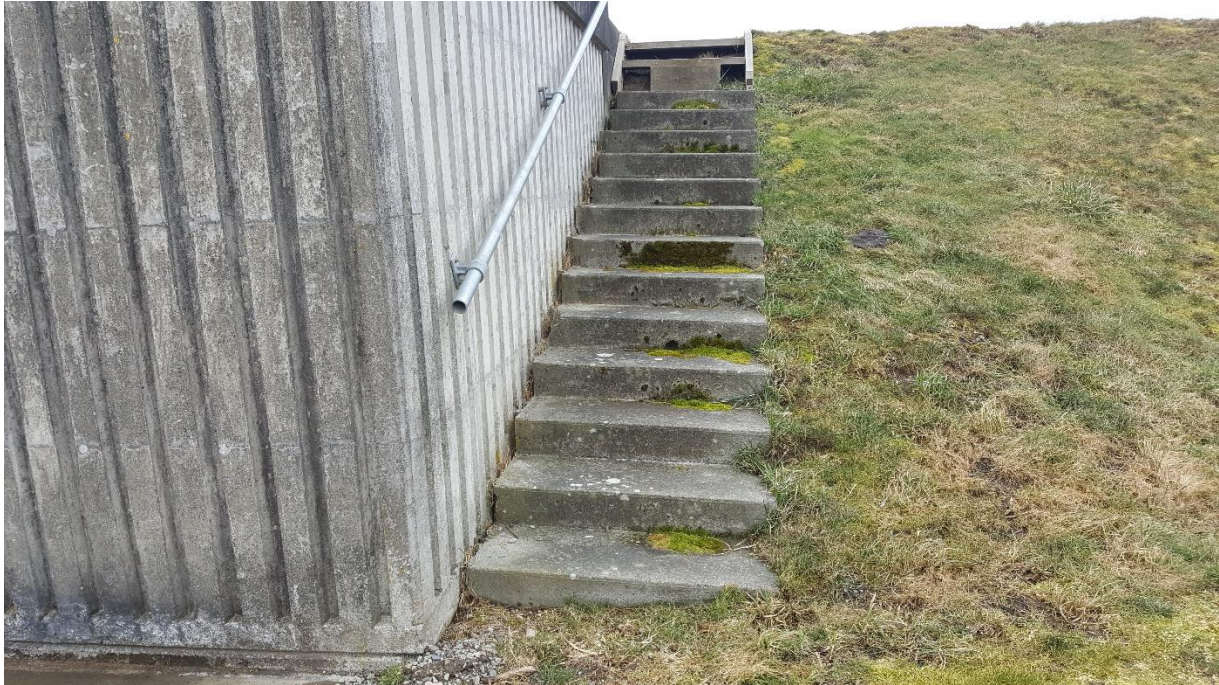
Photo 8 – North Stairs for Cloverdale Pump Station.

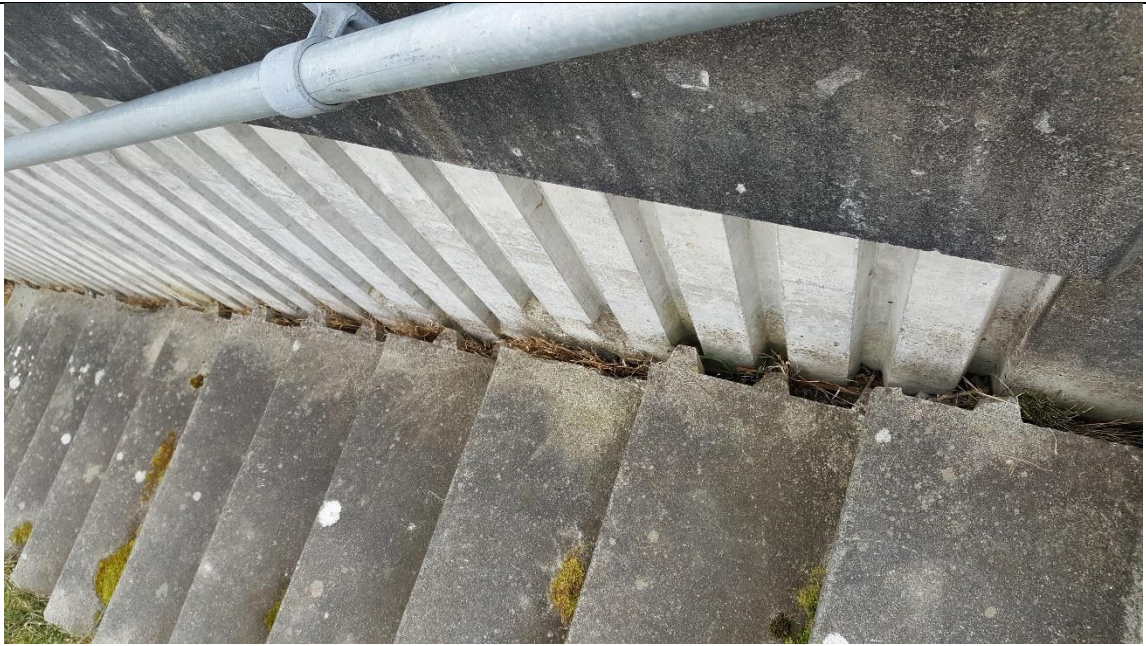
Photo 9 – North Stairs for Cloverdale Pump Station.
