Coyote Gold Mine – Stage 2, Bald Hill

2014-2015 Annual Compliance Assessment Report

Ministerial Statement No. 749

Prepared for Tanami Gold NL

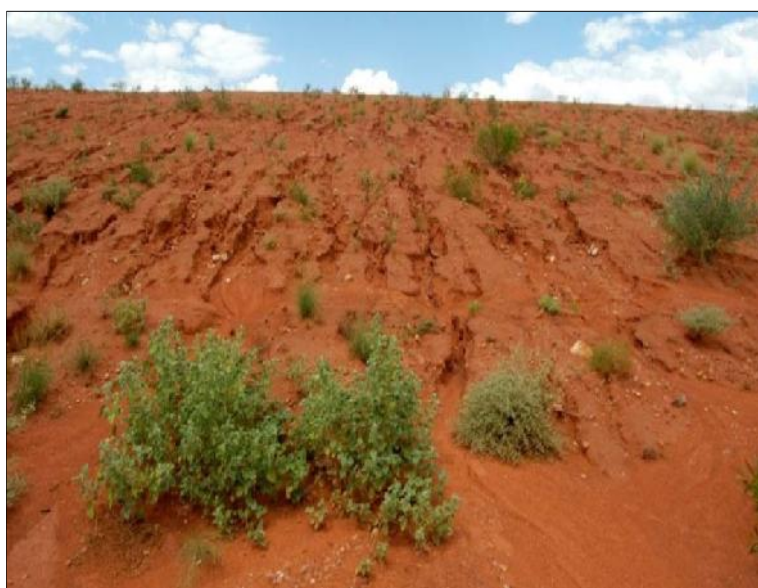
The 2009 to 2010 Annual Environmental Report (AER) reported moderate gullying at the western end following an average wet season, vegetation growth was progressing well and assisting stabilisation of the soil (**Plate 6**). A variety of grasses (*Triodia* species) and shrubs (predominately *Acacia* species) were present (TGNL 2010a). However, at the eastern end, the outcome of the trial is less clear as this area was deep ripped after the trial surfaces were established in a late attempt to better mix in topsoil with the mine waste, and encourage infiltration. Erosion in this area was exacerbated by incomplete water management structures on the upper surface and berm of the WRL, hence the trial in this area was deemed to not be as successful (TGNL 2010a). A final landform design which incorporates surface water management is required to minimise erosion and meet a key objective of the Environmental Management Plan (EMP) (**Table A51**).

Plate 6: Coyote WRL, west end of southern slopes- two years after rehabilitation (TGNL 2010a)

There is currently no toe bund to capture sediment emanating from the WRL. Consideration will be given to the installation of a toe bund in order to mitigate the impacts to the surrounding vegetation.

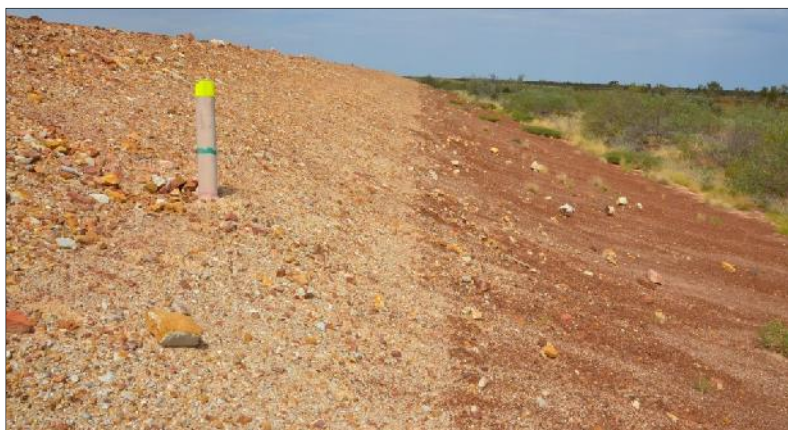
Plate 10: Vibrating wire piezometer PT2N, Cell 2 northern downstream embankment face

The embankment piezometers have recorded a water level rise over the past 30 months. The maximum rise was 1.39 m in piezometer PT2N, with rises of 1.27 m, 1.11 m, and 0.83 m in piezometers PT1W, PT2E and PT1N respectively (Coffey 2013). The water level in PT2S dropped 1.48 m over the same period. The highest embankment piezometer water level was recorded at PT2E at 4.09 mBGL (Coffey 2013).

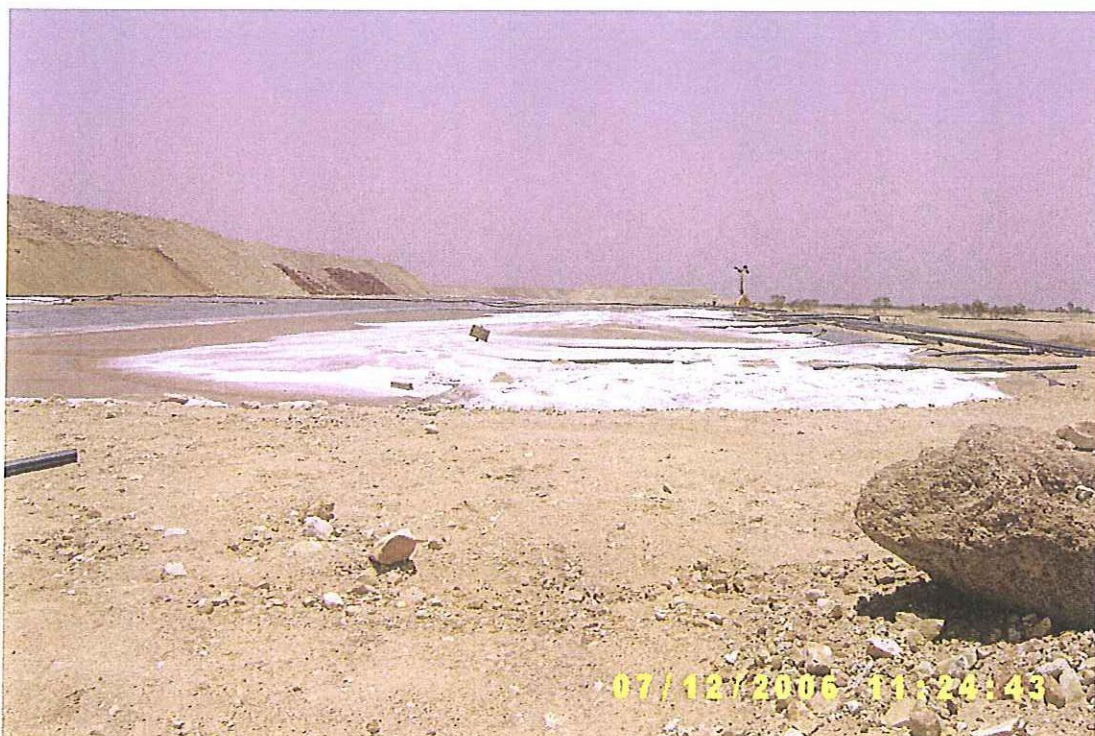
During the inspection it was noted that the filling of the two most eastern Vat Leach cells with crushed ore has resulted in a loss of freeboard. Due to the irregular beaching of ore into the cells, it was difficult to ascertain the amount of freeboard which remains (Photo 1).

Photo 1: Irregularly loaded vat leach.

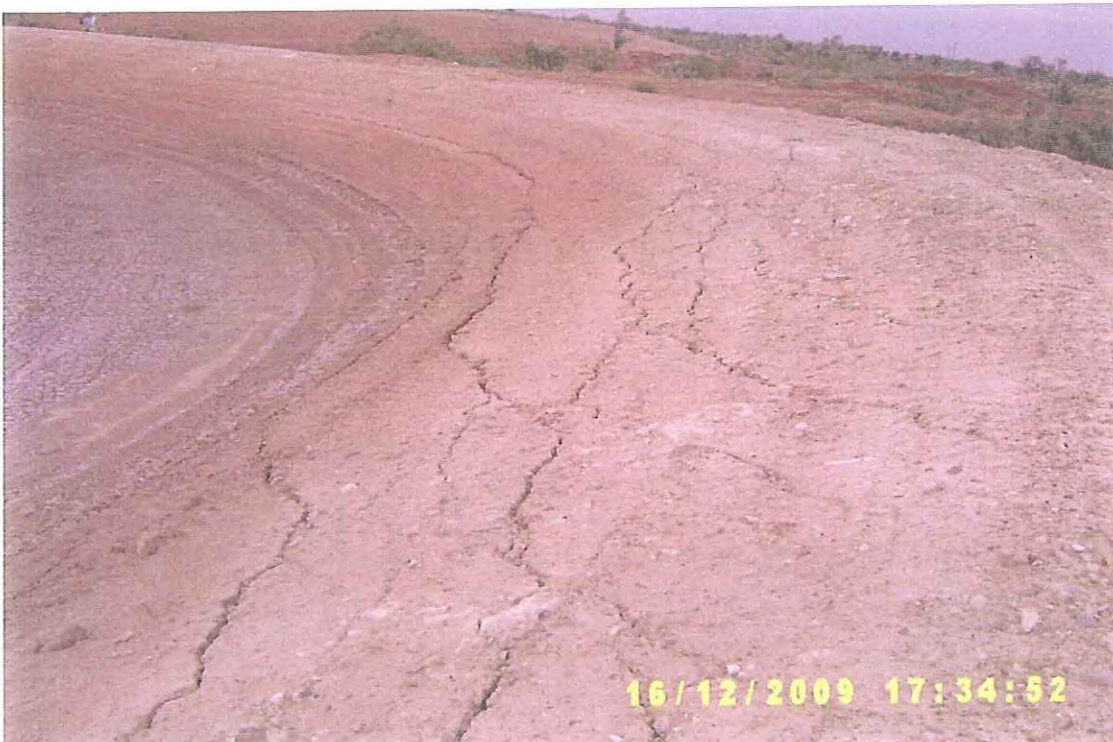
Photo 4: Cracks within Evaporation/Water Dam Embankments.

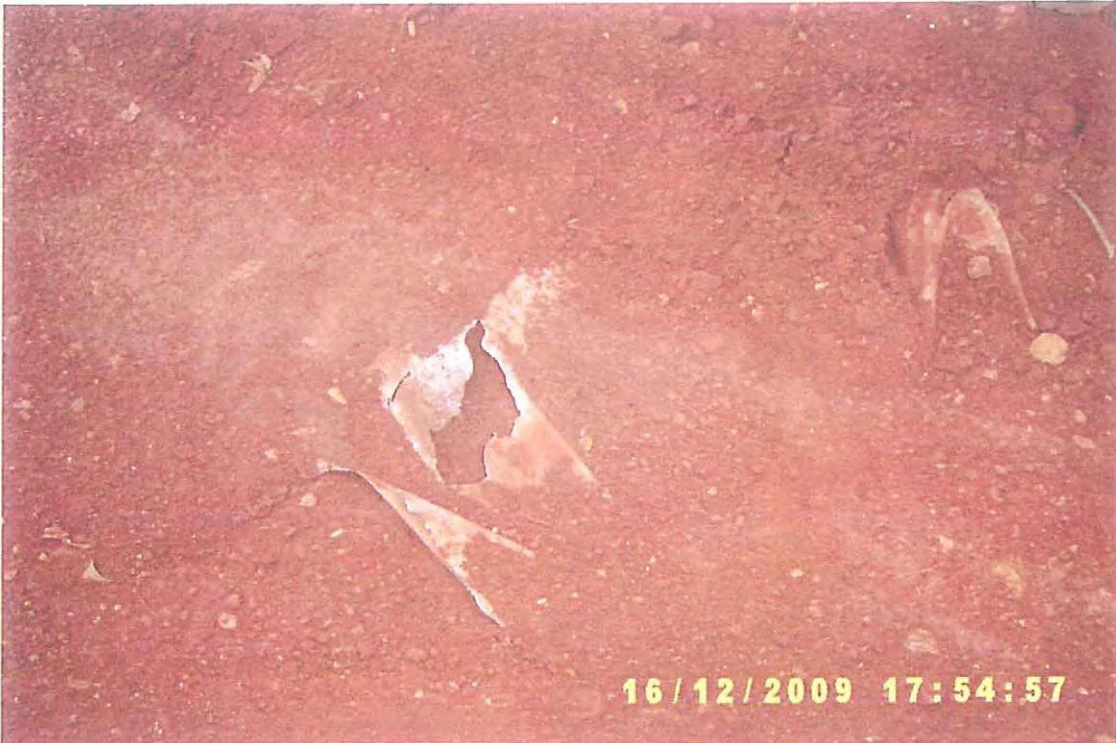
Photo 5: Tears within the Bulk Fuel Storage Facility Liner

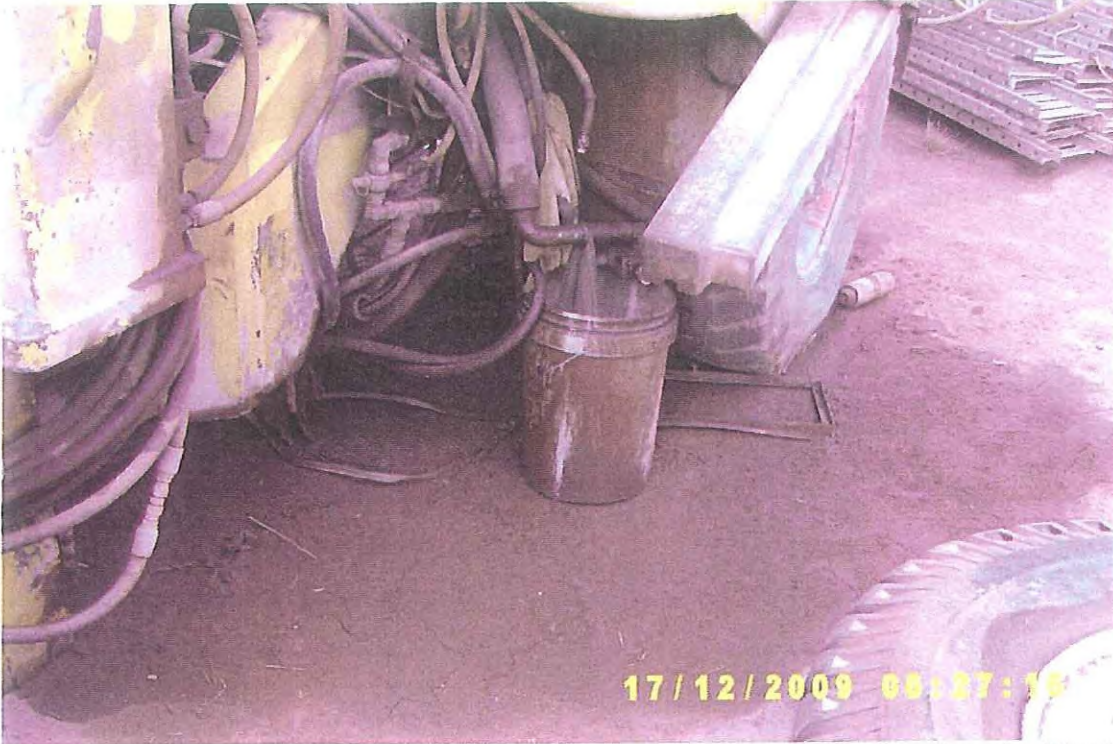
Photo 15: Hydraulic Oil Leaking from disused Equipment in the Coyote Plant Laydown area.

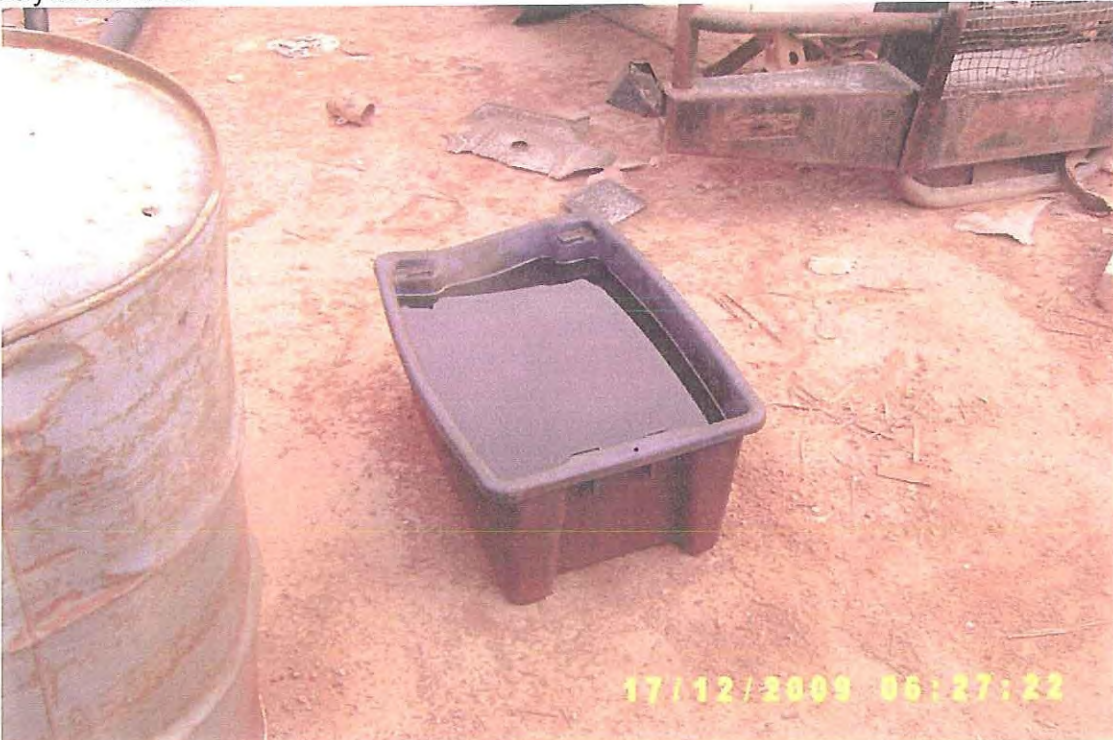
Photo 16: Plastic Tub Containing Oil in the Coyote Plant Laydown area.

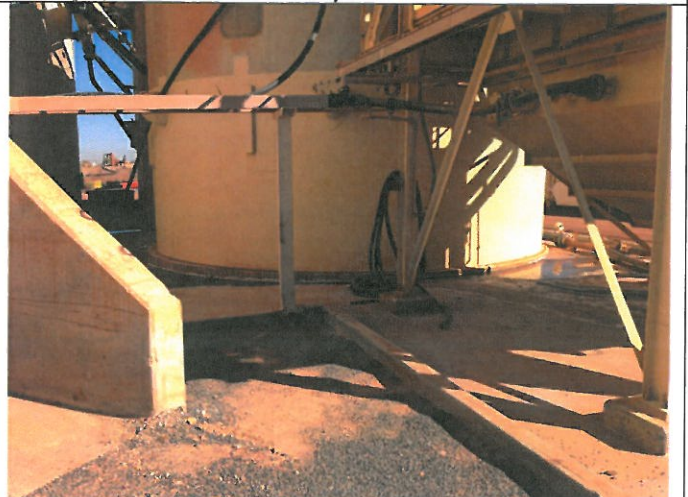
Photograph 4 – Water leak from an old unused leachate tank

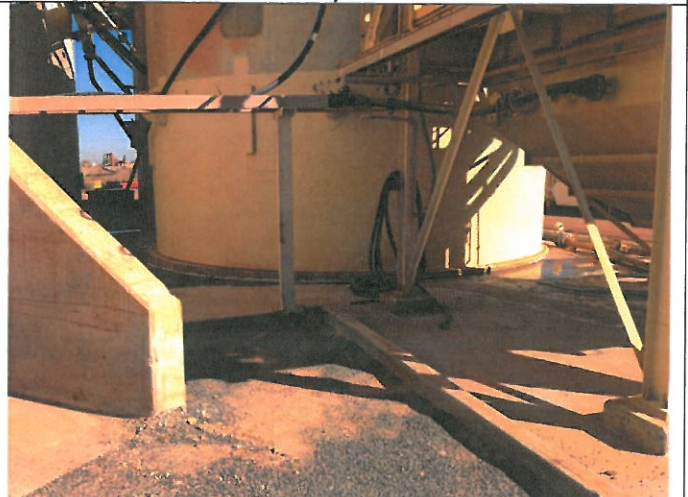
Photograph 4 – Water leak from an old unused leachate tank

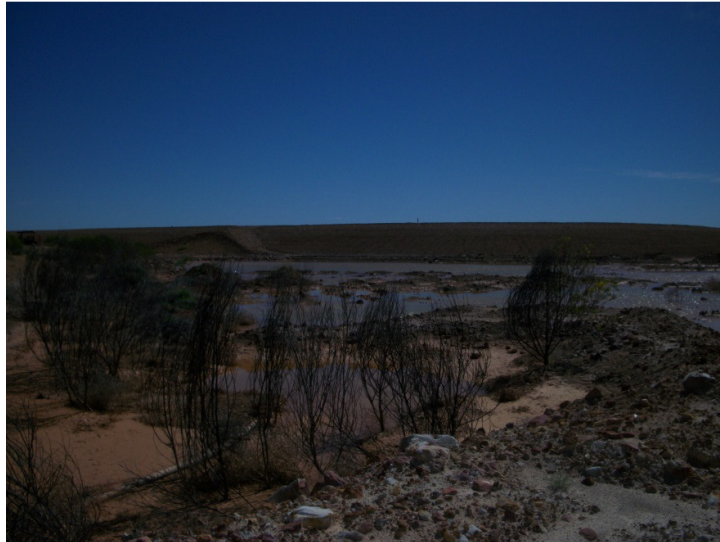
Plate 1: Image showing area affected by overflow.
