BRITISH MOUNTAINEERING COUNCIL

TECHNICAL COMMITTEE MEMORANDUM TCM 14/01

Wild Country Alpine Shield Helmet Incident Ref. 02/14/F.SMI

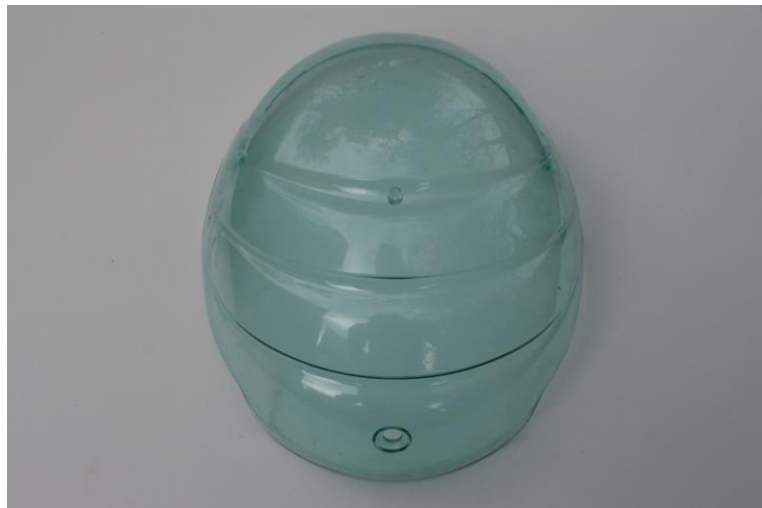
Fig 1
The shield

The outer surface of the EPS shell shows several scratches and small dents, consistent with 18 months use. None of these are considered to be grounds for retirement. The inner foam is undamaged. The polycarbonate shield shows small scratches but no dents corresponding to those on the main shell, indicating that the shield was not normally used. In the direct centre of the shield there is a dimple approx. 5mm dia. on the inside. This locates in a groove on the helmet so it is assumed that this is to position the shield when fitting (Fig 1).

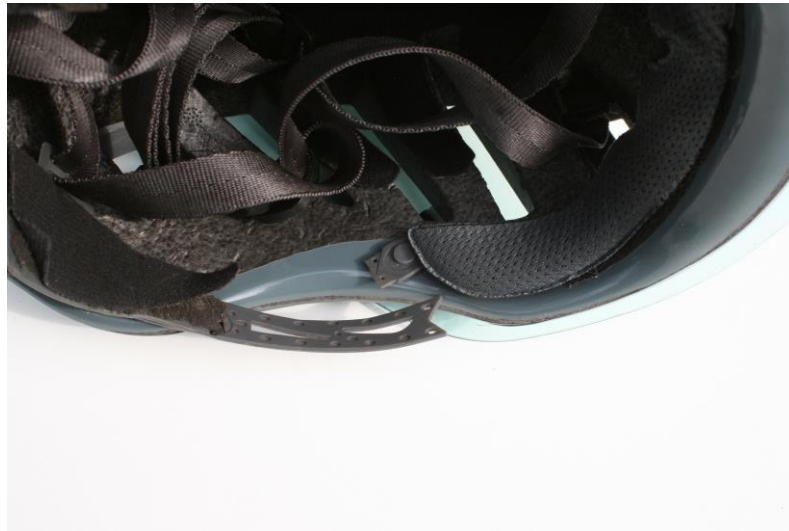
Fig 2
Broken headband fitting

The headband itself has broken on the left side of the helmet at the point where the flexible plastic strap joins the more rigid fitting attached to the inside of the shell (Fig 2).

It seems likely that the glancing blow on the helmet caused it to slide forward on the wearer's head thereby loading the headband in tension which then caused the strap to be pulled from its fitting. These two parts connect together as shown in Figs 4 & 5 with the fitting inside the strap which is hollow at the end. The other strap is shown in Fig 6 for comparison.

1. Climbers should be advised to check their helmet before use including the headband fittings to the shell.
2. It is suggested that this incident should be brought to the attention of the British Standards Technical Committee PH/6/6, Protective helmets for sport and leisure with the request that they consider incorporating a test of the actual strength of the headband into the standard. It is the opinion of the BMC Technical Committee that mountaineering helmets should remain on the climbers head if possible since even a damaged helmet would provide some protection.

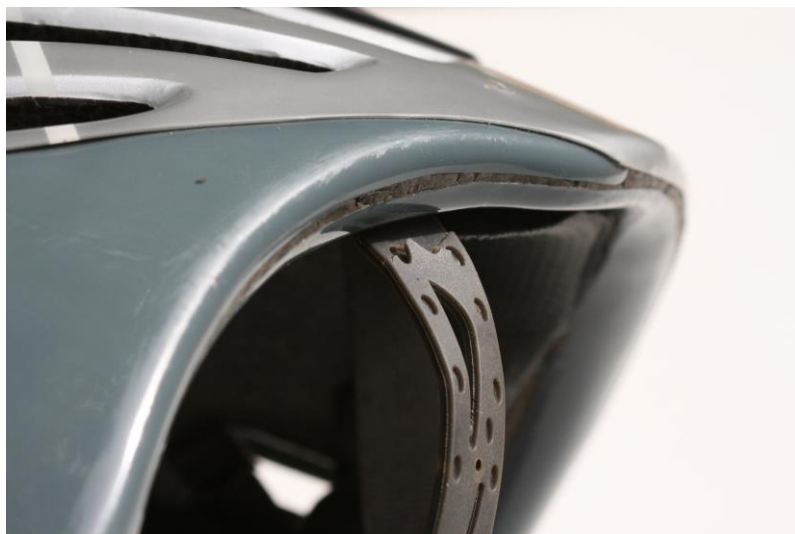
Fig 3
Partly damaged fitting

The strap on the other side of the helmet is still attached but is partly separated from its fitting on the outside (Fig 3).

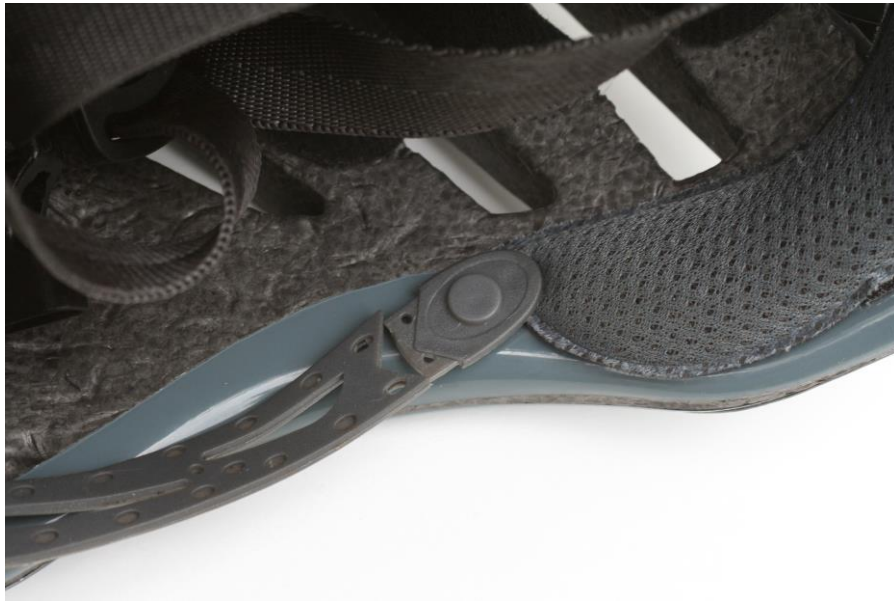
Fig 4
Left side broken fitting

It appears that the strap and fitting are held together by either adhesive or by plastic welding but as can be seen on Fig 4 the contact area is rather small.

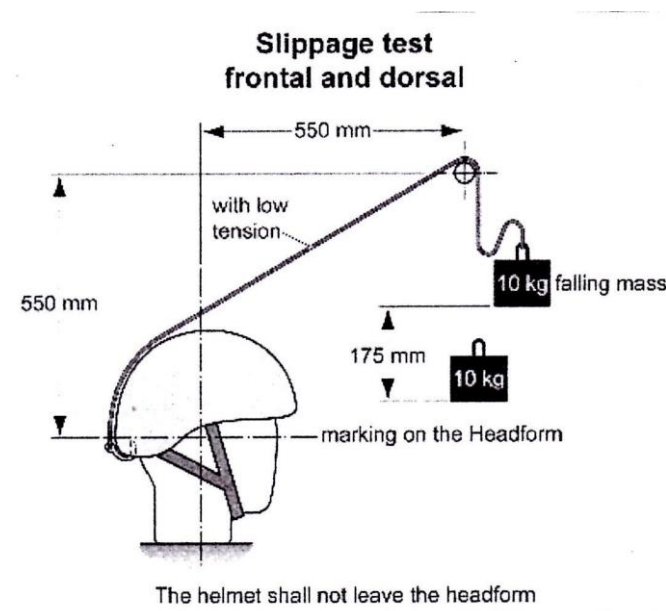
Fig 7
EN 12492 Slippage test

The mountaineering helmet standard EN 12492:2000 and the new standard EN 12492:2012 do not contain a test for the strength of the headband, only a test of the effectiveness of the retention system. This is shown in pictorial form in Fig 7. The helmet passes this test if it does not come off the headform.

Although this test does not directly check the headband strength obviously if it broke it would fail the test. Comparing the incident with the above test, a glancing blow from

a falling object would have the same effect as the rope and the falling weight. In the test the retention system must be able to absorb the energy produced by a 10kg mass falling 175mm (1.75 kgf.m) . The same amount of energy would be produced by a 1kg block of ice falling 1.75m or a 100gm piece falling 17.5m. It seems feasible that something more than this occurred which would exceed the design requirements. However, since neither the weight of ice nor the distance it fell are known there can be no positive conclusion.
