**Subject: Submittal of the Heavenly Mountain Resort Mitigation and Monitoring Plan  
Annual Report**

# Heavenly Mountain Resort

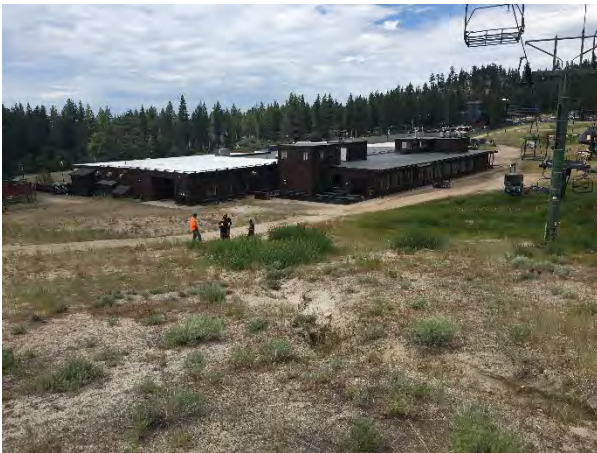
### First Ride

Before: Gully extending across ski slope in erosive soil causing sediment deposition.

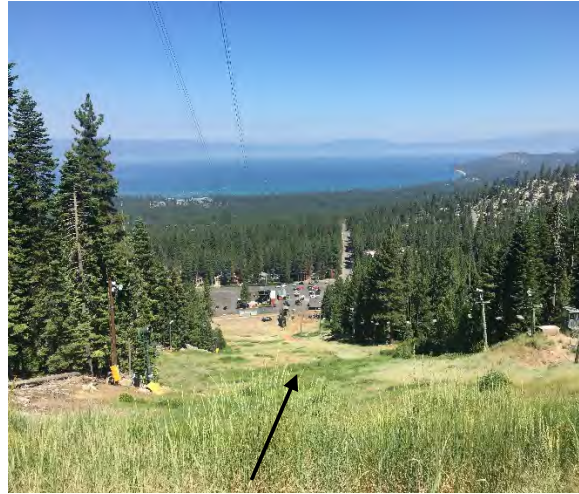
After: Repaired gully from above, fully mulched for erosion resistance.

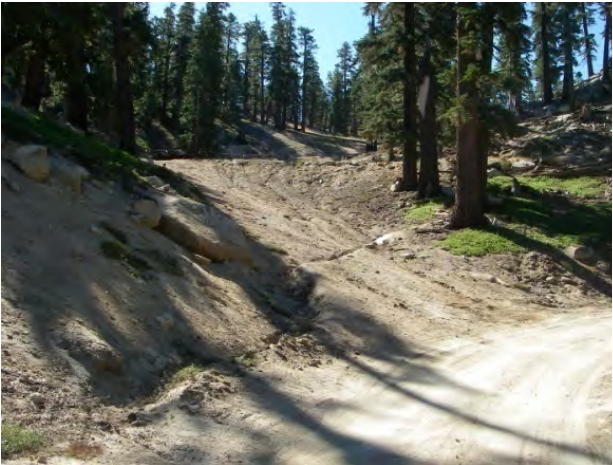
Hand Grenade Chute 2017 Before: bare soils, rilling, water bar minimally functioning

The restoration treatment included placing rock armor on the gully, restoring the water bar above the switch back to function properly, applying the “rip and chip” method to the steep ski slope and installing a new culvert at the road crossing. The restoration treatment included 21 cubic yards of pine needle mulch, 18 cubic yards of wood chips, 22 tons of riprap and 20 pounds of Heavenly seed mix. A row of pine needle wattles was installed at the toe of the slope. The “rip and chip” method involves tilling and loosening the soil to provide depressions for water to collect (“rip”) and mulch application provides organic matter to support microorganism growth in the existing soils (“chip”). A hydroseeder was used to apply mulch and seed to the slope. This was the first project at Heavenly to utilize a hydroseeder (borrowed from Northstar) to apply mulch and seed.

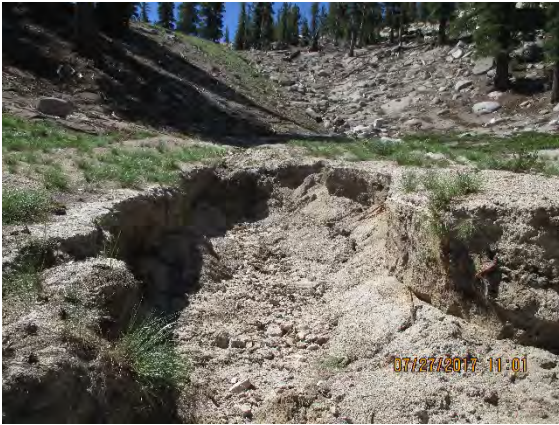
Ridge Bowl is located in the Heavenly Valley Creek Watershed upstream from the Sky Meadows area. The soils in Ridge Bowl are highly erosive decomposed granite. Past erosion control efforts in the area had degraded and were no longer functional. Remnants of erosion control fabric and several gullies were identified in the area following an inspection in 2017. Heavenly crews regraded spreading basins and check dams. An excavator placed angular riprap (12-inch minus) on outlets of the spreading basins. Evidence of excavator access was raked and covered with existing natural material and old erosion control blankets were removed. A visual assessment will be conducted in 2019 during the spring runoff season to ensure the spreading basins are functioning properly. The site will be evaluated for need of erosion control fabric.

Ridge Bowl Before: bare soils, gully not protected

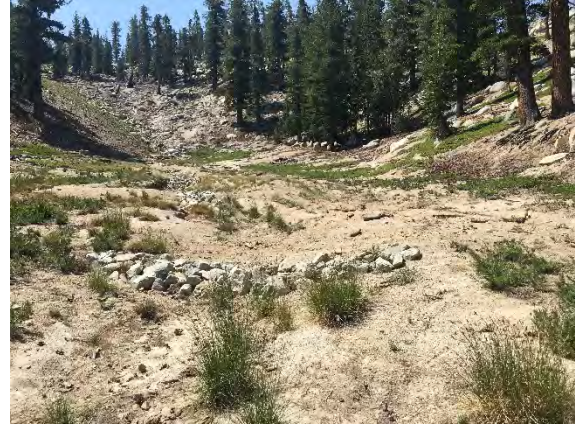
Ridge Bowl After: gully regraded with riprap  
protection of outlets

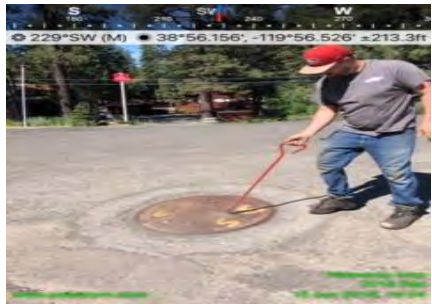
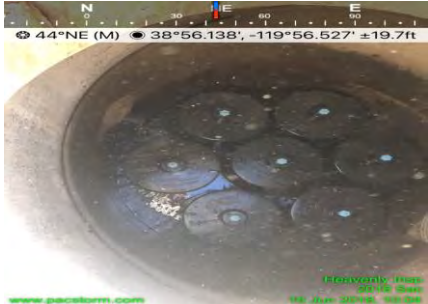
Unit #9

Loose clean media

Maintenance is being recommended on unit #9

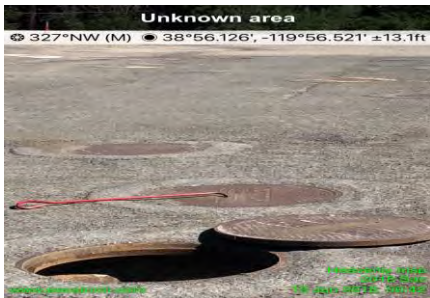
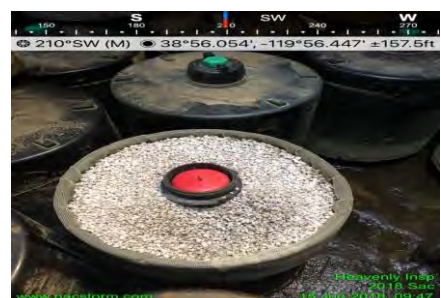
Unit #4

Loose clean media

Recommend sediment removal only. No filter replacement needed.

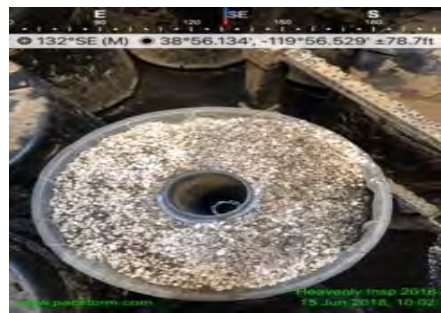
Spent media

Maintenance is being recommended on unit #11

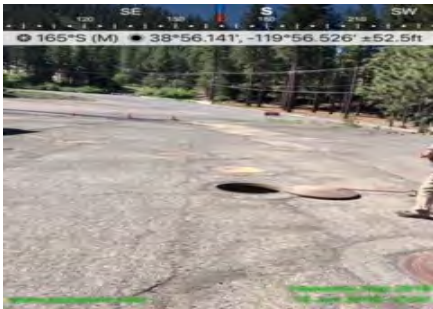
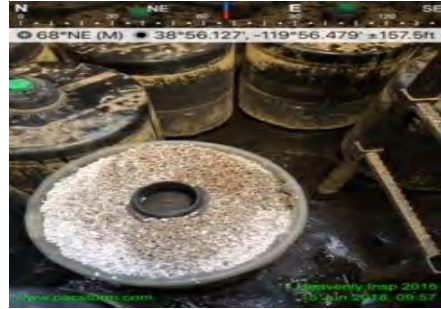
Unit #10

Loose clean media

Recommend sediment removal only. No filter replacement needed.

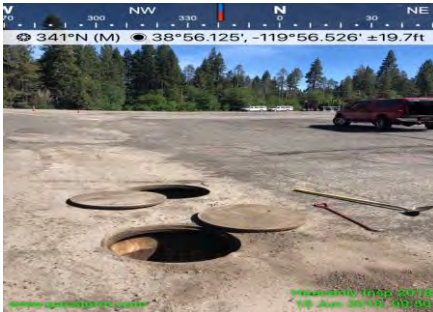
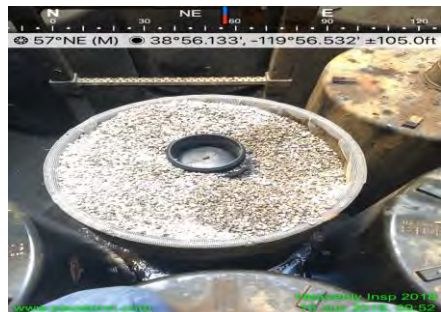
Unit #5

Loose clean media

Recommend sediment removal only. No filter replacement needed.

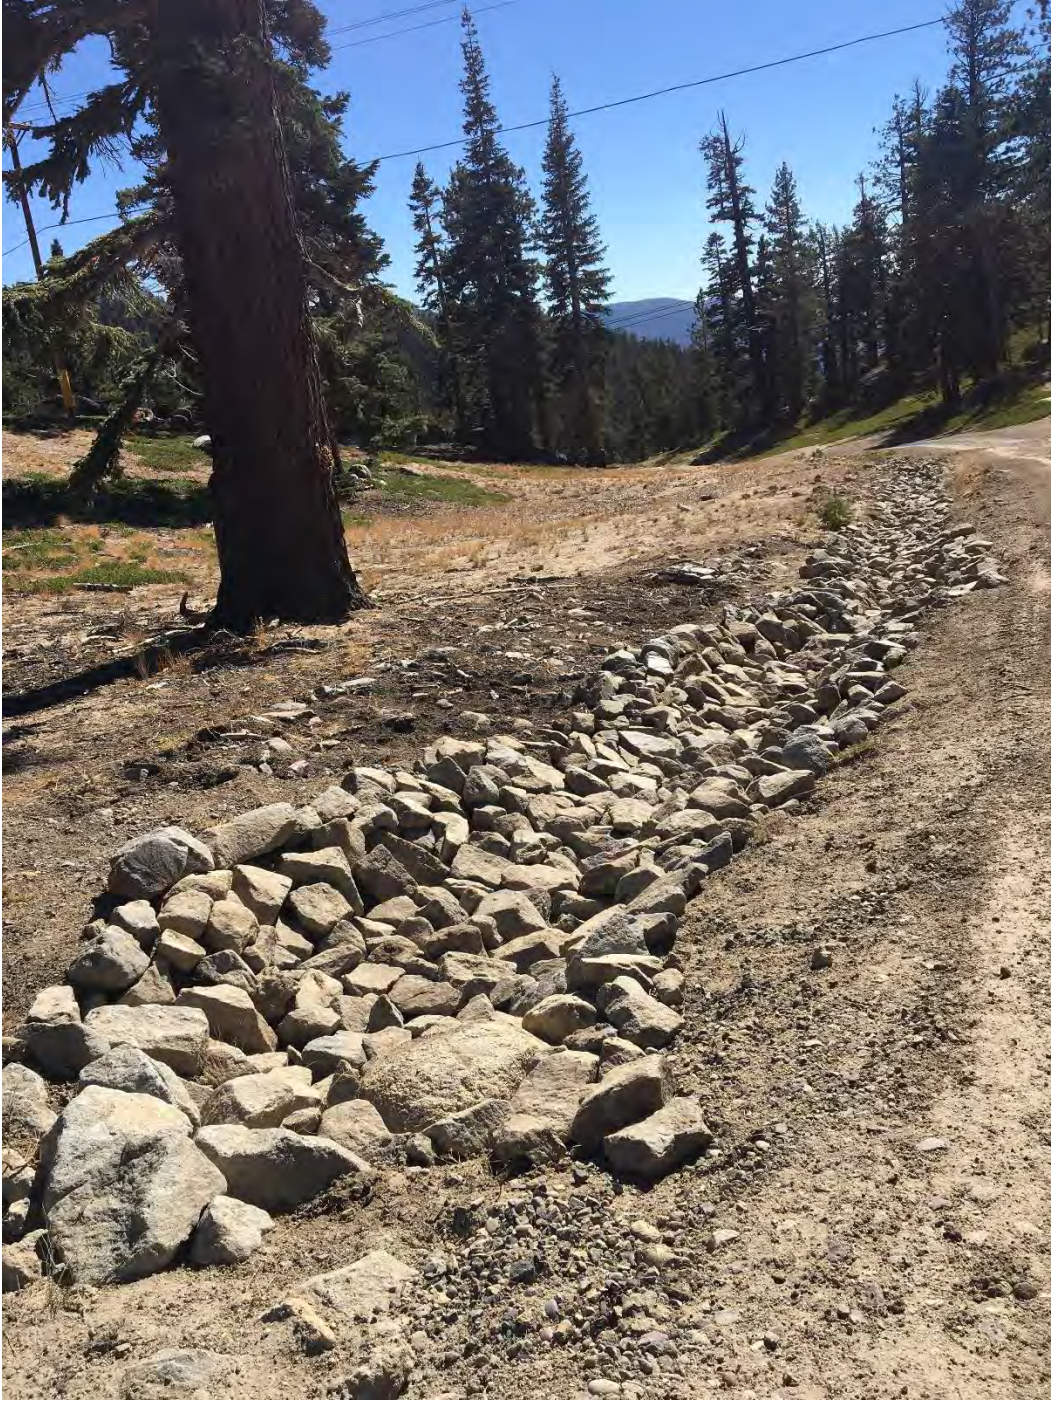
Trail Crew restored the Upper Shop Road rock line ditch – photo taken 9-25-18:
