# Condition and Management of Monterey Cypress on Coastal Bluffs at The Sea Ranch

Joe R. McBride  
Consulting Forester  
Berkeley, CA

December 27, 2008

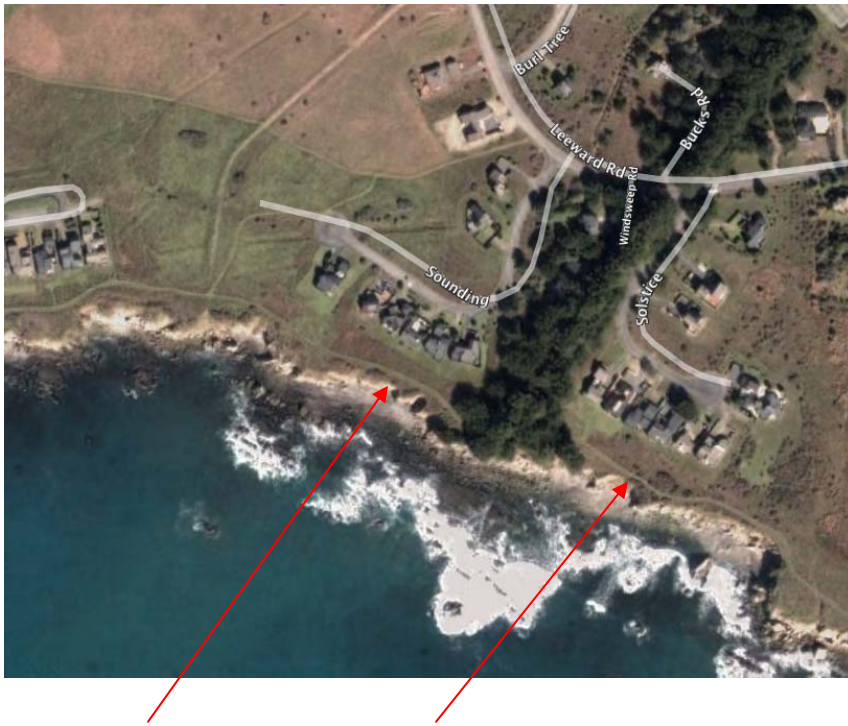
The effects of Monterey cypress preventing coastal erosion is apparent along the bluff from Konigsmark's Sounding B site to the Soltice A site (Figure 1). Bluff erosion has carved away the bluffs supporting grassland at each site while the area supporting Monterey cypress between the two sites appears to be resisting erosion. This section of the bluff is characterized by thinly bedded sandstone and shale.

Figure 1. Influence of Monterey cypress on coastal bluff erosion between Sounding B site and Solstice A site

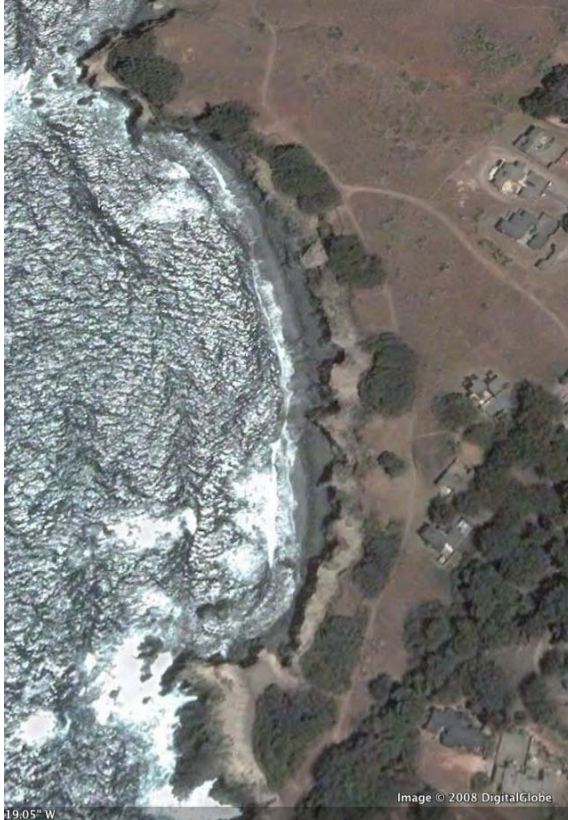
Figure 2. Unit #17

The nine Monterey cypress stands in Unit #17 are typical of many bluff cypress stands that are more or less oriented at a right angle to higher velocity accompanying winter storms (Figure 2). These storms combined with prevailing winds from the west have resulted in the development of a wind foil of branches and foliage on the windward side of the stand and the tipping over of trees within the stand. The trunks and branches of tipped over trees have for the most part remained alive and support living foliage. As a result of the wind, the trees have grown toward the coastal trail and at some points attempted to grow over it. Pruning in certain sections has kept the trail

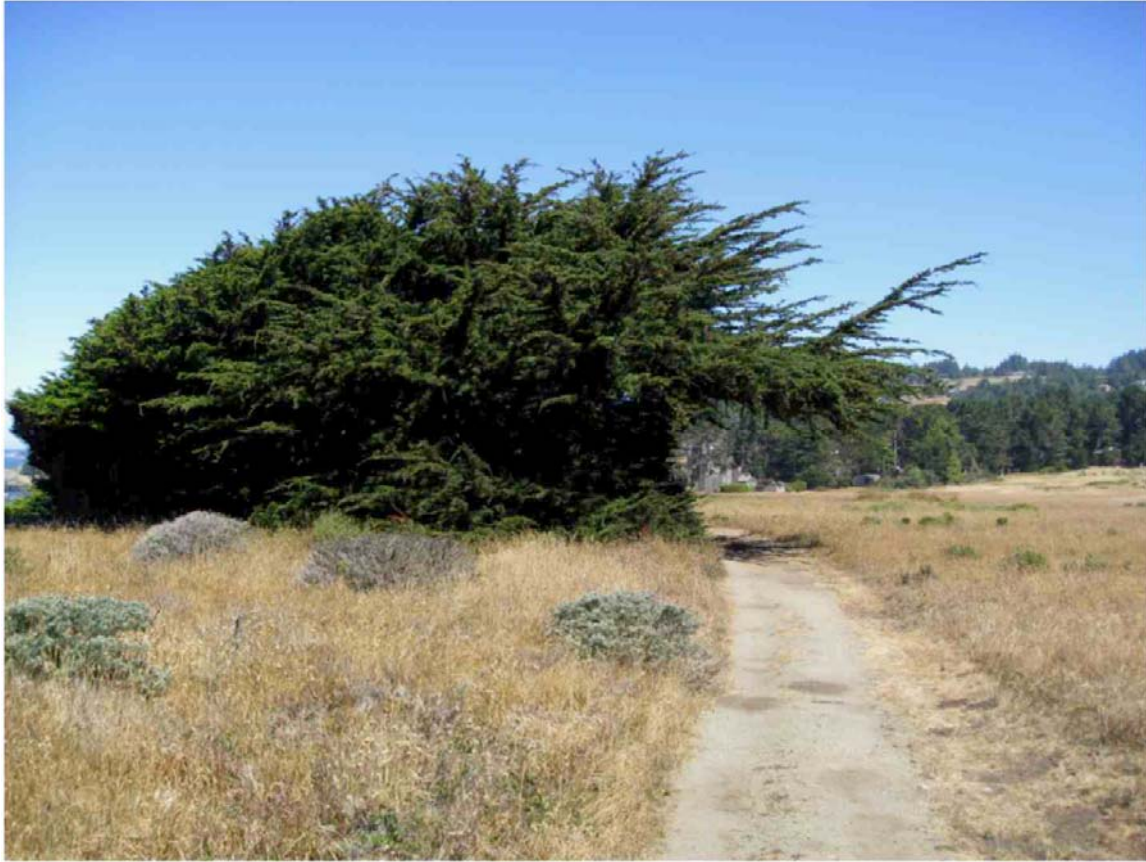
open, but resulted in near tunnel-like sections of the trail (Figure 3). Past pruning has also been used to keep the height of some units of this site low so that adjacent homeowners may see the ocean. Openings cut through what was once a more or less continuous stand have created the nine separate stands currently on the site.

Figure 3. Monterey cypress growing over coastal bluff trail

Where larger stands of bluff cypress in Unit #17, as well as in other units, are encroaching on the bluff trail it is recommended that a more aggressive cutting back of the inland edge of the stands be undertaken. These stands could effectively be hedged back on the landside as much as ½ of their width without compromising their capacity to protect the bluff top from erosion and provide habitat for wildlife. Such removal would not affect the important wind foil on the seaward side of the stands. Within a few years sprouting of the landward side of the stands would restore the green wall which characterizes these bluff

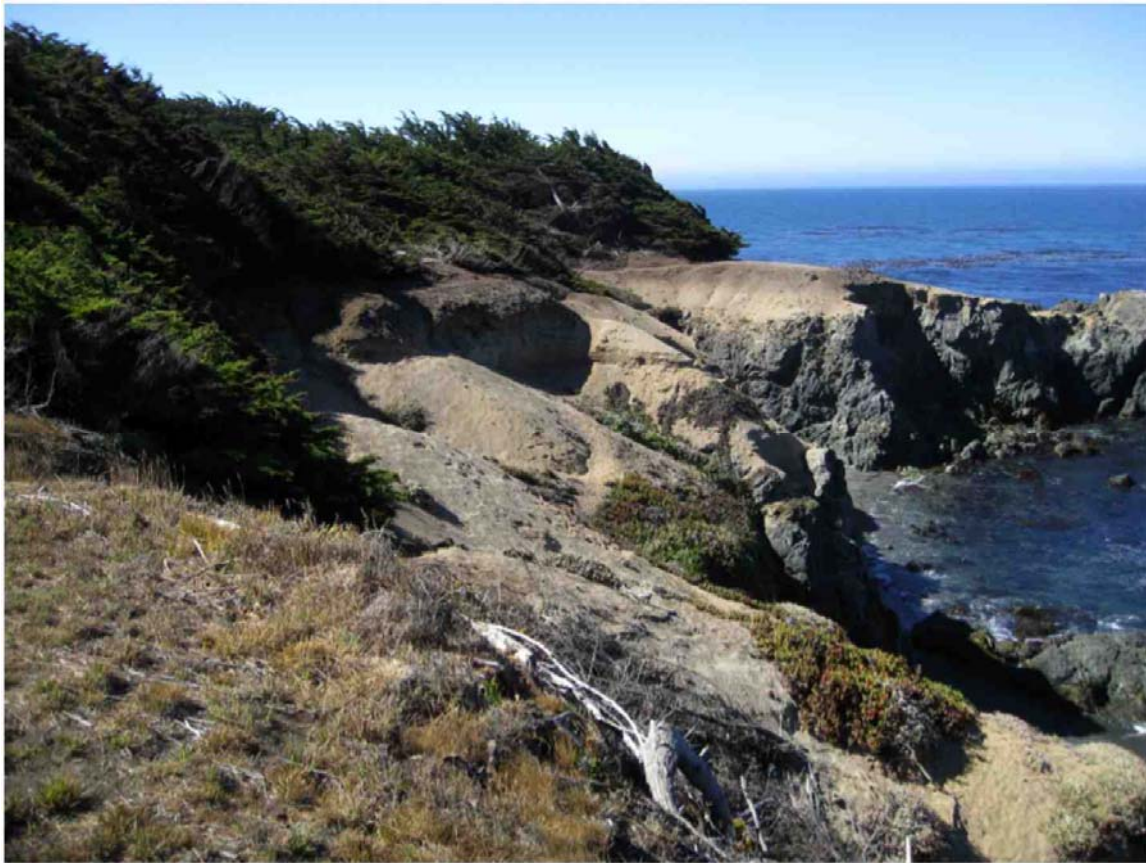
Tree branches forming the outer edge of the wind foil are in contact with the ground and have protected the unconsolidated sediments (Figure 4). One can anticipate further erosion of the unconsolidated sediments on top of the bluffs if the protective cover of the Monterey cypress were to be removed and not replaced with appropriate species to protect the surface deposits. Planting a mixture of dwarf coyote brush (*Baccharis pilularis*), bush lupine (*Lupinus arboreus*), coast buckwheat (*Eriogonum latifolium*), wooly sunflower (*Eriophyllum lanatum var. arachnoideum*), California blackberry (*Rubus ursinus*) and beach strawberry (*Fragaria chiloensis*) on two foot centers

Figure 4. Eroding layer of unconsolidated sediments between the Monterey cypress and the coastal bluff in Unit # 17.

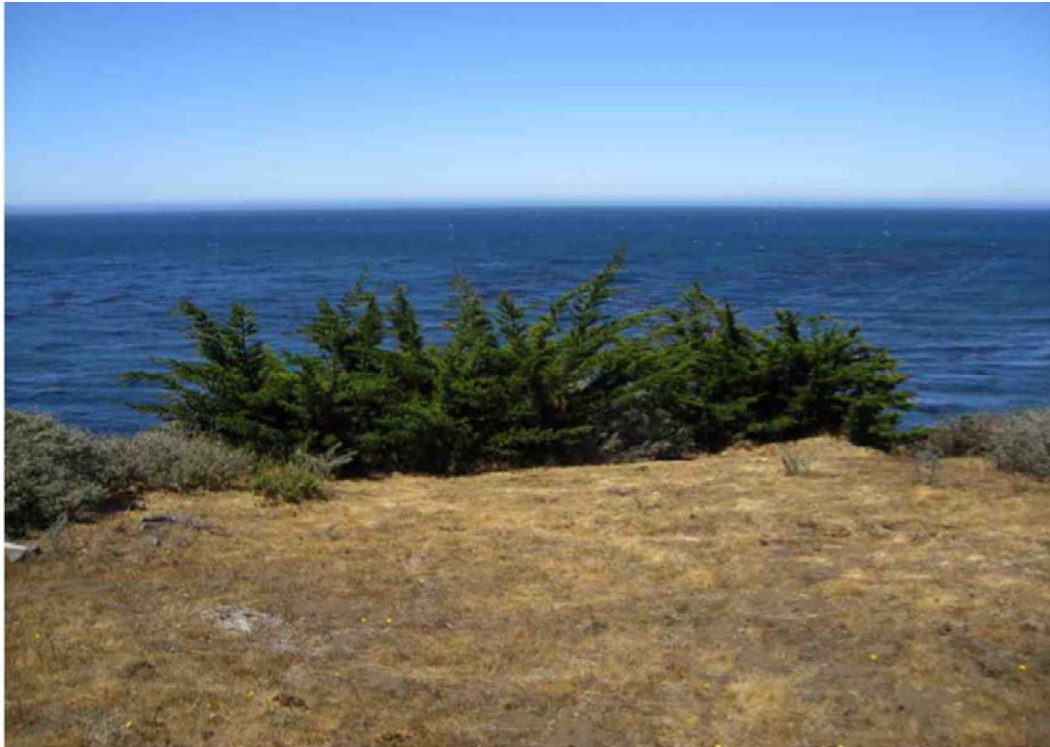
The gaps cut in the original bluff cypress stand has exposed trees adjacent to these openings to the direct effects of the wind. Foliage mortality is evident on many trees at the edges of these openings. This results in an unsightly appearance of the trees and a reduction in their vigor. The gaps between the stands generally support grasses and some coastal shrubs. One often sees, for example in the opening between stands 4 and 5, Monterey cypress saplings that have become established on the exposed unconsolidated sediments. These are growing up and will eventually block the views through the gaps (Figure 5).

Figure 5. Monterey cypress volunteers growing on slope below opening in bluff cypress stands.

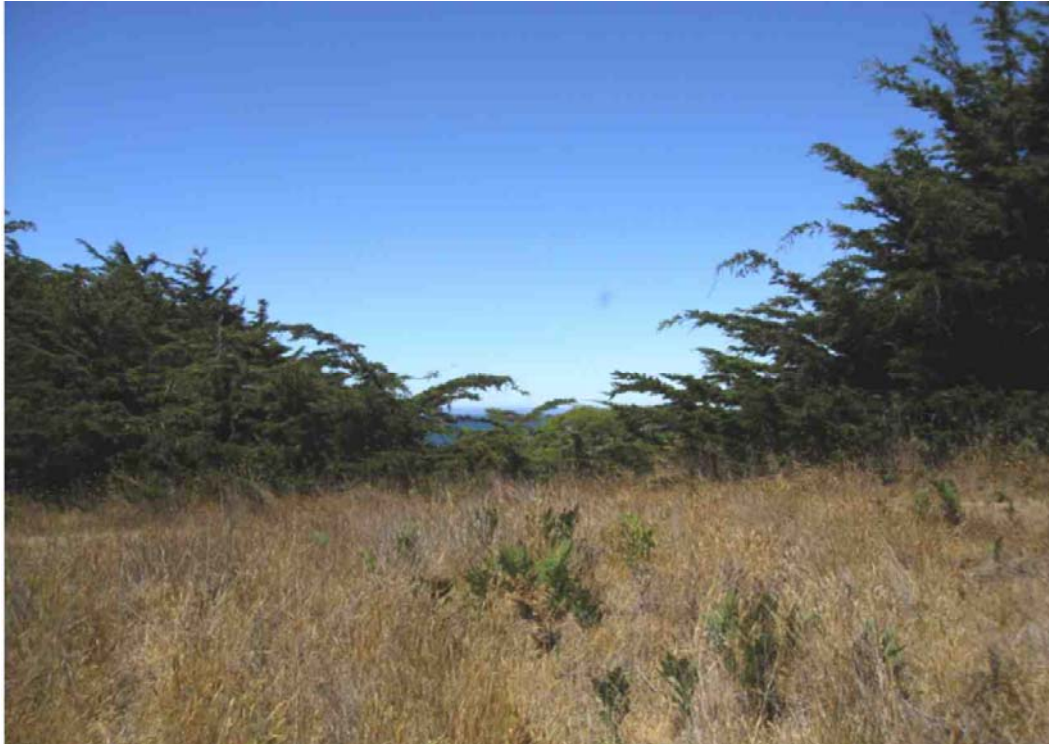
In other portion of the Unit #17 bluff cypress site one can observe in-growth into openings by Monterey cypress that will eventually lead to the closure of the openings (Figure 6). This lateral growth of tree branches is not common to all gaps but is found in those smaller gaps at the south end of the site where the orientation of the stands and the small size of the gaps has provided some wind protection to the adjacent trees. These two conditions, growth of Monterey cypress volunteers below the bluff edge and in-growth from trees adjacent to gaps, will lead to the filling of the gaps and the

Figure 6. Closure of gap between stands in Unit #17 due to in-growth by Monterey cypress and growth of volunteer sapling below bluff edge.

elimination views out to the ocean. If these gaps are to continue to function, periodic pruning and removal of volunteer saplings will be required.

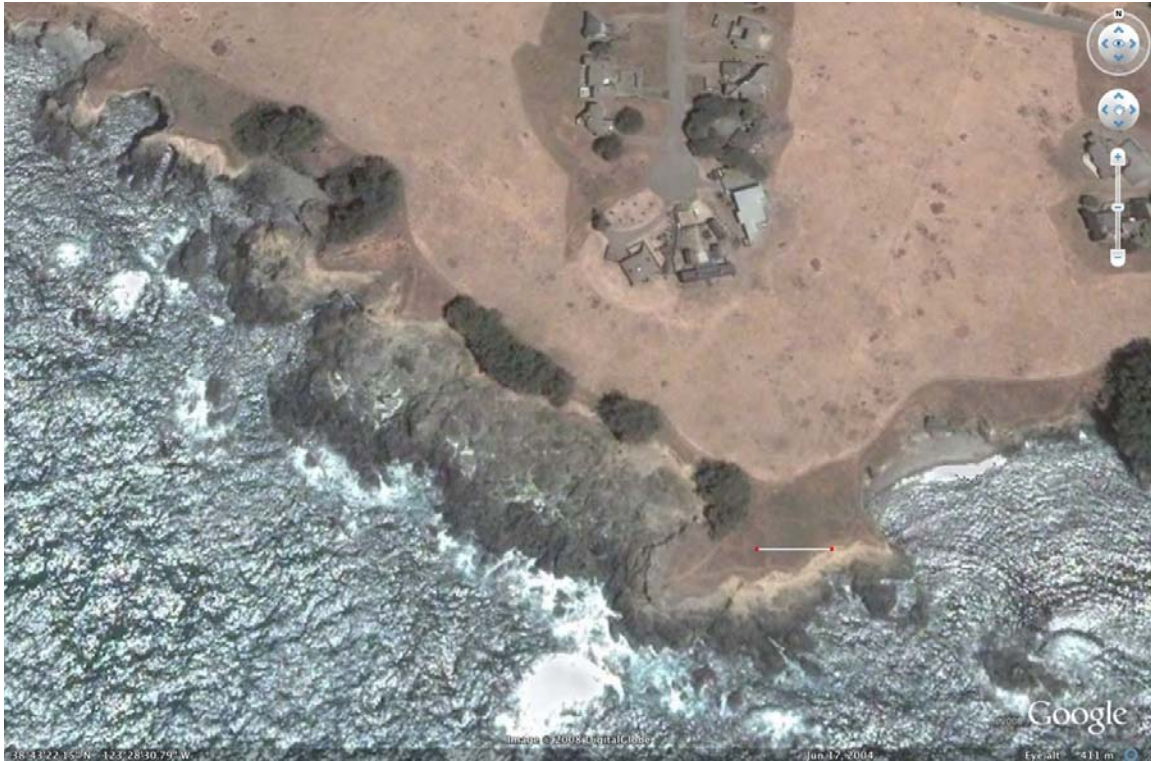
The Monterey cypress bluff stands in Unit#24 are characterized by much taller trees than those observed in Unit #17 and by less evidence of trees being toppled by the wind until fairly recently (Figure 7). These stands are oriented parallel to the stronger

Figure 7. Monterey cypress stands along the coastal bluff in Unit #24 (The white line on the photo represents 100' on the ground. Note the wide area of exposed Gualala Formation sandstone and shale between the Monterey cypress and the ocean)

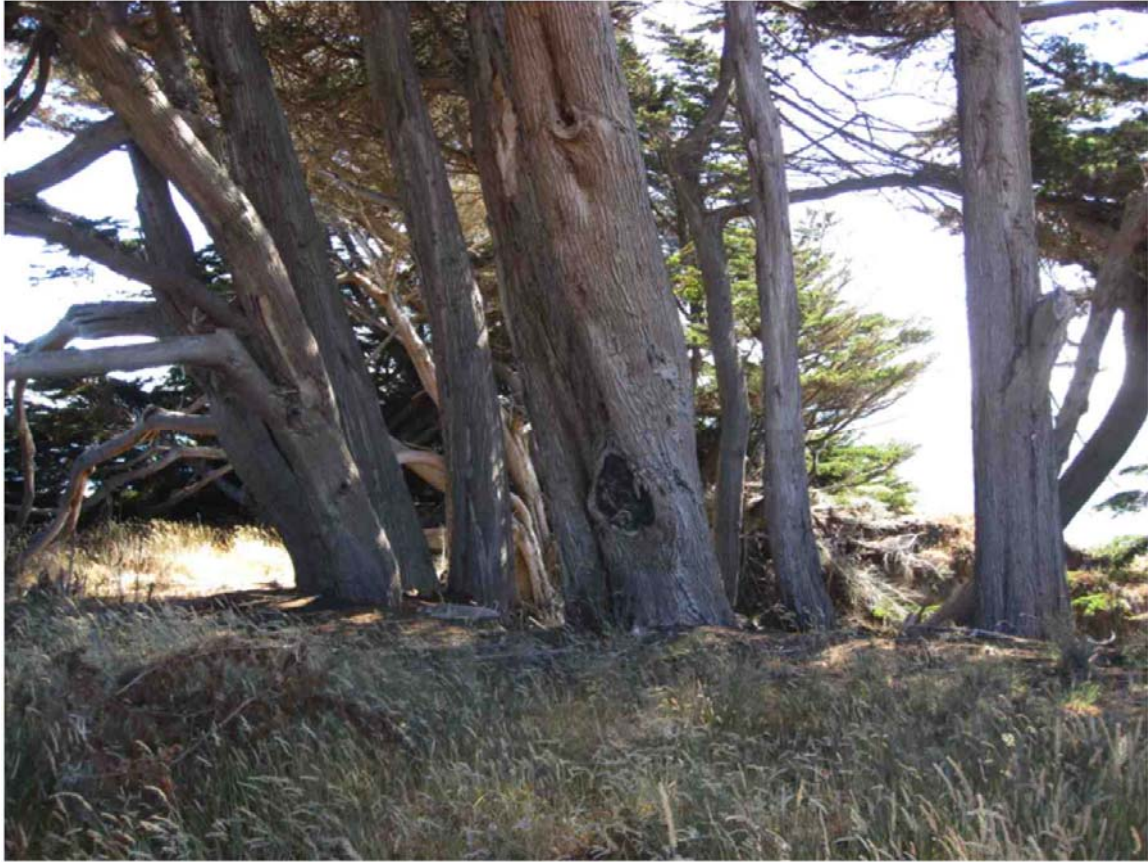
winds and as a result exhibit few horizontal branches that lay on the ground as is the case in the stands in Unit # 17. Trees located in the southernmost portions stands #1 and #4, which wrap around the coastal bluff, have large horizontal branches resembling the trees in Unit#17. The southern portions of these two stands experience wind that is at a right angle to the row of planted trees, as opposed the other trees in these stands that are oriented parallel to the direction of the higher velocity winds. There is evidence of past pruning of some lower branches in these stands (Figure 8).

Figure 8. Pruning scars on trees in Unit # 24.

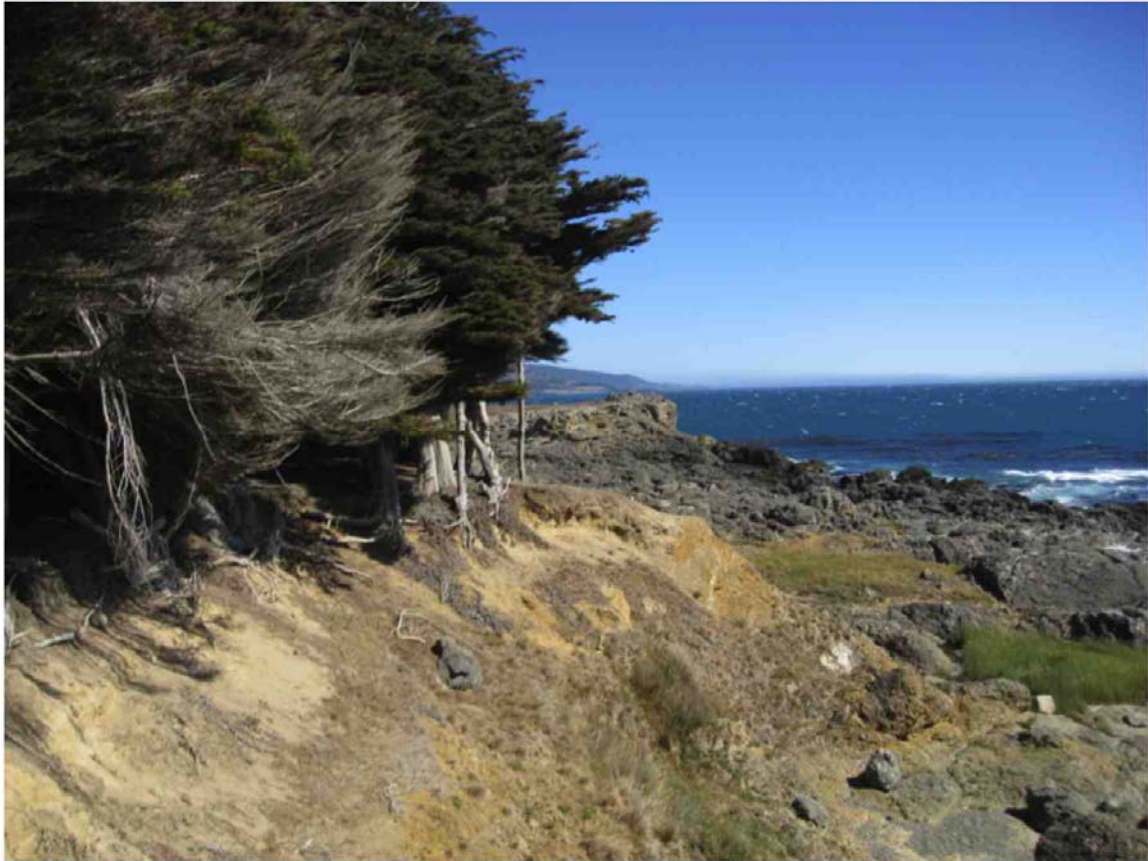
One tree in Unit # 24 was observed to have been undermined by erosion of the unconsolidated sediments on the coastal terrace and has toppled down onto the consolidated sandstones and shale of the Gualala Formation. The coastal bluff in Unit # 24 contrasts with that in Unit # 17 by lack of an abrupt edge to the consolidated rock beneath the unconsolidated sediments (Figure 9). The exposed sandstone and shales of the Gualala Formation form a relatively gentle slope, nearly 100' wide at some locations, from the unconsolidated sediments down to the water. One sees more of a vertical escarpment at the edge of the unconsolidated sediments than one sees in the exposed sandstone and shale beds (Figure 9). The exposure of tree roots along the edge of the

unconsolidated sediments indicates the trees have been undermined by erosion of these sediments and not by a collapse of the coastal bluff due to the erosion of rocks in the Gualala Formation. Trees in the stands have not formed a wind foil over the edge of the sediments, as is the case in Unit # 17, due to wind direction. Without this wind foil to protect the edge of the unconsolidated sediments one can expect further undermining

Figure 9. Variation in steepness of unconsolidated sediments and consolidated beds of sandstone and shale in the Gualala Formation

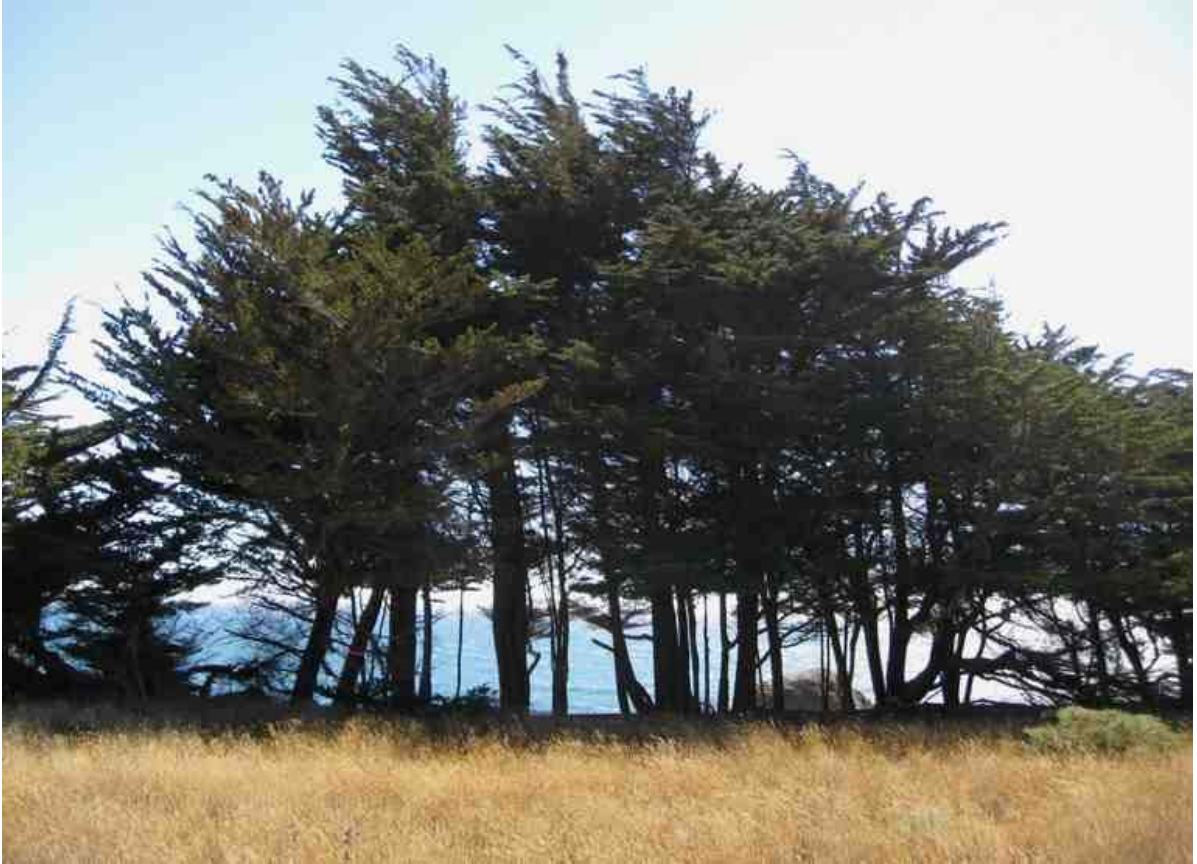
Tree thinning and pruning have opened up filtered views through some of the stands in Unit # 24 (Figure 10). Tree vigor has not been impaired by this action because of the size of the trees and their orientation to the wind. The amenity and wildlife

Figure 10. Stand thinned and pruned to provide filtered view of the ocean in Unit # 24

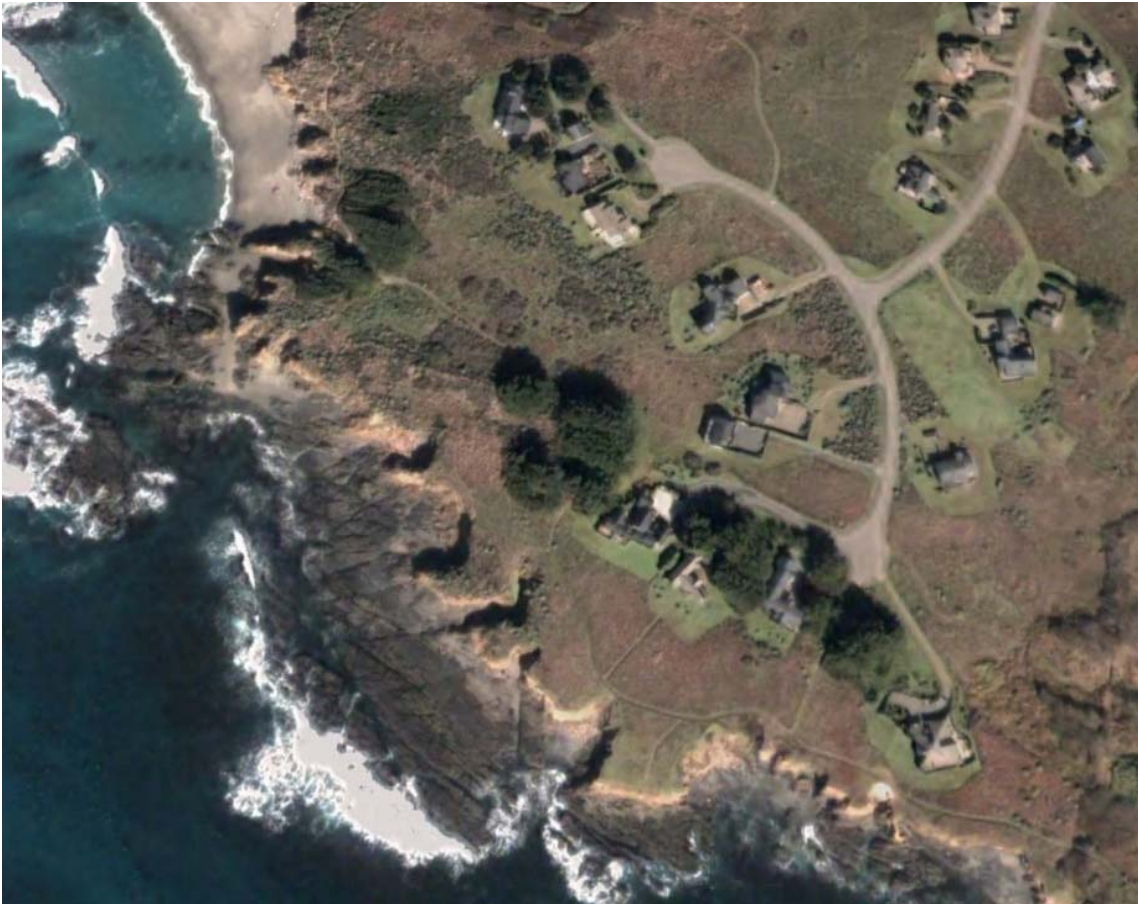
Figure 11. Unit # 28.

The Monterey cypress stands in Unit # 28 were planted to control the movement of sand dunes on the coastal terrace (Figure 11). The stands, therefore, differ from those in Units # 17 and # 24 due to their positions further inland from the coastal bluffs

Pruning or thinning these stands should be held to a minimum in order not to lose the control these stands have over sand movement. It would be possible to remove the stand (#1A) farther to the north and replace it with lupines or wax myrtle to provide wind protection to the sandy area leeward of this stand. Because of the height of the sand dunes adjacent to the other stands in Unit # 28 it would be difficult to replace the Monterey cypress with either lupine or wax myrtle and get successful erosion control. The depth to water table beneath here is too great for the establishment of the shrub species and the height of the dune puts it into higher velocity winds.

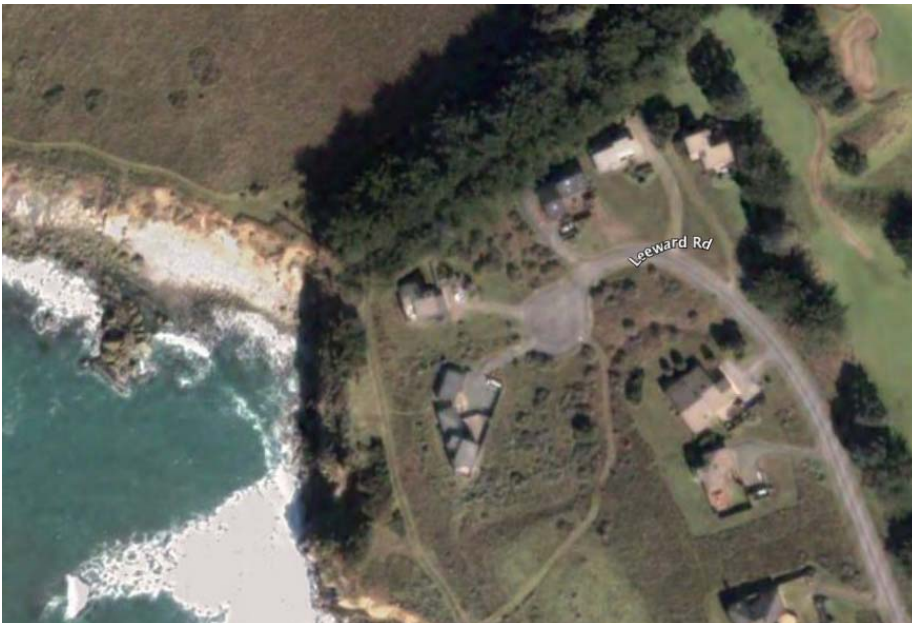
A hedgerow was planted by the rancher at what is now the northern end of The Sea Ranch is the focus of Unit 35E (Figure 12). Examination of images available from the California Coastal Records Project [ 7210029 (1972), 7917040 (1979), 8715238 (1987), 12117 (2002), 200504218 (2005)] suggests the western-most trees in this hedgerow were planted within about 6 feet of the edge of the bluff. An additional row of young cypress appears in the 1972 image along the edge of the bluff to the south of the Hedgerow. Some bluff erosion occurred, but none of hedgerow trees appear to have been

Figure 12. Hedgerow at north end of Unit # 35E

undermined in the 1987 photographs. In the winter of 1997/98 trees at the end of hedgerow were reported by Konigsmark to have fallen as a result of a 30' long section

of the bluff being undermined. The rocks forming the consolidated formation along the bluff are thick sandstone beds in the German Ranch Formation. Collapse of the bluff at this location has been exacerbated by the presence of a fault zone occurring at the border of The Sea Ranch property.

Management of the trees at the outer edges of Monterey cypress hedgerows or in coastal bluff stands situated on the more vulnerable German Ranch Formation probably will not influence the stability of these trees. The wind foil edges of these stands will protect the unconsolidated sediments on the top of the bluffs from eroding, but will not prevent the undermining the bluffs in the German Ranch Formation. Tree removal might be in order at these locations to prevent the trees from tearing out sections of the unconsolidated sediments on top of the bluff when they fall into the ocean or onto the rocks at the base of the bluffs. Protection of the trees in such locations would require mechanical solutions, such as sea walls of concrete or gabions that shore up the bluffs. However, I do not recommend that The Sea Ranch pursue this direction in coastal bluff management. It would be best of recognize the weakness of the bluffs in the German Ranch Formation and be prepared to move the coastal trail inland as erosion proceeds. Some existing Monterey cypress will be lost to the erosion, but the cost of building and maintaining of sea walls will never prove cost effective.
