**TIER 3**

**ENVIRONMENTAL RISK ASSESSMENT**

**FORMER MUNICIPAL LANDFILL**

**KILRUSH,**

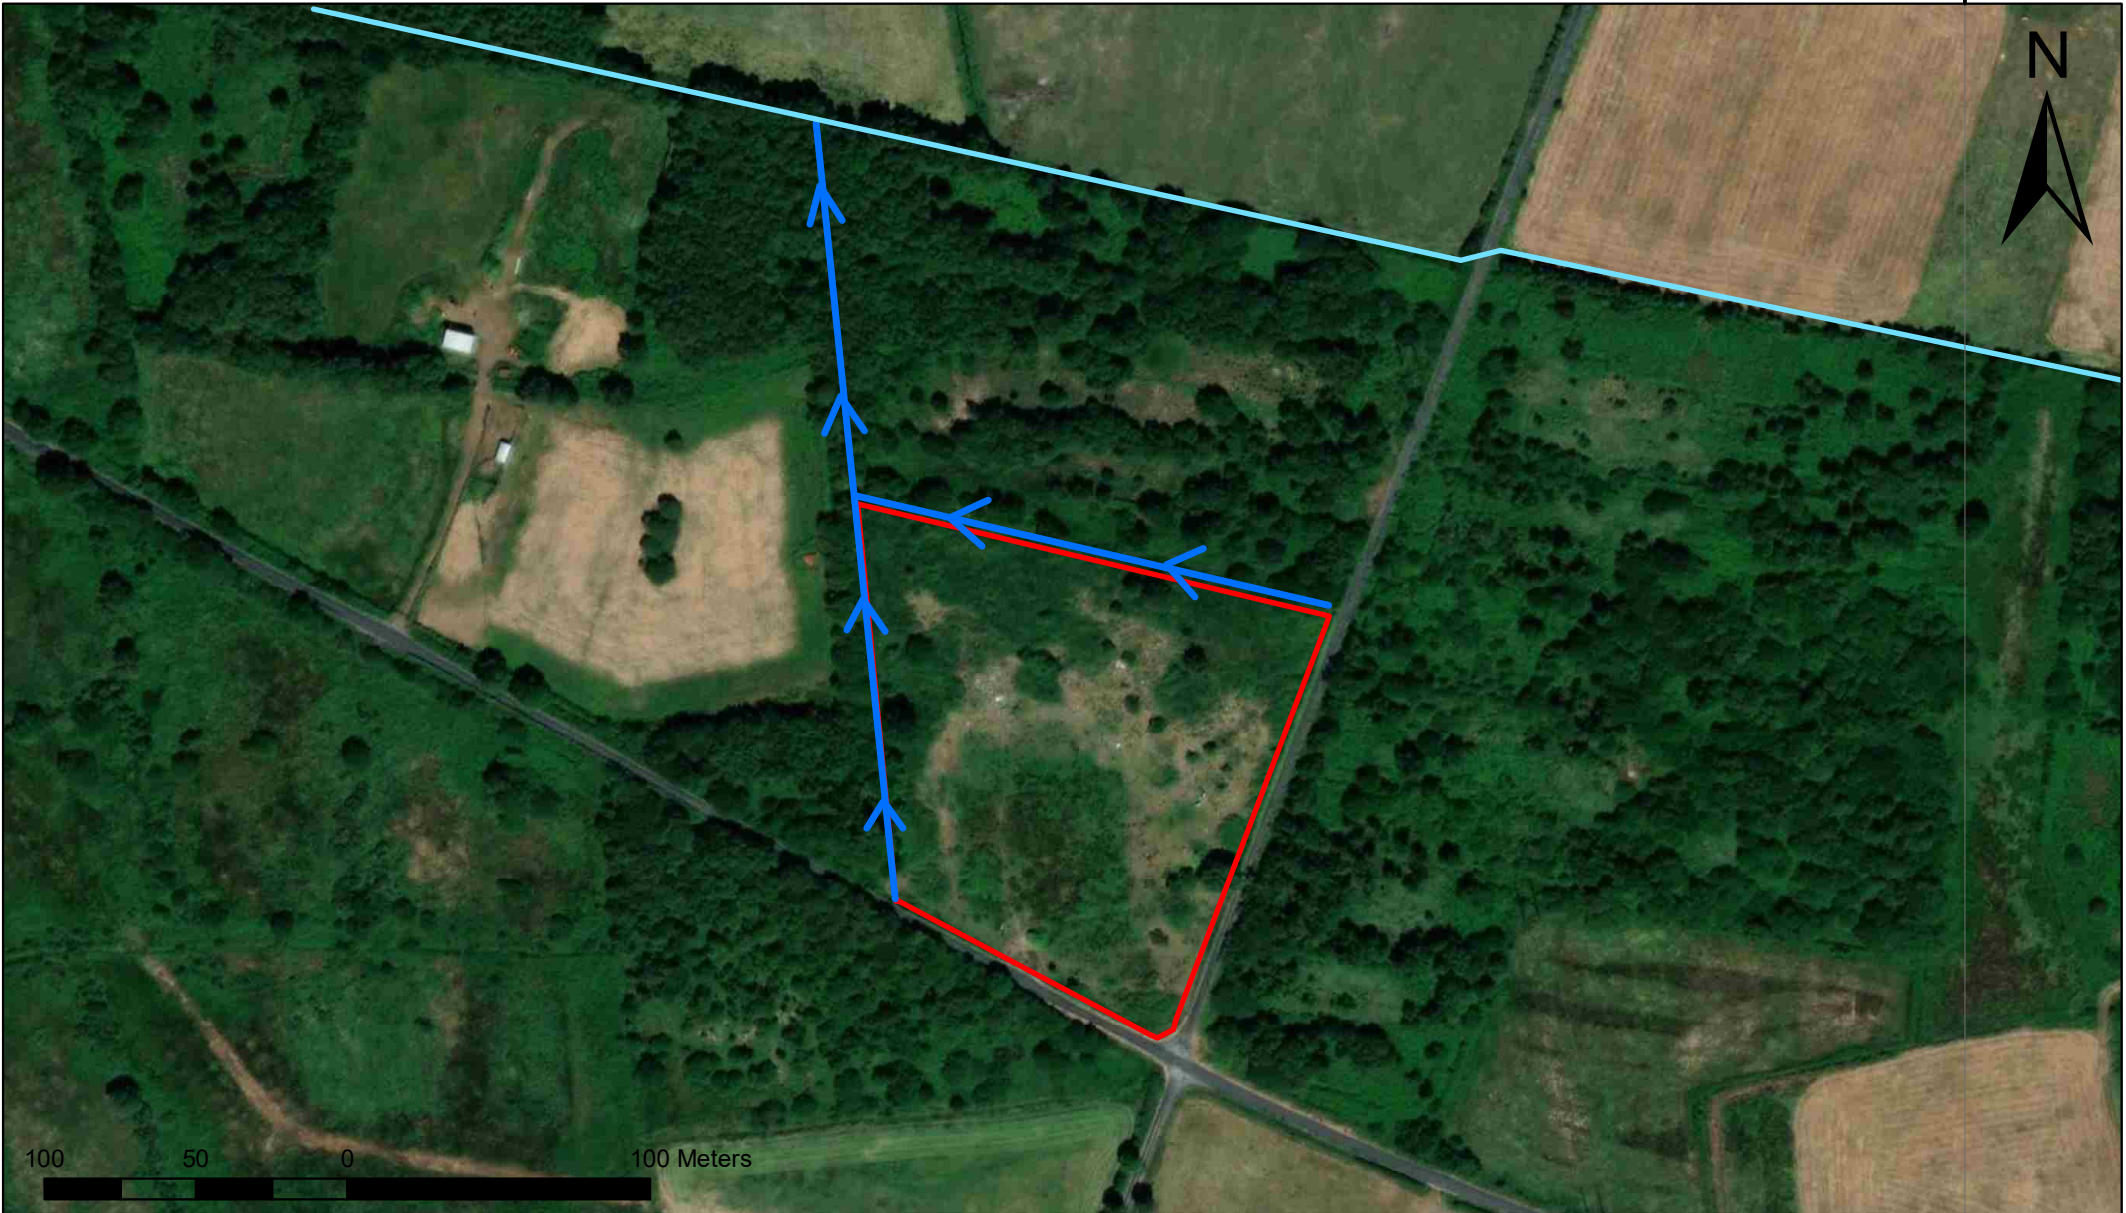
Figure 2.2

The landfill occupies 1.9 hectares (ha) and is securely fenced and has a thin top soil cover though waste is visible at the surface in some locations. Grass and rush vegetation are present on the surface.

The site is slightly raised above the surrounding lands. It slopes slightly from south to north. The site is bound to the south and east by the local public road and further south and east by cut over peat bog. It is bound to the north by cut-over peat bog and to the west by agricultural grass land (Figure 2.2). There is a land drain running along the western boundary in a northerly direction. The drain most likely connects to the Moyadda Bed stream c110m to the north of the site.

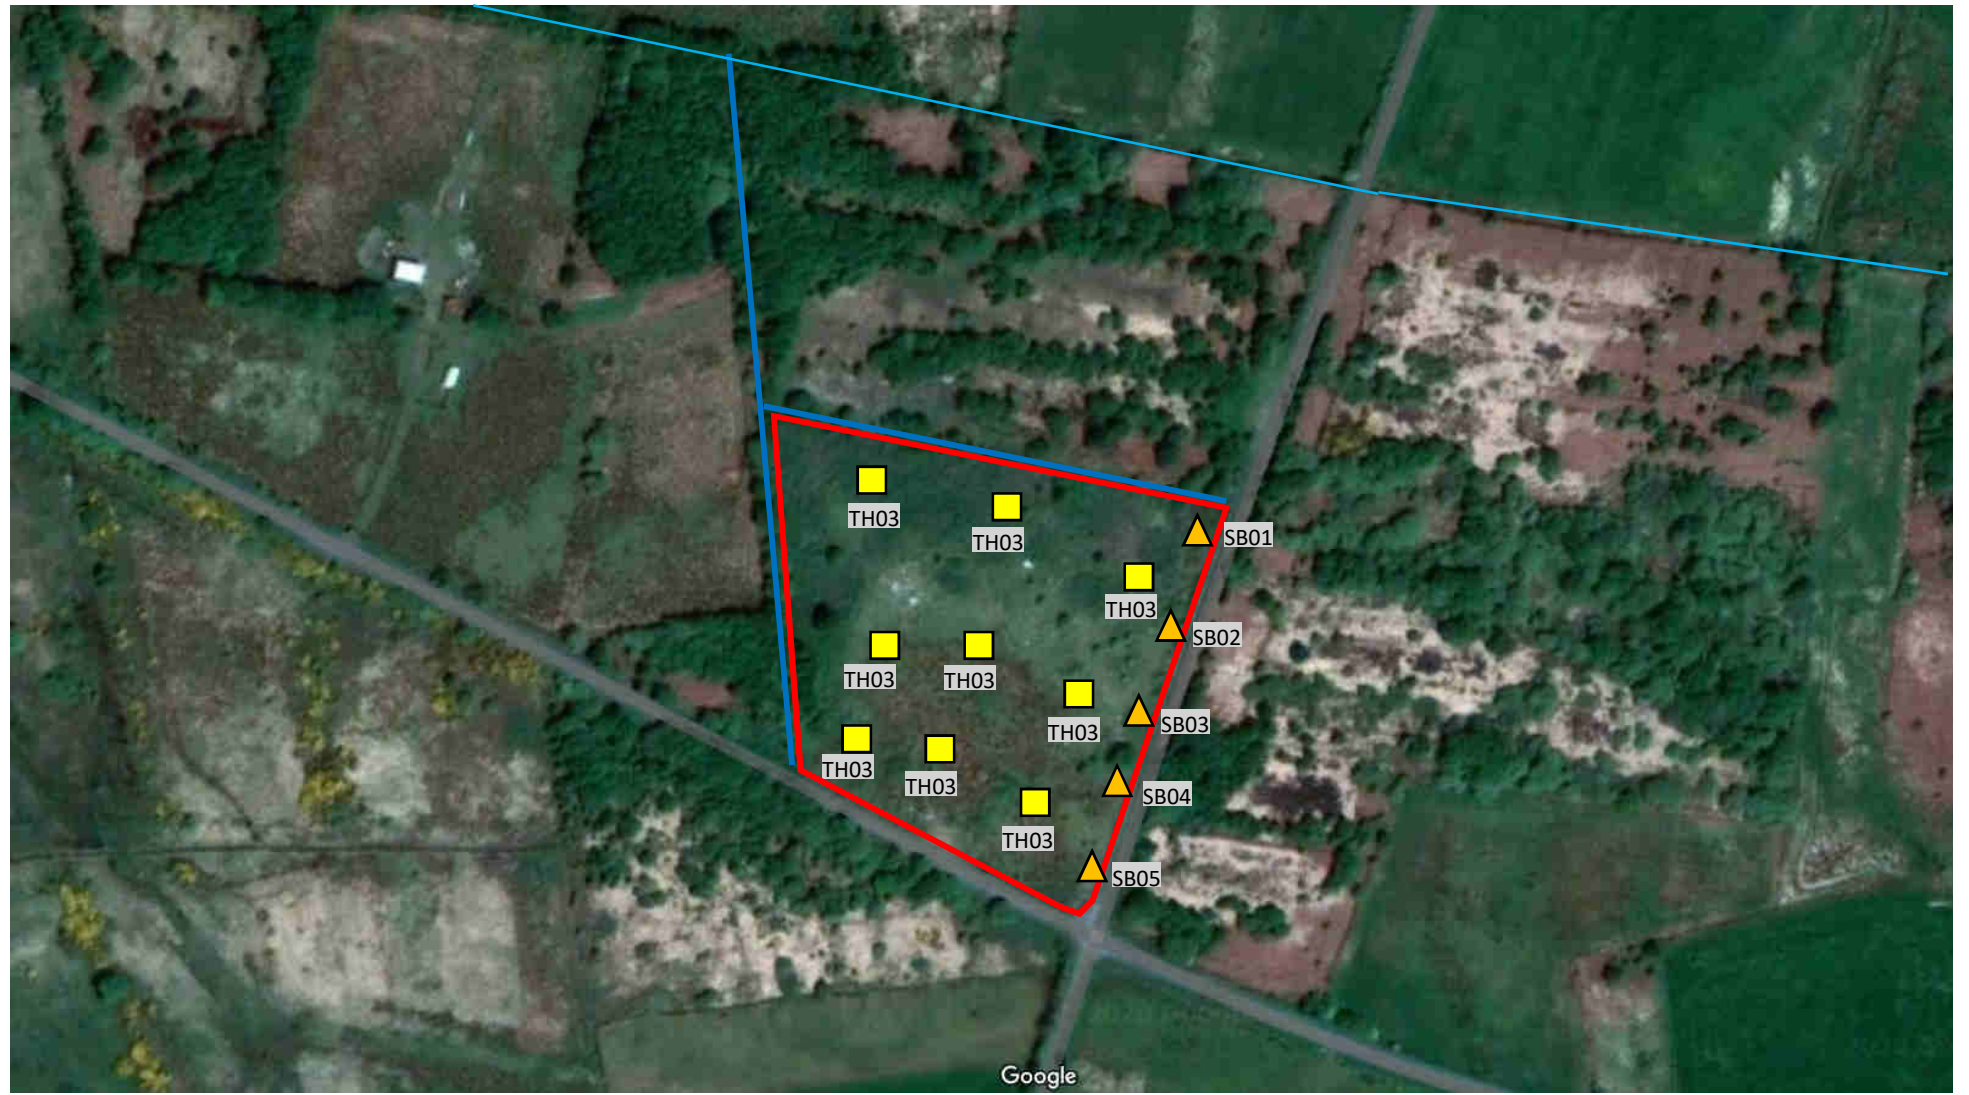
Figure 3.1 Sample Locations

Nine trial pits (TH-1 TH-9) were opened across the site which confirmed the presence of thin c200mm capping layer comprising top soil though it was not present continuously across the site. In some locations waste was visible at the surface. Waste is present across the entire site area and averages 3.5m in thickness and is 4.5m at its deepest. It is underlain in all trial pit locations by peat.

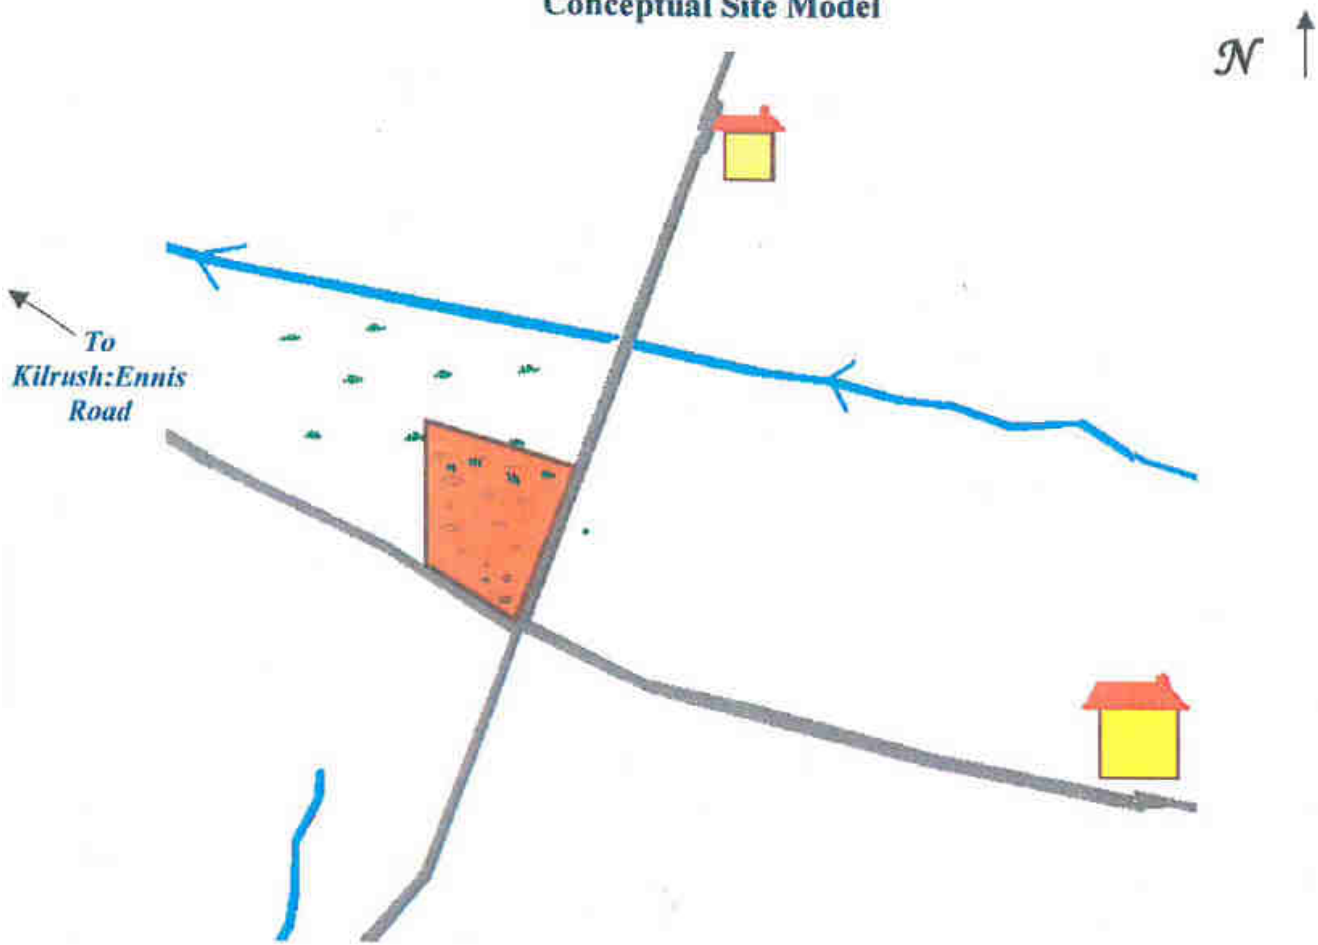
**KILRUSH LANDFILL  
Conceptual Site Model**

The Tier 1 Conceptual Site Model (CSM) is shown in Figure 4.1. It shows the waste mass on the underlying peat with waste filled close to the road bordering the southern boundary and the drain along the northern boundary.
