Magnetec Monthly Chronicle

Issue No.12 " FROM THE FIELD " December 2005

Reactor Effluent Condensers

**Subject: Reactor Effluent Overhead Condensers
Ammonium Bisulfide Corrosion**

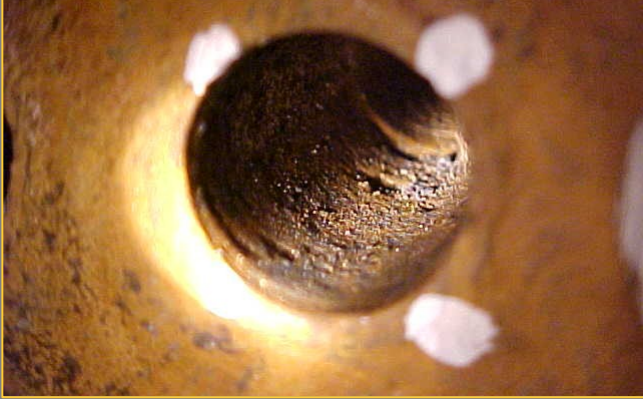
Ammonia bisulfide corrosion/pitting within roll area

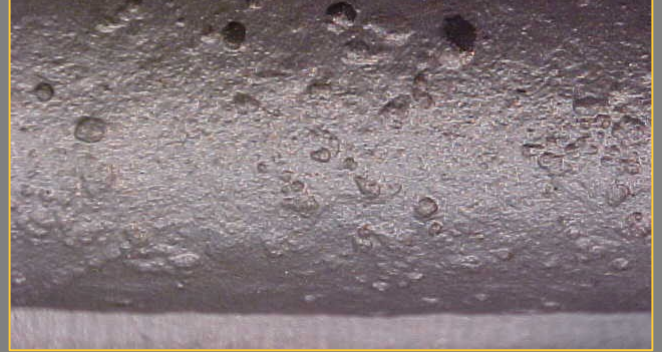
Removed tube sample – Top Row – Middle of tube

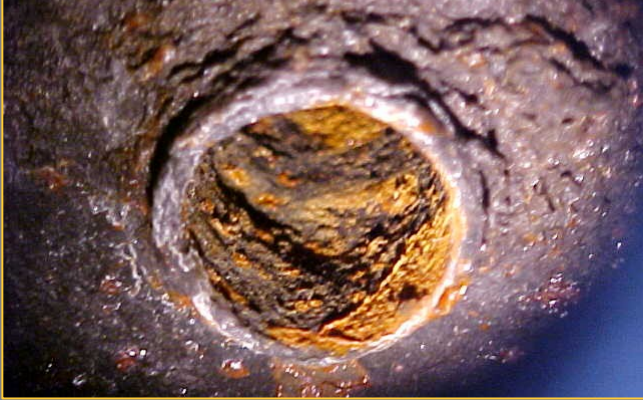
Heavy fouling and tube end corrosion

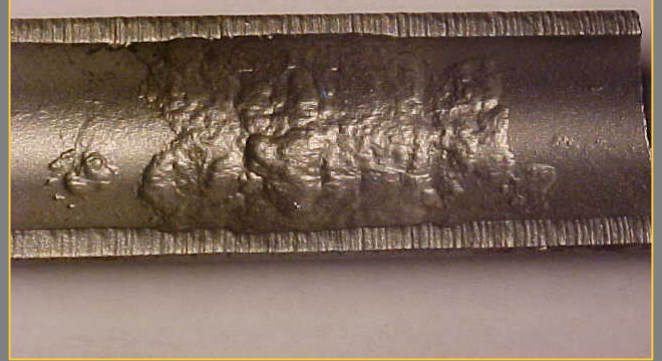
Tube sample (Aluminum fins removed) – heavy corrosion concentration

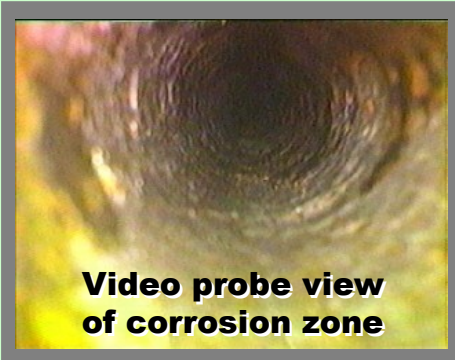
Video probe view of corrosion zone
