COMPLETE THIS SECTION FOR ALL SPILLS:

Date of Spill: 97/12/01 Date Found: 97/12/02 Date Reported: 97/12/03
 Area: Estevan 10 Pool: Quensdale EAST FROBISHER ALIDA BEDS
 Surface Land Location: LS 14 SC 12 TP 6 RG 1 W 2 Horizontal: Yes No
 Company: Talisman Energy Phone No: (306) 453-2545
 Reported By: Travis Doty Company Rep Landowner Other
 Substance Spilled: Oil Salt Water Emulsion Condensate Fresh Water
 Spill Source: Line Well Facility Misc
 Status of Line/Facility/Well: Active Suspended Abandoned
 Estimate of Fluid Spilled: 30.0 m³ Oil 2.0 m³ Water 28.0 m³ Condensate m³
 Estimate of Fluid Recovered: 6.0 m³ Oil 1.5 m³ Water 4.5 m³ Condensate m³
 Surface Feature Affected: (Choose up to 3)
 Cultivated Uncultivated Bush Surface Water Groundwater Access Other
 Size of Area Affected: (Fill in one) Square Meters 300 OR Hectares
 Total Area Affected: On Lease % Off Lease 100 %
 Landowner: Lionel Boutin Phone No: (306) 443-2381 Crown Land: Yes No

Occupant: Same Phone No: ()
 Contacted by Company: Yes No Contacted by SEM: Yes No
 Comments: This incident resulted from a flowline failure
 Signature: [Signature] SEM - Regina SEM - Field ENV - Canada

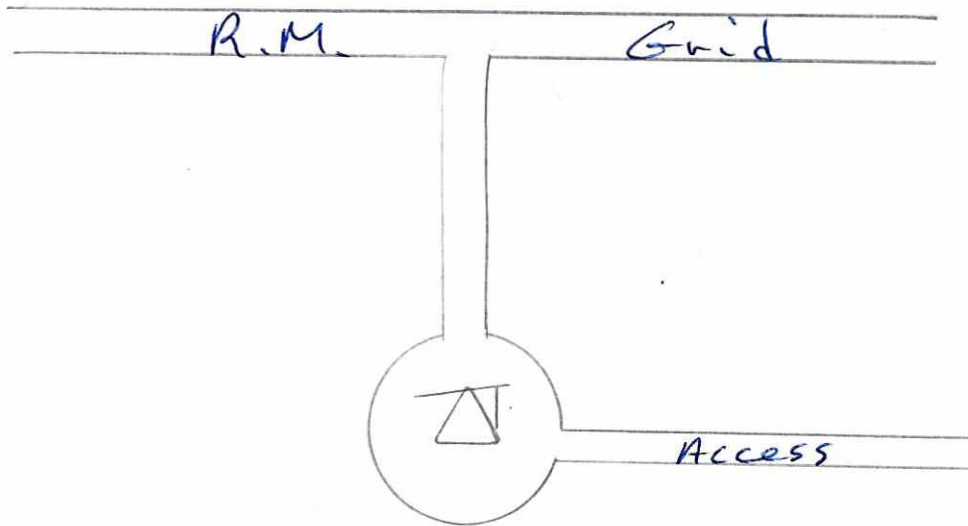
DIAGRAM OF SPILL AREA:

Affected area on seeded grassland

Additional Comments: 97/12/03 All free standing fluid has been picked up! 4m³ bails of straw around perimeter
The line is shut in - has not yet been repaired.

There is oil staining on the surface and P.W.R. are responsible for soil reclamation

98/07/07/ ^{peat moss} ~~straw~~ has been applied - looks good
still shut-in.

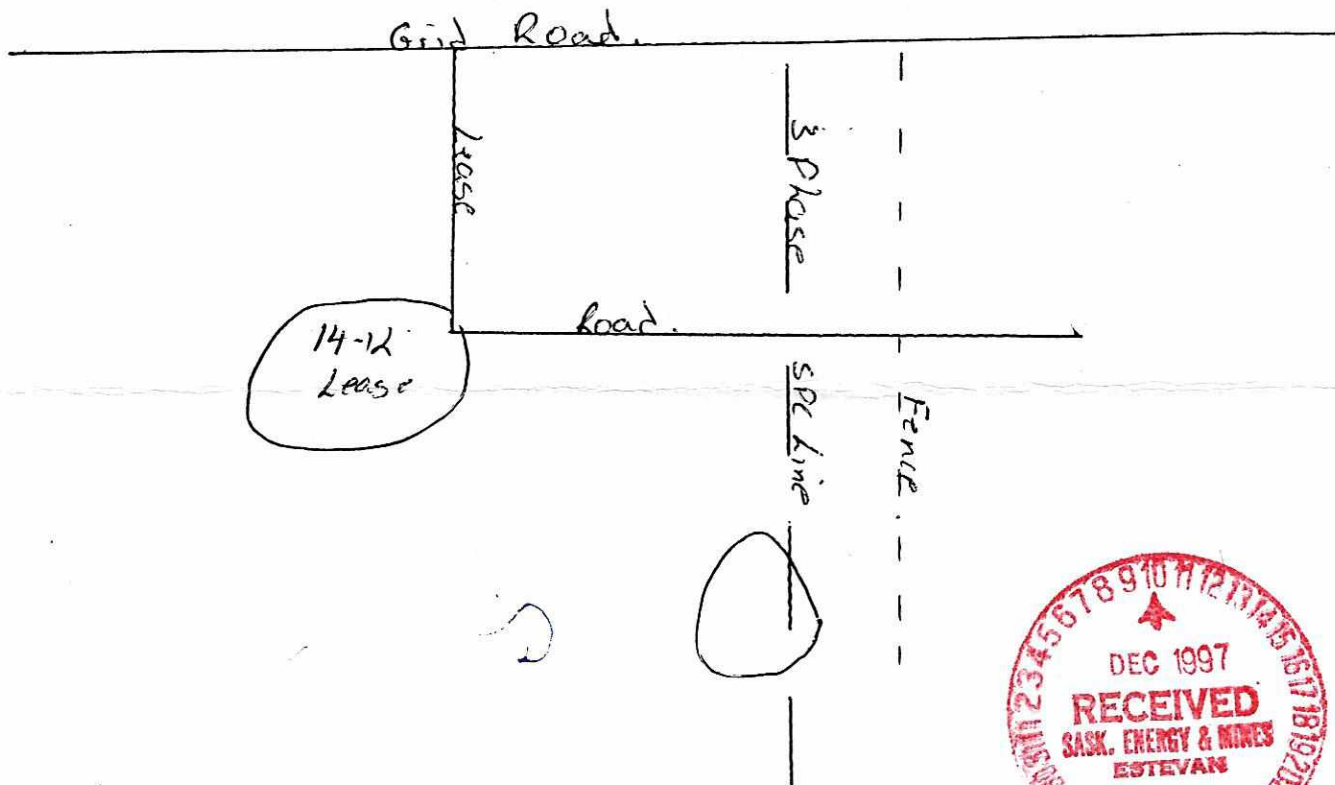
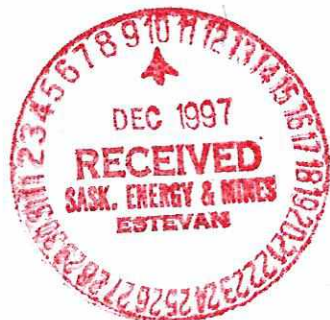
DIAGRAM OF SPILL AREA:

Estimate of Fluid Spilled: 30 m3 Oil 2 m3 Water 28 m3 Condensate m

Size of Area Affected: (Fill in one) Square Meters 300 OR Hectares

Cause: Corrosion X Mechanical Failure Human Error Vandalism Test Failure

Details of Clean-up: Dec 2/97 had vacuum truck suck up any
free standing fluid and haul to Newalta.
