Journal of the American Institute for Conservation Summer 2008 Volume 47, Number 2

CALCIUM TARTRATE TETRAHYDRATE PRECONSOLIDATION OF SALT-CONTAMINATED LIMESTONE AT MISSION SAN JOSÉ Y SAN MIGUEL DE AGUAYO

JENNIFER CORREIA AND FRANK MATERO

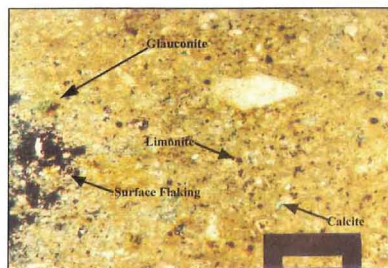
Fig. 2. Petrographic thin section of Sacristy window basal limestone. Note fine micritic texture and the presence of accessory minerals limonite and glauconite. Surface decay is evident on the left, mag. 100×, cross polarized light (McDowell 1997).

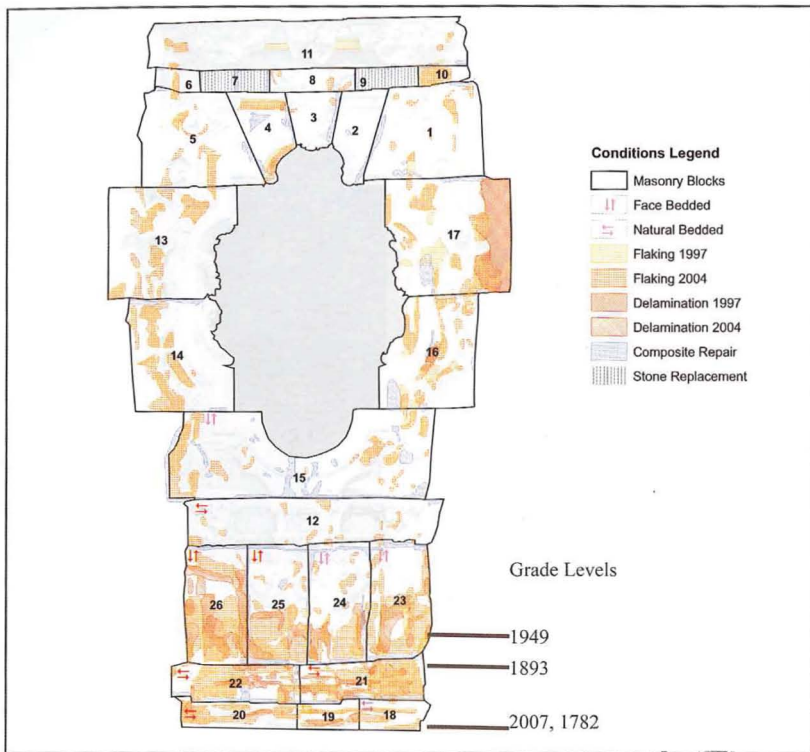
Fig. 3. 1997 and 2004 condition surveys for flaking and delamination of the Sacristy Window limestone.

the total percent area of flaking with 10% in 1997 and 20% in 2004 (Correia 2005). Delamination, a more serious form of detachment than flaking, was less extensive but also showed a significant increase. Total percent area of delamination in 1997 was 2% and increased to 6% in the 2004 assessment (Correia 2005). Historical photographs from the late 19th century reveal that a significant rise in the grade level had occurred, resulting in burial of the lower stonework for at least 50 years (see figs. 1, 3). This condition has led to salt contamination from groundwater and later wet-dry cycling after the base was exposed for display in 1950 (McDowell 1997). The resulting flaking and delamination caused by salt crystallization, disso-

lution, and recrystallization, in an open environment, have clearly accelerated over the past decade since condition recording began (1997–2007) and can be attributed to the excessive precipitation recorded for southern Texas from the late 1990s to 2004 (Correia 2005).

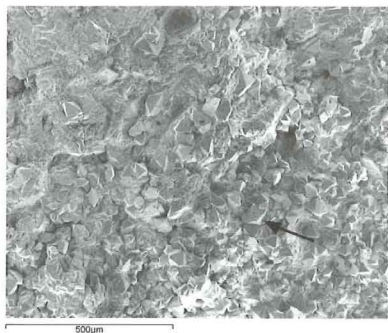
Fig. 4. SEM micrograph of the interior surface of a laboratory sample from group H (salt-contaminated and treated with HCT) after a poultice treatment. The arrow points to a single CTT grain. Note the clean faces of the CTT grains, and the good coverage on the calcite grains, mag. 100 \times , 2005.

The results confirmed that the white crystalline pustules on the flaking surfaces of the lower stonework are predominately gypsum. The identification of CTT on the pustules scraped from preconsolidated stone surfaces also confirmed the successful introduction of the HCT. SEM examination also revealed that the salts recrystallized onto and around the CTT grains in a sample taken from the window after preconsolidation. Similar results were also observed in the laboratory impregnated quarry limestone (figs. 4, 5).

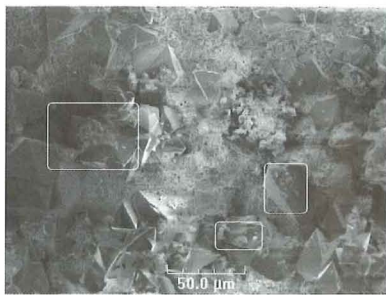
The results were assessed by examining the untreated and salt-treated samples with SEM. Surface topography and crystal morphology were studied to ascertain the formation of CTT on the calcite grains and any potential interference from salt impregnation. Although CTT could not easily be identified with EDS on the limestone, as it is a calcium compound, it was possible to identify CTT formation through visual observation of its characteristic crystal morphology under high magnification. Original and quarry stone samples were prepared for SEM examination by breaking off an edge of the treated cube samples, mounting the interior edge on an SEM stub mount, and coating the sample with gold. The formation of CTT crystals was clearly observed in the HCT treated samples as orthorhombic grains on the calcite matrix (fig. 4). Where salts were present, these appeared to have formed around and on top of the CTT crystals, thus suggesting post CTT recrystallization (fig. 5).

Fig. 5. SEM micrograph of a sample taken from the Sacristy Window after two applications of the preconsolidant HCT. Note salt recrystallization on the faces of the CTT grains in the outlined areas, mag. 500 \times , 2006.

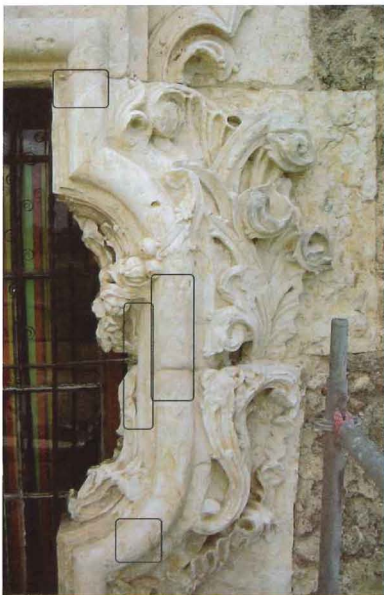
Fig. 9. The outlined areas are finished mortar fills that replaced incompatible previous repairs.

ratio (by volume) of 3.5 NHL (St. Astier) and yellow bar sand formulated to match the existing original lime mortar in color, texture, and overall properties. Where necessary, mortars were tinted with raw sienna and marble dust to match the darker cleaned stone surfaces. Larger areas of compensation, where previous repairs had been removed, needed to be applied in layers over a 2 to 3 day period. Final finishes were achieved on the molded elements with sheet metal profiles cut to match the original. Surfaces were then pressed with natural sponges to pull excess water from the mortar and leave a slightly granular finish to match the weathered stone surface (figs. 9, 10).

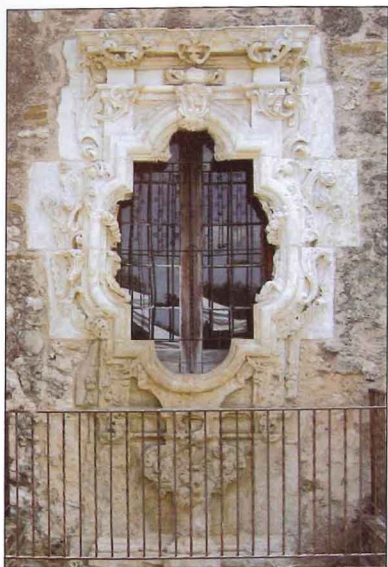
Fig. 10. The Sacristy Window after conservation.

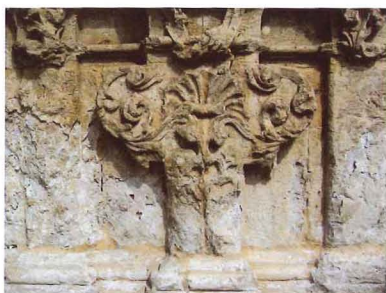
Fig. 11. The Sacristy Window base before conservation.

The final step involved integrating the repairs with the surrounding cleaned masonry. Dilute tinted acrylic emulsion washes (3%) were applied to break up large flat areas of mortar repairs and emulate the variegated color and patterns of the weathered limestone. The acrylic was also applied to integrate existing sound repairs in the same manner (figs. 11, 12).

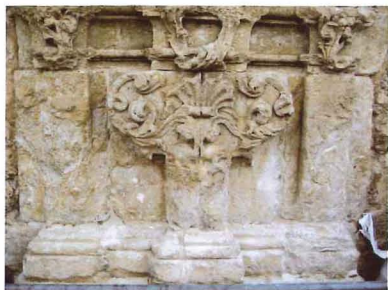
Fig. 12. The Sacristy Window base after conservation.
