Number: 727-57A0135
Original Issue: February 07, 1975
Revision 4: September 26, 2012
ATA System: 5742

SUBJECT: ATTACH FITTINGS Flight Control - Foreflap Carriage Attachment Inspection And Adjustment

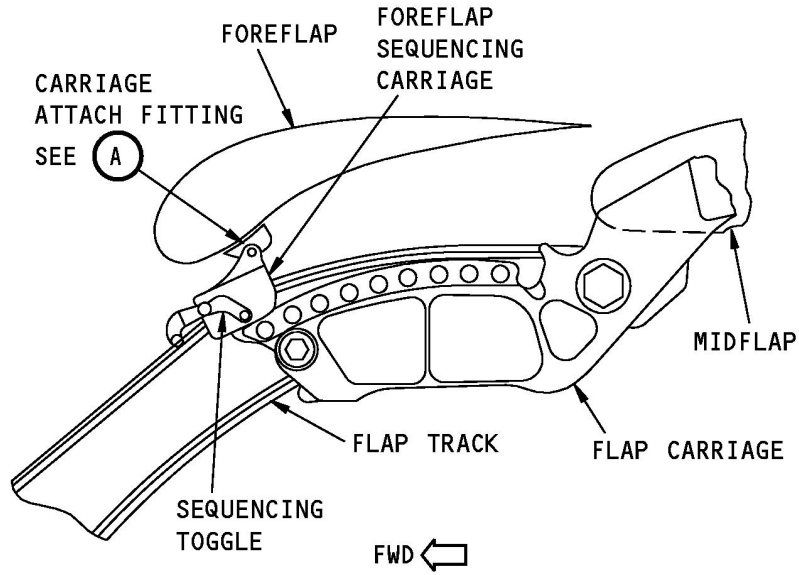
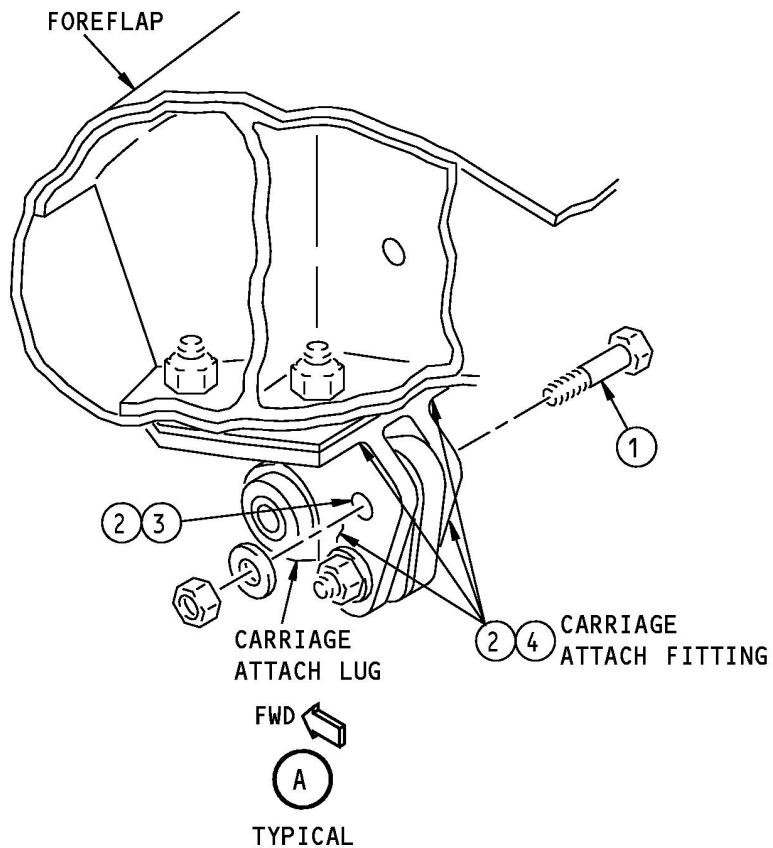
FIGURE 1: INSPECTION (SHEET 1 OF 2)

2. Inspect the two carriage attach fittings on the inboard and outboard Foreflaps, of each wing, in accordance with Figure 1.
 - a. If no cracking is found, continue on with Paragraph 3 (note compliance time for this requirement).

STEP	TASK	NAME	PROCEDURE	NOTES
1	Remove / Keep	Bolt, Washer, Nut	-	Keep the parts to use again if they are in an approved condition for service.
2	Inspect	Hole, Base Radius, Lug Face, forward edge	Detailed Inspection	Look for any crack or surface deviation on all edges, surfaces and holes. (a)
3	Inspect	Hole	High Frequency Eddy Current	Look for any crack in accordance with 727 NDT Part 6, 51-00-00, Figure 2.
4	Inspect	Hole, Base Radius, Lug Face, forward edge	High Frequency Eddy Current	Look for any crack in accordance with 727 NDT Part 6, 57-40-27, Figure 3.
If there is no crack, reinstall the bolt, washer and nut.				
(a) Nicks, scratches or dents are NOT permitted on the forward surface or in the hole. If found, replace the fitting. The lug surface finish must be 125 microinches or better.

- b. If any crack is found, remove the carriage attach fitting from the Foreflap. The Foreflap Sequencing Carriage will first have to be removed. Refer to 727 AMM 27-51-04 (Inboard Flap) and 727 AMM 27-51-14 (Outboard Flap) as an accepted procedure for carriage removal. Then remove the carriage attach fitting. Refer to OHM 57-52-11 (Outboard T.E. Flap) and OHM 57-52-01 (Inboard T.E. Flap) as an accepted procedure. Transfer the mounting holes from the removed carriage attach fitting to its replacement carriage attach fitting (The fittings are unique to their location.).

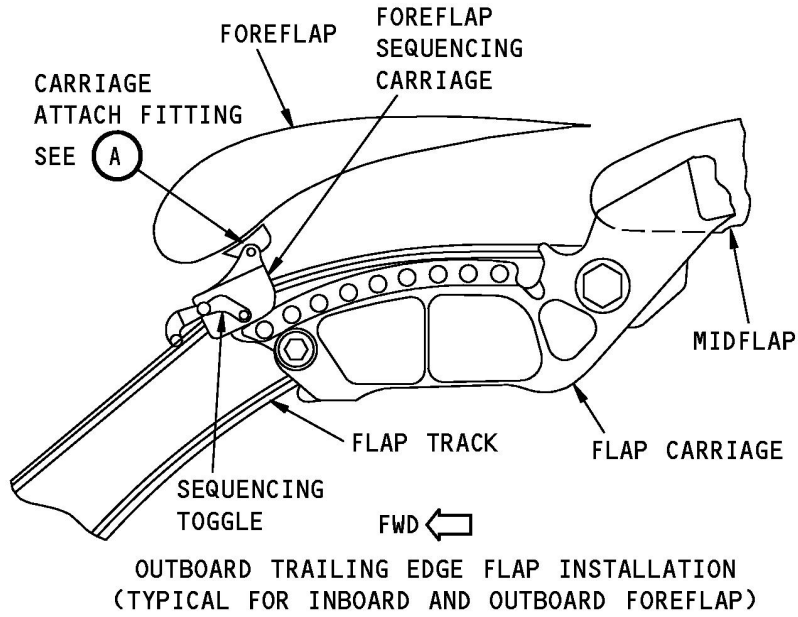
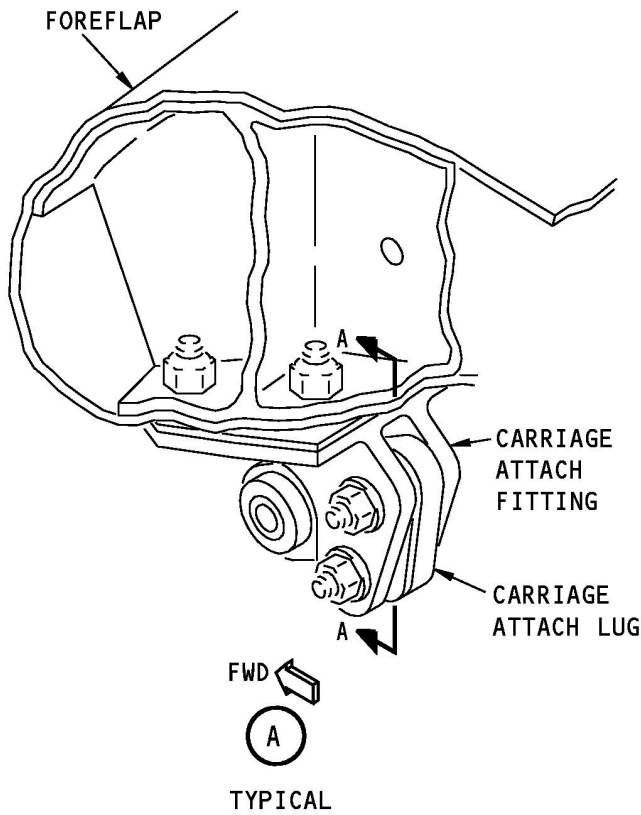
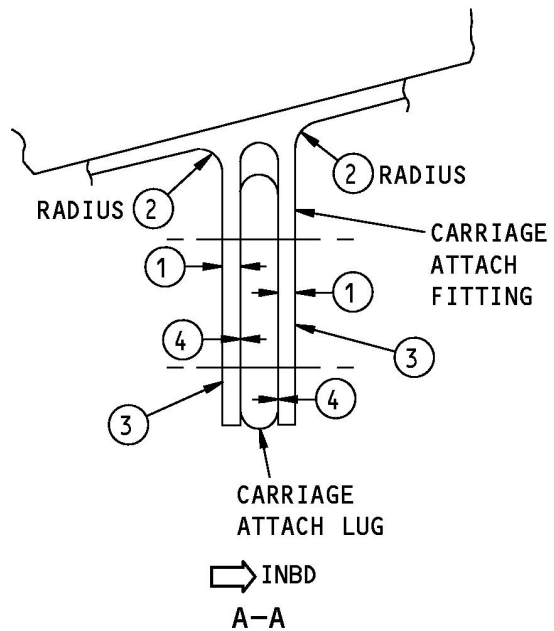
FIGURE 2: CHECK FOR CLEARANCE / INTERFERENCE (SHEET 1 OF 2)

It has also been noted that reverse dimensional tolerance at the carriage attach lug and carriage attach fitting could result in interference, as opposed to excessive gap and clamp-up.

Do a one-time clearance/interference check of the carriage attach fitting. Shim if required. If interference is found, rework the carriage attach lug.
