FALCON SERVICE BULLETIN

FALCON 900

No 372-R1

**LIGHTING
EXTERIOR LIGHTING
ELECTRICAL BONDING OF WHELEN FIN TIP ANTI-
COLLISION LIGHT**

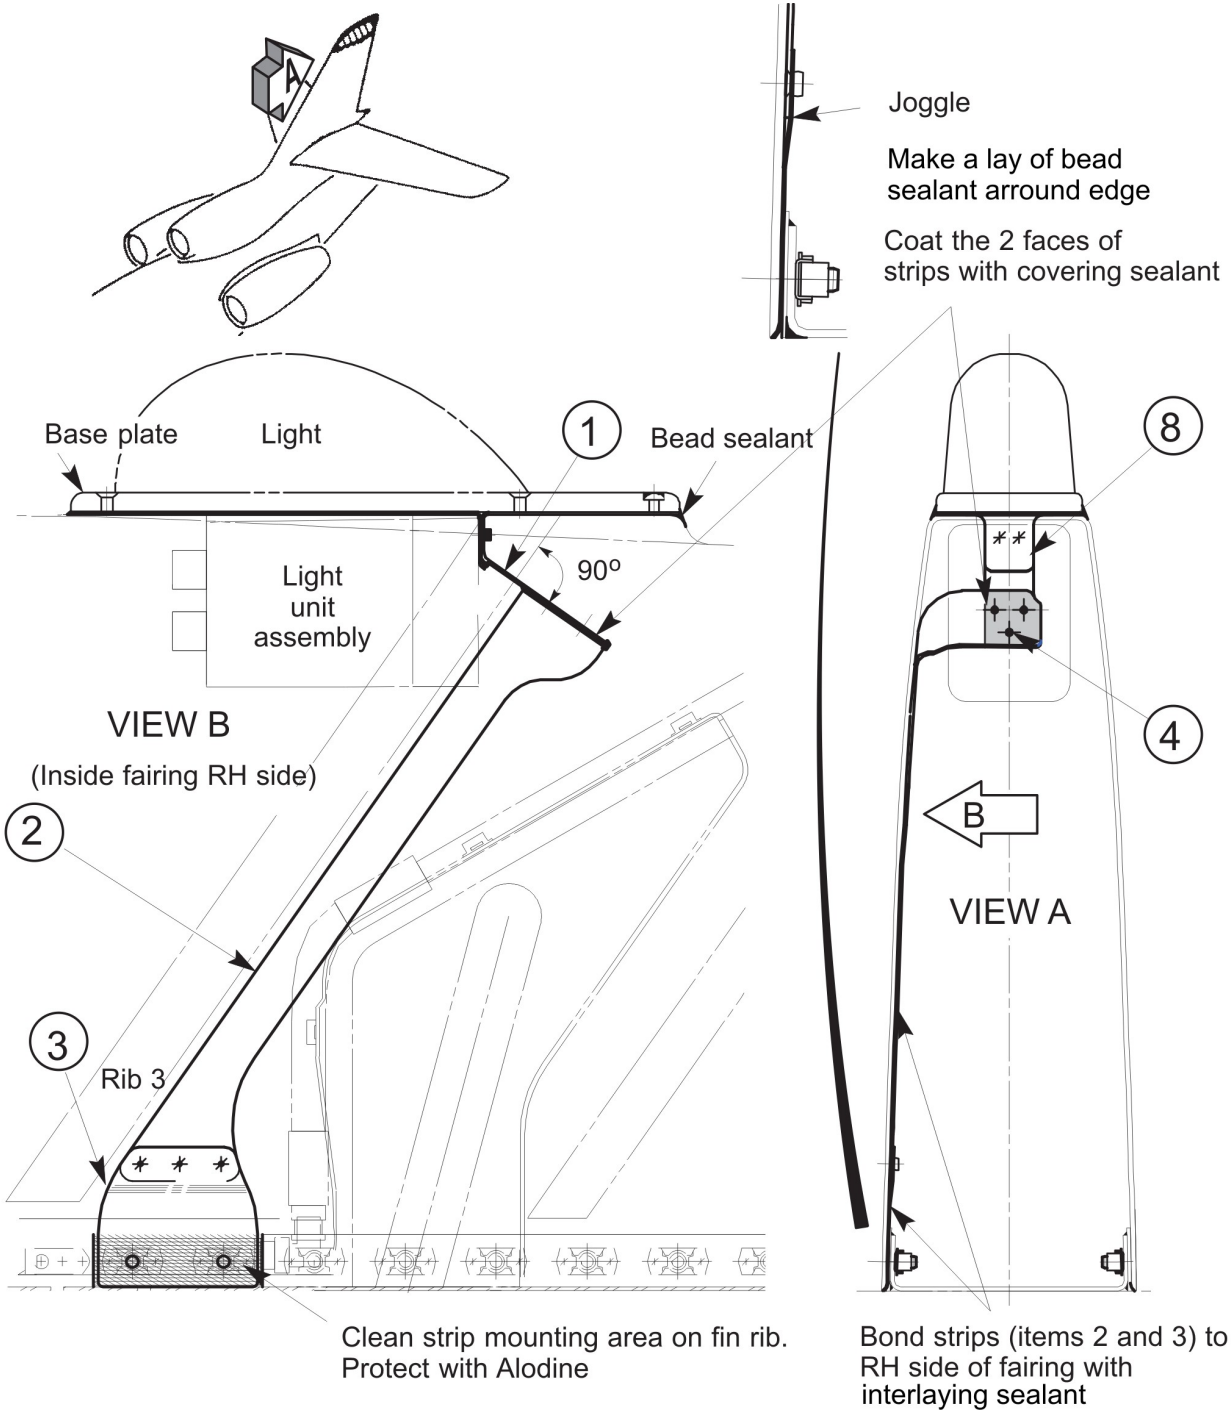
Figure 1: ELECTRICAL BONDING ON AIRCRAFT WITH FAIRINGS F50B319BX AND FGFB319A2 (A3)

The investigation conducted on a Falcon 2000 aircraft that had been struck by lightning has shown that the electrical bonding of the fin tip anti-collision light may not be sufficient under certain circumstances, potentially resulting in damaging the aircraft wiring.

In accordance with **fig. 1** or **fig. 2** depending on the P/N of the existing fairing:

- (1) Cut out the run outs of the compound seal to obtain a plane mounting surface.
- (2) Set the mounting-base bonding strip (item 1), equipped with shim (item 8), into place on the fairing. Attach with two screws.

- (3) Fold the tab of the strip to a 90° angle with respect to the fairing's rib.
- (4) Pin the strip assembly (items 2 and 3) to the fairing.
- (5) Position the strip assembly (items 2 and 3) in contact against the RH side panel of the fairing and on strip (item 1). If necessary, rework the shape of the strips to obtain proper contact.

- (6) Remove the strip assembly (items 2 and 3).
- (7) Install double-sided adhesive tape on the face coming in contact with bonding strip (item 1).
- (8) Re-install strip assembly (items 2 and 3). Pin to hold in contact against the fairing.

- (9) Install strip (item 1) over the strip assembly, pressing firmly at the contact area).
- (10) Remove the strip assembly (items 1, 2 and 3).
- (11) Counterdrill bonding strip (item 2) to a diameter of 0.1 in (2.5 mm). Disconnect the strips and discard the adhesive tape, remove all remaining adhesive.

- (12) Enlarge the holes drilled in the strips to a diameter of 0.126 in (3.2 mm). Assemble bonding strips (items 1 and 2) using rivets (item 4). Coat the faces of the strips with **covering sealant** making a bead at the contour edge with **bead sealant**.
