April 5, 2019

**Re: Recall 19V-199 (2017-2018 MY Dodge Journey Reflex Reflector Noncompliance per FMVSS 108) and
Recall 19E-025 (Replacement Dodge Journey Headlamp Assembly Reflex Reflector Noncompliance per
FMVSS 108) Petition for Determination of Inconsequential Noncompliance**

Subject: FCA US LLC Subjective Evaluation of Dodge Journey Front Side Reflex Reflectors.

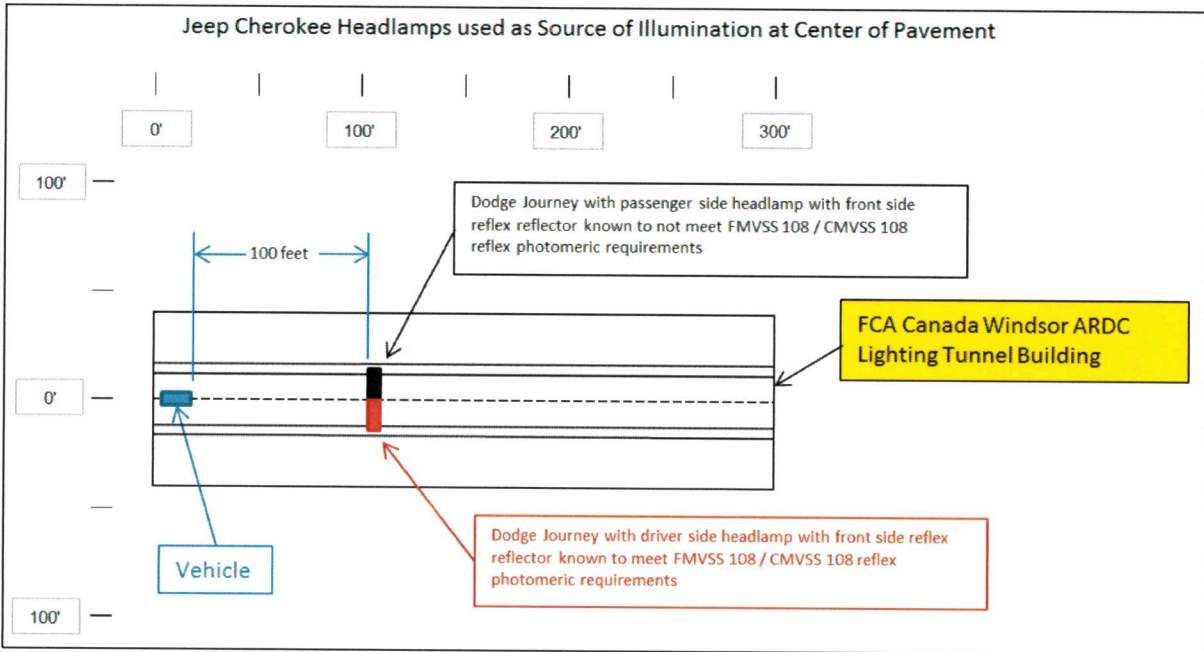
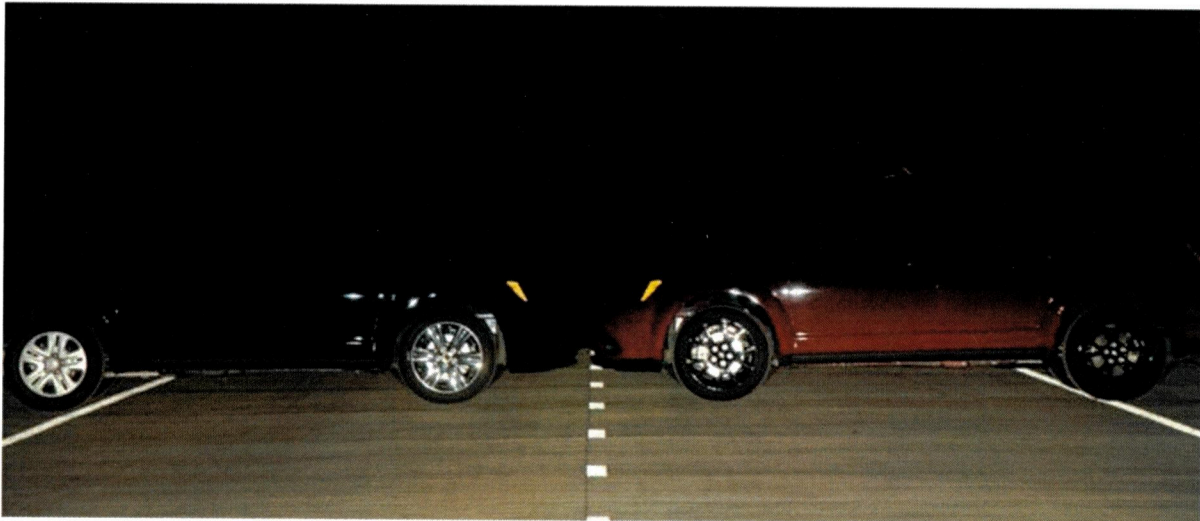
Subjective Evaluation A: Jeep Cherokee Low beam Headlamps used as light source at center of the pavement shining towards the two Dodge Journey vehicles. See Figures 1 and 2.

Figure 1 - Diagram of Subjective Evaluation of Dodge Journey Front Side Reflex Reflectors viewed from center of pavement with Low Beam Headlamps used as source of illumination.

Figure 2 - Photograph of Subjective Evaluation using Jeep Cherokee Low Beam Headlamps as light source. Camera lens set at centerline of road, centerline of the Jeep Cherokee, and height above ground equivalent to that of an average height female driver sitting in the driver's seat of the Jeep Cherokee.

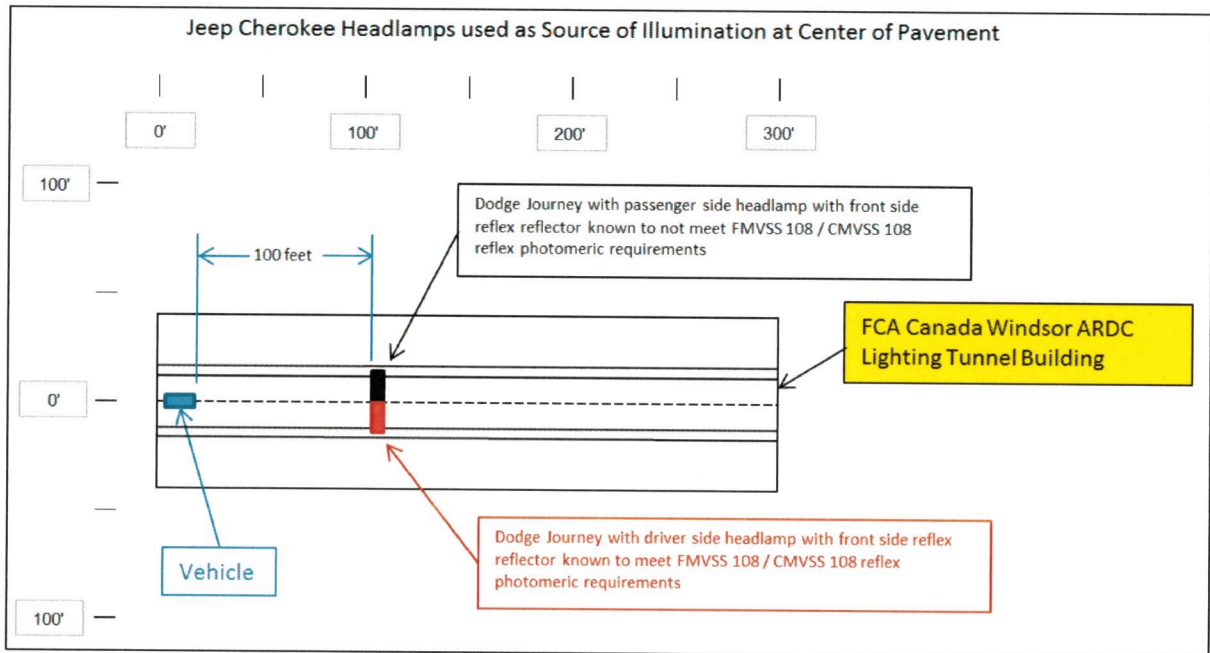
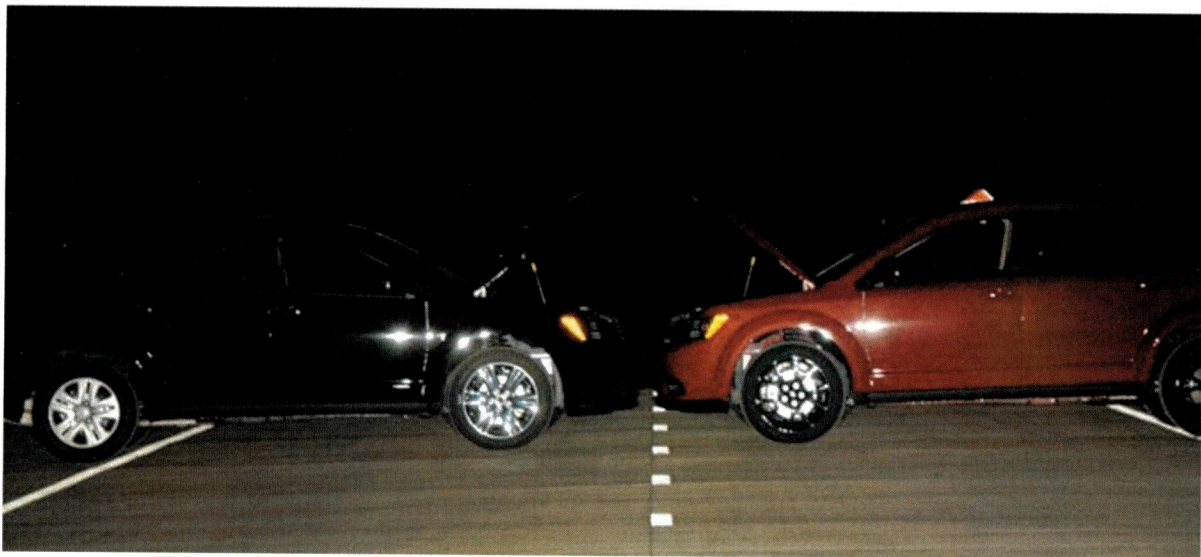
Subjective Evaluation B: Jeep Cherokee High Beam Headlamps used as light source at center of the pavement shining towards the two Dodge Journey vehicles. See Figures 3 and 4.

Figure 3 - Diagram of Subjective Evaluation of Dodge Journey Front Side Reflex Reflectors viewed from center of pavement with High Beam Headlamps used as source of illumination.

Figure 4 - Photograph of Subjective Evaluation using Jeep Cherokee High Beam Headlamps as light source. Camera lens set at centerline of road, centerline of the Jeep Cherokee, and height above ground equivalent to that of an average height female driver sitting in the driver's seat of the Jeep Cherokee.

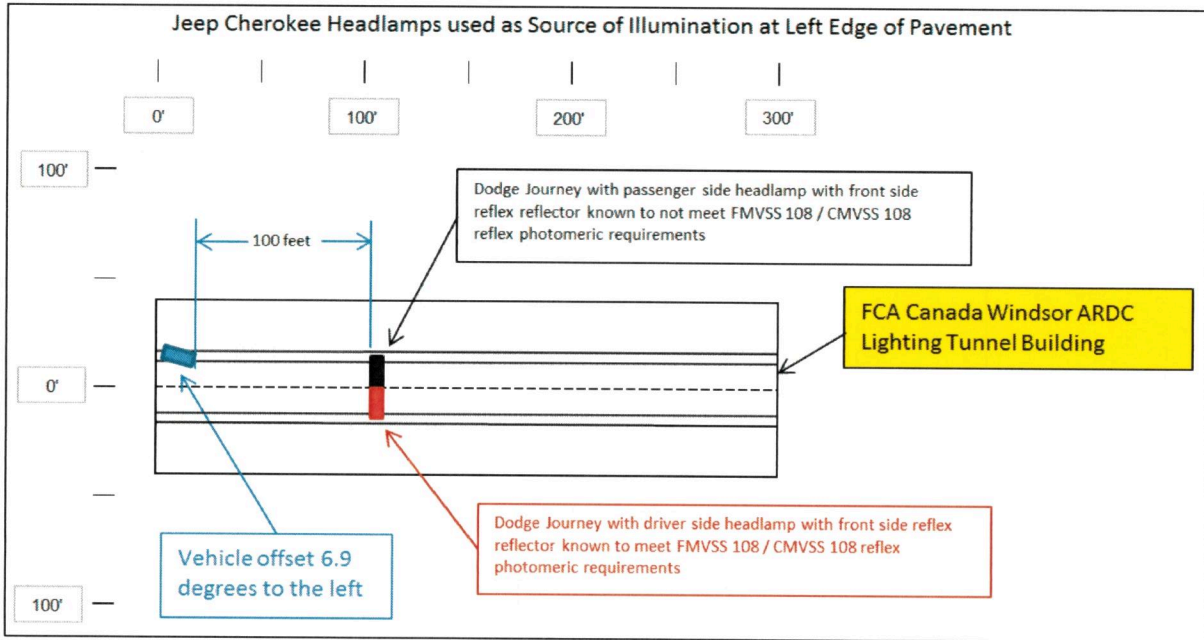
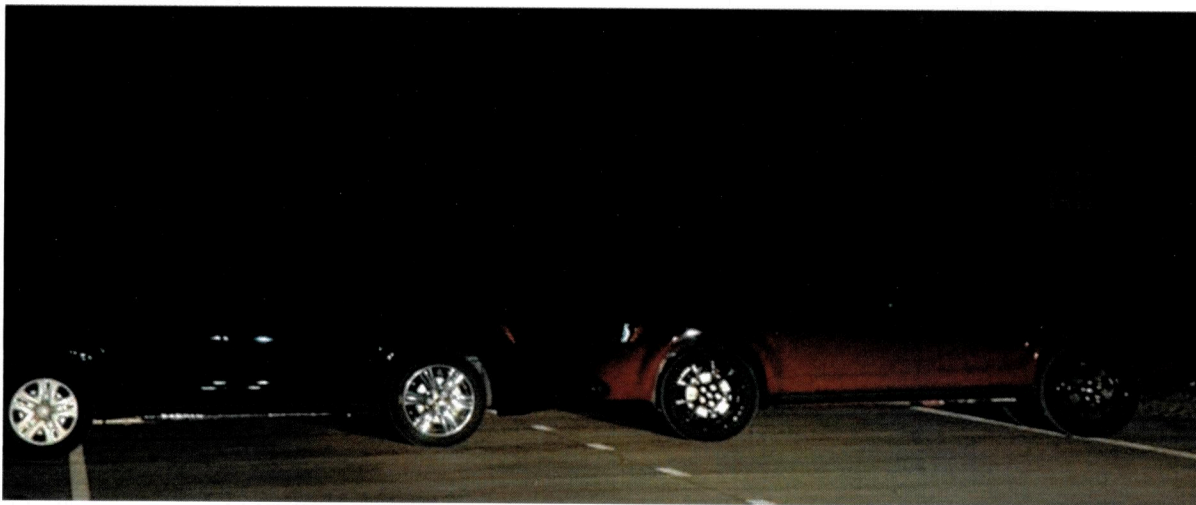
Subjective Evaluation C: Jeep Cherokee Low beam Headlamps used as light source at the left edge of pavement (146 inches to the left of the centerline of pavement) shining towards the two Dodge Journey vehicles. See Figures 5 and 6.

Figure 5 - Diagram of Subjective Evaluation of Dodge Journey Front Side Reflex Reflectors viewed from left edge of pavement with Jeep Cherokee Low Beam Headlamps used as source of illumination.

Figure 6 - Photograph of Subjective Evaluation using Jeep Cherokee Low Beam Headlamps as source of illumination. Camera lens set at left edge of pavement, centerline of the Jeep Cherokee, and height above ground equivalent to that of an average height female driver.

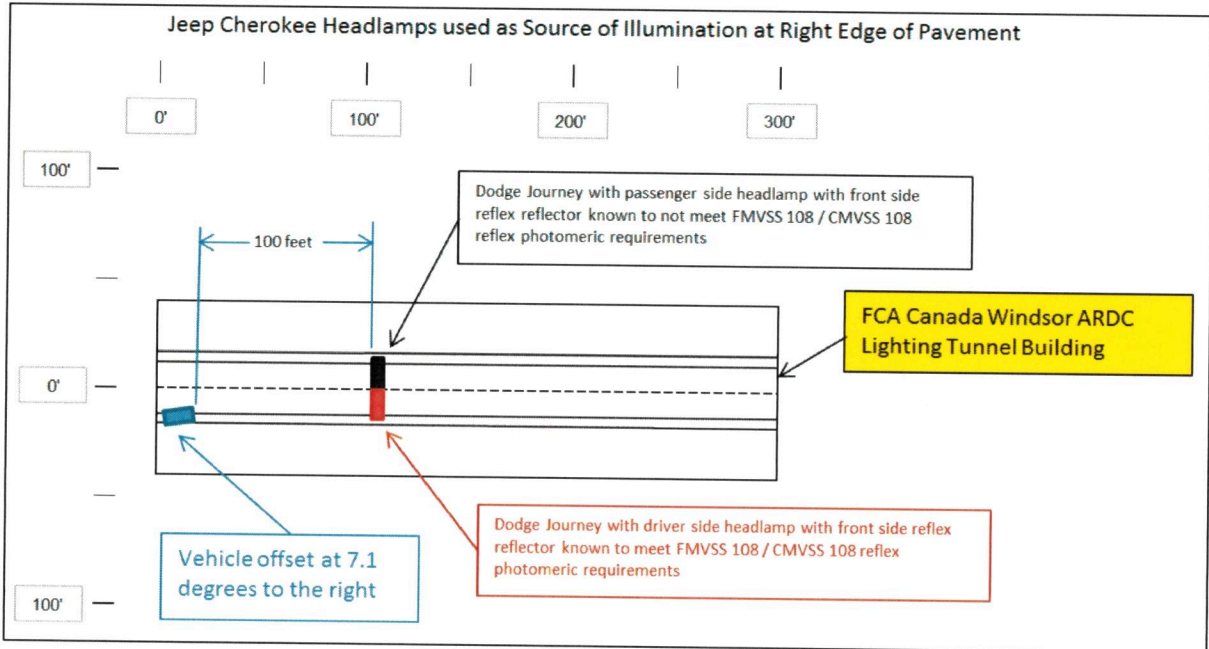
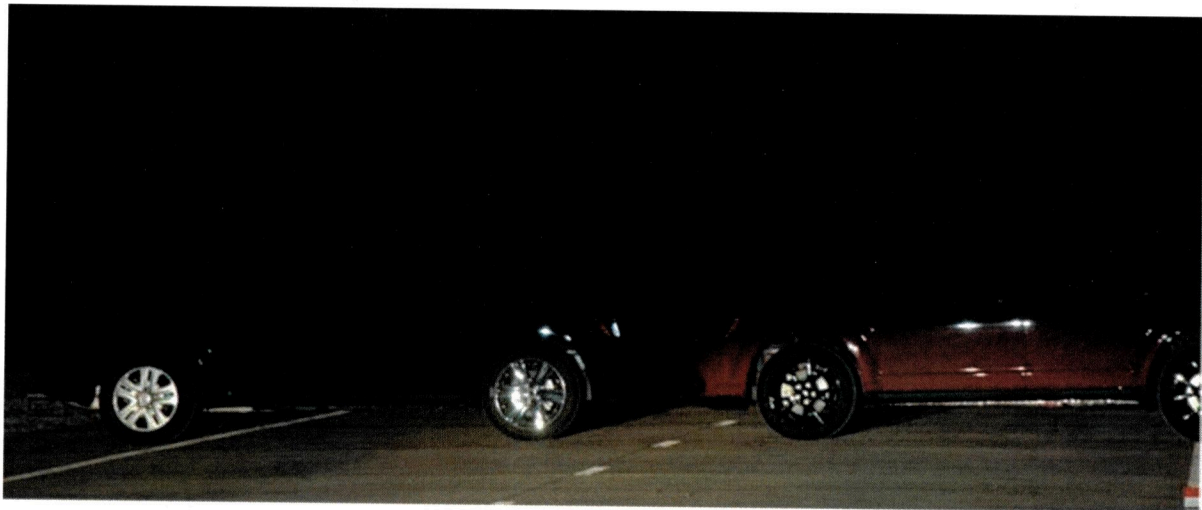
Subjective Evaluation D: Jeep Cherokee Low beam Headlamps used as light source at the right edge of pavement (150 inches to the right of the centerline of pavement) shining towards the two Dodge Journey vehicles. See Figures 7 and 8.

Figure 7 - Diagram of Subjective Evaluation of Dodge Journey Front Side Reflex Reflectors viewed from right edge of pavement Illumination with Low Beam Headlamps used as source of illumination.

Figure 8 - Photograph of Subjective Evaluation using Jeep Cherokee Low Beam Headlamps as source of illumination. Camera lens set at right edge of pavement, centerline of the Jeep Cherokee, and height above ground equivalent to that of an average height female driver.

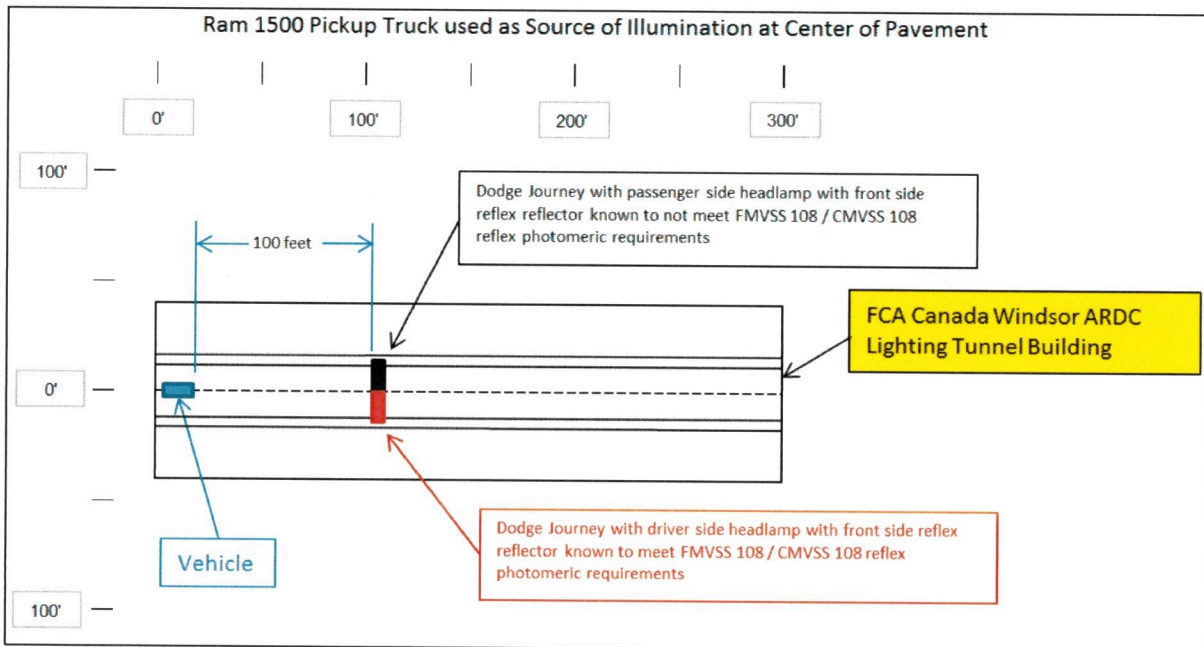
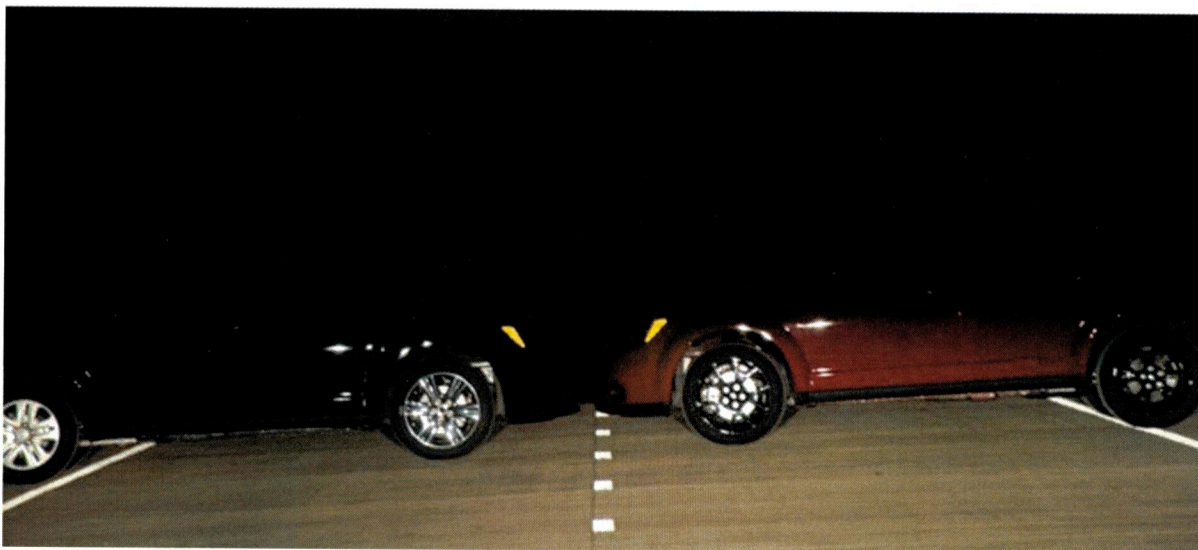
Subjective Evaluation E: Ram 1500 Pickup Truck Low beam Headlamps used as light source at the center of the pavement shining towards the two Dodge Journey vehicles. See Figures 9 and 10.

Figure 9- Diagram of Subjective Evaluation of Dodge Journey Front Side Reflex Reflectors viewed from center of pavement Illumination with Ram 1500 Pickup Truck Low Beam Headlamps used as source of illumination.

Figure 10- Photograph of Subjective Evaluation using Ram 1500 Pickup Truck Low Beam Headlamps as source of illumination. Camera lens set at right edge of pavement, centerline of Ram 1500 Pickup Truck, and height above ground equivalent to that of an average height female driver sitting in the driver's seat of the Ram 1500 Pickup Truck.
