WILD TROUT TRUST

Advisory Visit

River Swale, Richmond & District Angling Society, Jan 2021

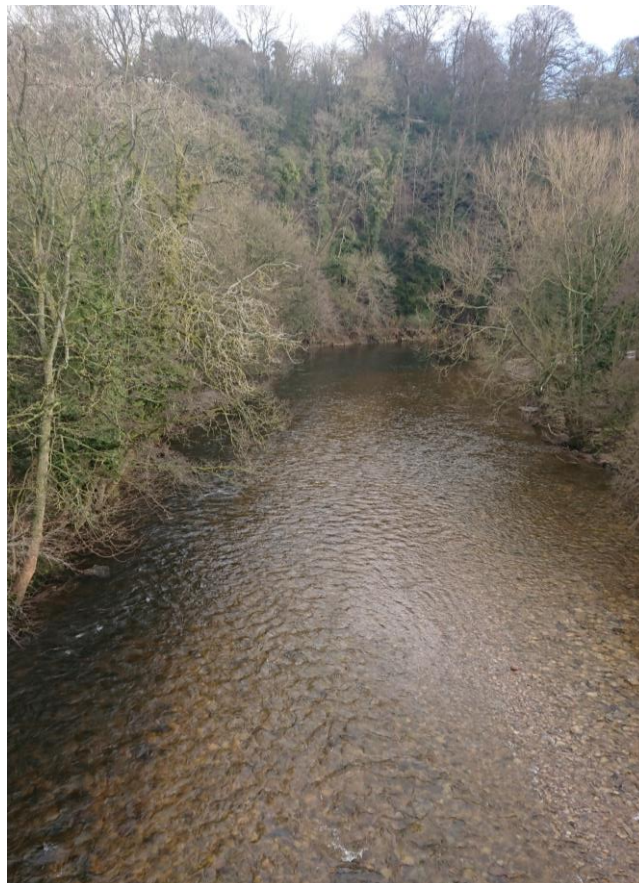
Fig 1. Looking d/s from the Mercury Bridge towards Clink Bank Woods, the channel was broad and straightened to accommodate the bridge and grounds of the former priory on the RB. Mixed, native deciduous trees provided reasonable cover along both banks although there was evidence of some low branch clearance.

The vantage point of Mercury Bridge provided a useful window onto the channel morphology in a modified, straightened reach (Fig 1). Due to the lack of flow variability, the substrate was dominated by larger cobble and boulder spread relatively uniformly over the full width of the channel and hence there was not much variation in depth either. Fast flowing, shallow riffles like this make good habitat for salmonid parr but do not offer the depth or cover to hold other life-stages or many other species.

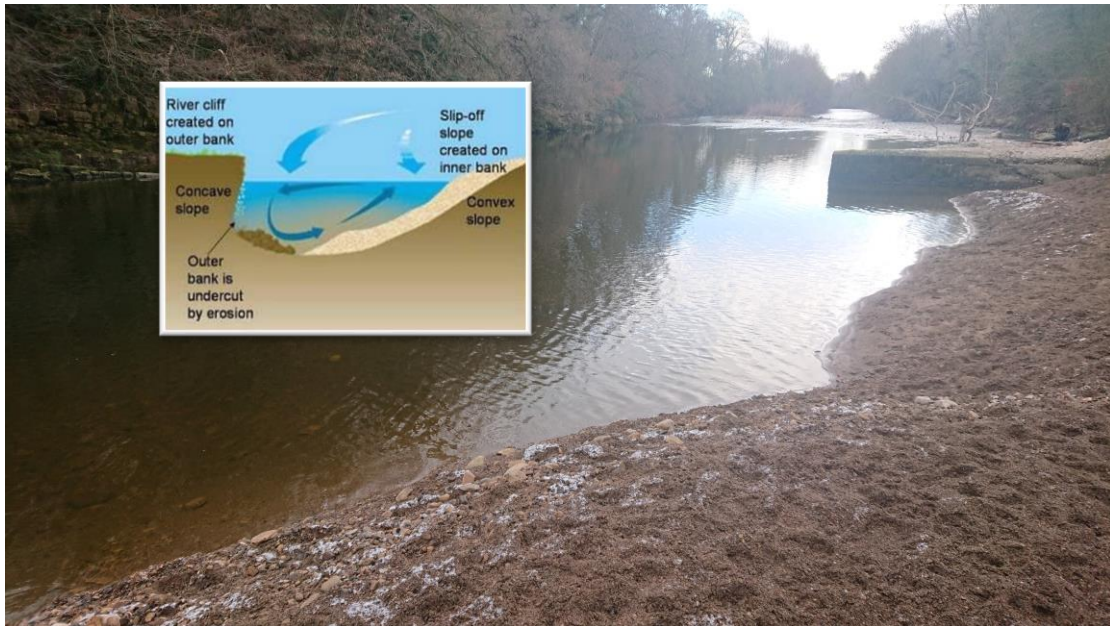
Slower, deep pool habitat, ideal for holding larger fish was available directly d/s where the river hit the sheer bedrock of Clink Bank Woods and, unable to scour laterally, has scoured downwards before bending abruptly to the right (Fig 2). The inside of the bend exhibited a classical slip-off slope of deposited material (see inset Fig 2). Redundant weir infrastructure which appeared to have been placed on a seam of bedrock was (fortunately) degraded to the extent of allowing free sediment transport and fish passage.

Fig 2. The deep pool and associated deposition (see inset) on the inside of the bend at Clink Bank Woods. There was also part infrastructure from an old weir and sluice-gate which has degraded over time.

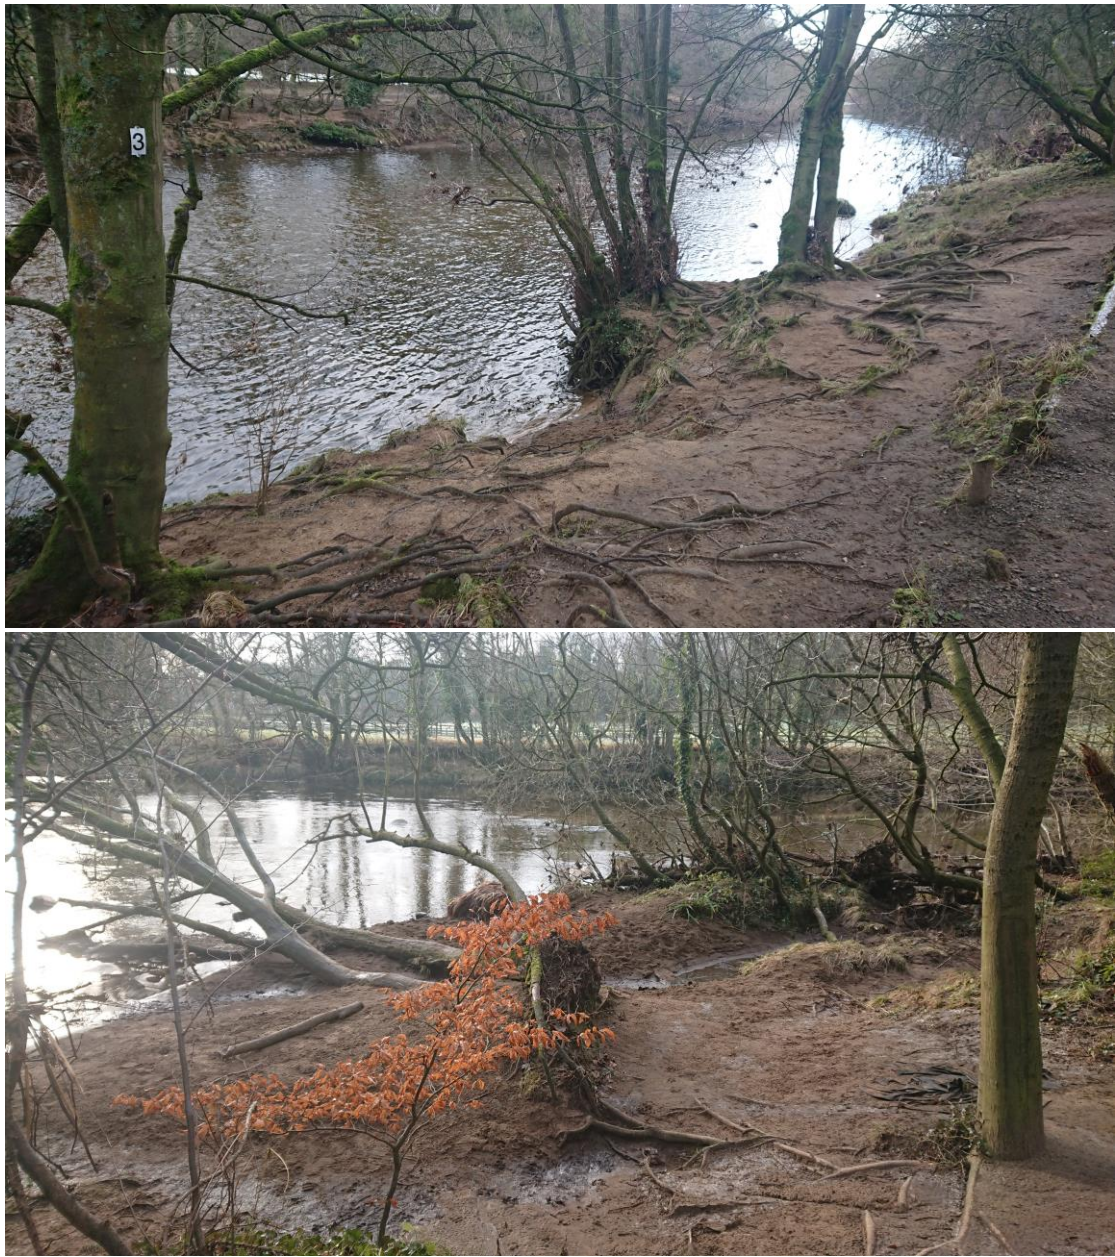
The friable, sandy nature of the catchment soils was evident on both banks (Fig 3). Public access so close to the city will always cause a conflict: people (and dogs) wanting to see and access the water, but associated footfall actually causing detriment to the flora and ultimately the stability of the banks. The mature canopy of riparian trees naturally reduces the density of understorey plants to species tolerant of shady conditions, and recurring spate flow brings fresh deposits of sandy material onto the banks, but these should stabilise over time as the plants bind them together. Only in places inaccessible to people was the understorey flourishing. Wherever there was constant footfall, much of the natural understorey was degraded and the soils around tree roots were disturbed leaving them susceptible to erosion.

Fig 3. Examples of the bankside characteristics on Station Bend to Fence End, and Clink Bank Woods waters. The mature canopy from the riparian trees would naturally result in a 'thinner' understorey, but the banks were essentially bare because of footfall and/or recurrent deposition of fine sand preventing establishment. Note the exposure of the tree root system.

Multi-stemmed trees along both banks hinted at previous coppicing. To simulate the naturally laid trunks in the lower image, trunks could be felled or hinged (dependent upon species) and wedged or tethered to increase diversity of habitat within the channel.

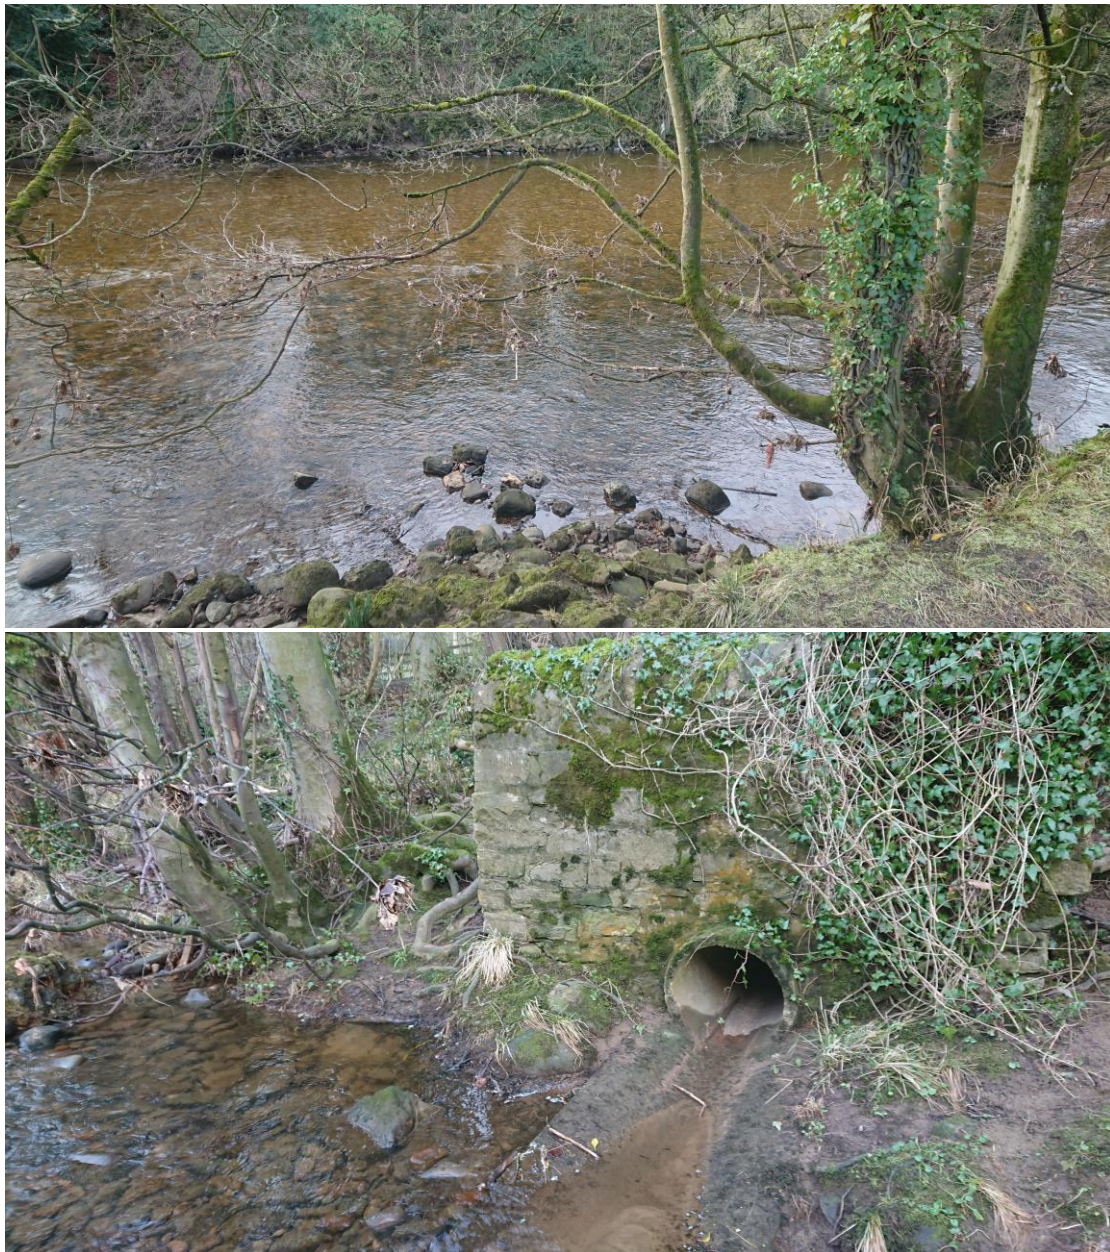
Within ~500m of the Mercury Bridge, wherever the channel was shallow enough to see the substrate clearly, there was a distinctly darker colouration to the bed consistently along the LB which appeared to be algal or biofilm in nature (most obvious in Figs 1&4). The association with the LB was striking, as parameters such as flow path, depth and angle of incident light which one might expect to govern algal growth varied considerably. However, several pipes were noted in the LB (Fig 4), and since the city of Richmond lies predominantly on the LB, there could be multiple sources of chronic nutrient addition affecting the substrate which should be investigated.

Fig 4. For at least ~500m (see Fig 1 from Mercury Br), the substrate toward the LB appeared markedly darker in colouration, despite changes in depth, flow path, shade / angle incident light etc. Various pipes were noted and the majority of Richmond infrastructure lies to the LB so this could reflect chronic inputs of nutrient from multiple sources.

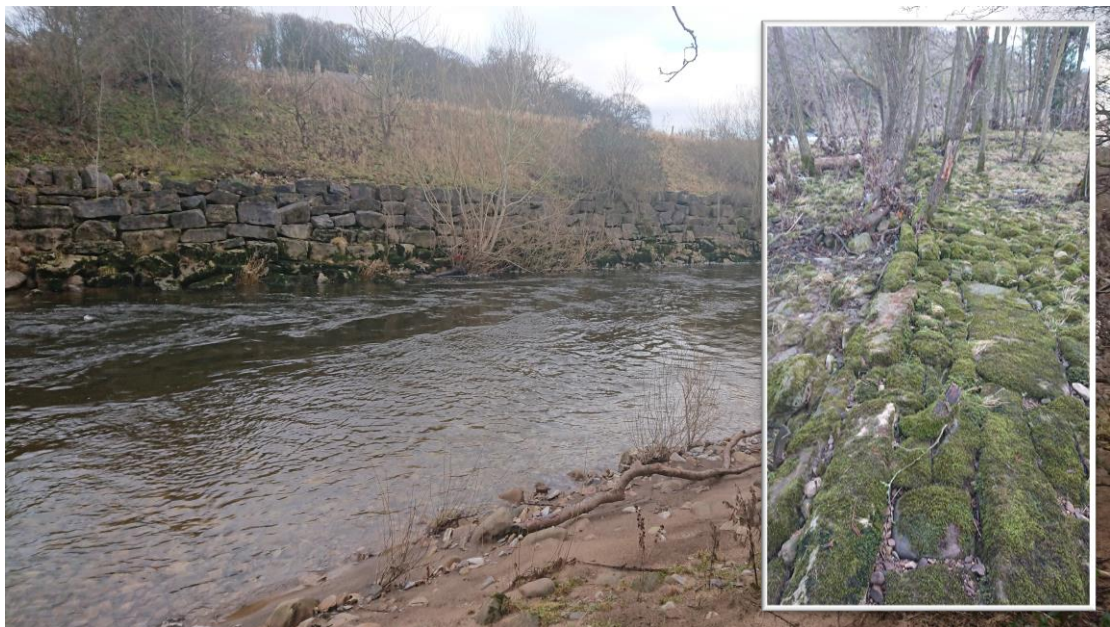
The degradation and collapse of a relatively modest height weir at Easby Abbey (Abbey Farm) was assumed to be in part responsible for increased erosion of the LB u/s, and which has since been curtailed by a substantial block stone revetment (Fig 5). While classified as bank 'restoration' according to the plaque at the top of the structure, such hard engineering in a sweeping curve simply transfers the full force of the energy further d/s. The walling does not allow any natural bank vegetation save for one willow which has managed to establish in a crack at the toe. On the slope above, there seemed to be a variety of non-native species planted, such as buddleia, contributing little to the natural functioning of the channel at this point. Conversely, the natural reclamation of the weir has been remarkable (Fig 5 inset) and a fantastic stand of mainly alder now thrives, providing shade and natural flood management benefits amongst many others.

Fig 5. A highly engineered solution of boulder revetment / walling to the LB to prevent the river returning to a natural course u/s of Abbey Farm (Easby Abbey Mill). It is unclear how long ago the weir (shallow, dressed stone; inset) that fed the mill failed, but the increased gradient at this point probably contributed to the excessive erosion.

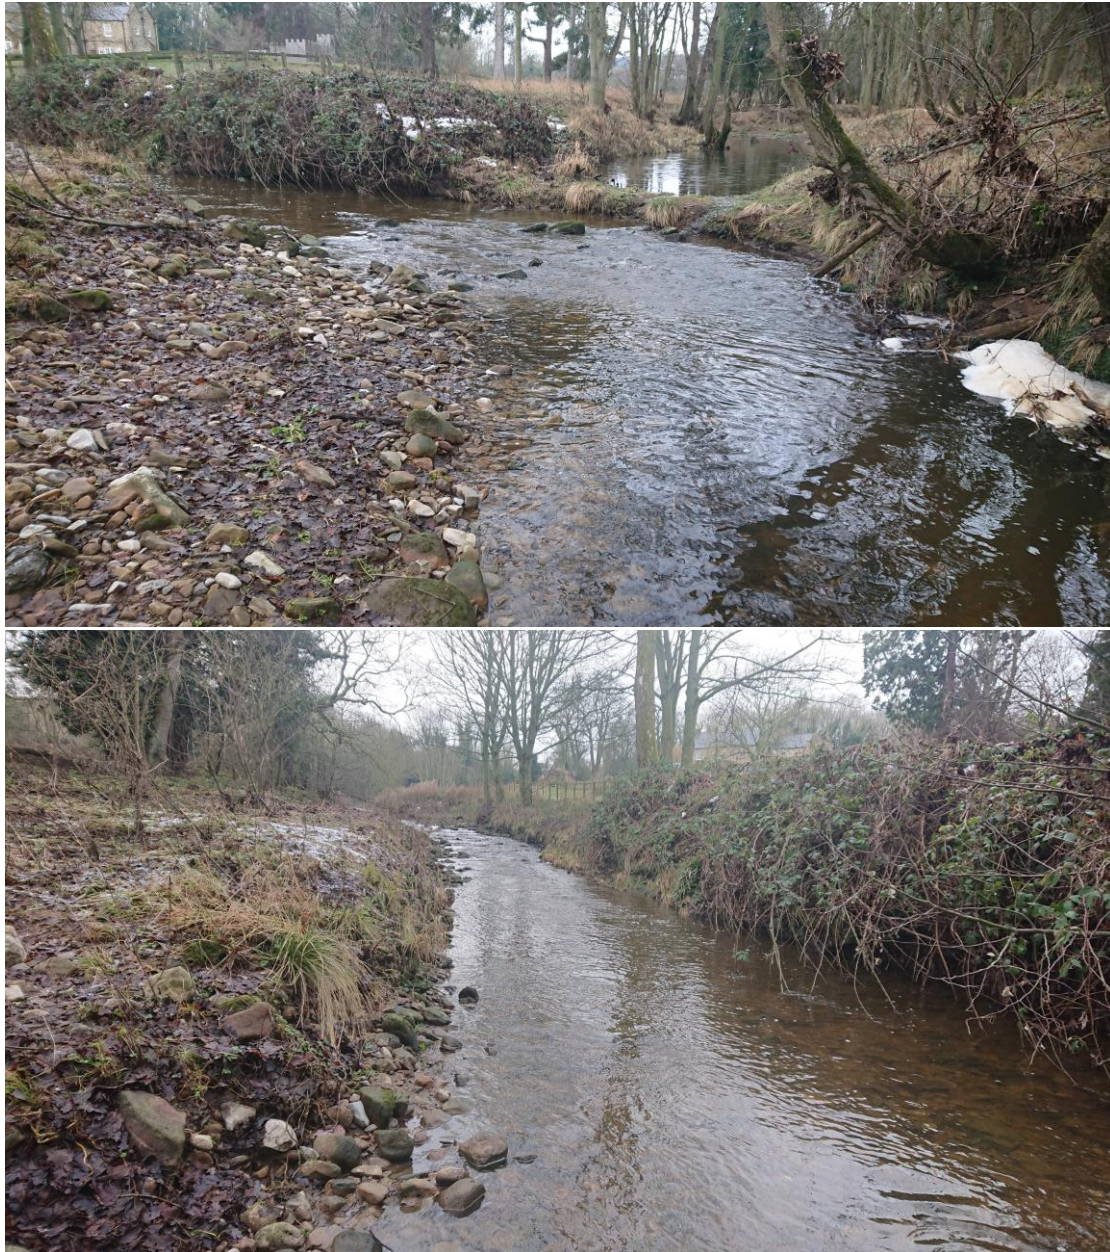
Cobble and gravel deposition bars below the weir were not mapped in 1854, but a substantial island had developed by 1891 forming a distinct channel against the RB (ref to OS maps). Evidence of that still remains today, connected and flushed sufficiently during modest to high spate flow to retain water and provide good fry nursery habitat with adequate overhead cover (Fig 6).

deposition bars have developed to such an extent in a d/s direction as to surpass the confluence and force Sand Beck to the right. Scouring flow from Sand Beck against alder roots on the deposition bar has created a deep pool in a perfect location to provide fish moving in and out of the smaller watercourse with good refuge.

Fig 6. Upper: from the confluence of Sand Beck, looking u/s along an old leat or relief channel parallel to the Swale, fish passage into the beck (which bends to the left) was unimpeded. Such a backwater, with ample overhead cover, creates good nursery habitat.

Lower: the lowest reach of the beck was artificially straightened and has been so for at least 150 years according to the 1854 Ordnance Survey; probably much longer associated with Easby Abbey.

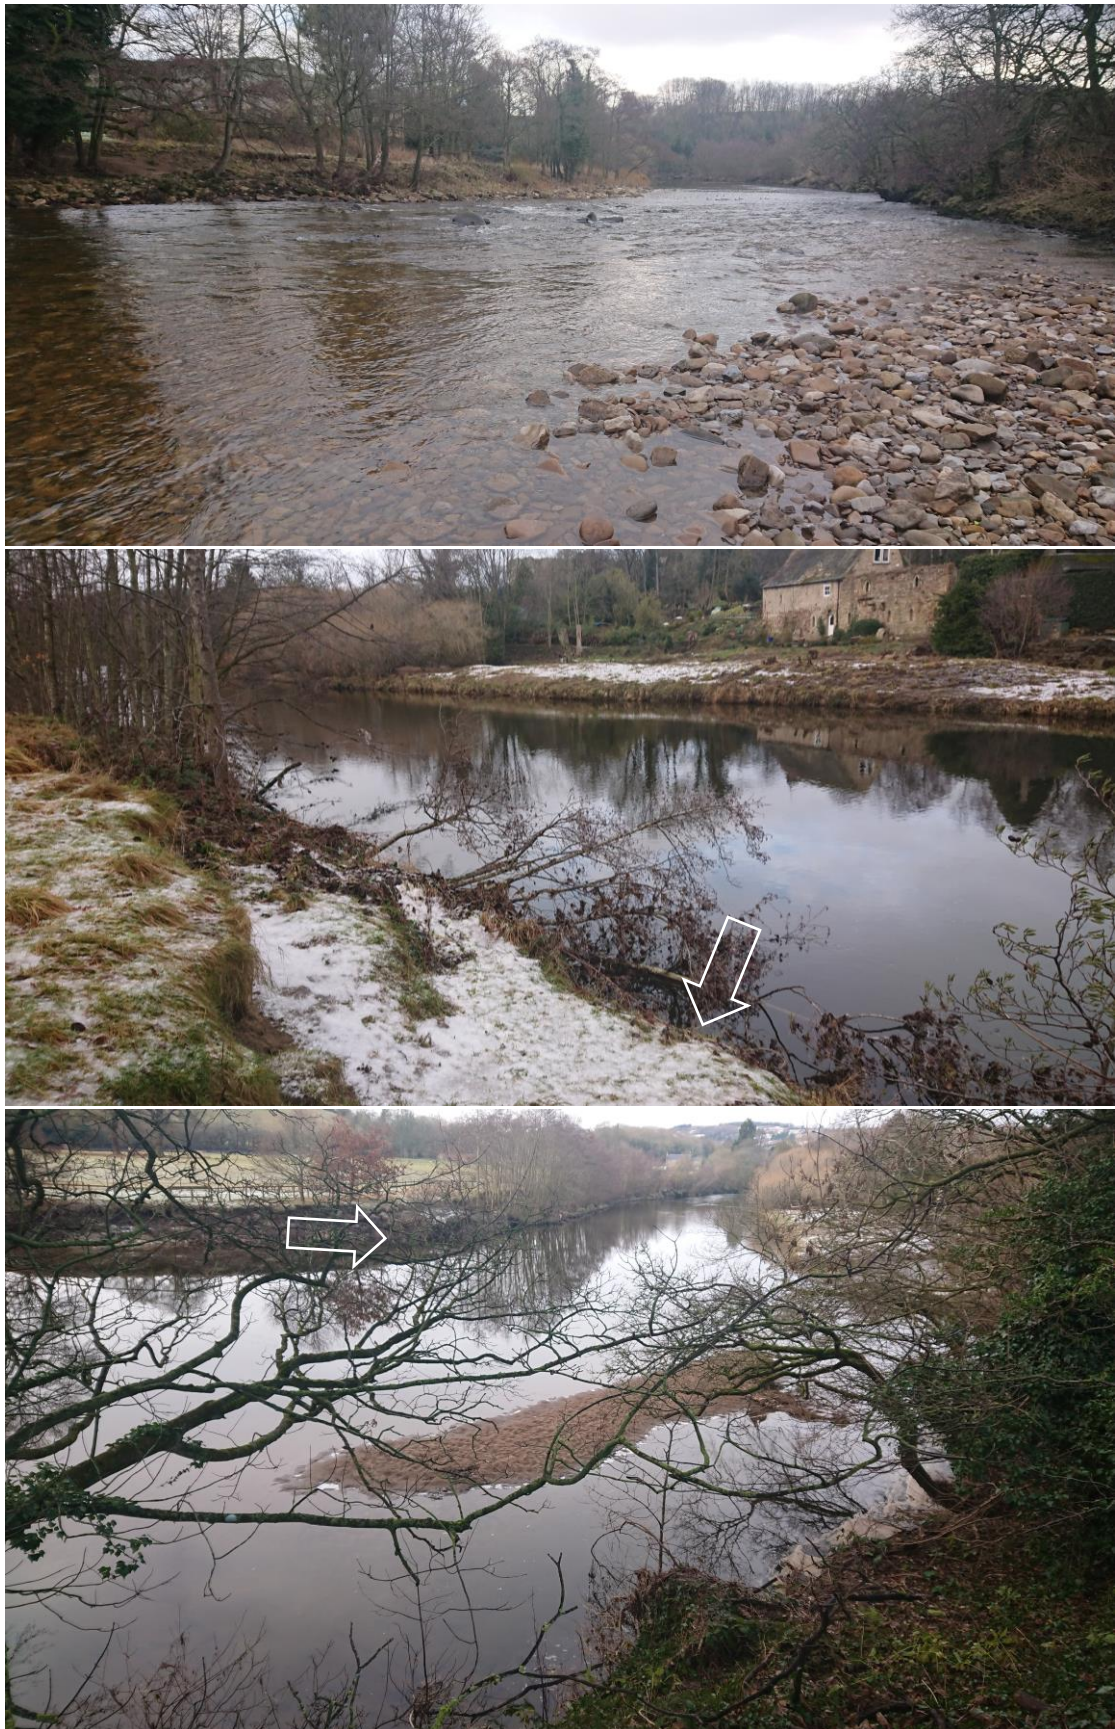
The top section of the Easby water (Abbey Farm to Abbey Woods) switched from fast, shallow riffle to deeper, slower glide, culminating in a deep pool at the end of the straight (Fig 7). Hence there was greater diversity of habitat for larger specimens of coarse species like grayling, barbel and chub, but limited opportunities for eggs, fry and juveniles. The artificial impoundment was due to the river being forced into a perched position towards the LHS of the floodplain and there coming into contact with bedrock seams. The RB has been planted up with alders relatively recently (Fig 7: mid) but only a few specimens or a very thin fringe have been placed on the inside of the bend. Increasing power, duration and frequency of recent winter spates has started to take a toll on the inside of the bend where block-failure erosion was evident (white arrows on Fig 7). In a natural functional channel, the inside of a bend is a deposition zone, further evidence that the channel has been perched out of position and trying to return to the lowest point in the valley.

Fig 7. The straightened reach of Easby water looking d/s from Sand Beck (upper), a mid point of deeper glide (mid), and looking back u/s from the bend at Abbey Wood (lower). The unnatural course has left the river pinned to the LB at Abbey Wood where it is forced abruptly right over a bedrock seam. This has left the river with impounded characters u/s of the bend and much steeper d/s (see Fig 8). White arrows on mid and lower panel indicate the same point on the RB where erosion is evident on the inside of the bend.

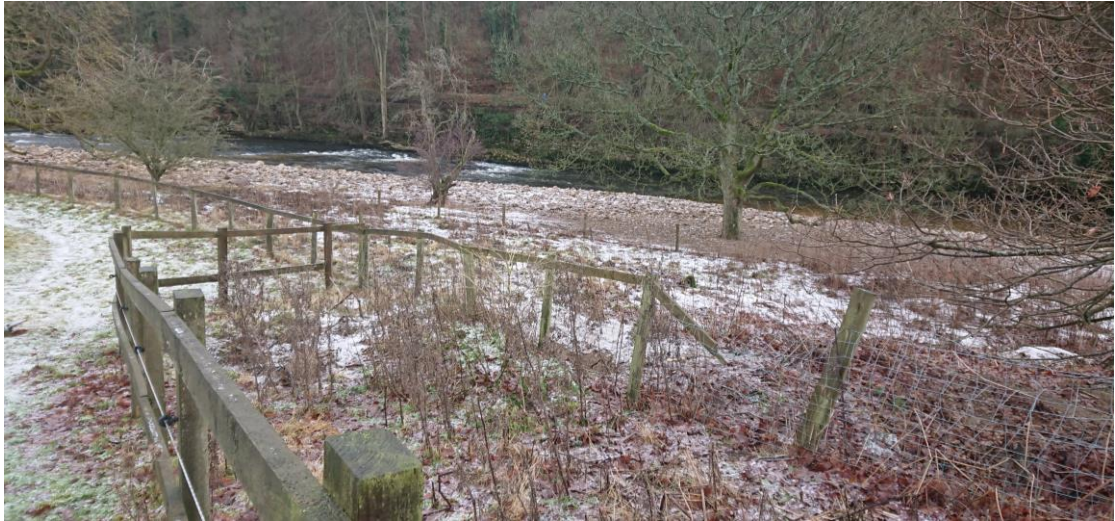
The landowner on the RB has excluded horses from the channel with a buffer strip varying between 5 and 15m and implemented some planting with native tree species. However, there was ample room within the protected strip to increase the density of planting, and extend into another fenced section between that strip and the channel at NZ 18497 00046 (see Fig 8).

Fig 8. Fenced plots with potential for more tree planting on the RB below the Easby water bend. One can see the much steeper gradient in the river alluded to in the legend of Fig 7.

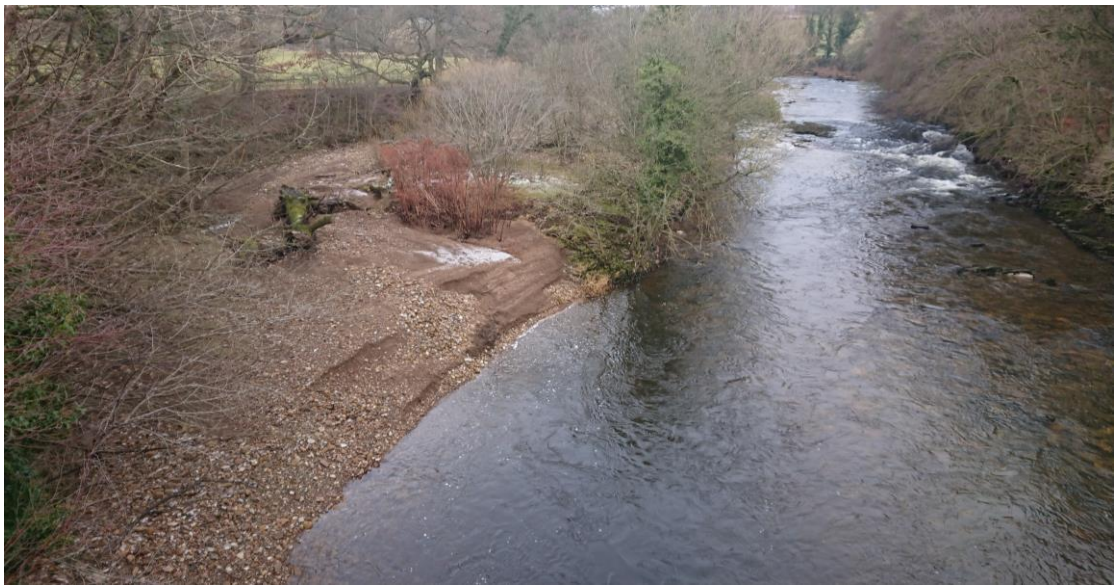
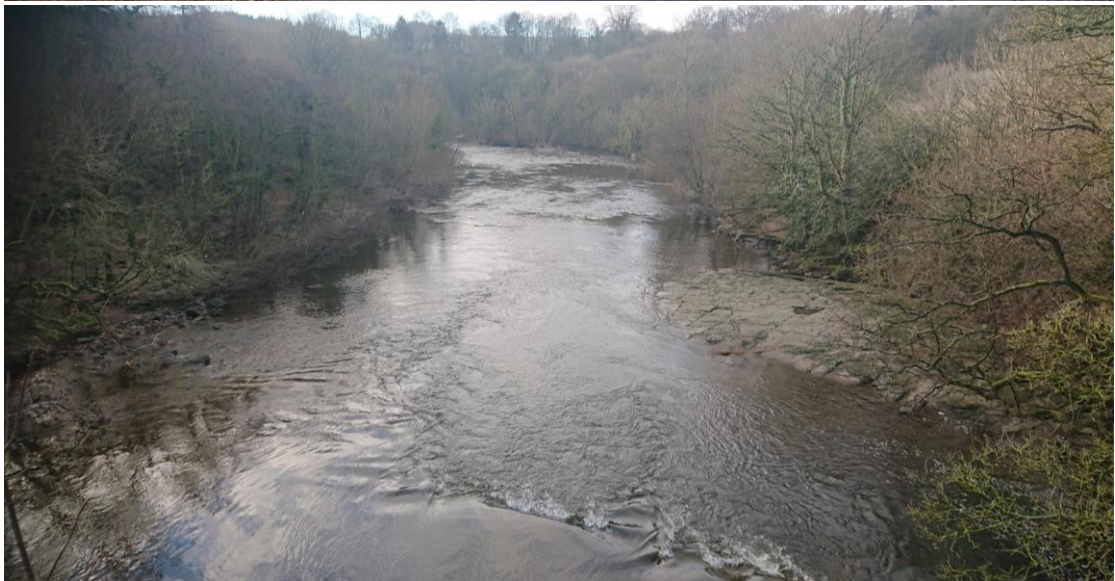
From the bend on Easby water (Fig 7), the river has been shifted unceremoniously from the LHS to the RHS of the valley, maintained on a straightened course to pass through the (disused) railway bridge at SE 18364 99887 (Fig 9). The straighter, steeper channel interacting with numerous bedrock seams has led to the creation of a series of low cascades interspersed with deep pools, and hence a diverse physical mosaic of habitats. However, the excessive erosive power appears to have stripped much of the valuable loose substrate that would be home to invertebrates and cast that aside onto the banks (esp RB, u/s of bridge; Fig 9) or down to the end of the straight, leaving only bedrock.

Fig 9. Looking u/s & d/s from the disused railway bridge at SE 18364 99887. The channel has been forced on a straight course from one side of the valley to the other and has cut across several seams of bedrock resulting in a variety of deeper pools amongst the faster riffles and small cascades. The oversupply of substrate has formed huge deposits for >200m on the RB u/s of the bridge (upper image).

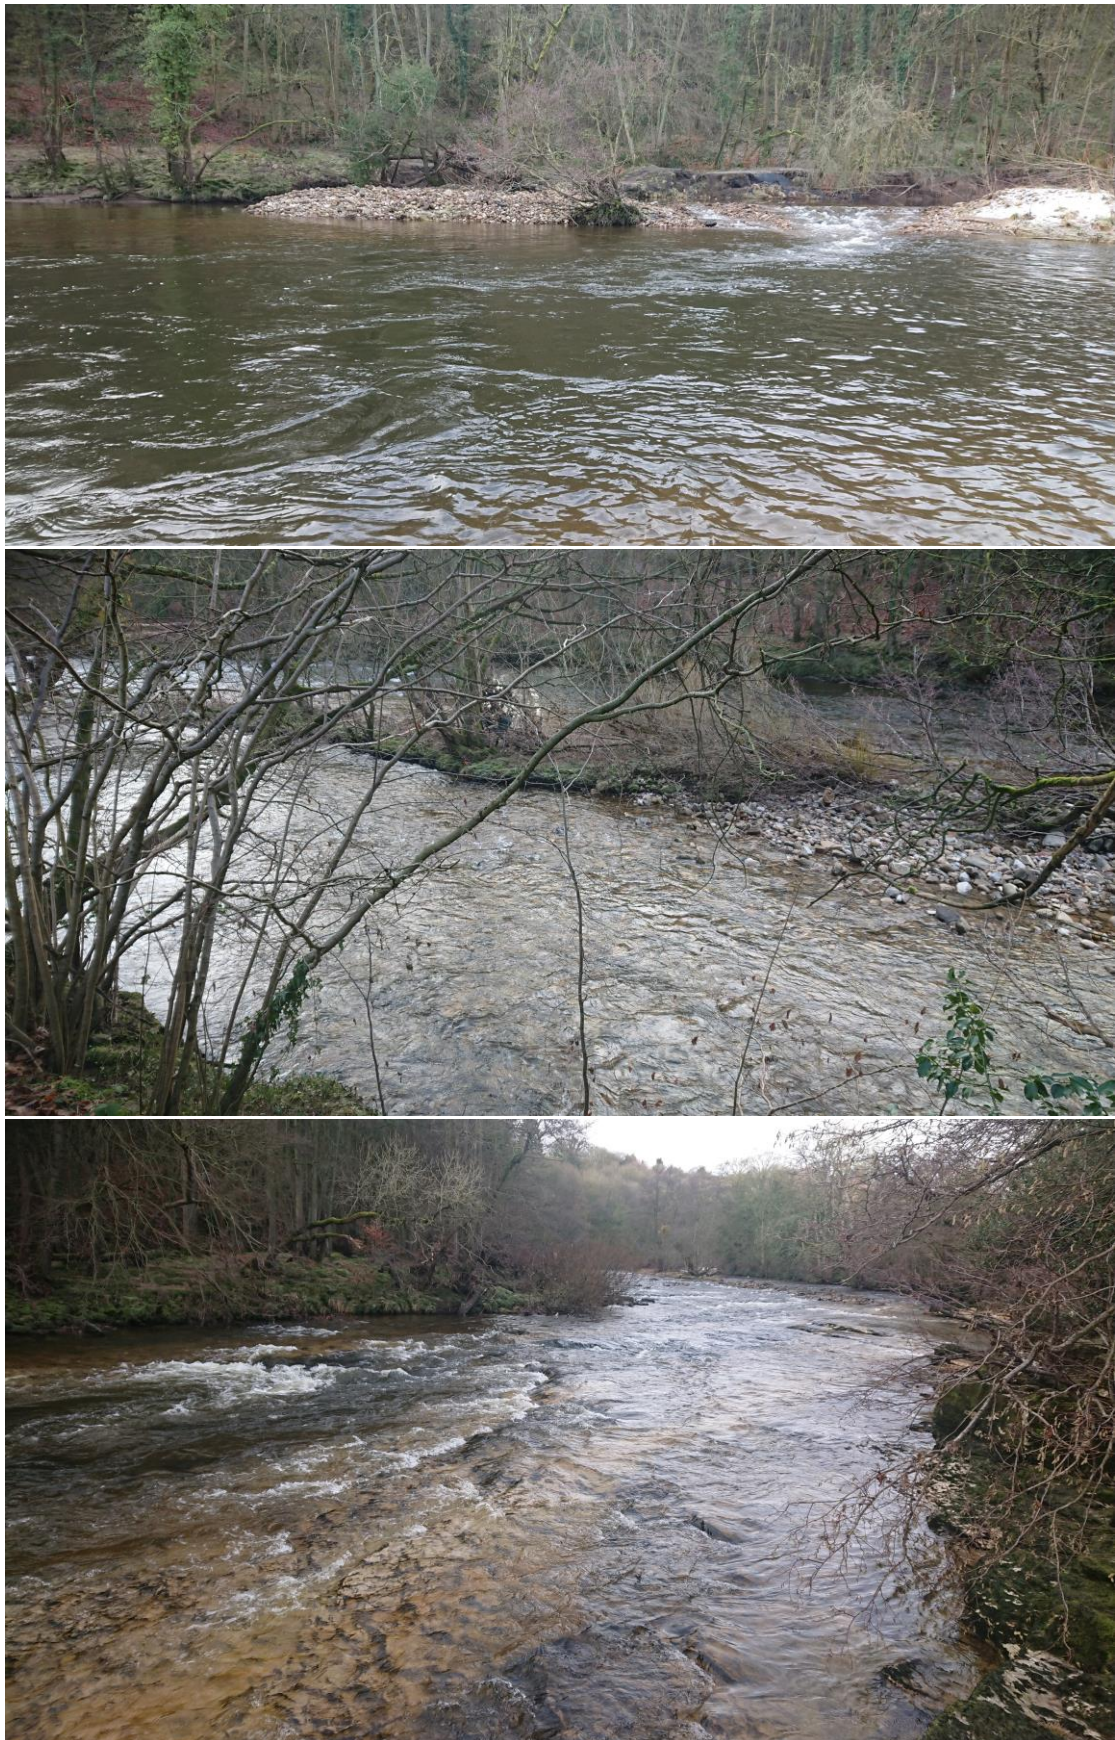
The abrupt left-hand bend of the Hagg Wood water has clearly received a considerable amount of the displaced substrate and there were numerous deposition bars, some more dynamic and some having been stabilised by alder and willow growth. Bedrock seams still played a considerable part too, and the channel retained a variety of physical habitat as a result (Fig 10).

Fig 10. On the Hagg Wood water, the channel turned abruptly left as it encountered the steeper valley side, and the habitat diversity and quality remained high because of the varied physical structure: bedrock seams and small deposition bar islands of varying stability. Riparian habitat quality was excellent also.

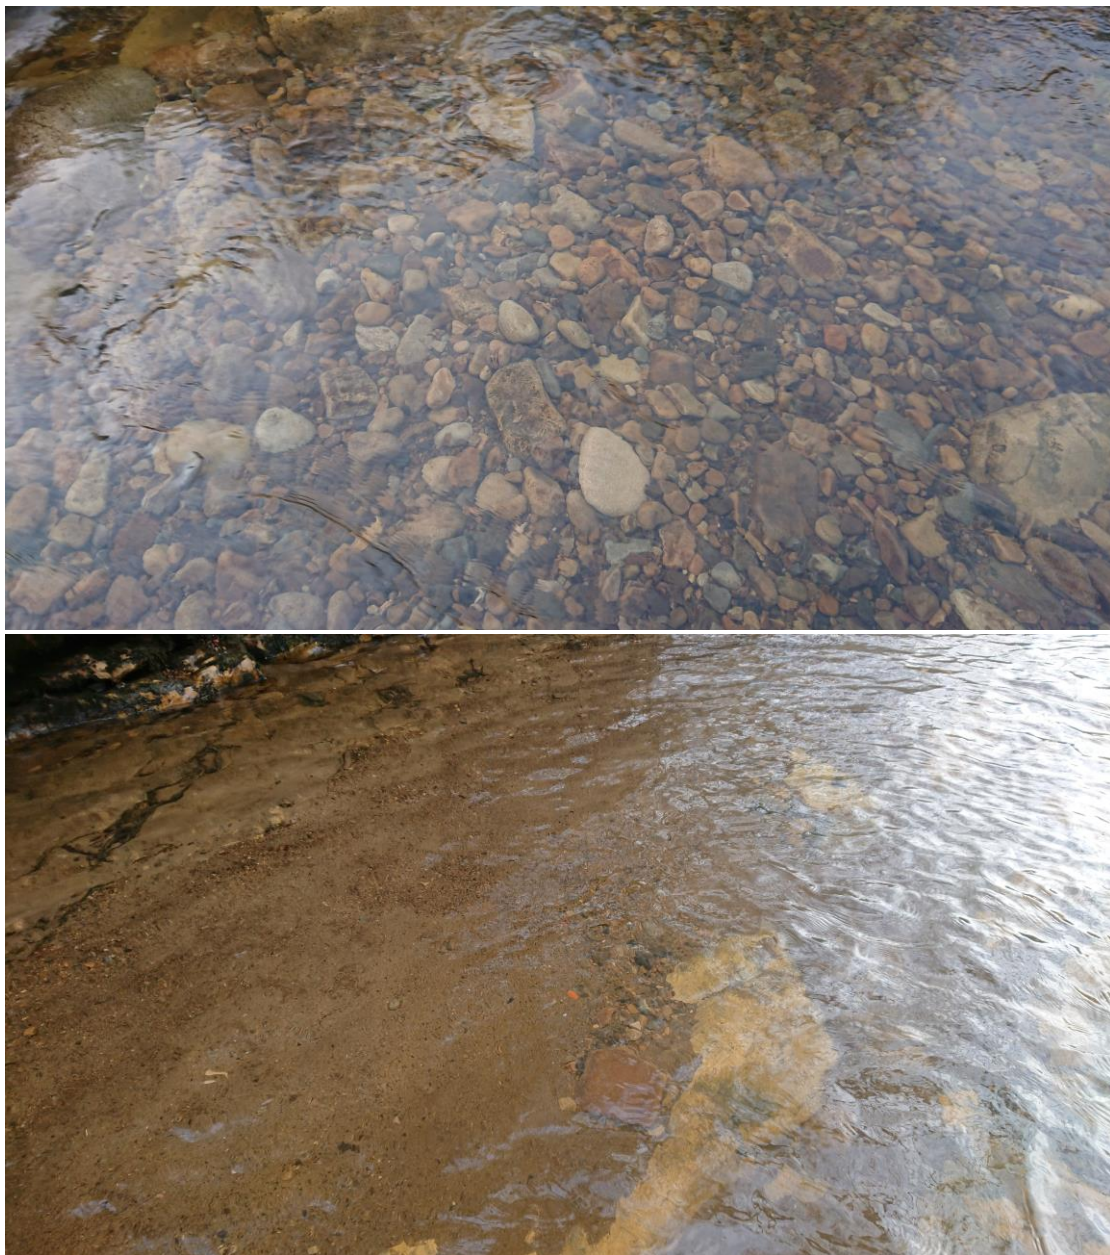
The varied physical structure imparted considerable flow diversity allowing for the sorting of sediments into discrete patches based upon size or density (Fig 11). Hence, there was likely considerable diversity of niches for different types of invertebrates (stoneflies and shrimp for example exploiting the interstices or gaps between the larger cobble and gravel, while burrowing mayflies and chironomid larvae would favour the finer sands and silts. However, given the highly dynamic and mobile nature of the substrate noted before, these patches of gravel may be too ephemeral for spawning habitat, especially for salmonids that create redds over winter.

Fig 11. That varied physical structure noted in Fig 10 allowed natural processes of sediment sorting to occur; separation of gravel and sand into distinct mosaic patches which would favour different invertebrate taxa. Gravel cleaned of silt and sand is required for successful spawning of salmonids and some coarse fish like chub and barbel but these patches may be too ephemeral in nature to offer potential.

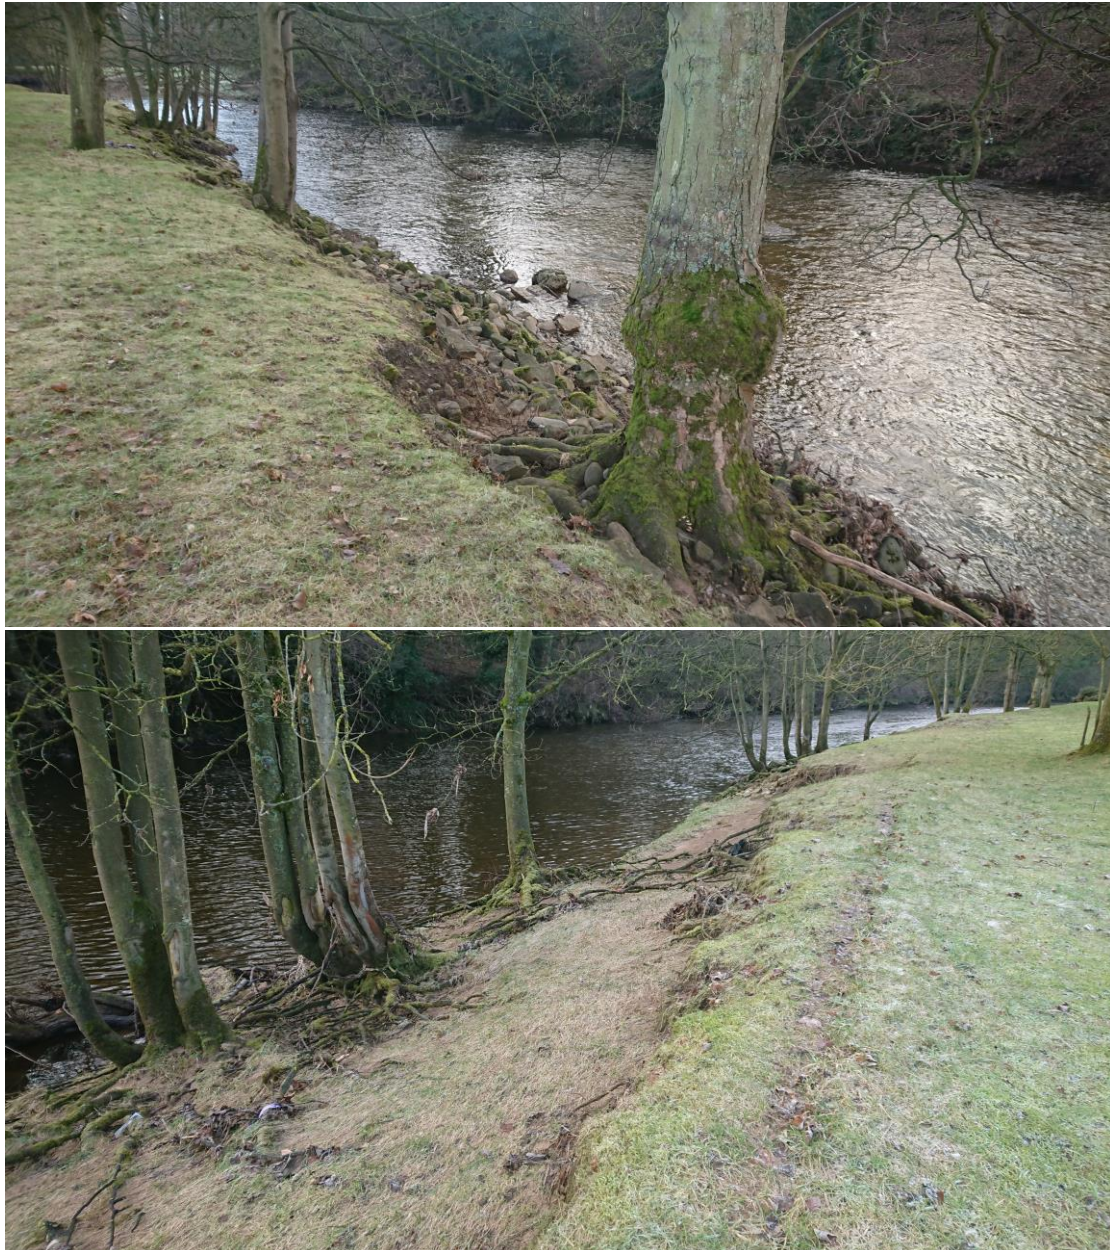
The remainder of the walkover through the Red House Farm water was conducted from the LB. Again, there was evidence of the channel being pinned to the RHS of the valley, probably to create contiguous parcels of agricultural land from the rest of the valley floor. As a consequence, the RB was steep and predominantly native deciduous woodland of mixed age structure, providing plenty of shade and some cover. D/s of the farm, the LB was highly formalised, a level plateau of short sward grass maintained by sheep, with a perilously narrow fringe of previously coppiced trees of mostly similar age (Fig 12).

Fig 12. The channel was pinned against the right-hand side of the valley for much of the Red House Farm water. The LB had a sparse fringe of more mature trees along the channel that were all suffering from exposure of their root systems due to livestock grazing and trampling. Eventually, these will be lost and, again due to the livestock, there was no self-set regeneration to replace them.

Grazing and trampling around the roots had weakened the integrity of the soils around the roots and allowed the river to erode around on the landward side, leading to the recent loss of some sizeable specimens. Continued grazing pressure was preventing any self-set regeneration of trees to help retain the stability of the bank. In time, the current aging trees will be lost and then there will be nothing knitting the bank together and preventing further lateral erosion.

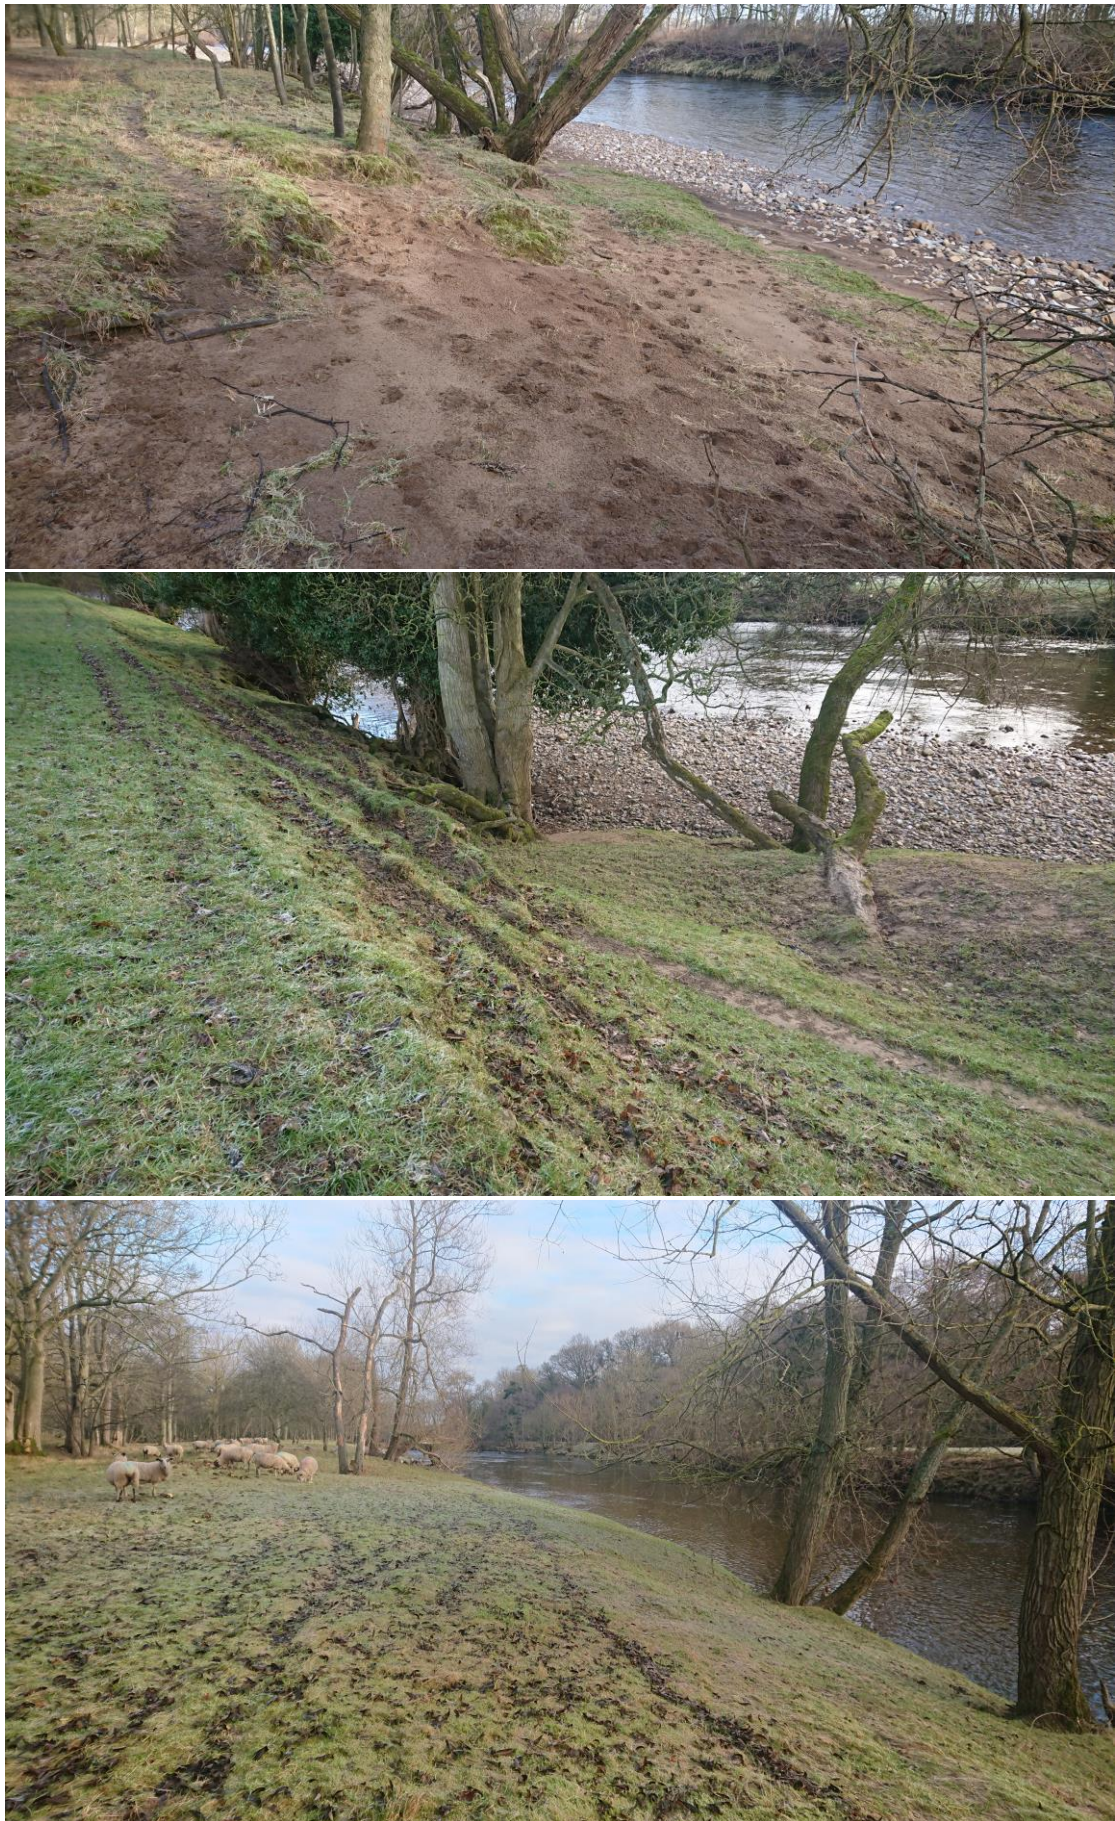
The high density of sheep maintained in a relatively narrow strip between the channel and arable fields adjacent was clearly having a detrimental impact: multiple desire line trails where the animals follow the same track continually, removing the vegetation and compacting the soils; continual disturbance of freshly deposited material from the river, preventing stabilisation by colonisation; and maintenance of a predominantly short sward of grass with poor root structure (Fig 13). In fact, at the time of the visit, the sward had been reduced to such an extent that supplemental feeding was required.

Combined, these factors leave the bank highly susceptible to erosion, and relatively smooth which does nothing to 'slow the flow' of water over the surface during spates. A more diverse herbage left longer over winter would impart hydraulic roughness helping to slow flow, trap sediments and increase resilience to erosion.

Fig 13. There was plenty of evidence of the damage that sheep can do to river banks which leaves the friable soils more susceptible to erosion: continued disturbance of unconsolidated material (upper); desire line tracks weakening the integrity of the soil (mid); and maintenance of short sward grass with poor root systems (lower).

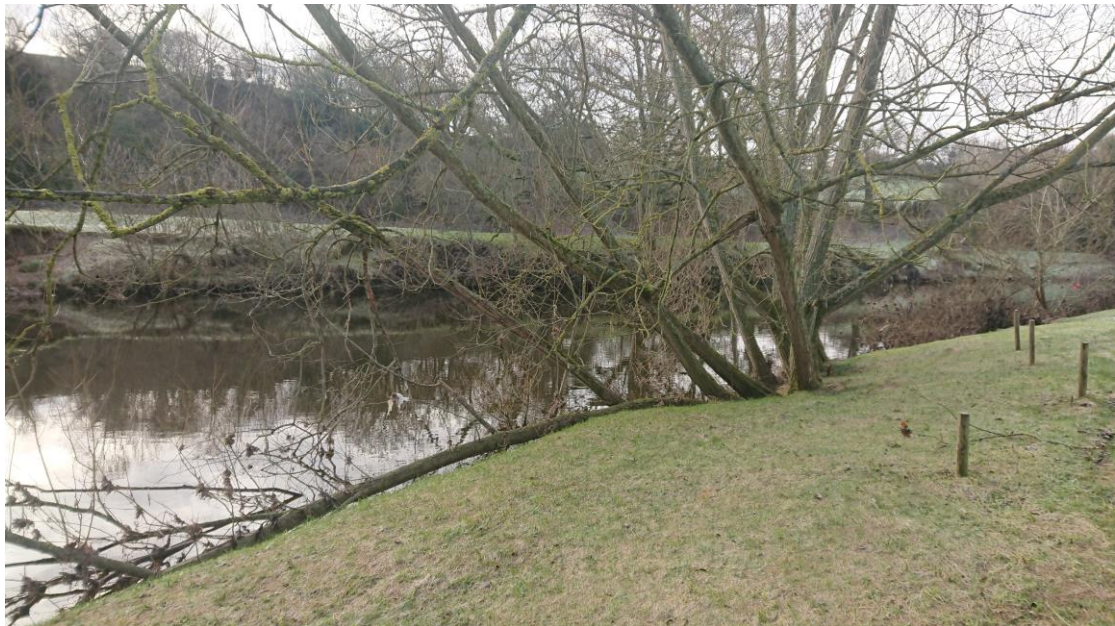
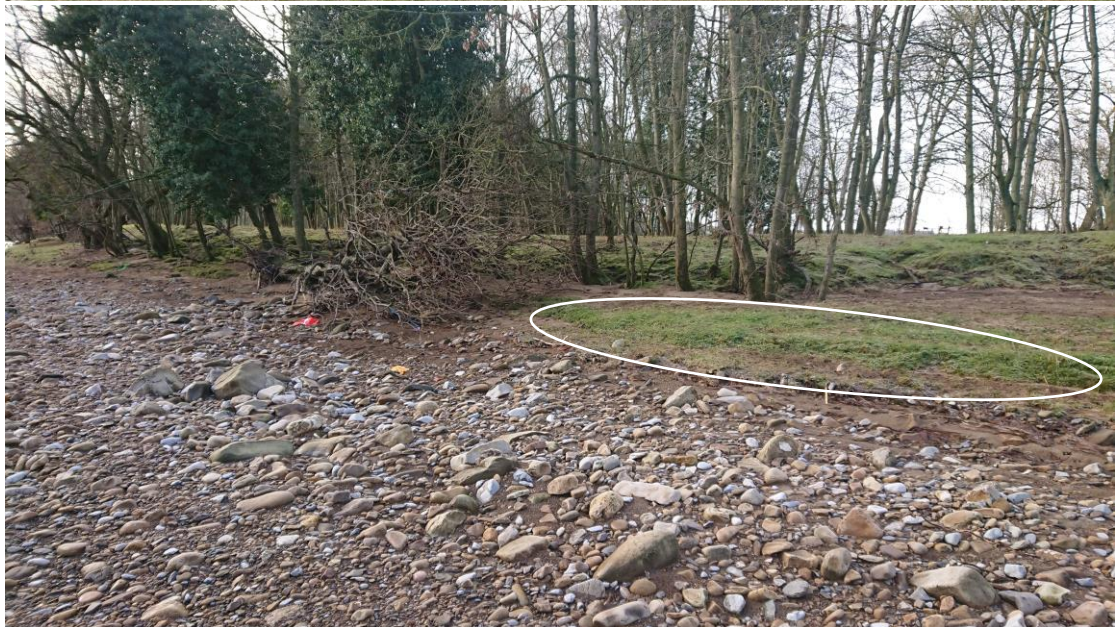
Towards the d/s limit, tree cover on the LB increased and there were several large, multi-stemmed crack willow specimens, some of which had leaning and laid trunks. The benefits of retaining these *in situ* were evident at the site; protecting the bank and/or causing the deposition of sediments in their lee (see Fig 14). Crack willow is relatively easy to work with, and further trunks that were already leaning at a d/s angle over the channel could be laid with a living hinge into the channel to provide valuable physical diversity in what was otherwise a relatively straight and uniform reach with limited refugia for fry / juveniles.

Fig 14. Towards the d/s end of the Red House Farm water, there were many multi-stemmed crack willows that were either laying naturally or could be encouraged to do so to diversify instream and edge habitat. A small, naturally laid and still living tree (lower image) appeared responsible for the retention of the bank on the d/s side (area highlighted by the white oval), although sheep grazing and trampling were degrading it.
