WILD TROUT TRUST

Advisory Visit

River Swale, Richmond & District Angling Society, Jan 2021

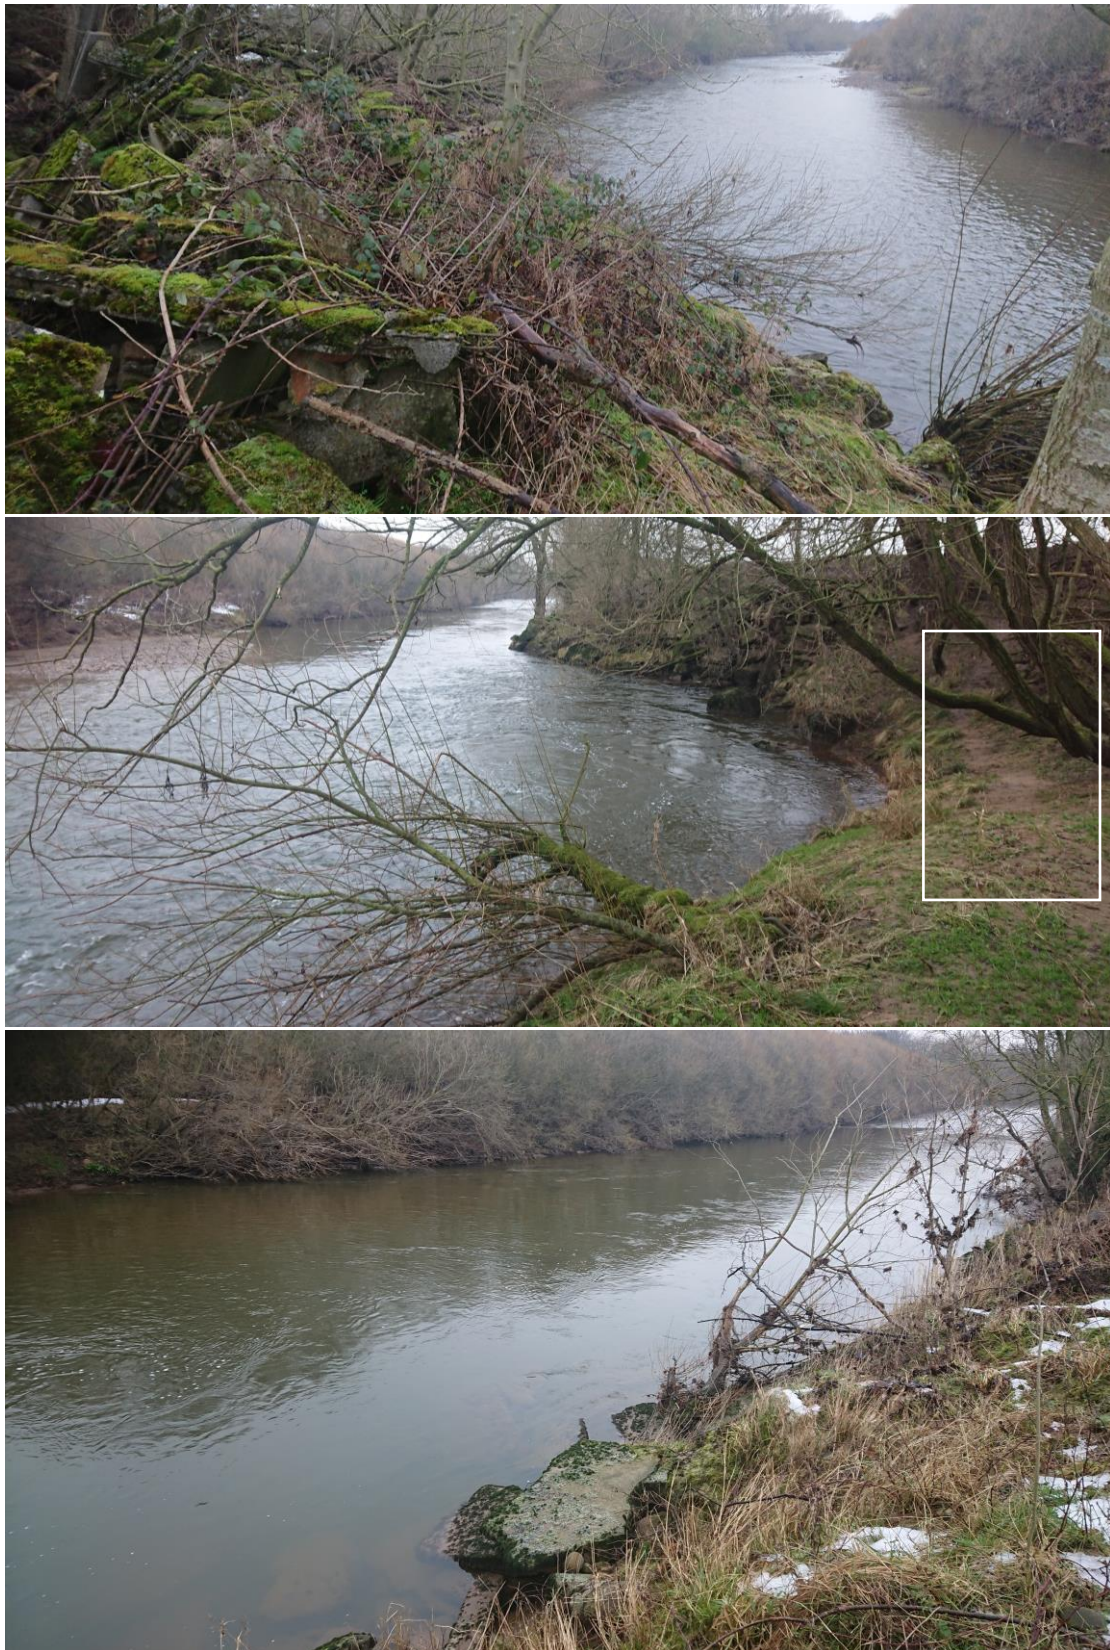
The full extent of the Great Langton water was examined from the RB. The river was much more uniform in character: long straightened sections with relatively long sweeping bends fixed in position by various methods of revetment with varying degrees of success. As a consequence, the substrate for the most part was evenly spread across the full wetted width of the channel and there was little apparent variation in depth – long, continuous glide habitat. The only marked exceptions were deeper holes on the outside of some of the bends, particularly toward the u/s end, where tonnes of concrete slabs from the former army garrisons had been piled onto the bank top and into the river as bank ‘protection’ (Fig 15). Preventing lateral movement has resulted in downward scour (see Fig 2 inset), thus creating the pools, but such hard revetment also transfers the energy d/s rather than absorbing or dissipating it, hence causing issues elsewhere. The artificial bank also prevents much of the natural vegetation from establishing, instead favouring ‘pioneer’ species that can tolerate high disturbance, such as bramble, nettle and Invasive Non-Native Species (INNS) like Japanese knotweed that appeared rife along both banks. Some small willows had managed to eke out an existence but with poor rooting options, there appeared to be an upper limit to the size these specimens achieved.

Fig 15. Various example towards the u/s limit where the RB top and face was predominantly concrete slabs dumped on the bank as 'protection'. Willow and bramble had managed to eke out a niche and establish some cover, but where sheep had easy access (eg middle image, white rectangle highlighting path), the cover was reduced and desire lines indicated weakening of the bank structural integrity.

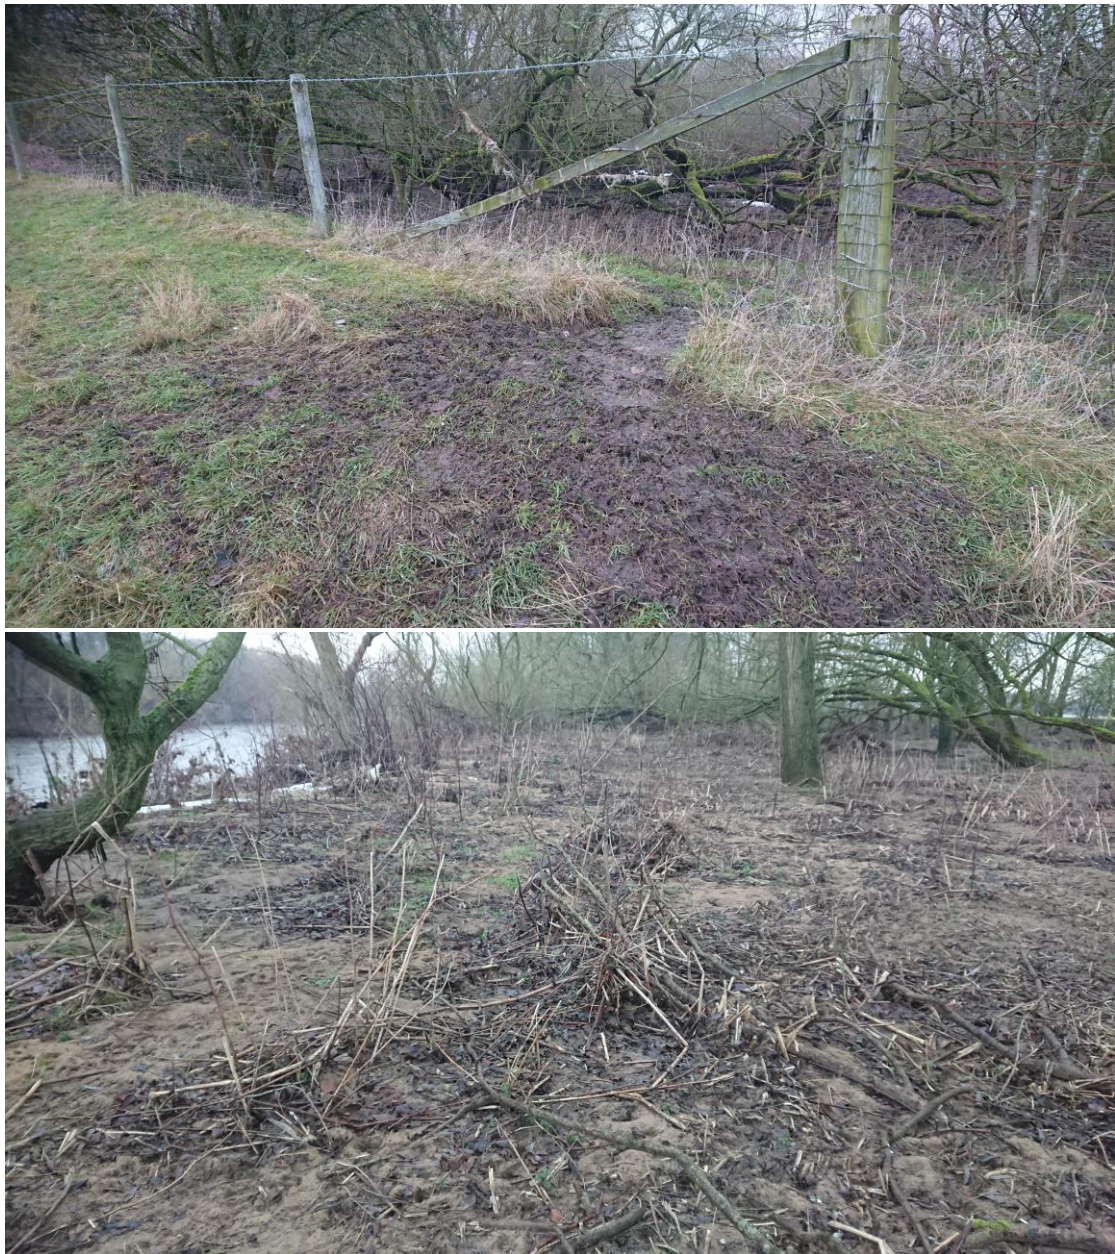
The understorey was clearly impacted by almost continuous grazing (Fig 16). Fencing was evident along much of the upper reach on the landward side of the flood bund but was in such a state of disrepair as to be ineffective at excluding stock. As for the u/s reaches, this left much of the bank less resilient to spate flow and here, compounded also by the presence of Japanese knotweed. Some might argue that allowing sheep to graze helps to control INNS but they were clearly having negligible impact. Reinstating protection from grazing via a functional fence-line would remove one stressor on the riparian environment.

Fig 16. Dilapidated fencing was apparent, especially towards the u/s end, but was not preventing sheep from accessing the riparian zone. The sandy deposits within were pockmarked with spoor. Such continual disturbance over winter will contribute to soil mobilisation and loss during spate events, and during the spring / summer, there would be little chance of any colonisation by understorey plants (aside from Japanese knotweed – see later) to help stabilise the banks.

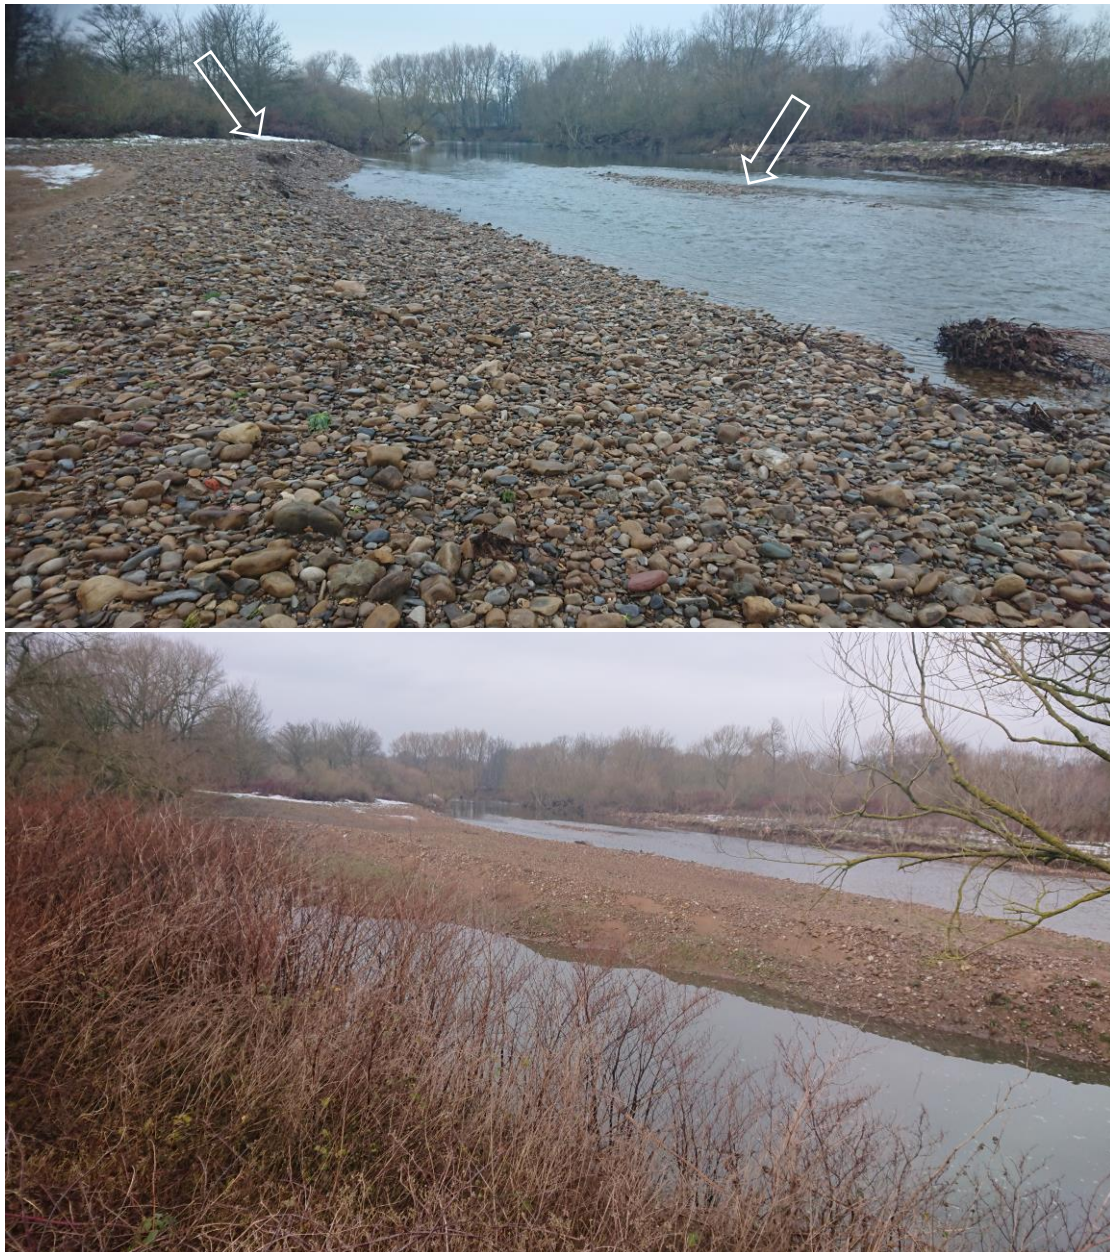
The other notable feature on this water was the ongoing modification of the channel and banks via gravel and cobble removal (Fig 17a&b). Dredging does not solve the problem of sediment deposition. Creating a deeper hole in a channel at a particular point will simply encourage greater erosion and supply of substrate from u/s to restore equilibrium. Over-widening a channel will simply cause the flow energy to be dissipated further and hence encourage the deposition of new sediment. This was clear at SE 28350 96667. Using unconsolidated material dredged from the river to create banks and prevent erosion elsewhere is similarly futile (Fig 17a&b).

Fig 17a. An enormous cobble and gravel bar at SE 28350 96667 where the river has recently changed course or, perhaps more likely, been encouraged to do so, straighter rather than arcing around the RB. There was evidence of substantial slumping of the unconsolidated material and deposition in the overwidened channel (arrows, upper image) indicating the river was already trying to return to its natural dimensions and previous course.

The channel in the foreground of the lower image was being maintained by inflow from Fiddale Beck, piped through the flood bund (Fig 17b).

Note the extensive stand of Japanese knotweed (reddish stems).

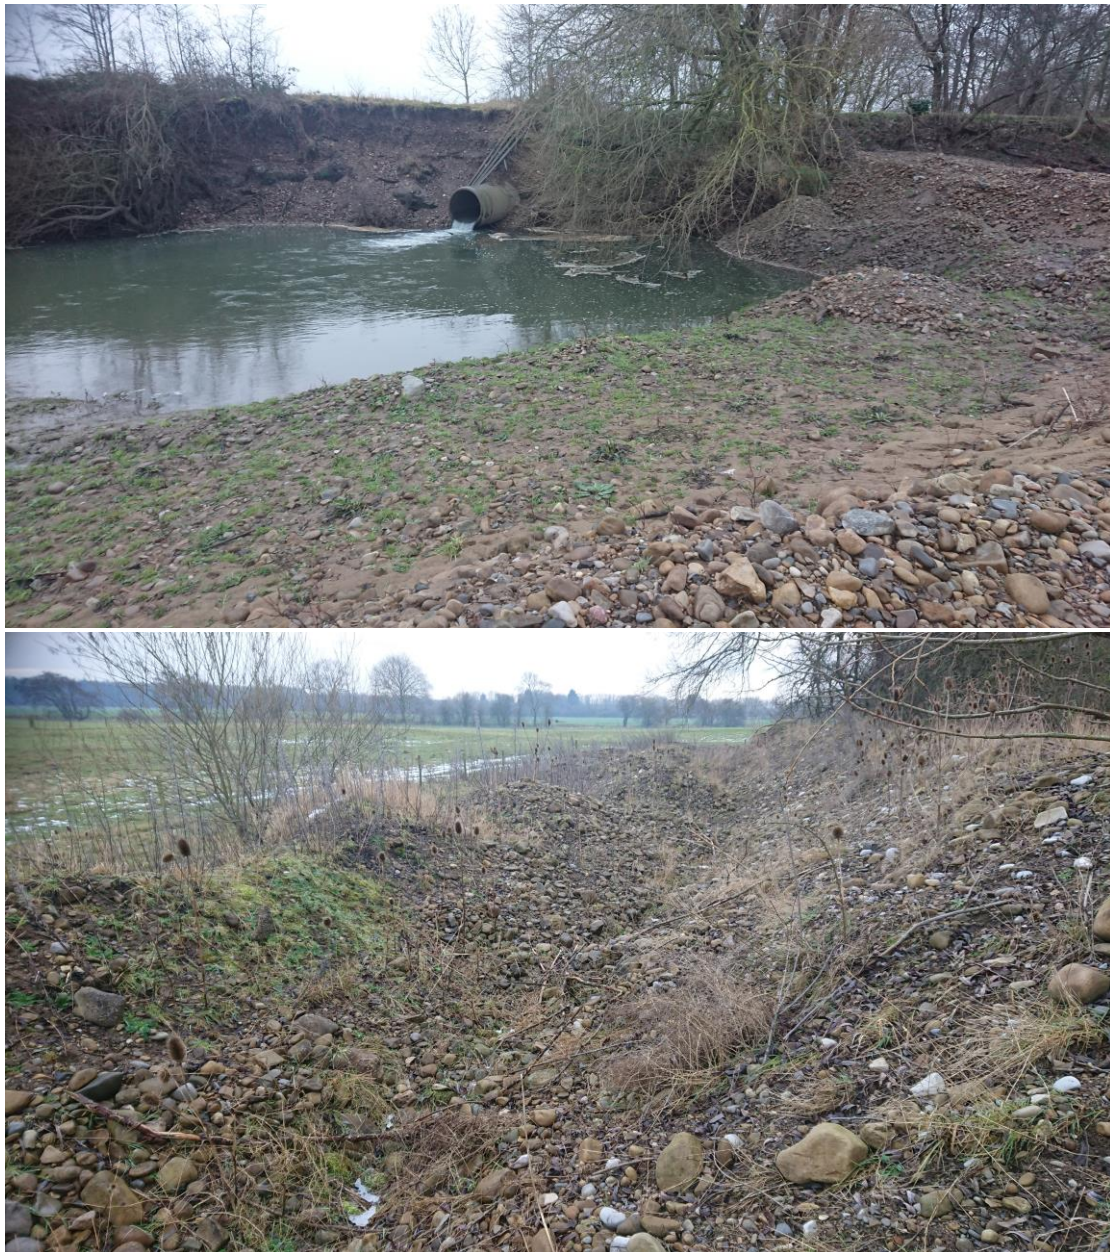
Fig 17b. Upper: the 'confluence' of Fiddale Beck with the Swale, piped unceremoniously through a perched culvert. There was evidence of recent and ongoing plant activity shifting substrate around , presumably in a futile attempt to protect the culvert pipe environs.

Lower: there was also considerable evidence of cobble and gravel having been removed for bolstering the flood bunds.

Fiddale Beck would once have been an important tributary, meandering across the floodplain and offering a contrasting lower energy environment compared to the mainstem Swale for spawning and juvenile nursery habitat. Unfortunately, it too has been highly modified for >150y; an upper network of smaller tributaries straightened into a series of drains around fields (with no visible buffering) and the lower 1km of channel bunded and latterly piped via a culvert into the Swale (Figs 17b&18). The culvert pipe was of insufficient diameter to accommodate all flows and set at an inappropriate depth; too high for the beck causing severe impoundment and siltation upstream, and perched above the Swale.

The structure has effectively disconnected the beck from the mainstem river, creating a virtually impassable barrier to fish movement.

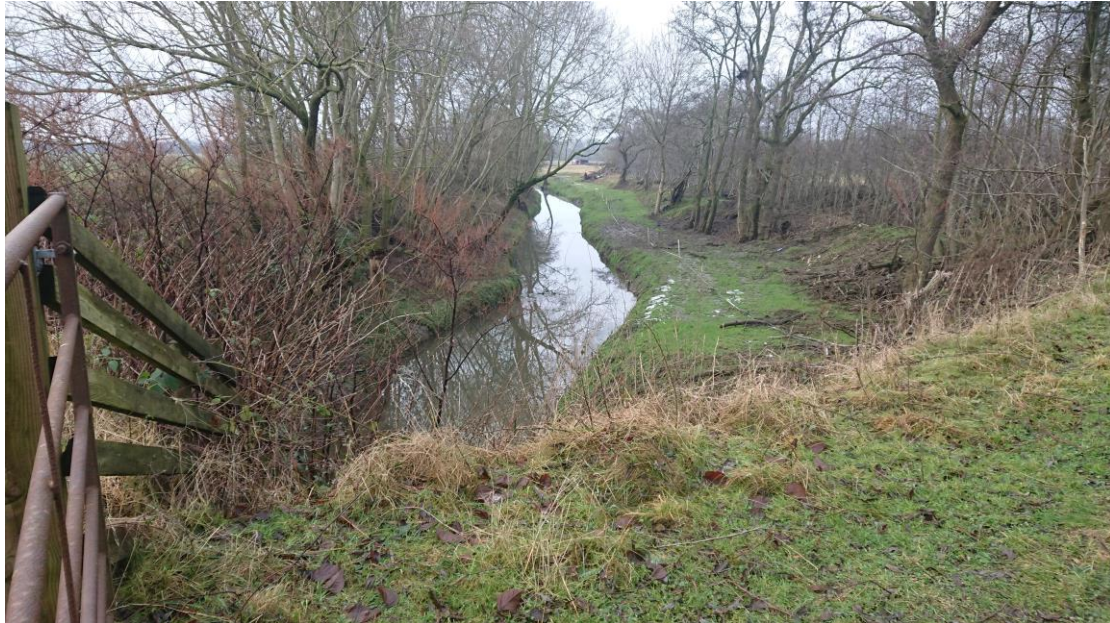
Fig 18. Looking upstream along the straightened and dredged channel of Fiddale Beck from the vantage point on top of the Swale flood bund and almost directly over the top of the culvert that links the two.

Flow was restricted by the culvert aperture, causing significant and extensive impoundment and hence sedimentation along the channel. An apparent lack of buffer zone, aside from the short (visible) reach on the RB, indicated that sediment ingress was highly likely u/s.

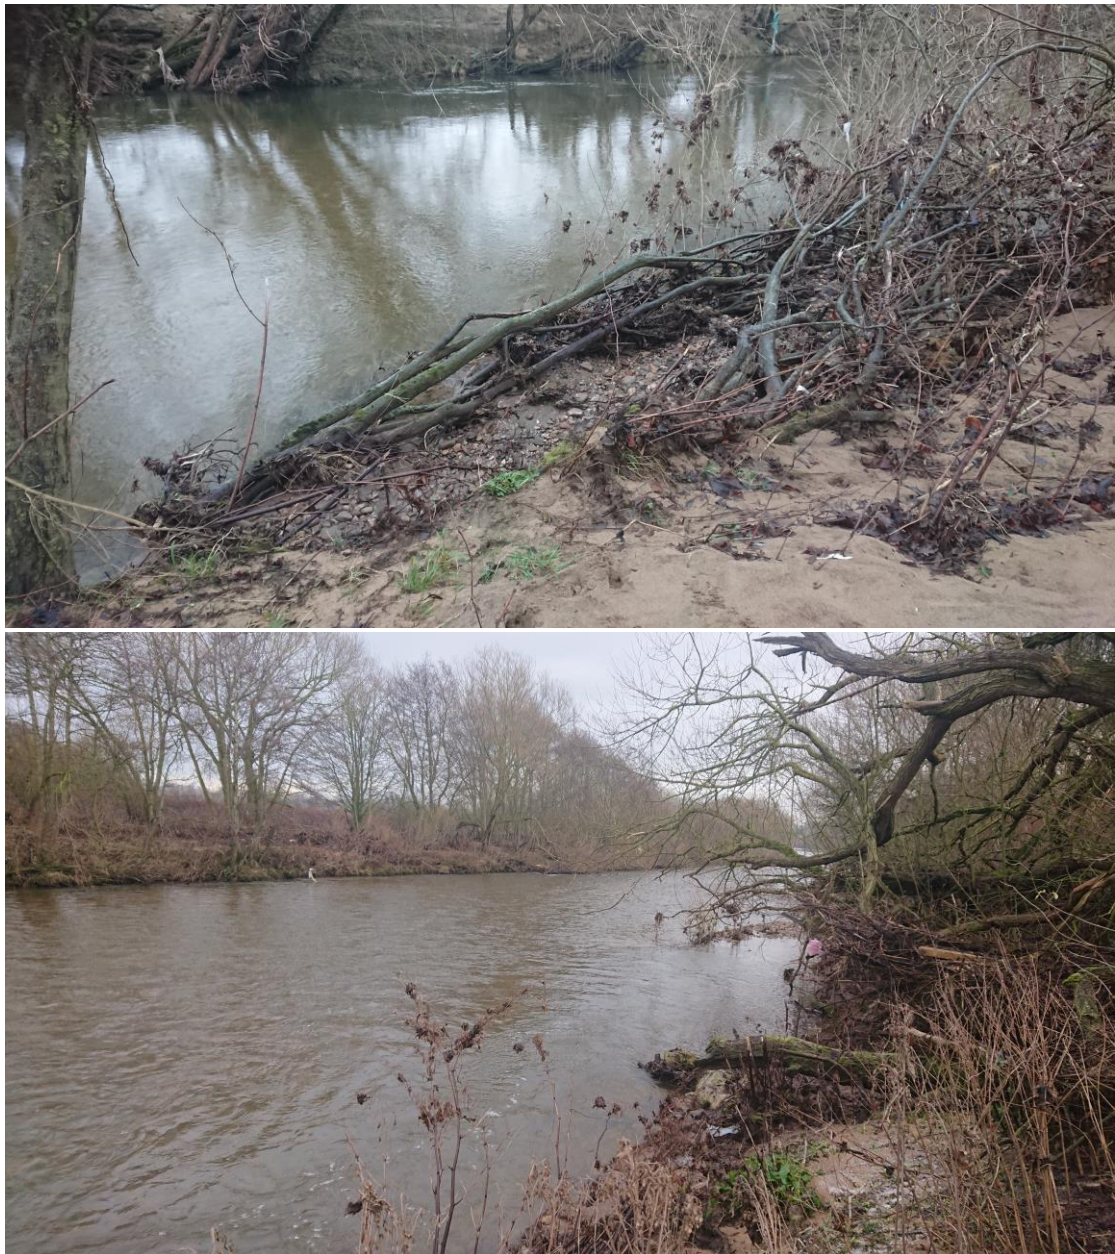
On the lower reaches towards Great Langton bridge, there were further areas of lower-lying riparian habitat 'inside' the flood bunding where willow and alder had established wet woodland, and mature trees were growing from the toe of the bank at the water's edge (Fig 19). Root boles would help stabilise the banks as well as providing valuable cover for fish. Smaller trees laid by high flows along the edge of the channel performed a similar role but the extent of cover was limited. Again, more recent deposits of sand from the river were left exposed and continually disturbed caused by the twin stressors of Japanese knotweed and sheep (Fig 20). The density of stands and sheer extent of the knotweed was concerning. It was mapped and reported via the Yorkshire Invasive Species Forum immediately after the walkover.

Fig 19. Mature willow specimens on the LB created some deeper water and cover around their roots. Small crack and goat willow specimens at the bank toe were providing the only other physical structure and cover within the channel but the extent of this was generally limited to within a metre or so from the bank. These images indicate how the complex of roots and branches trapped debris and caused the deposition of finer sediments (sand and gravel). Unfortunately, a combination of livestock trampling and Japanese knotweed had prevented further stabilisation of these sediments.

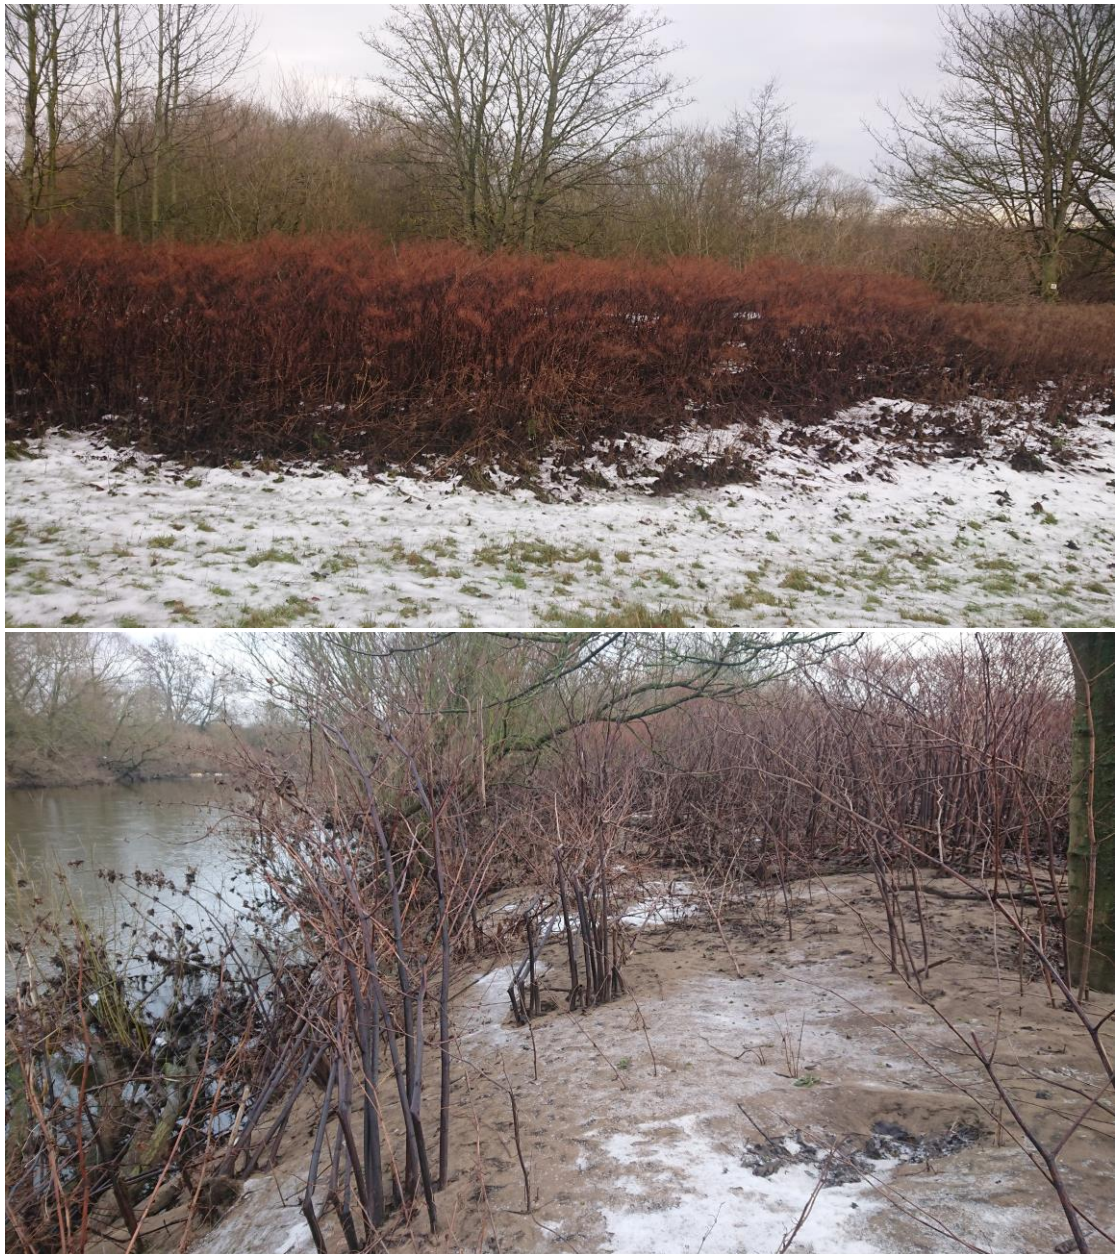
Fig 20. The extent and density of Japanese knotweed along the RB on the lower reaches, and the bare sand beneath.

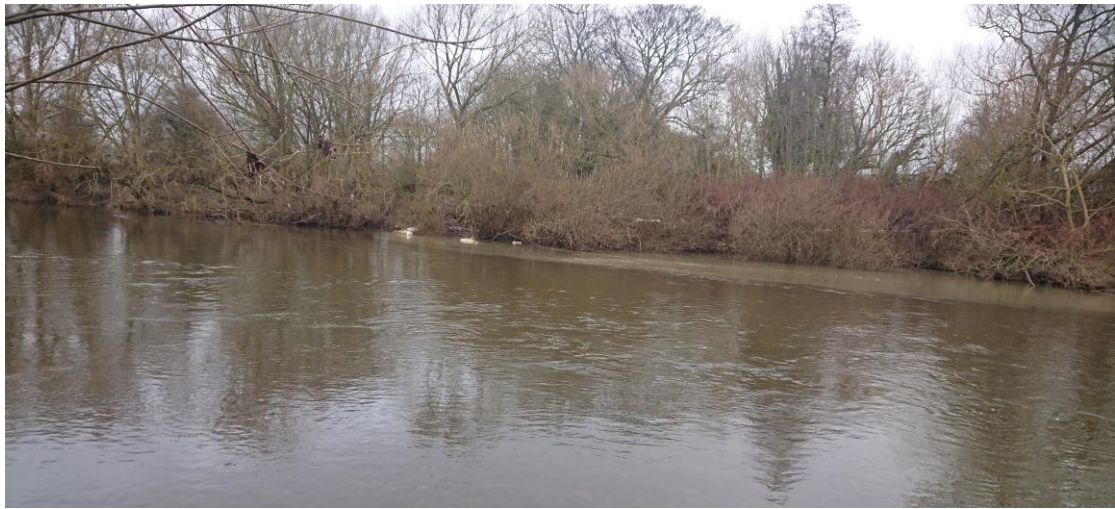
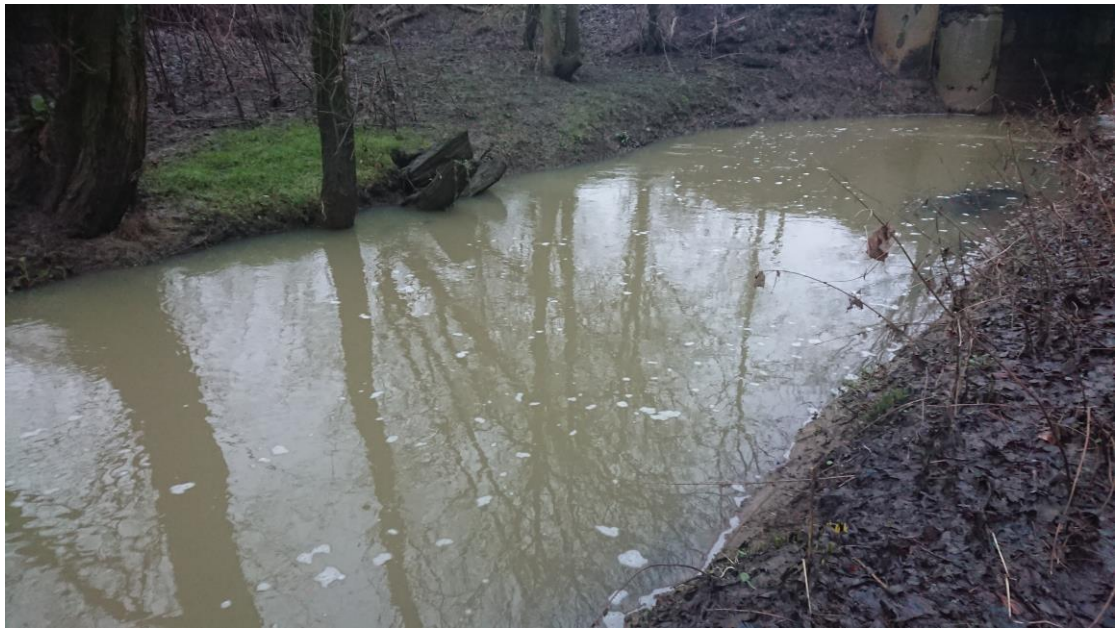
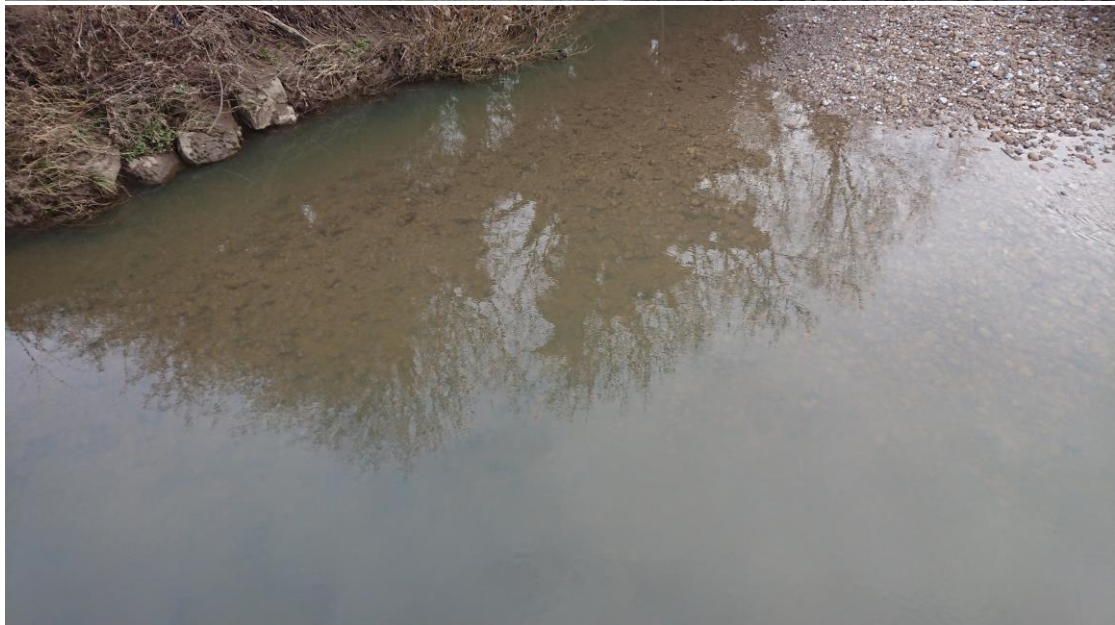
Almost at the d/s limit, Kiplin Beck was assessed at its confluence on the LB (Fig 21). It was highly turbid and contributing a considerable suspended sediment load at the time of the walkover, reported via the Environment Agency National Incident Reporting Service (0800 807060). The extent of discolouration of the water column and silt on the bed at the bridge indicated a chronic problem.

Fig 21. Upper: a plume of discoloured water caused by high suspended solid load was plain to see below the confluence of Kiplin Beck. Mid: Kiplin Beck was affected, bank to bank. Lower: immediately d/s of Great Langton Bridge, along the LB toe of the Swale, the fine sediment from Kiplin Beck was smothering the bed of the main river.

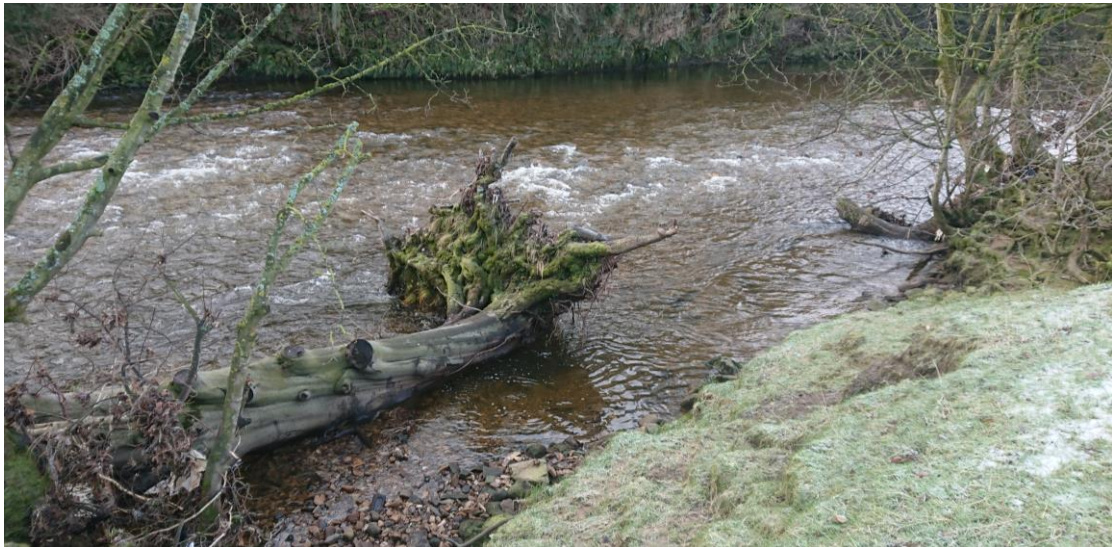
Fig 23. An almost intact tree retained on the inside of the (slight) bend and hence the more depositional area (Red House Farm water), providing localised scouring around the bole and cover under the roots and trunk.

It was notable throughout the walkover that retention of large wood in the channel was relatively scarce, despite a rich potential supply from the wooded sections of bank. Whether that was due to removal from a perceived flood risk management perspective or simply the power of the Swale along a modified channel in full spate could not be ascertained; most likely a combination. However, there were one or two examples where sizeable material had been retained naturally, either as 'debris' (see Fig 23) or still attached via a living hinge (eg Figs 3 or 13). Wood fall and associated habitat can be simulated by

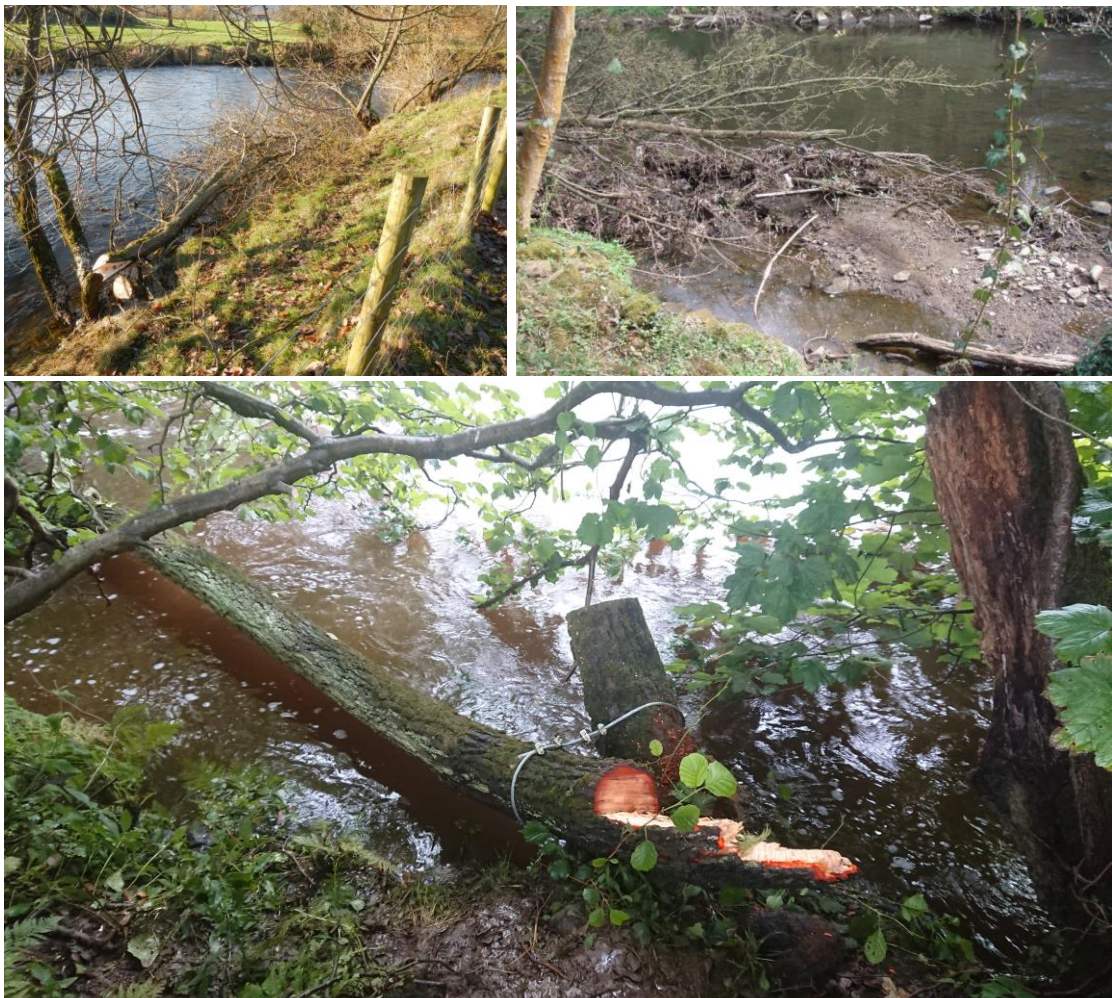
Fig 24 LH upper - hinged trees laid into the margins; RH upper- the impact of the crown of a tree kicker encouraging deposition in the lee and providing complex refuge habitat; Lower - felled alder and cabled back to living stump.

hinging pliant species (eg willow) or felling and tethering trunks back to the their living stump or adjacent trunks (Fig 24).

Any activity like this requires careful planning and consent from landowner and the relevant authority (in this case, the Environment Agency for work on main river) but can be achieved relatively easily and cheaply. Appropriate areas where this type of habitat improvement might be attempted would be: Station Bend to fence end, lower parts of Red House Farm, and the Great Langton waters. Working with previously coppiced, multi-stemmed trees is advantageous as the felling of one or two trunks does not alter significantly the aesthetic or shading function. The anchor point can also be protected by trunks on the u/s side.
