Newsletter of **Environmental, Disaster, and Crises Management Strategies**

The Mw 6.6, July 21, 2017 Kos Earthquake Scientific Report (Version 2.0)

EARTHQUAKE INFORMATION, EARTHQUAKE ENVIRONMENTAL EFFECTS AND BUILDING DAMAGE

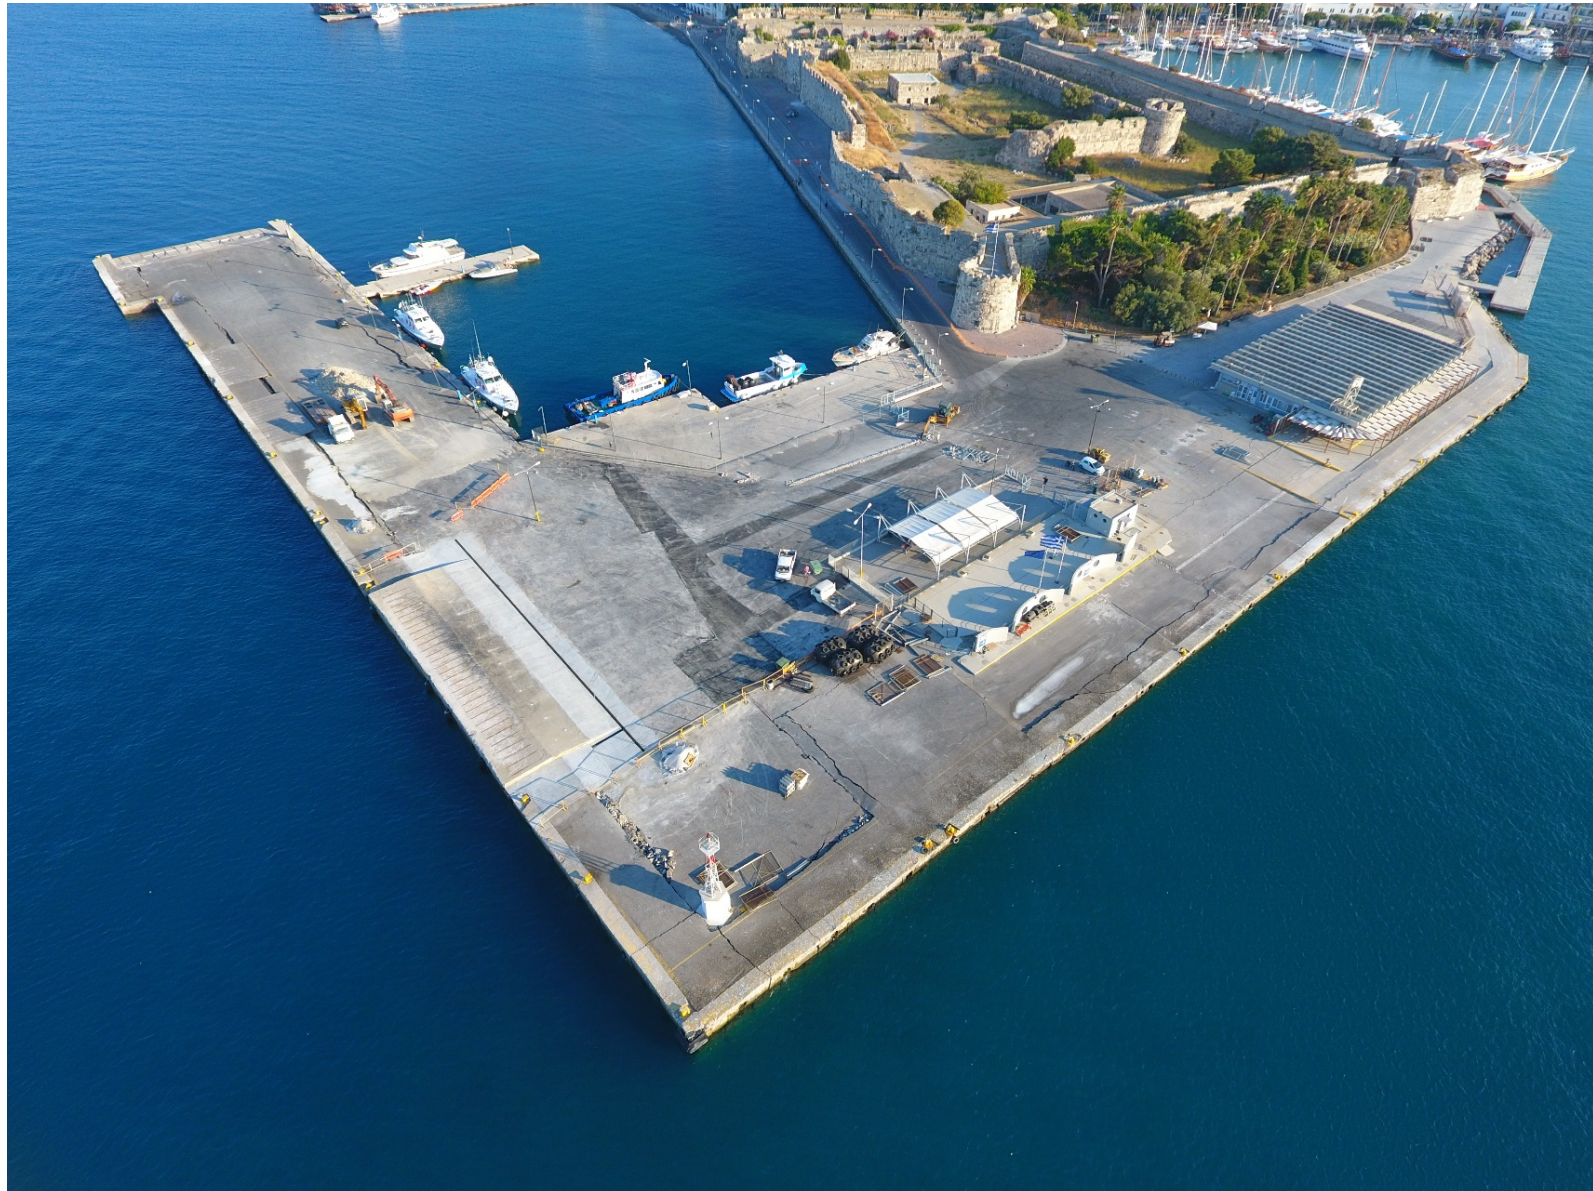
DAMAGE TO KOS PORT

Kos port and related facilities underwent failures including longitudinal cracks of the jetties parallel to the seashore, detachments and displacements of the quay seawalls as well as significant subsidence.

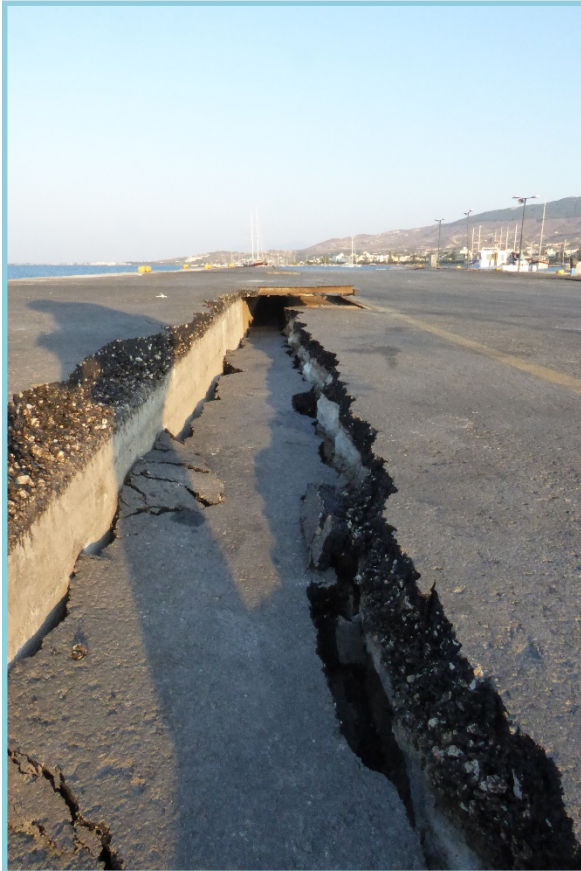
▲ No horizontal deformation along the plane and perpendicular to the surface of the retaining wall was observed. A vertical subsidence attributed to the dynamic consolidation along with liquefaction of the fill material may be observed.

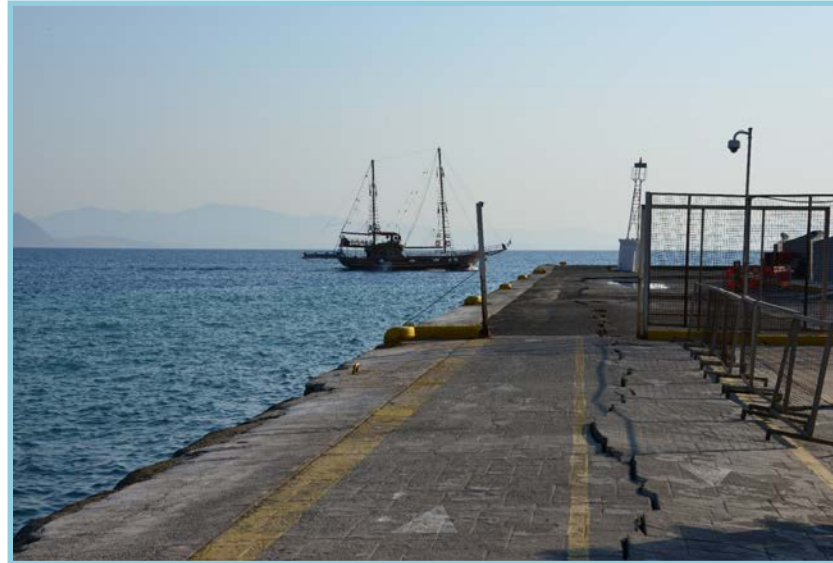
◀ The quay seawall is not disturbed at both horizontal and vertical planes and along its length. This indicates that there is not any major structural damage of the quay seawall.

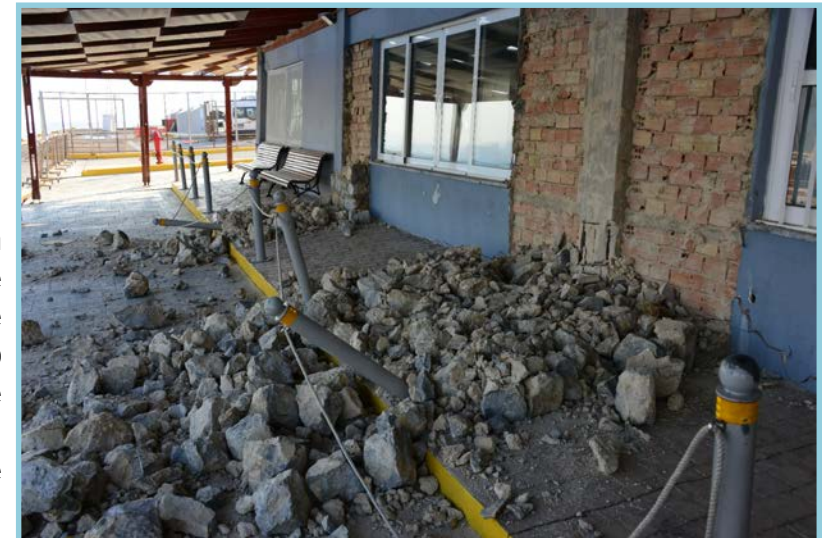
▶ The direction towards which debris of rigid bodies collapse shows the location of the epicenter. The debris of two walls collapsed and present the same orientation. They fell parallel towards the same direction.

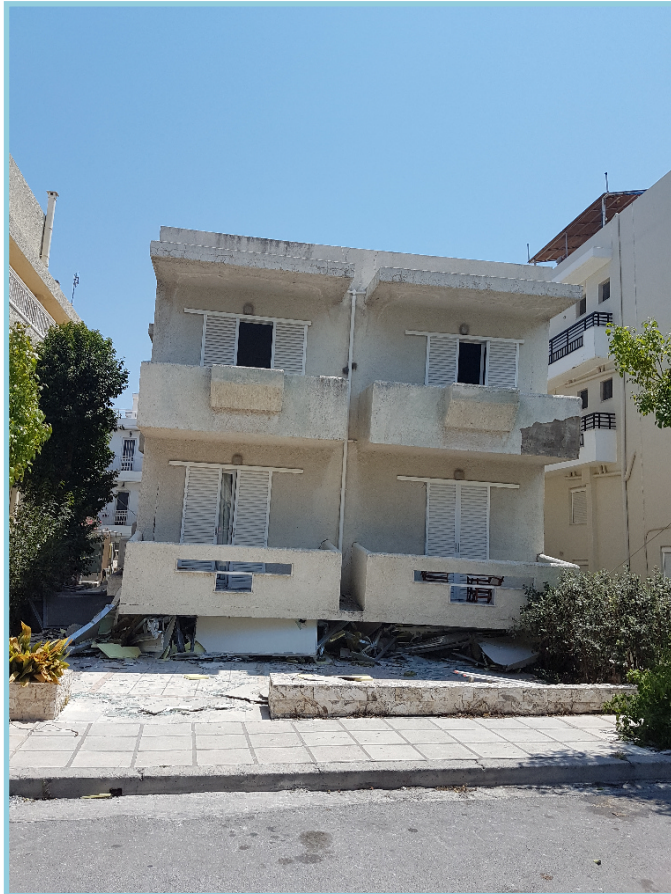
Two stories were added at a later stage on an existing weak ground floor. The ground floor totally collapsed being squeezed, while the two upper stories suffered relatively no damage.

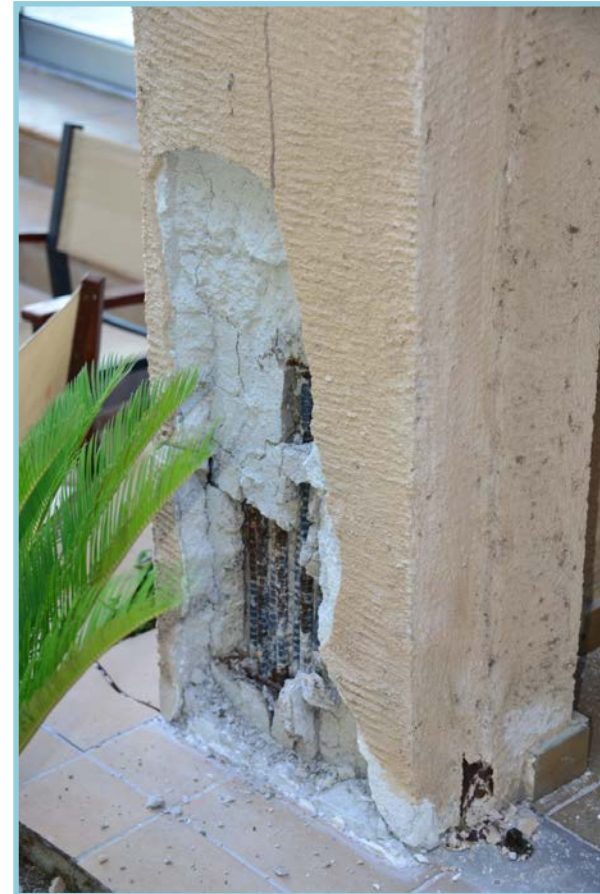
Spalling of the concrete cover attributed to concentration of many steel bars without retaining the appropriate distance among them. Steel corrosion and the resulting bloating of bars is also observed.

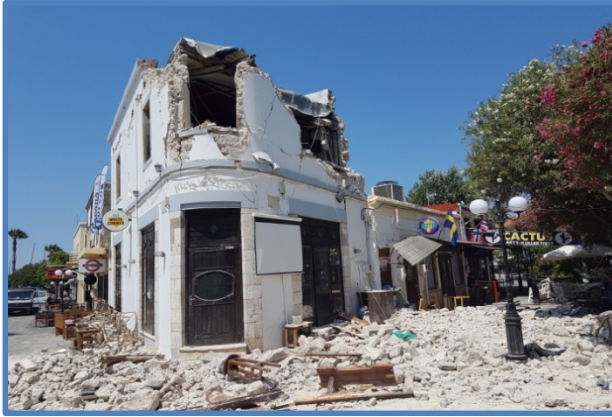
The down-town areas, where the historic centers of cities are located, offering a romantic atmosphere, old houses are hardly transformed into restaurants and bars where people crowd. The earthquake threat in the most of the cases is ignored. The reason of a partial or total collapse of the structure, which in the most of the cases, result in fatalities and injuries, is common: lack of maintenance and non-proper human interventions.

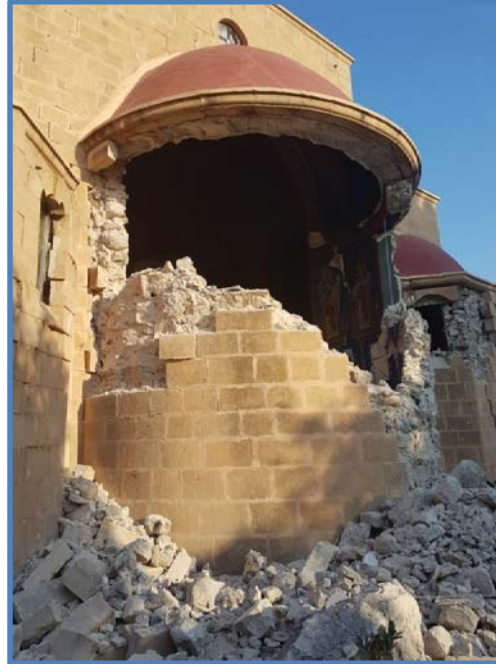
The symmetrical damage of the wall of the chancel arch indicates the prevalence of the vertical component of the earthquake ground motion.

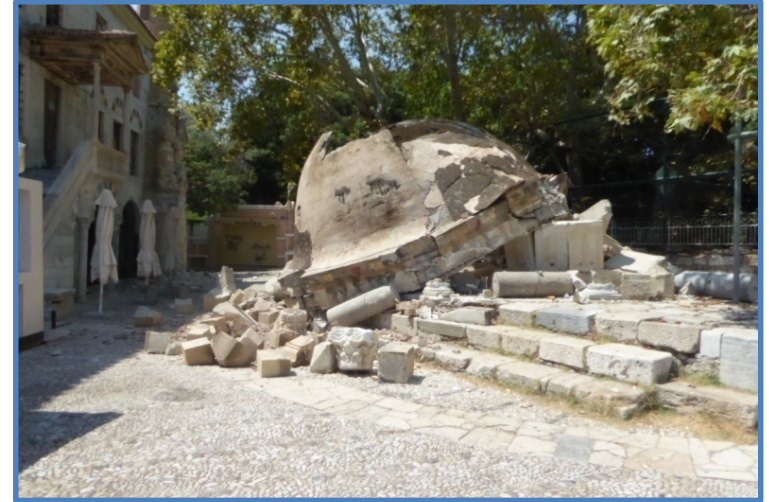
The fountain of Hippocrates. Very strong and heavy cup over slender and weak columns, without adequate column to cup and column to ground connections. Moreover, the connections between consecutive architectural elements (vertebrae) is realized mainly by simple friction.

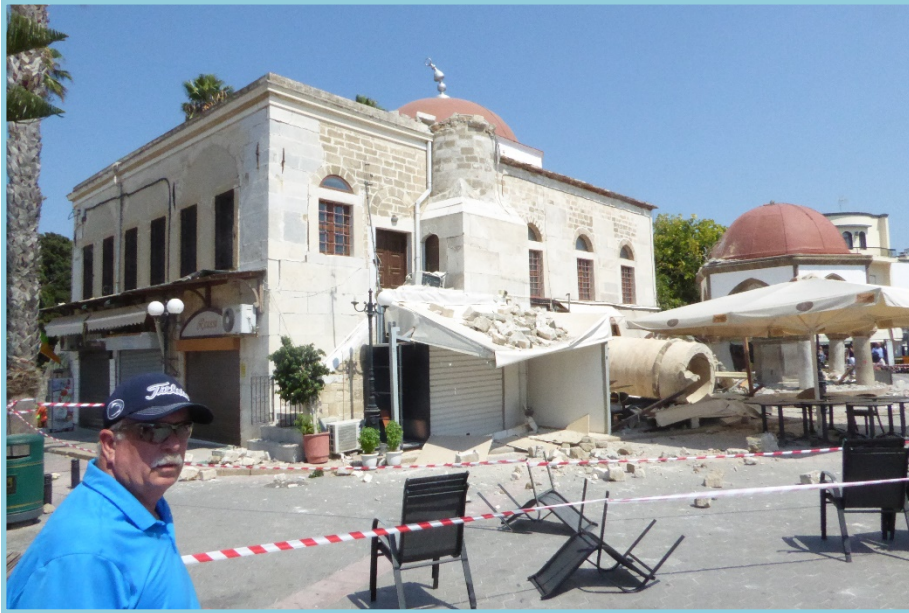
▲ The orientation of the collapse of the minaret indicates the location of the epicenter. The collapse is not attributed to the initial strong pulse, but later on, after some oscillations, to its higher flexibility. If the minaret was not fixed to the rigid structure, the collapse might be avoided.

▼ The displacement of the stiff structure is oriented towards the location of the epicenter due to the first strong pulse of the seismic motion.

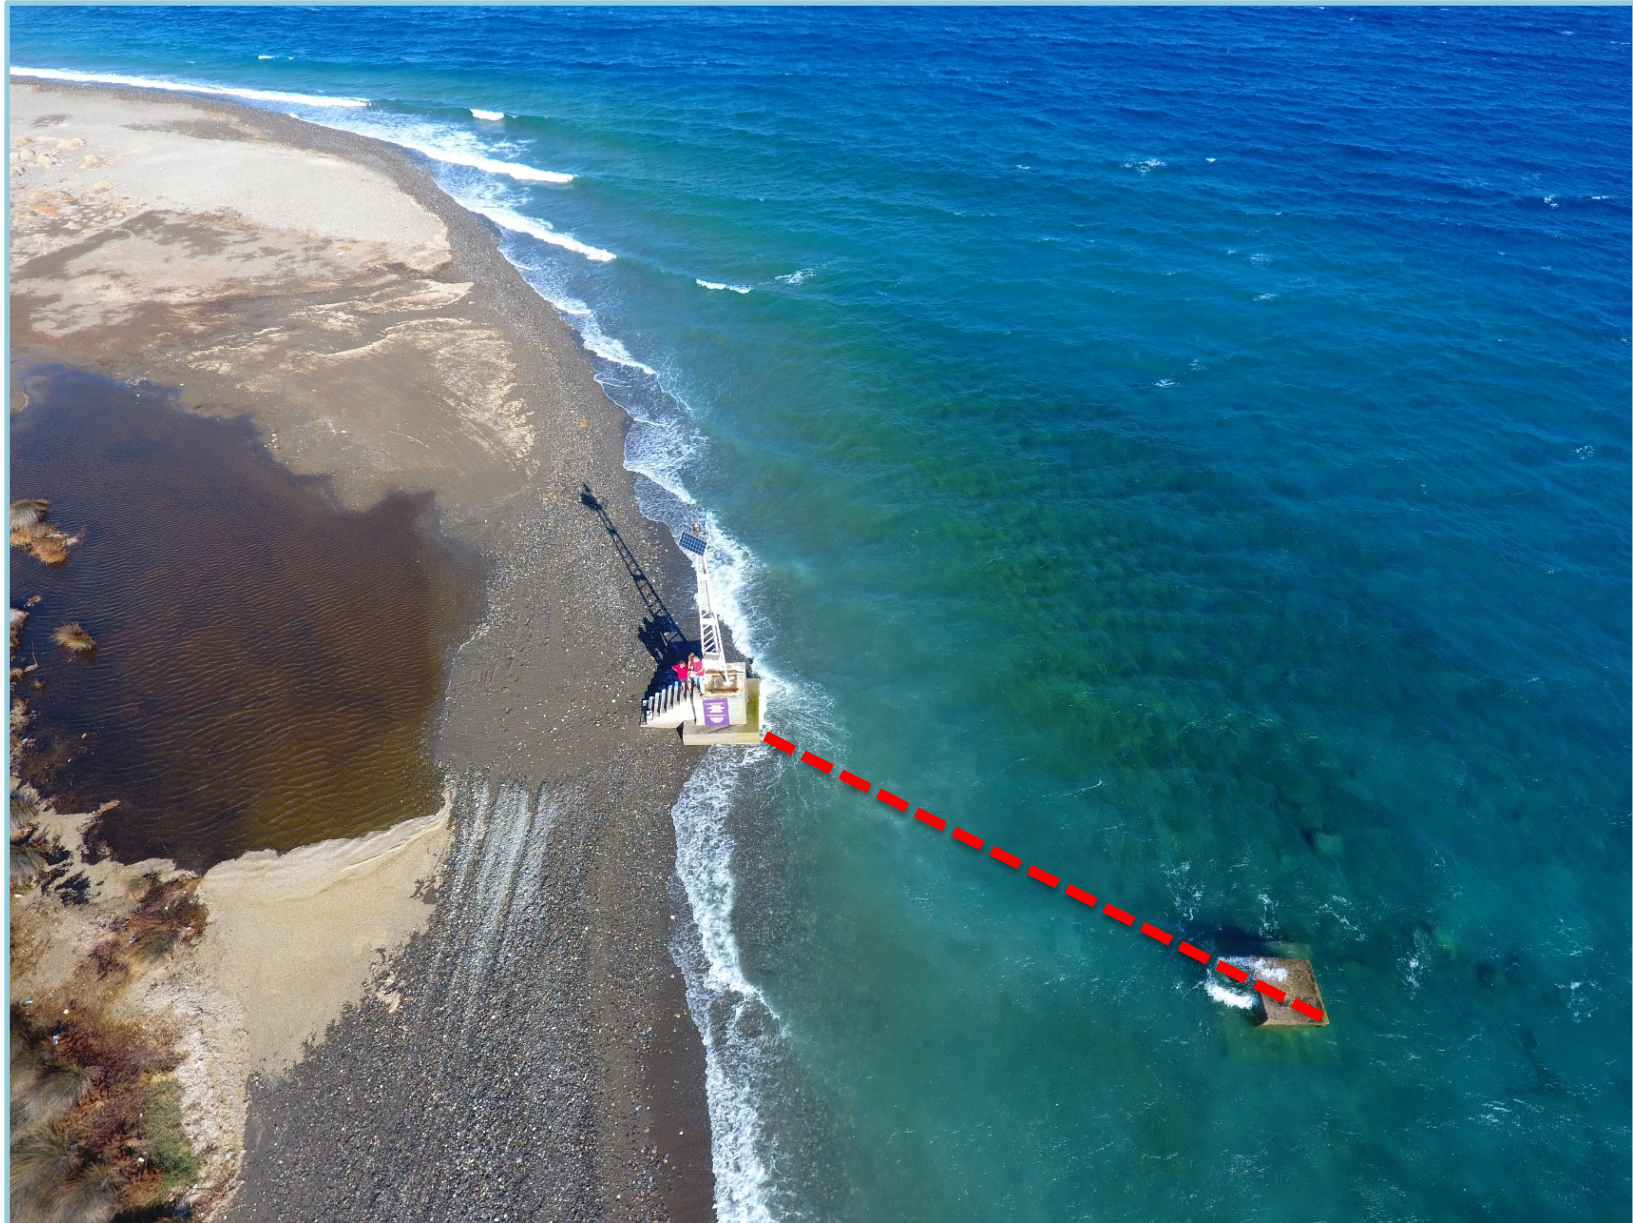
COASTAL SUBSIDENCE

Staff of the EPPO conducted a macroseismic survey in order to detect the earthquake impact in the meizoseismal area. More specifically, in the eastern coastal part of Kos, liquefaction phenomena were generated in the form of mud volcanoes and coastal subsidence varying from 30 to 40 cm was also detected resulting in inundation of the coast.
