TRANSPORTATION SAFETY

REFLEXIONS

Issue 25 – February 2002

A I R

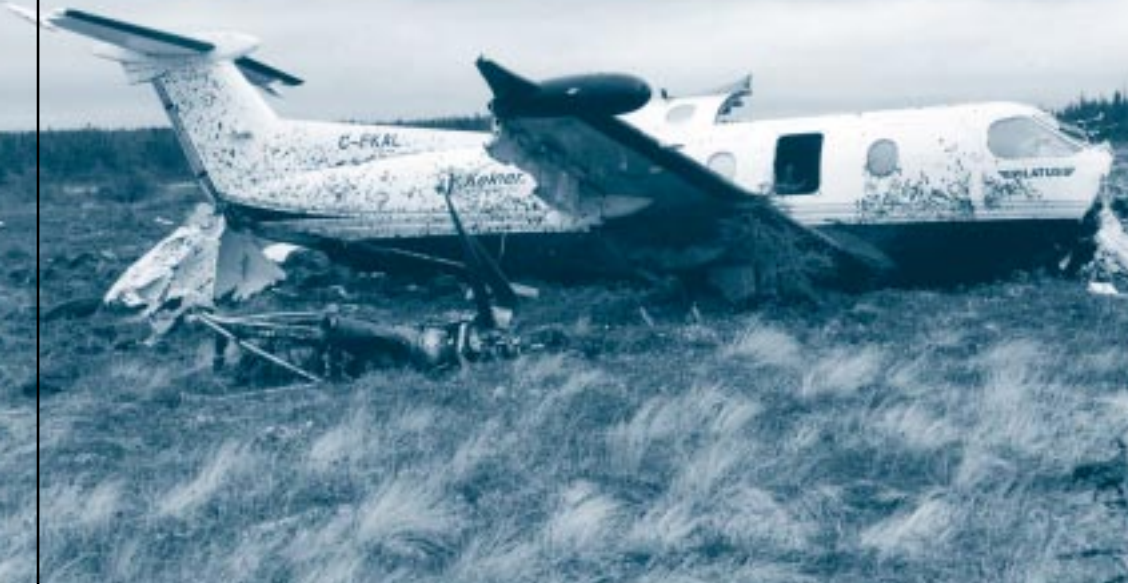
Acting on TSB recommendations, Transport Canada initiated several changes affecting single-pilot IFR operations after this accident involving a Pilatus PC-12.

The TSB forwarded six recommendations to Transport Canada (TC) as a result of the 18 May 1998 forced landing of a Pilatus PC-12 into a Newfoundland bog following an engine failure. The Pratt & Whitney PT6A-67B engine failed because of interrupted oil flow to the first-stage planet gear assembly. The cause of the oil flow interruption could not be determined. The pilot, a company observer, and one of the eight passengers on board sustained serious injuries in the forced landing. — Report No. A98A0067

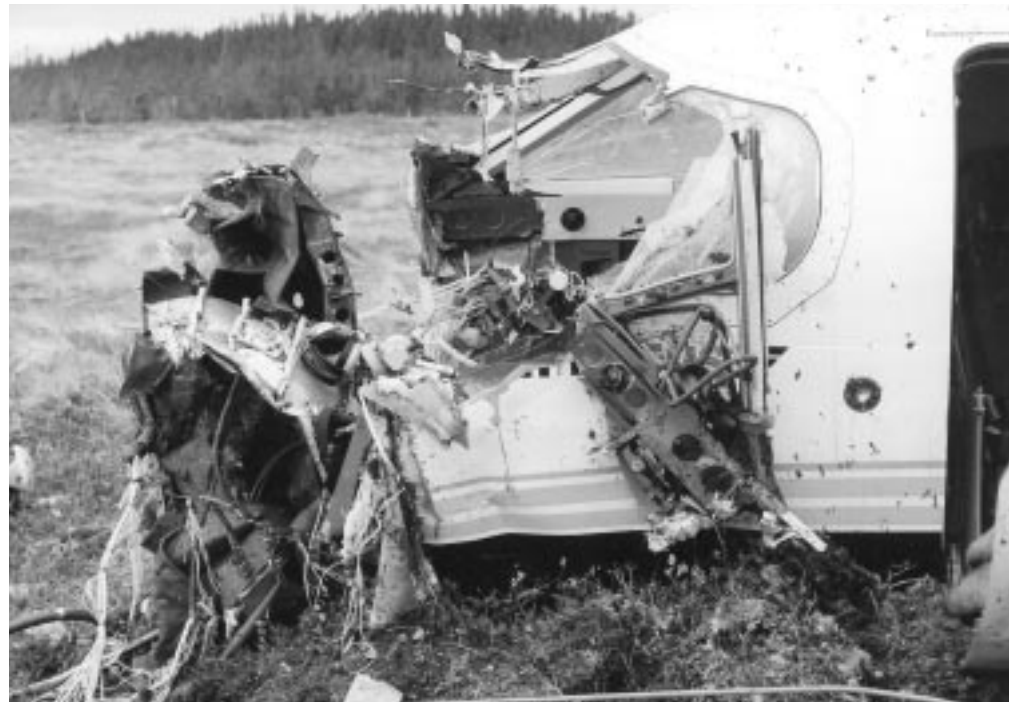
The PC-12 pilot thought the oil pressure indications were not valid and did not land as soon as possible.

Further, the engine chip detecting system, as it is currently configured on the PC-12, does not monitor the entire engine lubrication system for ferrous particles, and other aircraft types using the PT-6 may be similarly configured. Therefore, the Board recommended that:

TC has since advised operators of the PC-12 to install an engine chip detector that functions in all flight regimes.

Concerning recommendation A00-03, TC reviewed the consistency of certification and operational requirements of the chip detector system for single-engine aircraft. The CASO Technical Committee accepted NPA 2000-312, which would amend CASS 723.22(2)(d) to require "a chip detector system to warn the pilot of excessive ferrous material in the entire engine lubrication system in all regimes of flight." In effect, this would require the installation of a second chip detector on engines used in SEIFR operation.

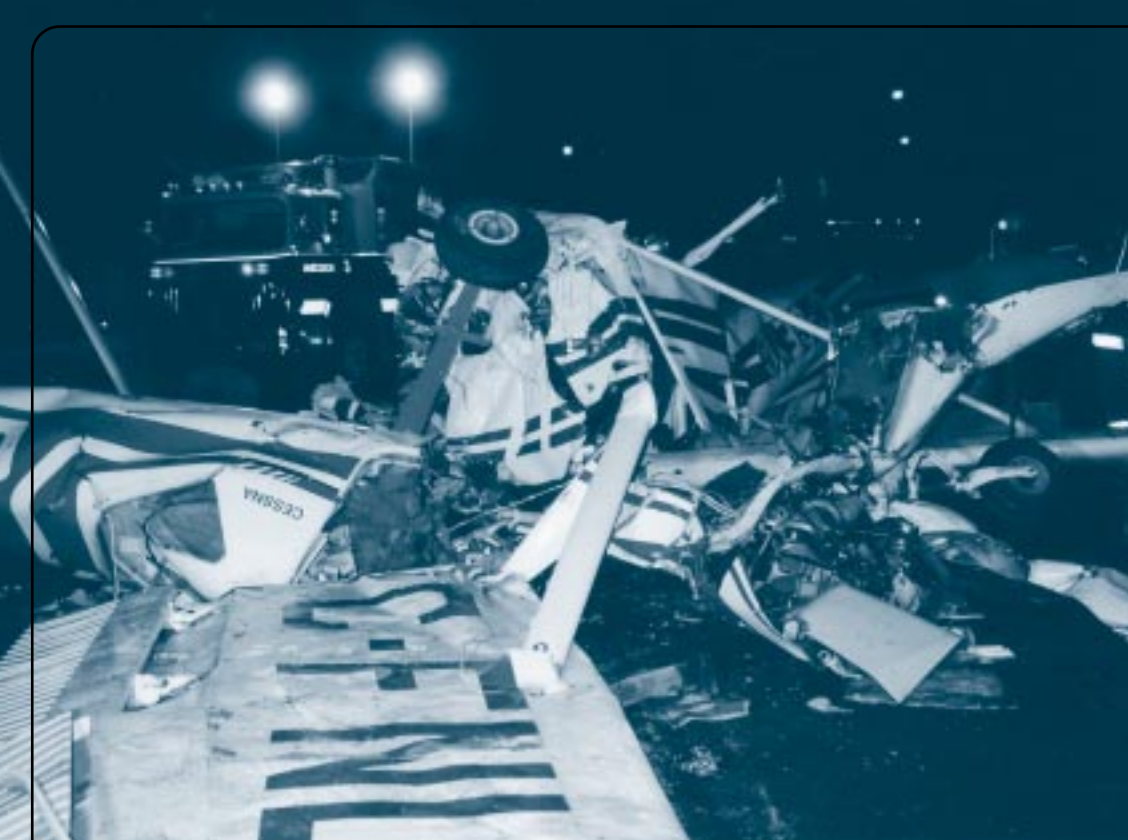
Despite good visibility and proper procedures in the circuit, these two Cessnas collided, fatally injuring the four occupants.

The crew of each aircraft could have seen the other aircraft at several places in the circuit. There was broken cloud at 2300 feet, and the visibility was 25 statute miles. The pilot of the 150 could have seen the 172 at turning on the base leg and after his turn to final. The pilot of the 172 could have seen the 150 while the 172 was on the downwind leg and during its descent on the base leg. Several factors, such as the appearance of the aircraft, the environment, a lack of attention, or operation of the radios, could explain the collision, but no single factor could be identified in the investigation. The lack of evasive action indicates that neither aircraft had noticed the other.

The two aircraft crashed by the bridge crossing Highway 640 at the exit for Mascouche Airport, 2000 feet from the threshold. Several laceration marks—caused by a propeller—were noted on the top of the Cessna 150's cabin.

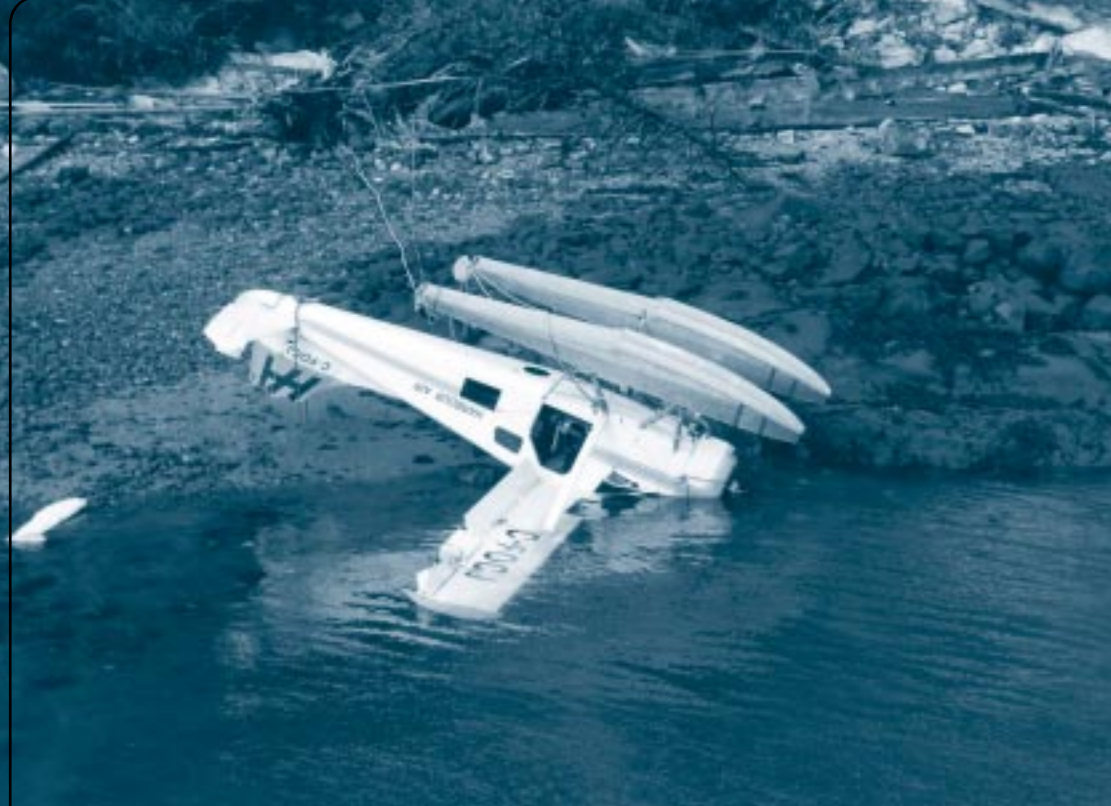
When the Beaver crashed, it flipped over on its back, leaving only the bottom of the floats visible.

In concert with the reported wind and water conditions, the brief accident sequence observed is consistent with two possible scenarios or a combination of the two:

a) On initial touchdown in a left-crosswind condition,

the left float struck a swell or wave that forced the aircraft into an attitude that the pilot was not able to control before the float(s) or wing dug into the water and caused the aircraft to overturn.

b) At or shortly after touchdown, the aircraft was upset by a wind gust that the pilot was not able to control before the float(s) dug into the water and caused the aircraft to overturn.

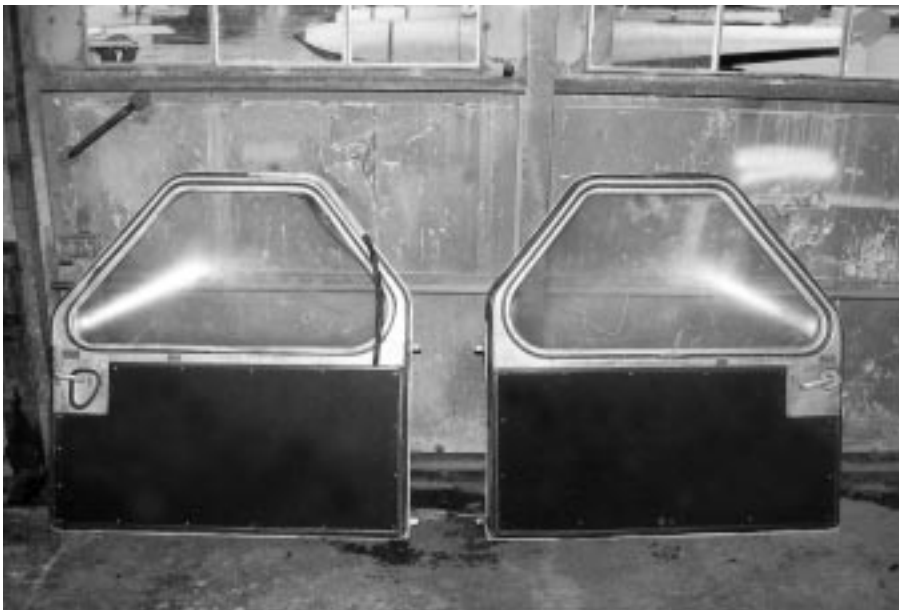
The doors were functional and operated without difficulty, yet the pilot and the four passengers were unable to escape the aircraft and drowned.

The normally easy action of locating and operating the door handles would have been a most challenging task.

It could not be determined why the occupants did not escape from the aircraft. The doors were found functional and without defect. The interior and exterior handles on both cabin doors were found to turn freely, and the latching mechanisms functioned correctly. However, when the aircraft overturned and rapidly sank, it is probable that the occupants became disoriented in the dark and frigid water and panicked. The confined and inverted cabin would also have made the normally easy action of locating and operating the door handles a most challenging task. After undoing their seat belts, the passengers would have lost reference to their relative locations, thus increasing the challenge. Had the pilot been

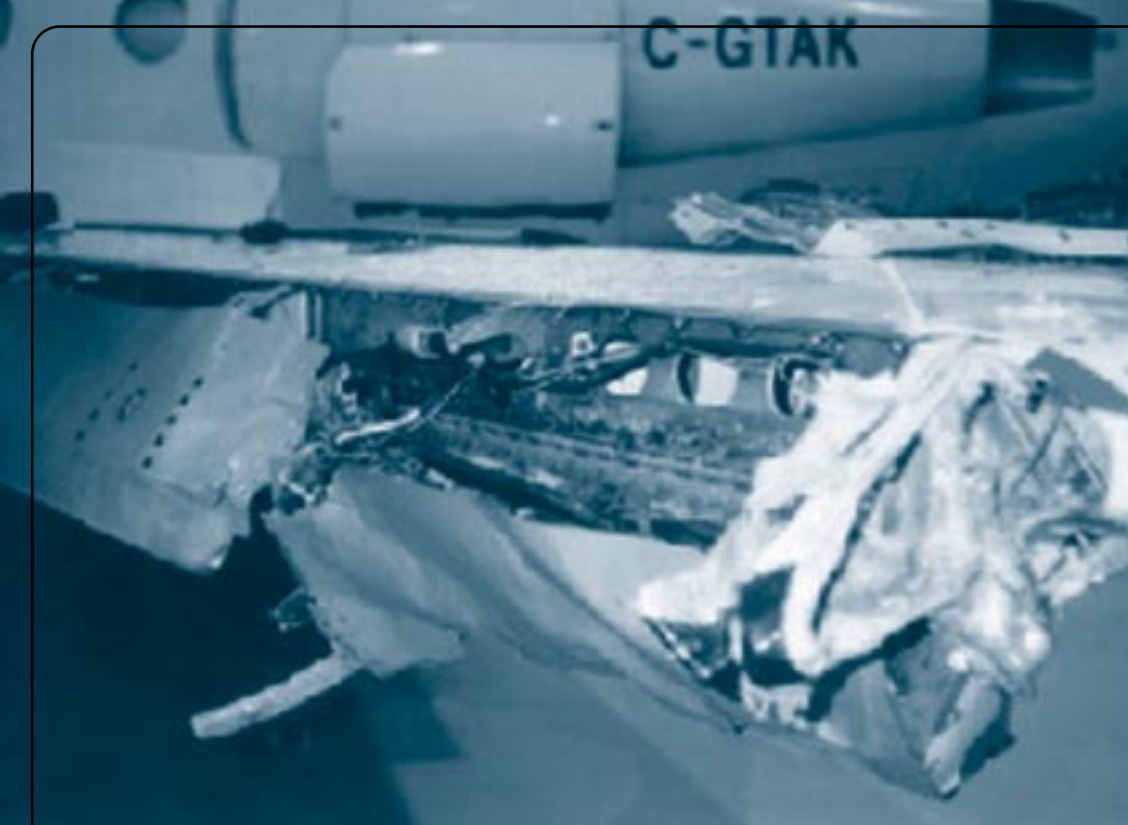
Impact with trees caused considerable damage to the Falcon's left wing.

power and increased the pitch attitude until the stall warning was heard. At about this time, the aircraft descended into trees atop a 920-foot (about 280-m) hill 5.5 nm from the threshold of Runway 16. After clipping several trees, the aircraft began to climb. The crew discontinued the approach and declared an emergency. During vectors for a second approach, the glide-slope became serviceable, and an uneventful ILS approach and landing were carried out. The accompanying photograph shows the damage caused to the aircraft's left wing by the trees.

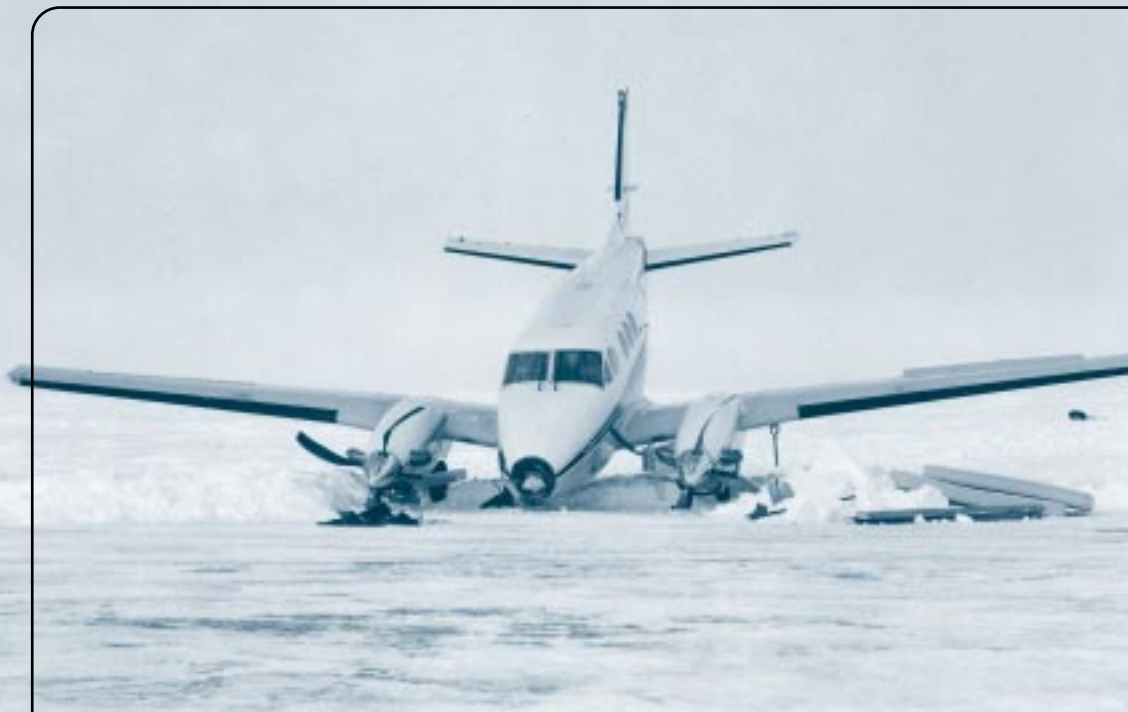
Both pilots heard and saw the altitude alert but did not react.

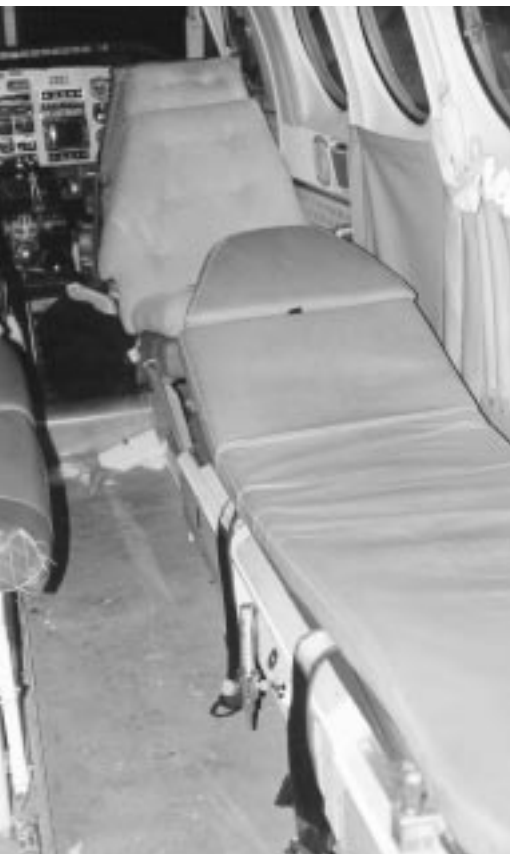
The medevac patient was not strapped in by the shoulder straps and was ejected from the stretcher upon impact with the ground.

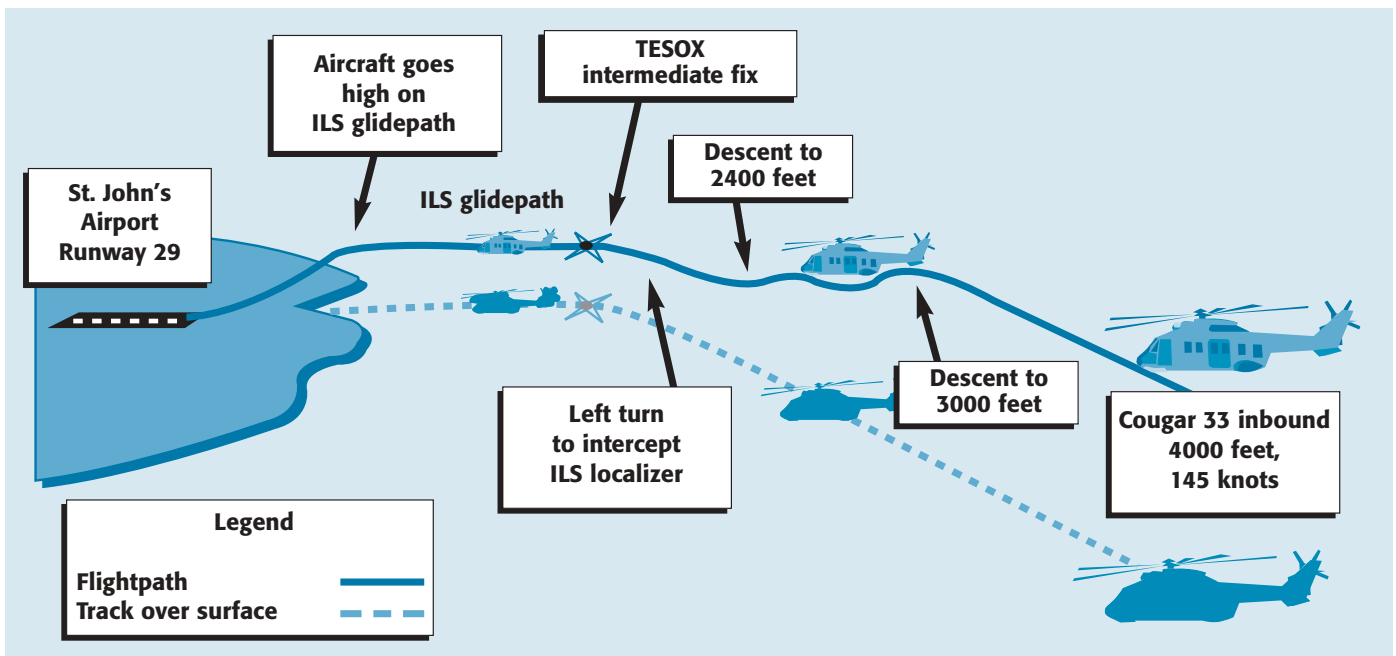
A combination of factors caused the helicopter to go high on the glidepath, requiring the crew to slow down and regain the desired approach profile.

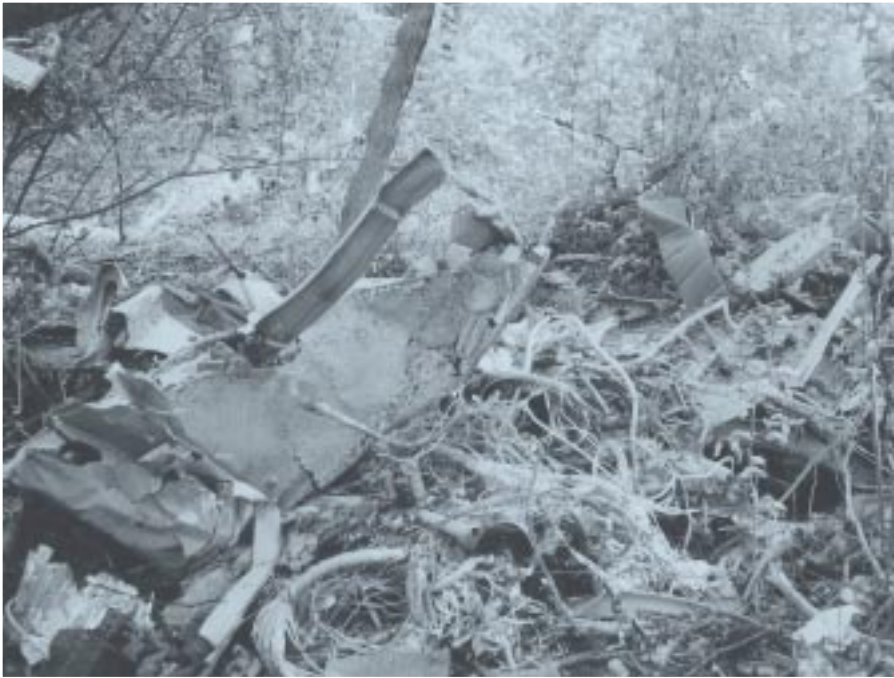
The pilot attempted, but never successfully completed, the instrument rating examination on several occasions.

Remains of the MU-2 flown by a non-instrumented pilot on a dark, rainy night.

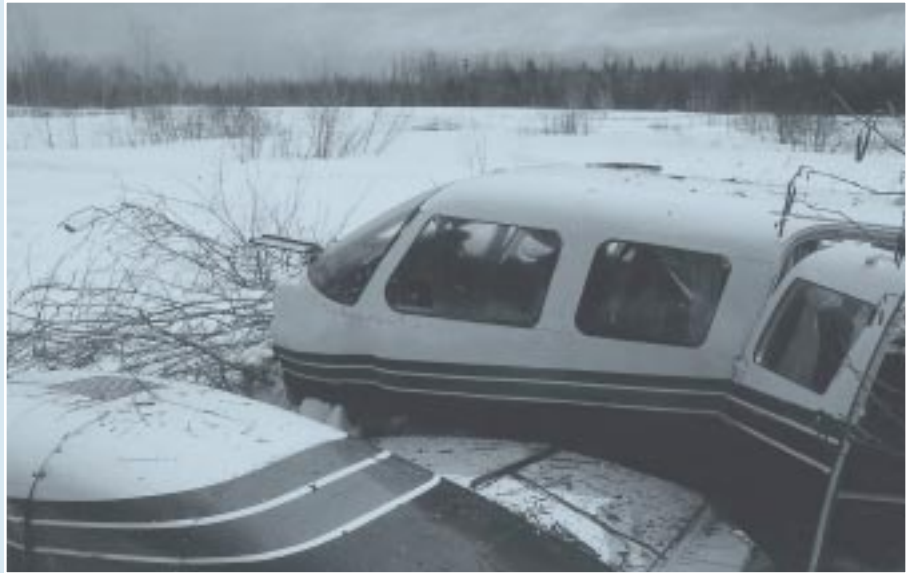
The pilot also performed a missed approach on the second approach. The radar data indicate that the aircraft's speed increased while its altitude continued to drop. The pilot did not modify the aircraft's attitude to begin a pull-up, and the aircraft crashed 3342 feet (about 1019 m) from the threshold of Runway 06. One of the five occupants suffered minor injuries.

The Piper Seneca crashed after a second missed approach.
