FY23 Aviation Annual Assessment

Manned Aviation

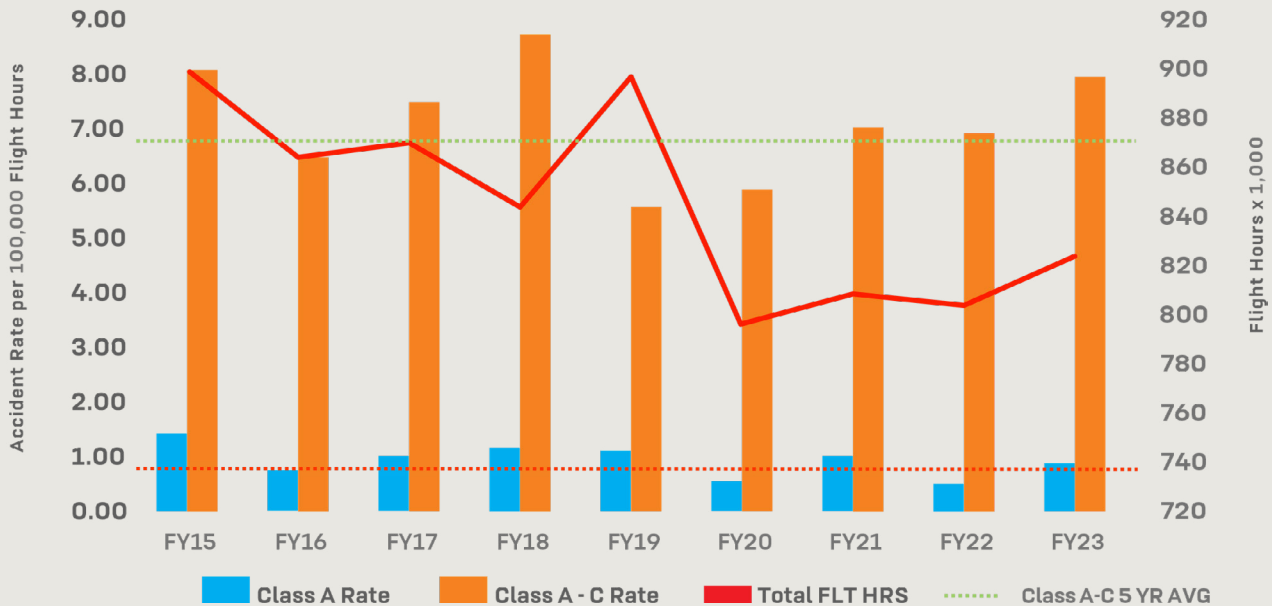
Figure 1: Manned Aviation Flight Mishap Rates

This year Army Aviation experienced 10 Class A mishaps and a rate above the five-year average of 0.85. As a result, the Army's mishap rate has risen above 1.0 for the first time since FY19. As shown in figure 1, FY23's manned Class A flight mishap rate was 1.08 per 100K flying hours. FY23 also had the

most aviation mishap fatalities (14) in the last 10 years and is the highest since FY10 when Army Aviation sustained 16 mishap fatalities. There were 10 Class A mishaps (9 flight; 1 aircraft ground) reported in FY23 with approximately 835,063 hours flown.

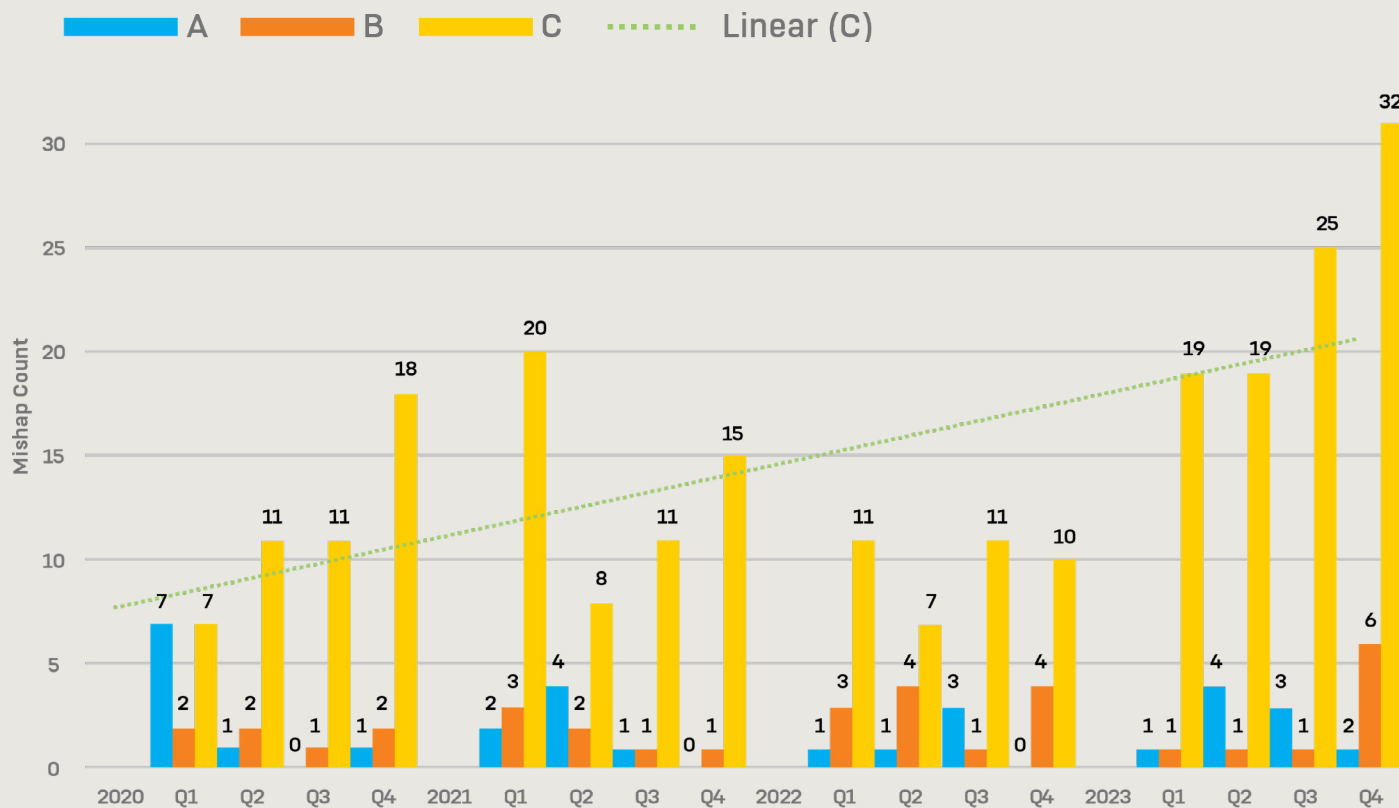
Figure 3: 4-Year Quarterly Mishap Comparison

In FY23, there were two Class A mishaps during the 4th quarter as compared to the following: FY17 = 4, FY18 = 4, FY19 = 5, FY20=1, FY21 = 0, and FY22 = 0. The reduction in 4th quarter Class A mishaps from FY17-23 is encouraging. However, as illustrated in figure 3 on page 3, Class B and below mishaps continue to be a concern. There is an overall upward trend in Class C mishaps since FY20 (see figure 3,

linear C trend line) and the start of the 4th Quarter Spike Campaign. While Army Aviation has enjoyed great success in reducing Class A mishaps in the 4th quarter, there is still a lot of work to do in maintaining this and reducing the number of Class C mishaps year-round. The 4th quarter of FY23 demonstrates the factors surrounding the 4th Quarter Spike are not gone with one Class A mishap and the increase in Class B-C mishaps. Continued vigilance is needed during this period of elevated risk.

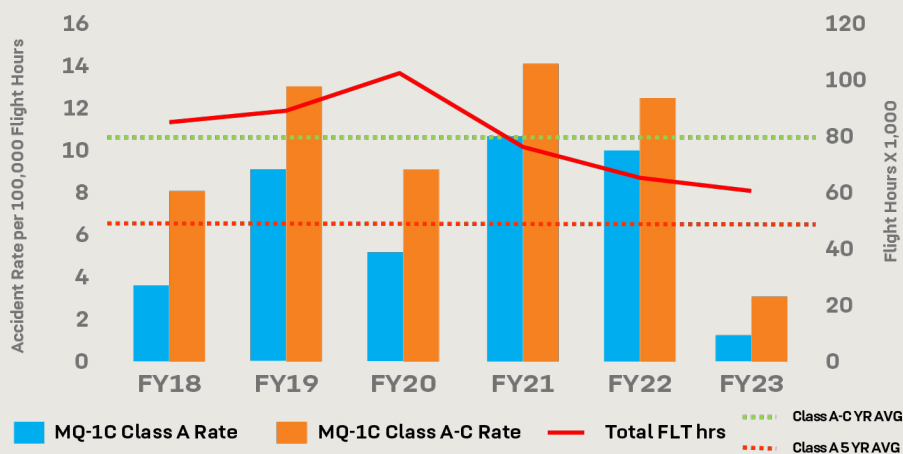
Figure 4: MQ-1C Mishap Rates

As shown in figure 4, on page 4, Gray Eagle had a significant improvement in its mishap rate in FY23 with a Class A mishap rate of 1.51 and a Class A-C rate of 4.52. This contrasts with FY22 with a Class A mishap rate of 10.32 and a Class A-C rate of 11.97. In

FY23, MQ-1C Gray Eagle experienced one Class A mishap, a lost link event caused by a dual generator failure. Total flight hours for FY22 were 14% below FY21 numbers and FY23 was 2% below FY22. This continues a downward trend in MQ-1C flight hours. In addition to the one Class A mishap, there was one Class B and four Class C mishaps reported. Gray Eagle’s FY23 Class A mishap rate of 1.51 per 100,000 flight hours is 85% lower than FY22 and 80% lower than the five-year rate. The Class A-C mishap rate of 4.52 is 62% lower than the FY22 average and 58% below the five-year level.

- Flight hours from FY22 to FY23 remained constant (within 2%)
- FY23: 1 x MQ-1C Class A mishaps, rate 1.5
- FY23: 6 x Class A-C mishaps, rate 3.0

- Human Error:
 - 2 x Ground Handling
 - 1 x MX procedure not followed
- Material failure causal factors:
 - 2 x Dual Alternator Failure
 - 1 x Servo Failure
- Environmental:
 - 1 x Weather Event

- Positive downward trend in Gray Eagle mishaps following implementation of recommendations from the 2016 assessment team and implementation of engineering solutions to materiel failures.
- FY23 had the lowest MQ-1C mishap rate in the past five years.

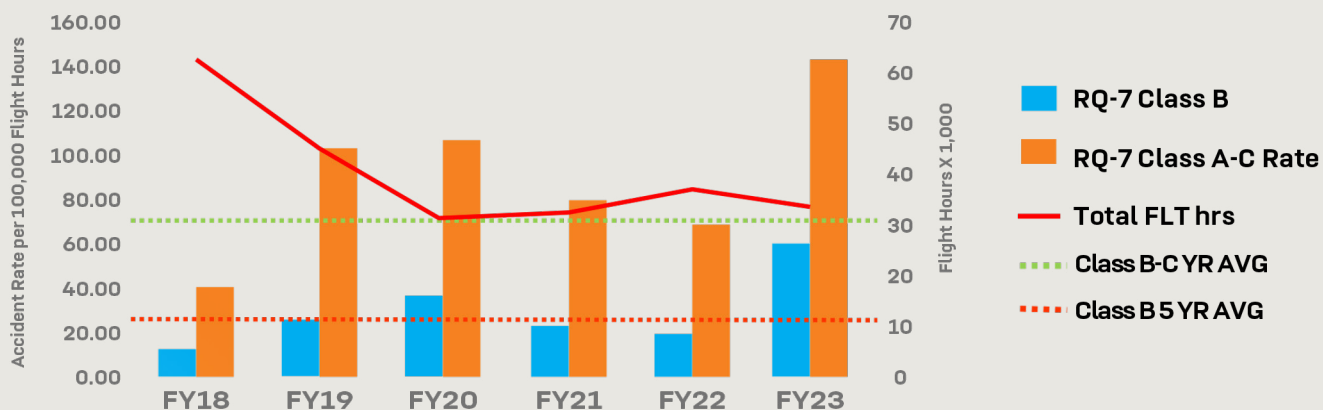
Figure 5: RQ-7 Mishap Rates

The RQ-7B Shadow flight mishap rate has increased from a Class B rate of 19.59 in FY22 to 61.83 in FY23. The Class B-C rate also increased from 72.76 in FY22 to 130.93 in FY23. The RQ-7B experienced 18 Class B and 19 Class C mishaps during FY23. Primary cause factors were associated with engine failures, improper site set up (arresting gear, tactical automatic landing system spacing, etc.), and procedures not followed correctly

(checklist discipline). As depicted in figure 5, on page 5, the Shadow’s FY23 Class B mishap rate of 61.83 per 100,000 flight hours is 216% higher than FY22 and 90% higher than the five-year rate. The Class B-C mishap rate of 130.93 is 80% higher than FY22 average and 101% above the five-year level. The hours flown in FY23 are roughly 23% less than FY22 hours. This continues a significant downward trend in Shadow flight hours.

- Material failure was the leading cause for mishaps in FY23. Primarily caused by the powerplant/propulsion system in both Version 2 and Block III RQ-7B's.
- Steady reduction in flight hours since FY18 are increasing the number of mishaps (25% fewer hours flown in FY23 vs FY22).
- Indiscipline - (procedural) Both maintenance and flight operations exhibited a lack of knowledge of fundamentals and limited experience, primarily relating to site emplacement. Training for this is being added back into AIT POI.
- Failure in mission planning/Risk identification - Failure to integrate risk mitigation into mission planning.

- Powerplant: Class B-C
- Electrical System: Class B-C
- EFI Control System: Class B-C
- ECU Harness: Class C

- Site Emplacement Errors: Class B-C
- Checklist Error (emplacement): Class B
- Incorrect Maintenance Procedure: Class C
- Exceeded Limitations: Class B

To combat these issues, PM UAS continues to take an active role in material improvements to both systems, specifically related to RQ-7B Block III. TRADOC has also begun the process of implementing additional training into the advanced individual training program of instruction in response to the identified procedural deficiencies.

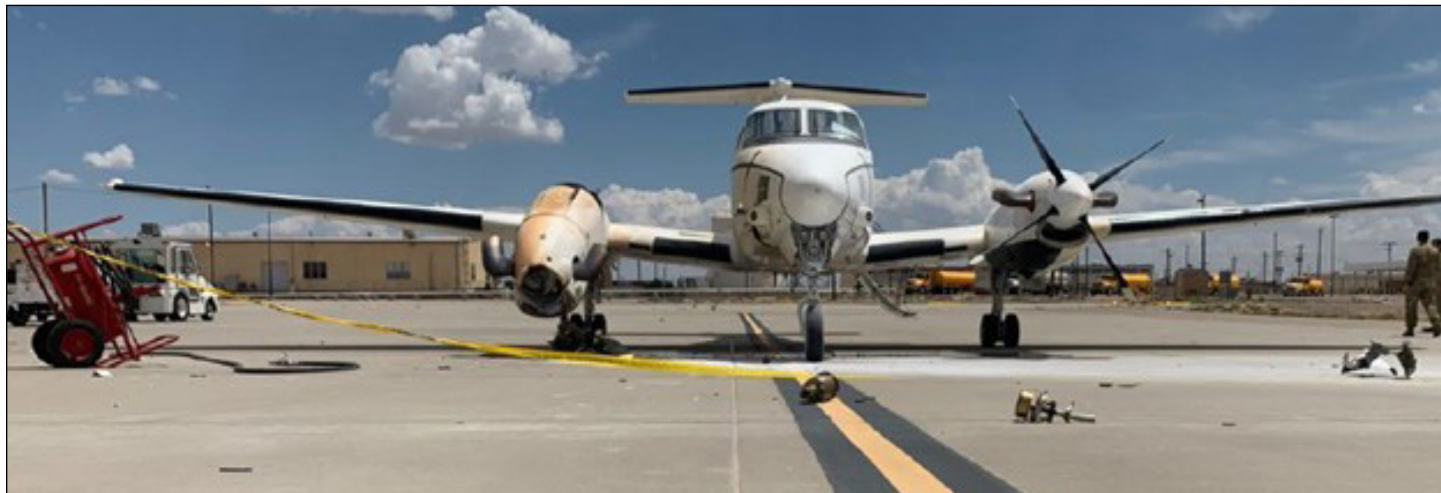
Mishap Review: C-12U

While conducting engine run-up procedures, the number two propellor struck the aircraft fuselage at the avionics bay which resulted in Class A damage.

While performing a rudder boost check on the number two engine the aircraft experienced a catastrophic failure of the number two propellor hub resulting in liberation of propellor, extensive engine and aircraft fuselage damage. The board suspects that internal fatigue cracking exacerbated by high rotational energy initiated this event. The aircrew in this mishap did everything right by securing the engine that was on fire and rapidly egressing the aircraft in accordance with their crew brief. Great job and awesome situational awareness by flight line personnel that extinguished the fire by employing flight line fire extinguishers. ■
