10. A slope stability problem in Hong Kong

Introduction

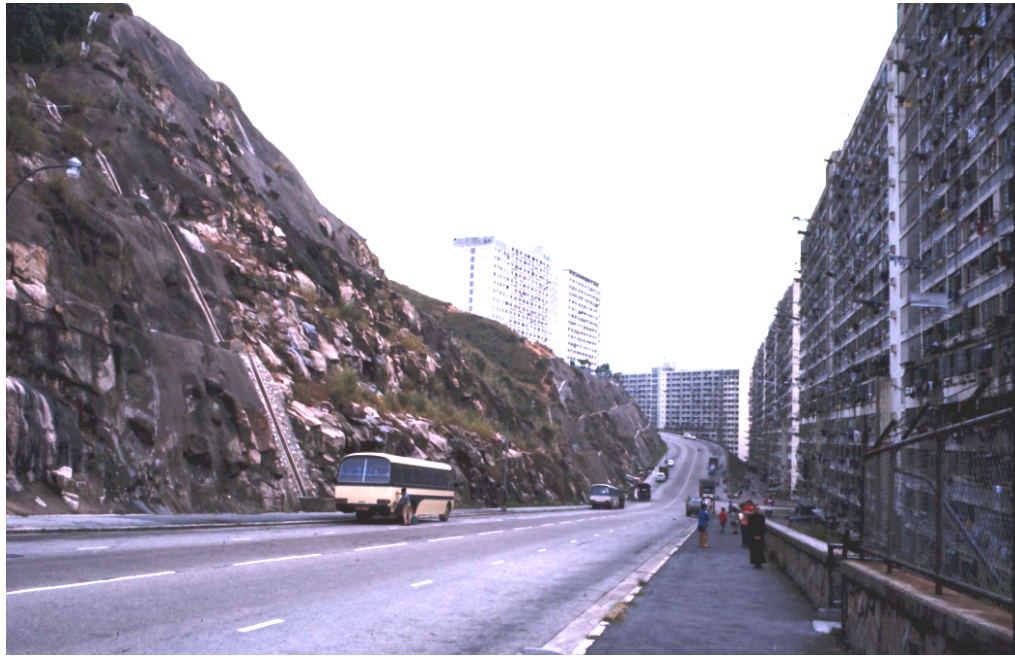
Figure 1 gives a general view down Sau Mau Ping Road, showing the steep rock slopes on the left and the apartment blocks on the right.

Figure 1: A view down Sau Mau Ping Road in Kowloon showing apartment blocks across the road from the steep rock slopes.

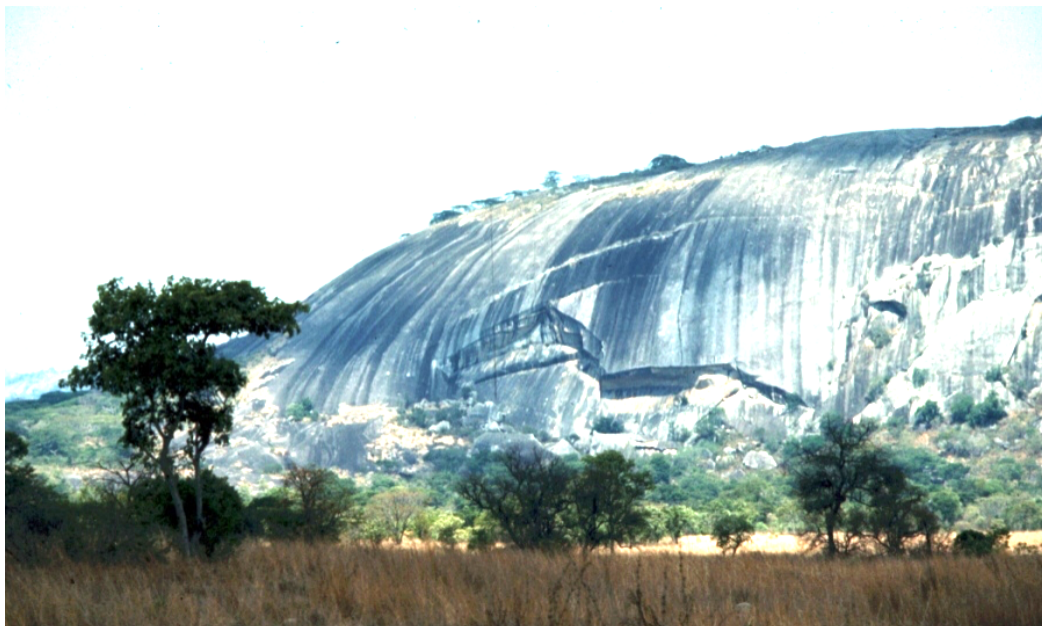
The rock mass, in which the slope adjacent to the Sau Mau Ping Road was cut, is unweathered granite with exfoliation or sheet joints similar to those illustrated in Figure 2. These joints are parallel to the original surface of the granite and the spacing between successive joints increases with increasing distance into the rock mass. Undercutting of these sheet joints can cause a rock slide such as that illustrated in Figure 3.

Figure 2: Sheet jointing in granite. These features, sometimes referred to as ‘onion skin’ joints, are the result of exfoliation processes during cooling of the granite.

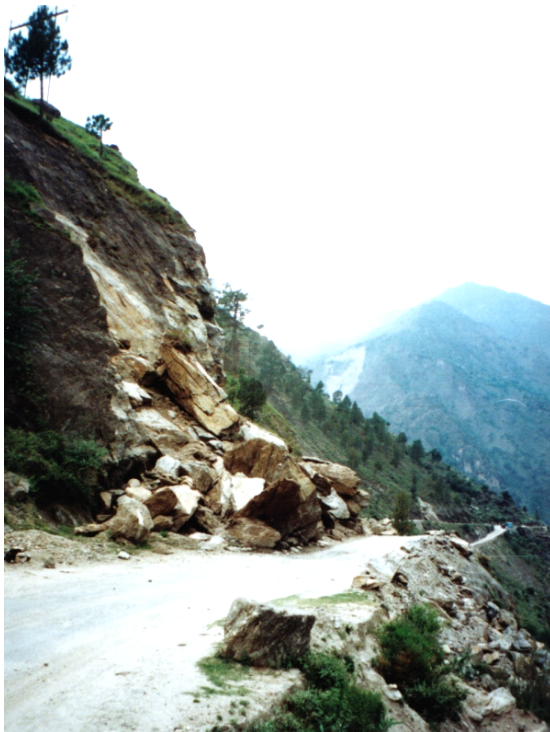
Figure 3: A rockslide on a road caused by the undercutting of sheet joints in a granite slope. In hard rocks such as granite, failure can occur very suddenly if the factor of safety of the slope is close to 1. A rise in groundwater levels during a heavy storm or ice jacking in winter may be sufficient to induce failure.

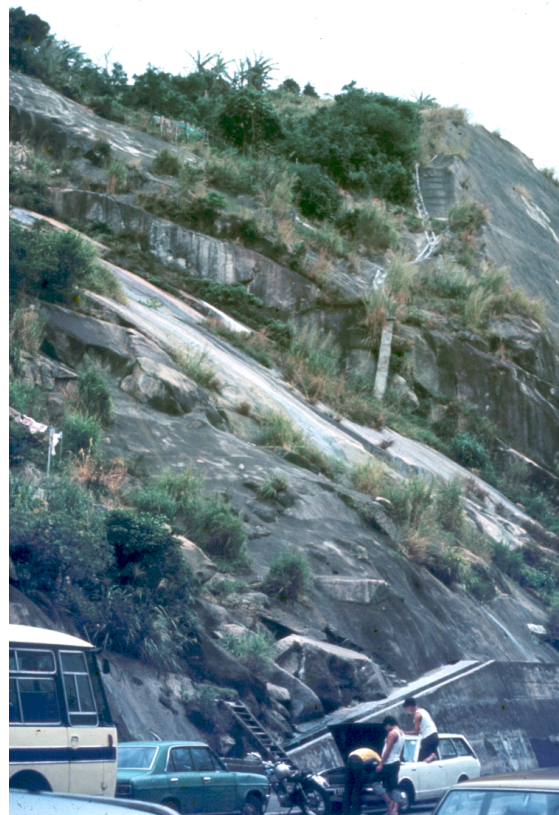
During excavation of the original slopes for the Sau Mau Ping Road, a small rock slide was induced by blasting. The surface on which this failure occurred is illustrated in Figure 4. Blasting, such as that used in civil construction in an urban environment, does not impose very large loads on rock slopes and it can be assumed that the factor of safety of the slope was close to unity.

Figure 4: The failure surface defined by a sheet joint surface on which a small slide occurred during blasting of the original cut slope for the Sau Mau Ping Road. The potentially unstable slope discussed is visible in the background.

The potentially unstable slope under consideration is visible in the background of the photograph in Figure 4. It is obvious that the sheet joint surface continues under the potentially unstable slope. Hence, from the evidence of the small-scale failure, it can be deduced that the factor of safety of the slope in question is not very high.

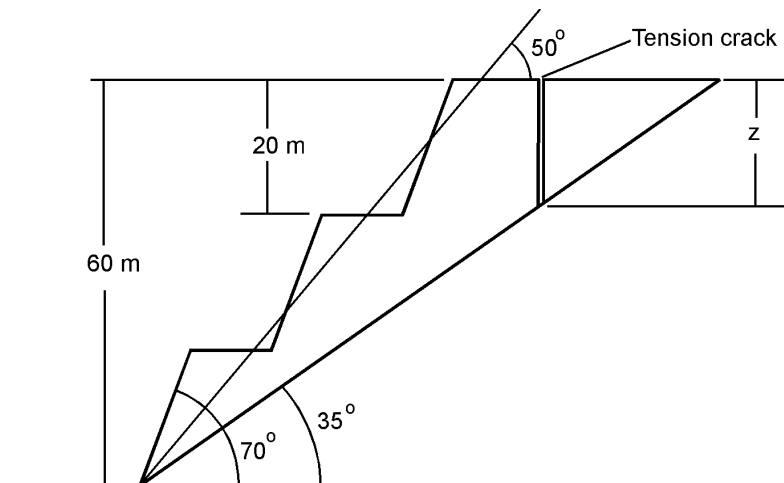
The geometry of the slope is illustrated in Figure 5 which shows a 60 m high slope with three 20 m high benches. The overall slope angle is 50° and the individual bench faces are inclined at 70° to the horizontal. An exfoliation joint surface dips at 35° and undercuts the slope as shown in the figure. The slope face strikes parallel to the underlying exfoliation surface, and hence, the slope can be analysed by means of a two-dimensional model.

Tension cracks are frequently observed behind the crest of slopes which have a factor of safety of less than about 1.2. These cracks are dangerous in that they allow water to enter the slope at a particularly critical location. Unfortunately, in the case of the Sau Mau Ping Slope, recently cultivated market gardens located on the top of the slope made it impossible to determine whether or not such tension cracks were present and hence it was decided to carry out two sets of analyses - one with and one without tension cracks. These analyses were carried out for both the overall slope and for individual benches.

Figure 5: Geometry assumed for the two-dimensional analysis of the Sau Mau Ping Road Slope.

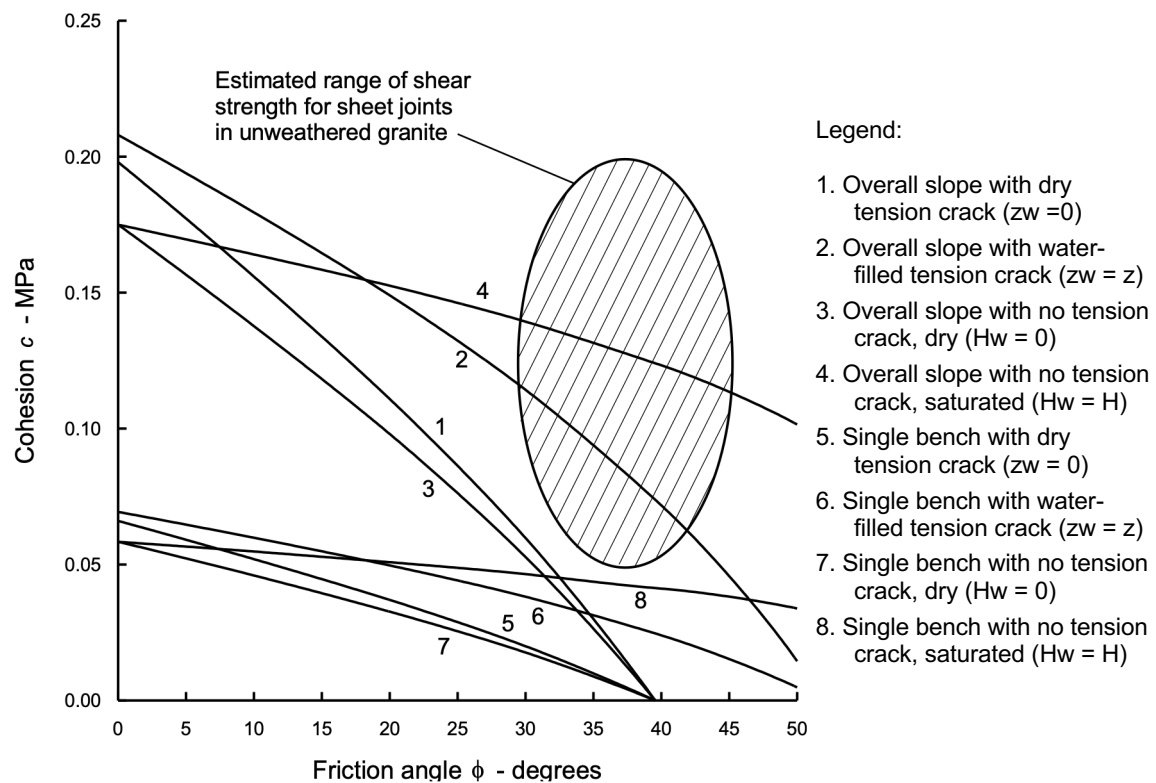
One method for assessing the stability of slopes is to calculate the shear strength that would be mobilised at failure and to compare this strength with the shear strength which is available along the failure surface. In the case of the Sau Mau Ping slope, this was done by substituting $F = 1$ in equations 1 and 5 and solving for the cohesive strength c and the friction angle ϕ . The results of this analysis are plotted in Figure 9. The estimated range of available shear strength (from Figure 8) is also shown on this plot.

Figure 9 shows that only two of the cases analysed result in conditions where the shear strength mobilised at failure falls within the estimated range of available shear strength. These two cases are designated 2 and 4 and they are for fully saturated slopes with and without tension cracks.

From the results of the sensitivity study described above, it was concluded that instability of this particular slope could occur if the slope was fully saturated and subjected to earthquake loading. Typhoons occur several times every year in Hong Kong and the intensity of precipitation during these events is certainly sufficient to saturate the slopes. As discussed earlier, minor earthquakes do occur in the region, but they are not very frequent. Consequently, the chance of simultaneous saturation and earthquake loading was considered to be small and it was concluded that there was no serious short-term threat of instability of the Sau Mau Ping Slope.

Figure 9: Comparison of the shear strength mobilised by failure under various conditions with the estimated shear strength available on sheet joints in unweathered granite.

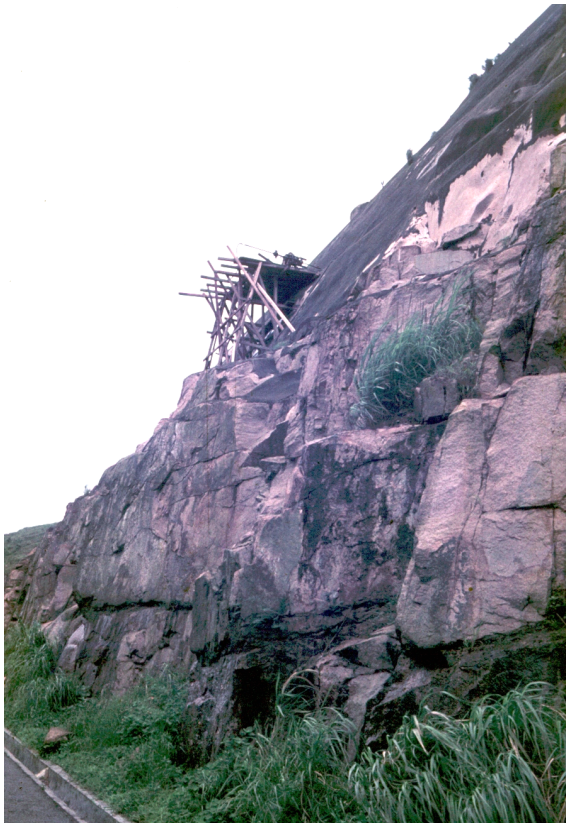
Figure 10: Drilling horizontal drain holes into the face of one of the benches of the Sau Mau Ping slope.

- No evacuation of the residents of the two apartment blocks, located across the street from the slope in question, would be carried out.
- Horizontal drainage holes would be drilled into the slope face to penetrate the potential failure surface to reduce uplift pressures in the slope.
- Piezometers would be installed in holes drilled from the top of the slope. These piezometers would be measured regularly during periods of significant rainfall and the road would be closed to traffic if water rose to levels decided by the engineers responsible for the project.
- An investigation would be carried out on the most effective remedial measures to stabilise the slope for the long-term.

Figure 10 shows the drilling of the horizontal drain holes into the slope face and Figure 11 shows the drilling of the vertical holes into which the piezometers were installed. These piezometers were monitored for the next few years, while preparations for the final stabilisation of the slope were made. The road was closed to traffic on two occasions when water levels were dangerously high.

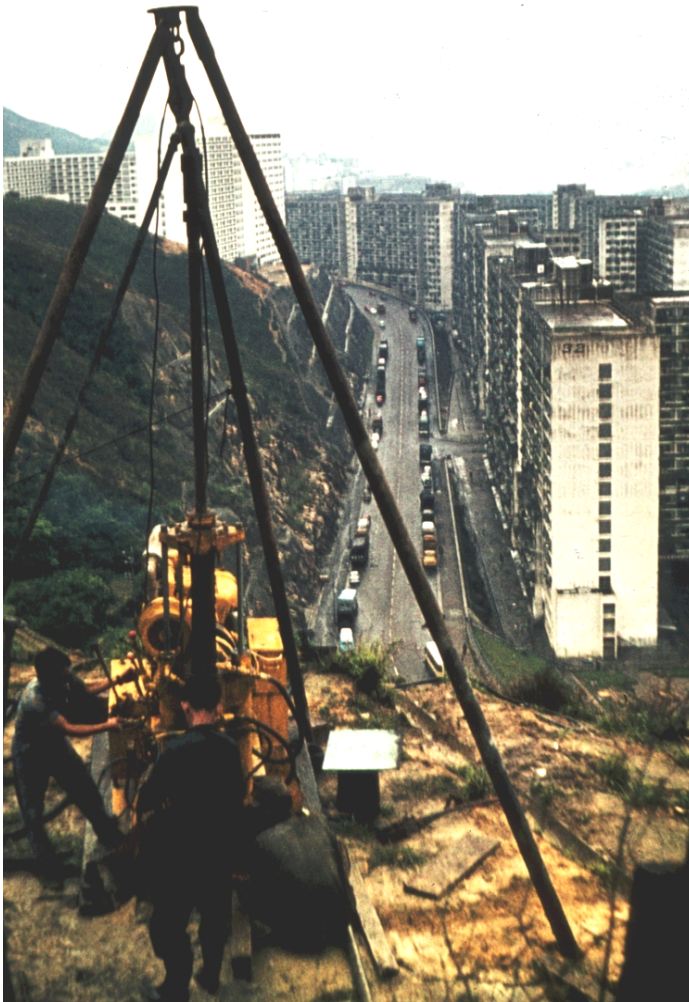
Figure 11: Drilling vertical diamond core holes into the Sau Mau Ping slope. These holes were used for geotechnical investigation purposes and for the installation of piezometers in the rock mass.

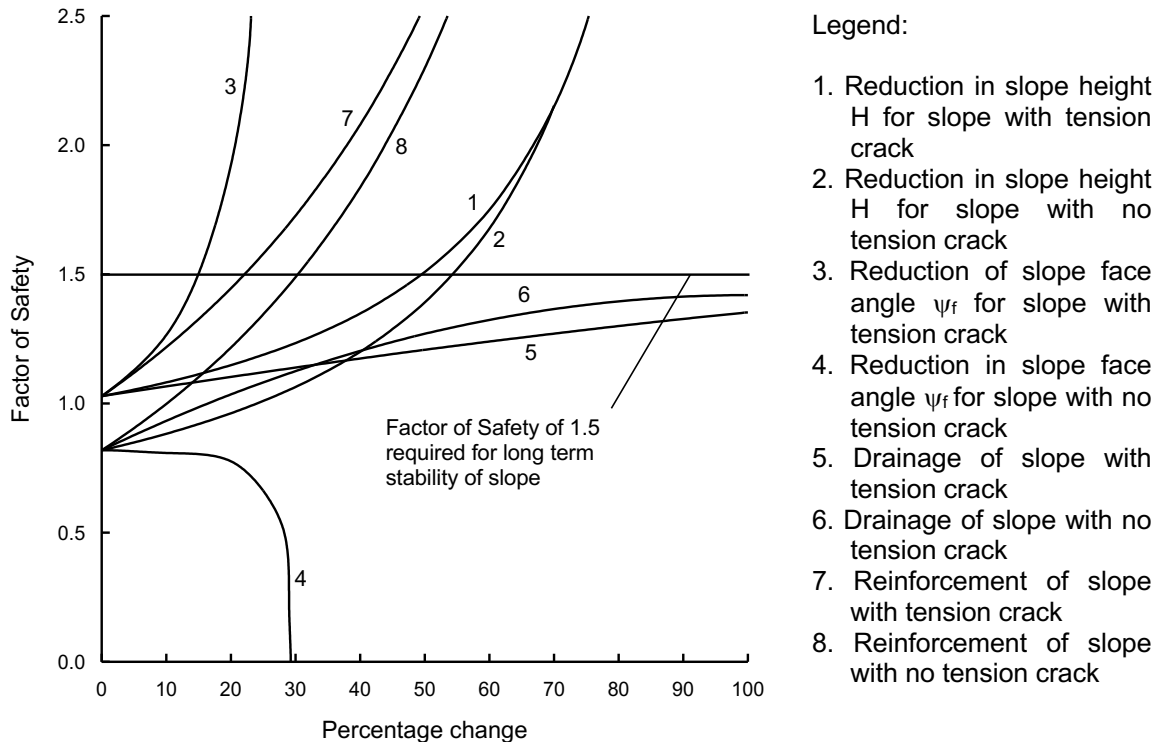
Figure 12: Evaluation of remedial options to increase the stability of the slope.

In calculating the factors of safety shown in this figure, the shear strength was maintained constant and was defined by $c = 0.10$ MPa and $\phi = 35^\circ$. Similarly, an earthquake acceleration of $\alpha = 0.08$ g was used for all the analyses. The percentage change refers to the ratios of slope height, slope angle and water depth to the original dimensions defined in Figure 5.

Curves 1 (slope with tension crack) and 2 (slope without tension crack) show that reduction of the slope height is not an effective solution to the problem. In order to achieve the required factor of safety of 1.5, the slope height would have to be reduced by 50%. If this solution were to be adopted, it would be more practical to excavate the entire slope since most of the volume of the rock to be excavated is contained in the upper half of the slope.

Curve 3 (slope with tension crack) shows that reduction of the slope angle is a very effective remedial measure. The required factor of safety of 1.5 is achieved for a reduction of less than 25% of the slope angle. In other words, a reduction of the overall slope face angle from 50° to 37.5° would achieve the desired result. This finding is generally true that a reduction in the face angle of a slope is usually an effective remedial step. In the case of slopes under construction, using a flatter slope is always one of the prime choices for achieving greater stability.

Curve 4 (slope without tension crack) is an anomaly. It demonstrates that calculations can sometimes produce nonsense. The reduction in factor of safety shown by this curve is a result of the reduction in the weight of the sliding block as the face angle is reduced. Since the water pressure on the sliding surface remains constant, the effective stress acting on the sliding surface decrease and hence, the frictional component of the resisting forces decreases. When a very thin sliver of rock remains, the water pressure will float it off the slope. The problem with this analysis lies in the assumption that the block is completely impermeable and that the water remains trapped beneath the failure surface. In fact, the block would break up long before it floated and hence the water pressure acting on the failure plane would be dissipated.

Curves 5 and 6 show that drainage is not a very effective option for either of the slope models considered. In neither case is a factor of safety of 1.5 achieved. This is something of a surprise since drainage is usually one of the most effective and economical remedial measures. The reasons for the poor performance of drainage in this case is due to the combination of the geometry of the slope and the shear strength of the failure surface.

Curves 7 and 8 show that, for both slope models considered, slope reinforcement by means of rockbolts or cables can be an effective remedial measure. The anchor force required for a factor of safety of 1.5 would be about 100 tonnes per metre of slope length for the slope with no tension crack.

The option finally chosen was to reduce the slope face angle down to 35° by excavating the entire block resting on the failure surface, and hence, removing the problem entirely. Since good quality aggregate is always required in Hong Kong, it was decided to work this slope face as a quarry. It took several years to organise this activity and, during this time, the water levels in the slope were monitored by means of piezometers. Although the road was closed twice during this period, no major problems occurred, and the slope was finally excavated back to the failure plane.
