Summarizing geotechnical activities after the 2011 Tohoku earthquake of Japan

I. Towhata

ABSTRACT: After the 2011 Tohoku earthquake in Japan, I as the Vice President and then as the President of the Japanese Geotechnical Society took initiatives in damage reconnaissance, developing new safety criterion for liquefaction-prone residential areas, quantitative evaluation of ageing effects on liquefaction resistance of sand, investigation on damage mechanism of river levees, recovery from the tsunami incidence of Fukushima No.1 Nuclear Power Plant and ground improvement in existing residential area. Some of them were conducted urgently within several months after the earthquake, while others encountered many difficulties from the viewpoint of public agreement. This paper summarizes the post-earthquake activities of geotechnical engineering in restoration of the community.

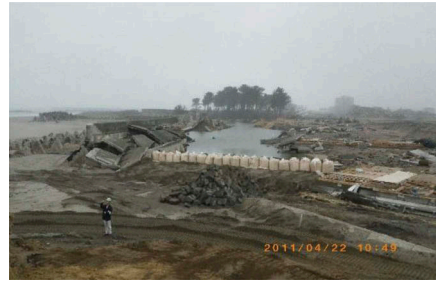
Figure 6. Damaged seawall near the Abukuma River mouth.

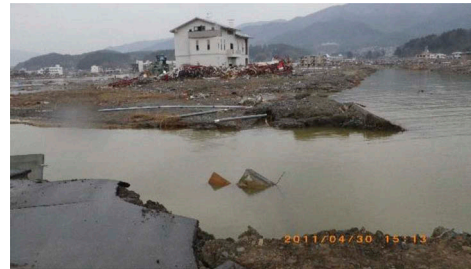
Figure 8. Rikuzen-Takata after tsunami washing.

Figure 7 shows the situation in Tohni-Hongo where the local community had been relocated to higher places after the previous tsunami in 1933. Thereafter, a sea wall was constructed; its height was higher than the tsunami in 1933. As a consequence, people felt safe and many of them came back to the coastal area. This was a reasonable decision because most people lived on fishing. In 2011, the tsunami was higher than the wall and the community behind the wall was totally destroyed. This is an unfortunate evidence to show that empiricism (height of previous tsunami) is not fully reliable under rare catastrophic natural disasters. Overtopping occurred in many other towns as well (Figure 8).

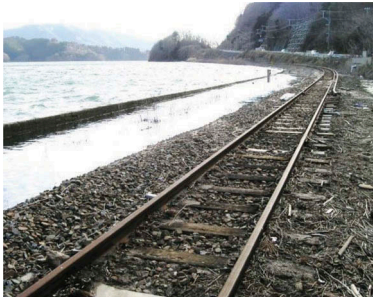
Figure 11. Tectonic subsidence in Banseki-Ura near Sendai.

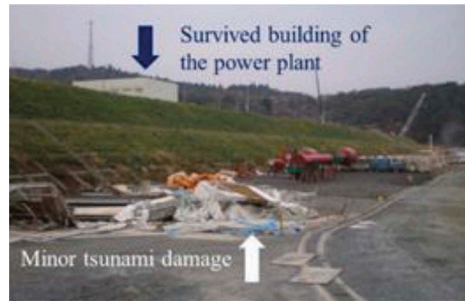
It is well known that gigantic earthquakes in the subduction zone are triggered by rebound of continental tectonic plates after rupture in its interface with the ocean plates. The rebound results in the uplift of the sea bed and triggers tsunami. At the same time, the inland part of the continental plate subsides because the rebound-induced elongation in the horizontal direction is associated with vertical contraction; recall *Poisson* ratio. Figure 11 is an example of such coseismic subsidence in Banseki-Ura near Sendai where the ground subsidence exceeded 1m. Similar subsidence occurred during the 1946 Nankai earthquake of $M_w=8.4$ in Japan (Kawasumi and Sato, 1949), the 1960 Chile earthquake of $M_w=9.5$ (Housner, 1963) and the 1964 Alaska earthquake of $M_w=9.2$ (Plafker, 1969). Figure 12 exhibits the post-earthquake situation of Onagawa Nuclear Power Plant that was situated at 14.8 m above the sea level. This height was sufficient to survive the tsunami inundation but the tsunami water came into the power plant through an underground conduit into one of the excavated basement spaces. Fortunately, the water was stopped by a water-tight door at the entrance of the reactor building. Noteworthy is that the power plant site had subsided one meter by the tectonic mechanism, without which the plant would have been safer.

Figure 12. Onagawa Nuclear Power Plant that marginally survived the tsunami-induced disaster.

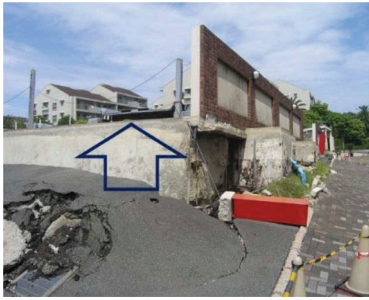
Figure 15. Floating of underground parking structure (Yokohama).

Figure 15 illustrates floating of an underground car parking. Figure 16 shows floating of a manhole and Figure 17 indicates floating of a sewage pipeline. Thus, the vulnerability of sewage lifeline network became evident at many places. Those buried structures that were lighter than unit weight of liquefied sand floated and stopped functions. Tilting of house was repeated as well due to softening of liquefaction-prone subsoil in the foundation. The situation in Figure 18 is the worst and other affected houses exhibited much smaller tilting without structural problem. However, it is nowadays known that tilting of as small as 0.6% causes

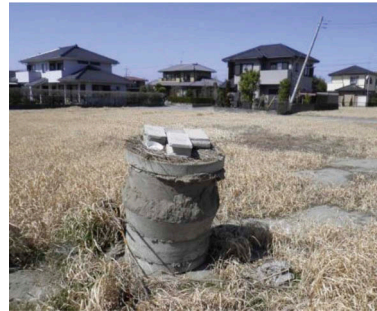
Figure 16. Floating of sewage manhole (Itako, Ibaragi).

The damage of sewage lifelines is classified into that of manhole (Figure 16) and floating of pipes (Figure 17). Because the mitigation technology for manhole has been investigated by Orense et al., (2003), Kiku et al. (2006), Tobita et al. (2011) and Yoshida et al. (2008) among others, the author put emphasis on existing embedded pipelines (Otsubo et al., 2016a and b). It was attempted therein to avoid overall excavation and improvement of liquefaction-prone backfill soil around the pipe and thereby to reduce the cost.

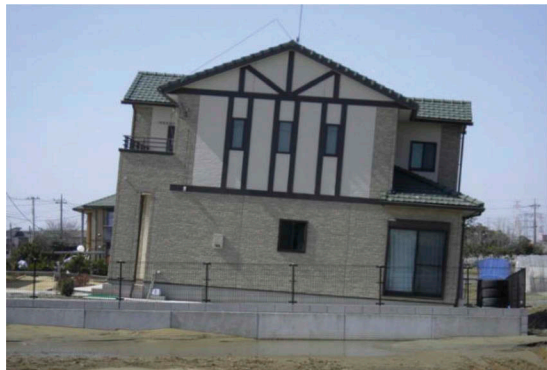
Figure 18. Tilting of house caused by subsoil liquefaction (Kashima, Ibaragi).

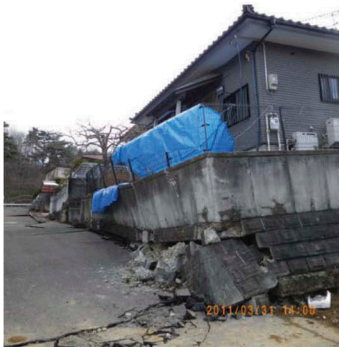
(a) Damaged fill part

Figure 19. Seismic damage of residential land in the suburban hill area of Sendai.

Sendai area developed its suburban residential land in hilly areas by cutting hills and filling valleys, thus producing level ground. This is in clear contrast with the situation in Kanto Region (Figure 14) where man-made islands were used for new residences. After completion, ground water in hills infiltrated into new fills and increased the weight of soil. Moreover, compaction of fill was insufficient to resist the seismic load and that the shear resistance in the interface between fill and the original valley surface was, most probably, poor. Accordingly, the fill parts collapsed during the earthquake (Figure 19a) and the value of the real estate was lost. Conversely, the cut

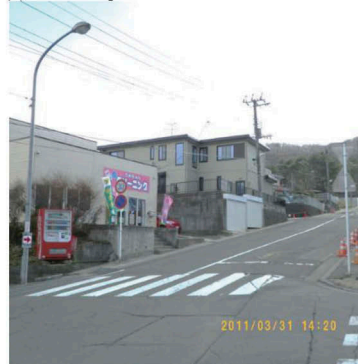
(b) Intact cut part

part in the vicinity was intact (Figure 19b). The problem is that the ground surface is flat after construction and people cannot capture the original condition (fill or cut) of the land when they purchase it.

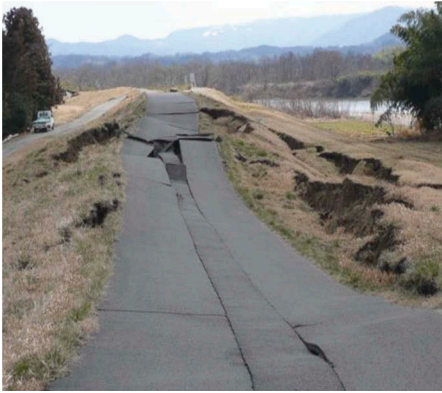
Figure 20. Crest subsidence and lateral spreading of Abukuma-River levee (Sasaki et al., 2012).

Significant subsidence occurred in many sections of river levee in both Kanto Plain around Tokyo and Sendai Plain (Figure 1). Figure 20 shows the induced subsidence and lateral spreading. According to the damage summary, the extent of subsidence (S) did not exceed 75% of the original levee height (H) (Figure 21), which is consistent with the previous summary of seismic damage of levees since the 1891 Nobi earthquake of $M=8.0$. The mechanical reason for the upper bound of 75% subsidence is schematically illustrated in Figure 22; compare the unit weight of water-saturated liquefied subsoil (typically 20 kN/m^3) and that of levee with less degree of saturation (typically 15 kN/m^3). Because of the support provided by the bearing capacity of subsoil,

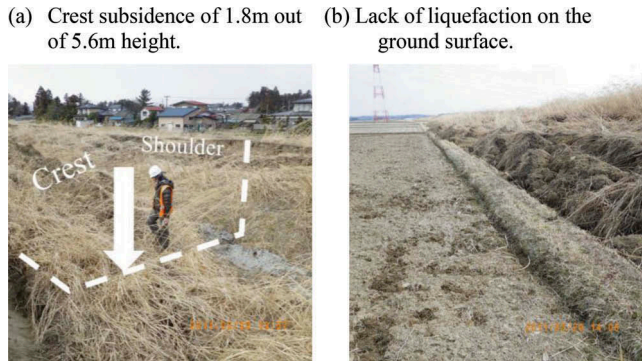
Figure 23. Consequence of liquefaction in levee body (Naruse River, Miyagi Prefecture).

A peculiar mode of levee deformation is shown in Figure 23. At this site, the levee crest subsided significantly, while two shoulders of the slope maintained their original height. Moreover, the local soil condition at the surface in this area is clayey and there is no evidence of liquefaction on the ground surface (Figure 23b). This phenomenon is attributed to liquefaction inside the levee body.

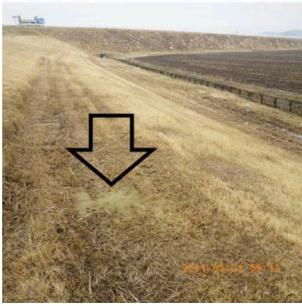
Figure 33. Sand ejecta from the middle height of a levee (Yoshida River, Miyagi Prefecture).

inside the body of levees despite that the local natural subsoil was clay and unlikely to liquefy (Figure 23). Figure 33 shows sand ejecta from the middle height of a levee. This is an evidence that liquefaction is possible to occur at elevations higher than local ground water level. Figure 34 schematically illustrates the mechanism of liquefaction inside a levee. The water is supplied into loose sand in the levee either by infiltration of rain water or from the surrounding subsoil into the subsided part of the levee. Note that levee is often constructed upon soft clayey soil along a river channel; the clay is unlikely to liquefy but its consolidation settlement leads to submergence of loose levee bottom that comes down below the water table.

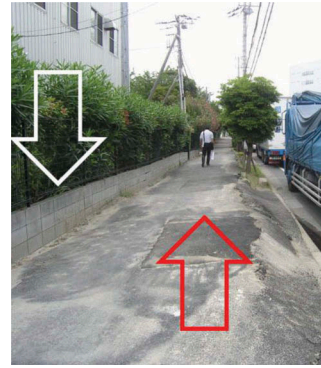
Figure 52. Heaving of road induced by subsidence in private land (Urayasu, Chiba Prefecture).

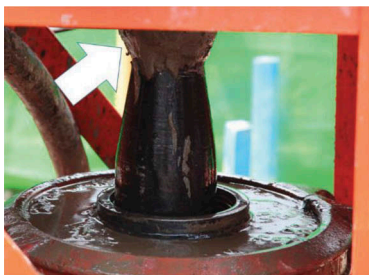
The works, however, had to be stopped in April, 2017. The first reason was non-uniform soil condition in the city. Jet grouting did not work well in clay parts. The second reason was detecting many embedded plastic drains that were not expected to be there during design. They had been installed at an interval of several meters for promotion of consolidation settlement probably in 1970s when the land reclamation took place. Rotating jet grout machines caught drains (Figure 62) and grout could not be injected into subsoil. Consequently, stable and continuous grid wall was not able to be constructed.

Figure 62. Plastic drain caught by rotation of jet grouting machine.

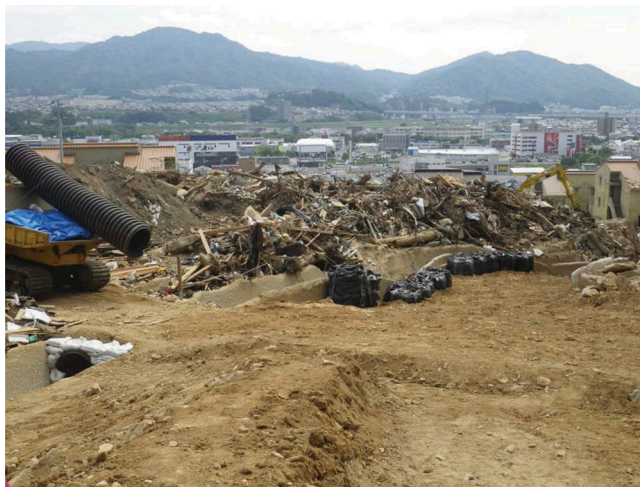
Figure 74. Consequence of rain-induced debris flow in Hiroshima, 2014.

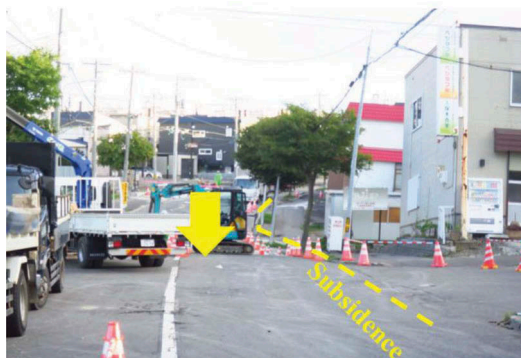
Figure 77. Liquefaction-induced ground distortion in residential area of Sapporo in 2018.
