Final Report No. 2225 by the Swiss Accident Investigation Board SAIB

concerning the accident involving the Agusta-
Bell 206B helicopter, registration HB-XPQ

on 24 May 2012

Eggschwand, municipality of Reichenbach/BE

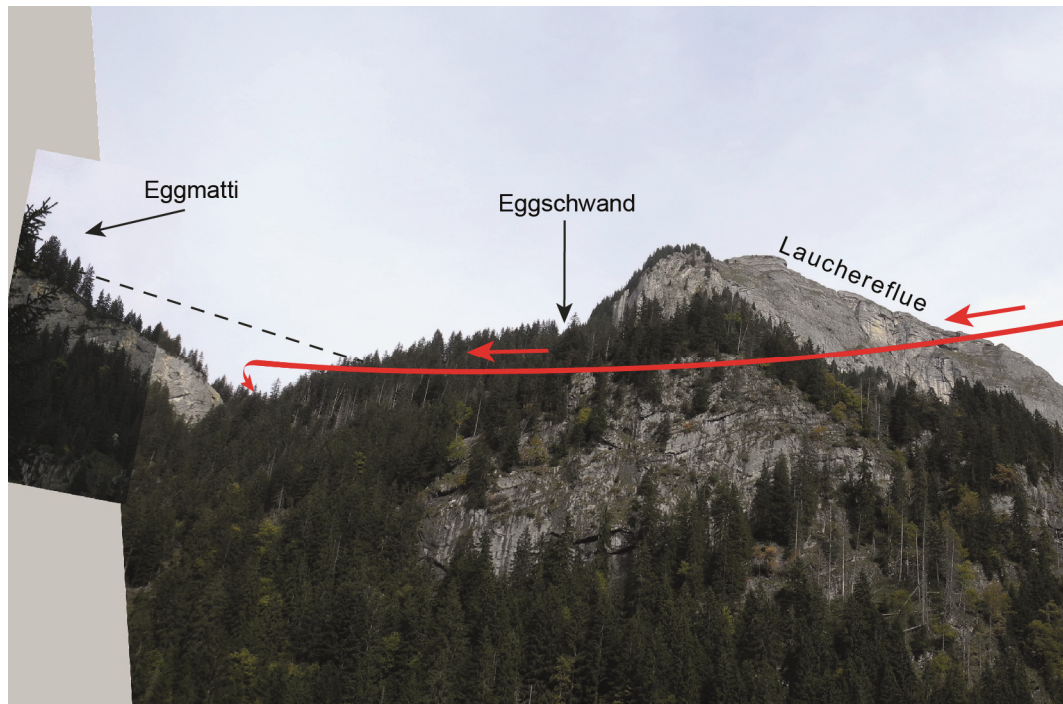
The support cable for the goods cable car between the "Eggmatti" and the "Eggburgli" (cf. Annex 1 and Fig. 1) was found severed after the accident.

Figure 1: Flight path when entering the "Eggbach" valley according to a flight path reconstruction created with the assistance of the herdsman from his position at the "Alti Weid" (red arrow). The new cable for the goods cable car between the "Eggmatti" and the "Eggburgli" (cf. Annex 1) has been traced with black dashed lines.

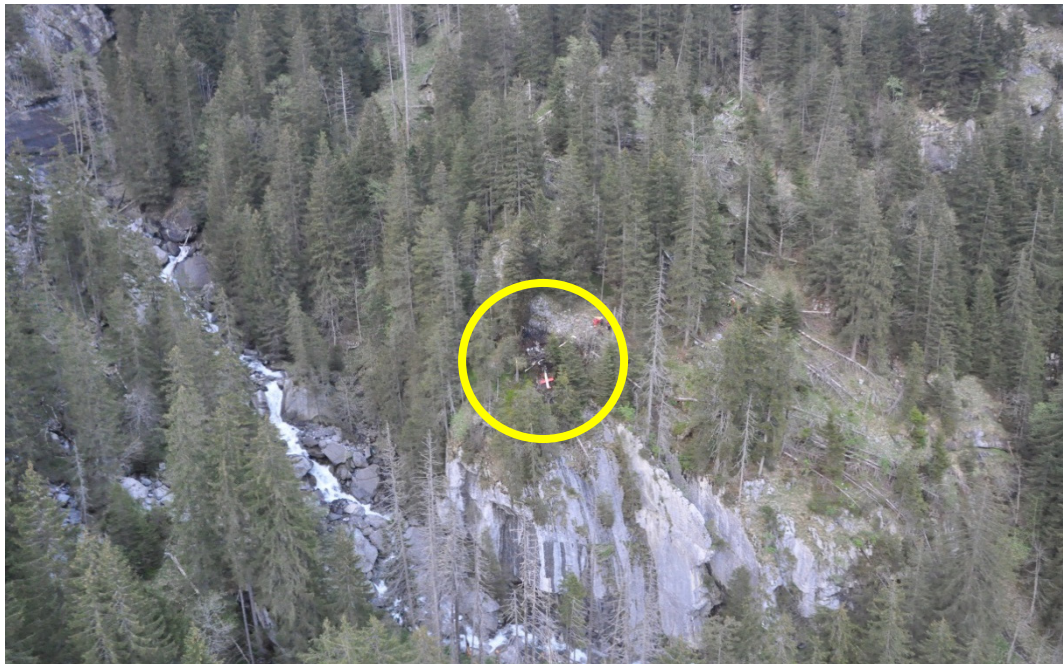
The final position of the wreckage was on the northern side of the Spiggegrund approximately 20 m east of the "Eggbach" creek on a rocky knoll below the "Eggschwand" (cf. Annex 1 and Fig. 2). The terrain in this area is steep, forested and almost inaccessible. There was insufficient network coverage for mobile telephony over the entire area around the site of the accident.

Figure 2: Final position of the wreckage on a rocky knoll east of the "Eggbach" creek.

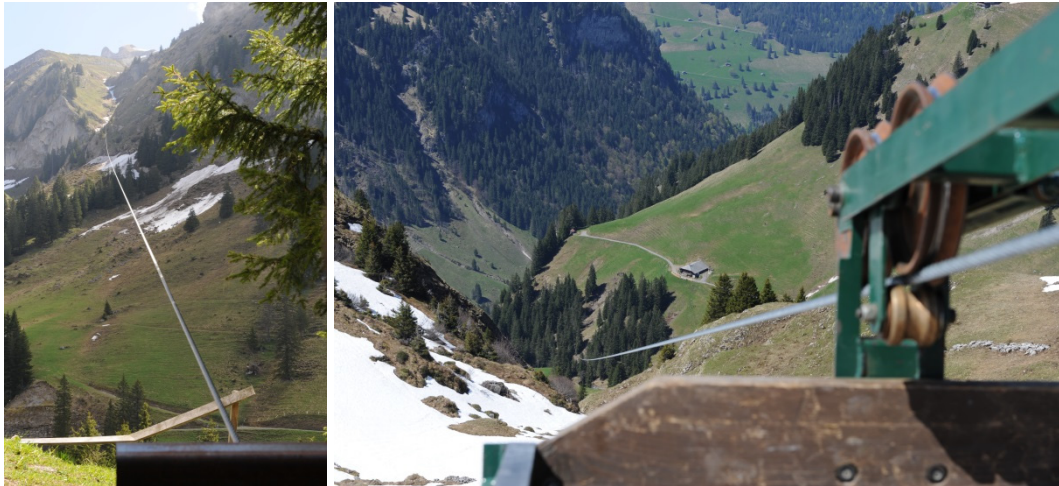
Figure 5: View from the valley station along the cable towards the mountain station (left). View from the mountain station along the cable towards the valley station (right). Photos from May 2013.

The support cable was severed during the accident and was found on the ground a considerable distance from the direct line between the valley and mountain stations towards the mouth of the "Eggbach" valley.

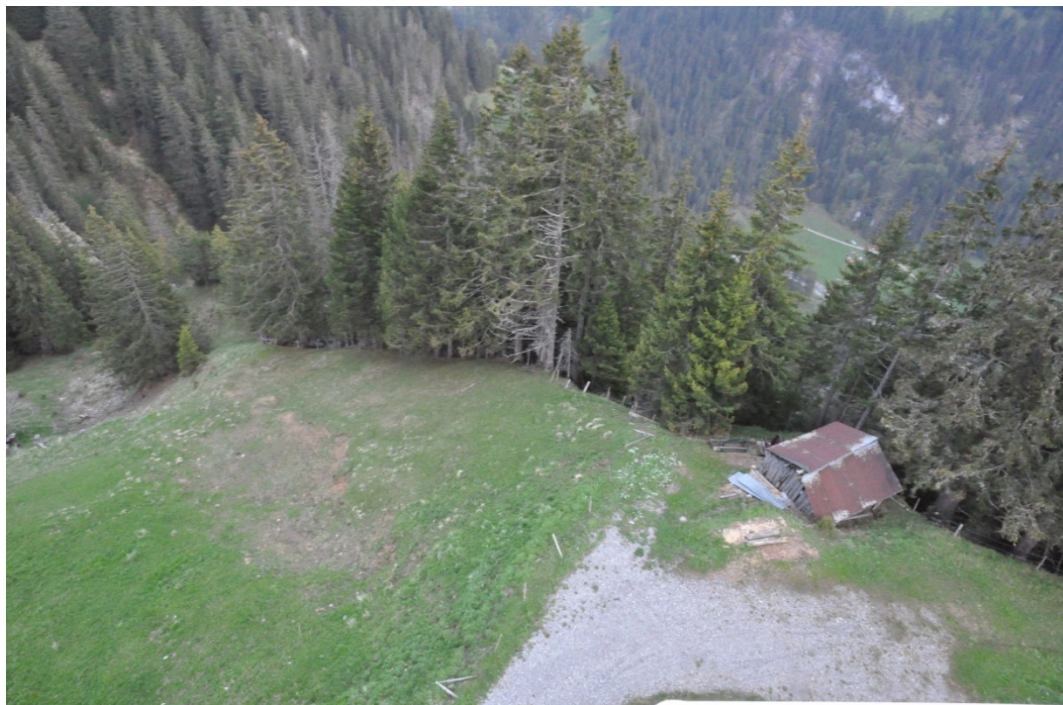
When flying in the opposite direction, from the "Eggbach" valley towards the "Spiggegrund" valley, the valley station is visible (cf. Fig. 6). In this case too, the mountain station is also hidden in a gully.

Figure 6: View of the valley station, looking from the "Eggbach" valley towards the "Spiggegrund" valley. The "Alti Weid" on the valley floor. Photo taken on the day of the accident.

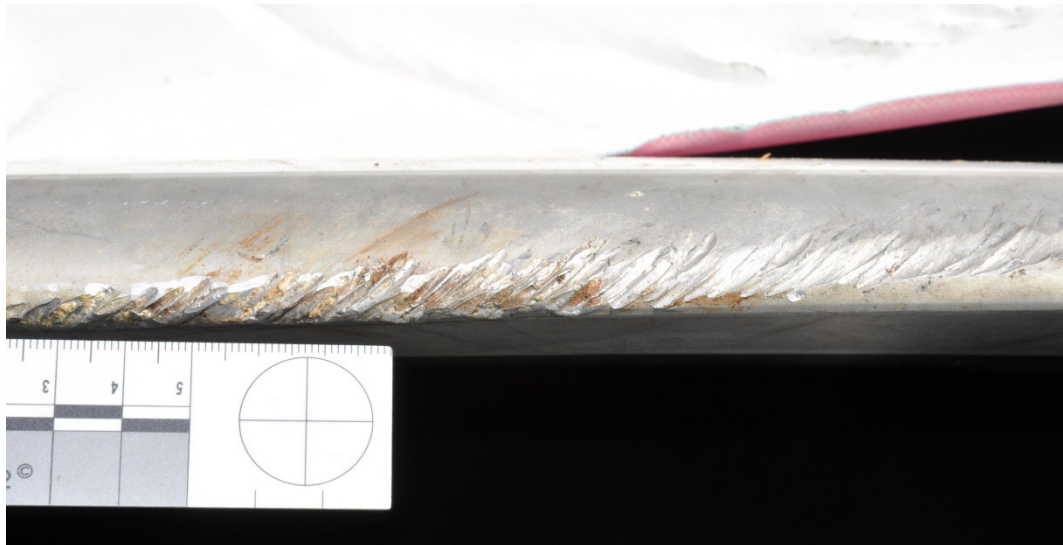
Figure 7: Traces of the wire cable on the leading edge of the main rotor blade.

As several traces of contact with the cable were found on both main rotor blades it can be assumed that they made contact with the cable several times.

The traces and the deformation of the wire cable in the area around the point where the cable was severed which were found mean that it is very likely that the point where the cable was severed corresponds to the point of collision with the main rotor blades of the helicopter.

The traces of the wire cable which were identified at various points over the entire length of the main rotor blades and the traces on one of the pitch links suggest that the rotor blade tips of the helicopter collided with the cable and that this then shifted towards the centre of the rotor. This resulted in deceleration and deflection of the helicopter from its flight path, as well as clockwise torque about the vertical axis. This would explain the pronounced lateral movement (side slip) of the helicopter which was observed, the "rocking" movements just before the crash and the flight path (cf. Annex 1). As a result of the collision, the helicopter became uncontrollable and crashed.

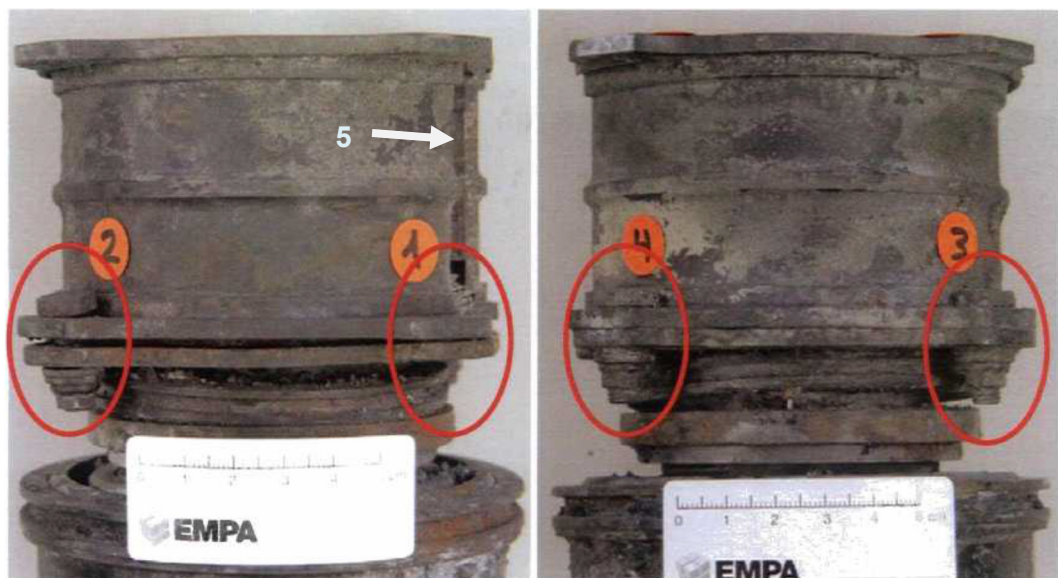
The main drive shaft's flexible gear coupling on the main gearbox compensates for slight axial play and shaft misalignment. It was here that a tooth segment was found to be missing in the coupling housing. There was also a missing bolt and another bolt connection was loose in the area around the missing segment.

Figure 8: Missing bolt (1), loose bolt connection (2), intact bolt connections (3 & 4), missing tooth segment (5).

- Very slight traces of abrasion were found in the borehole (1) in which the bolt was missing.
- The bolts (3 & 4) exhibited a certain degree of deformation.
- The bolt (2) was bent and when compared with the bolt connections (3 & 4) the nut was not screwed on to the bolt as tightly.
- Almost the entire length of the bolt thread (2) was deformed/damaged.
- None of the boreholes (1-4) revealed any fire residue deposits.
- The coupling housing was slightly deformed.

- The two broken edges of the missing housing segment had ingressed into the inner gear cavity and had been expanded concentrically.
- On the counterpart of the coupling housing, the gear, three teeth were partially broken.

"The observations made regarding the loose screw suggest it is possible that it was not properly tightened.

The somewhat prominent damage to the coupling housing of the main drive shaft is certainly consistent with the sequence of the accident. Although it is in principle possible that a bolt was forgotten or a nut was not fully tightened during the extensive revision work on the helicopter shortly before the accident, this seems unlikely considering the fact that the helicopter had been functioning properly for several hours.

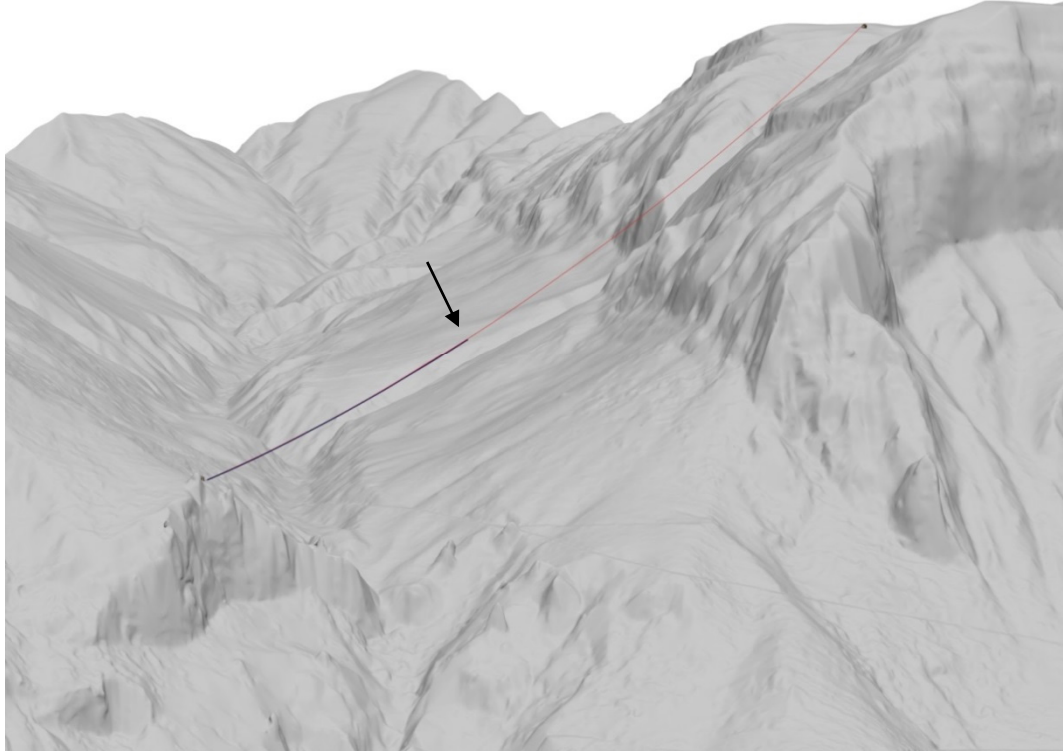
occurred. Specifically, it was possible to determine and visualise the probable approximate point of collision in a 3D terrain model (cf. Fig. 9).

Figure 9: 3D model of the new cable installed after the accident. The first 405 m from the valley station upwards are in blue; the rest of the cable is in red. Where the two colours change (black arrow) corresponds to the approximate position the cable installed at the time of the accident was severed. The point where the cable was severed is also very likely to correspond to the collision point.

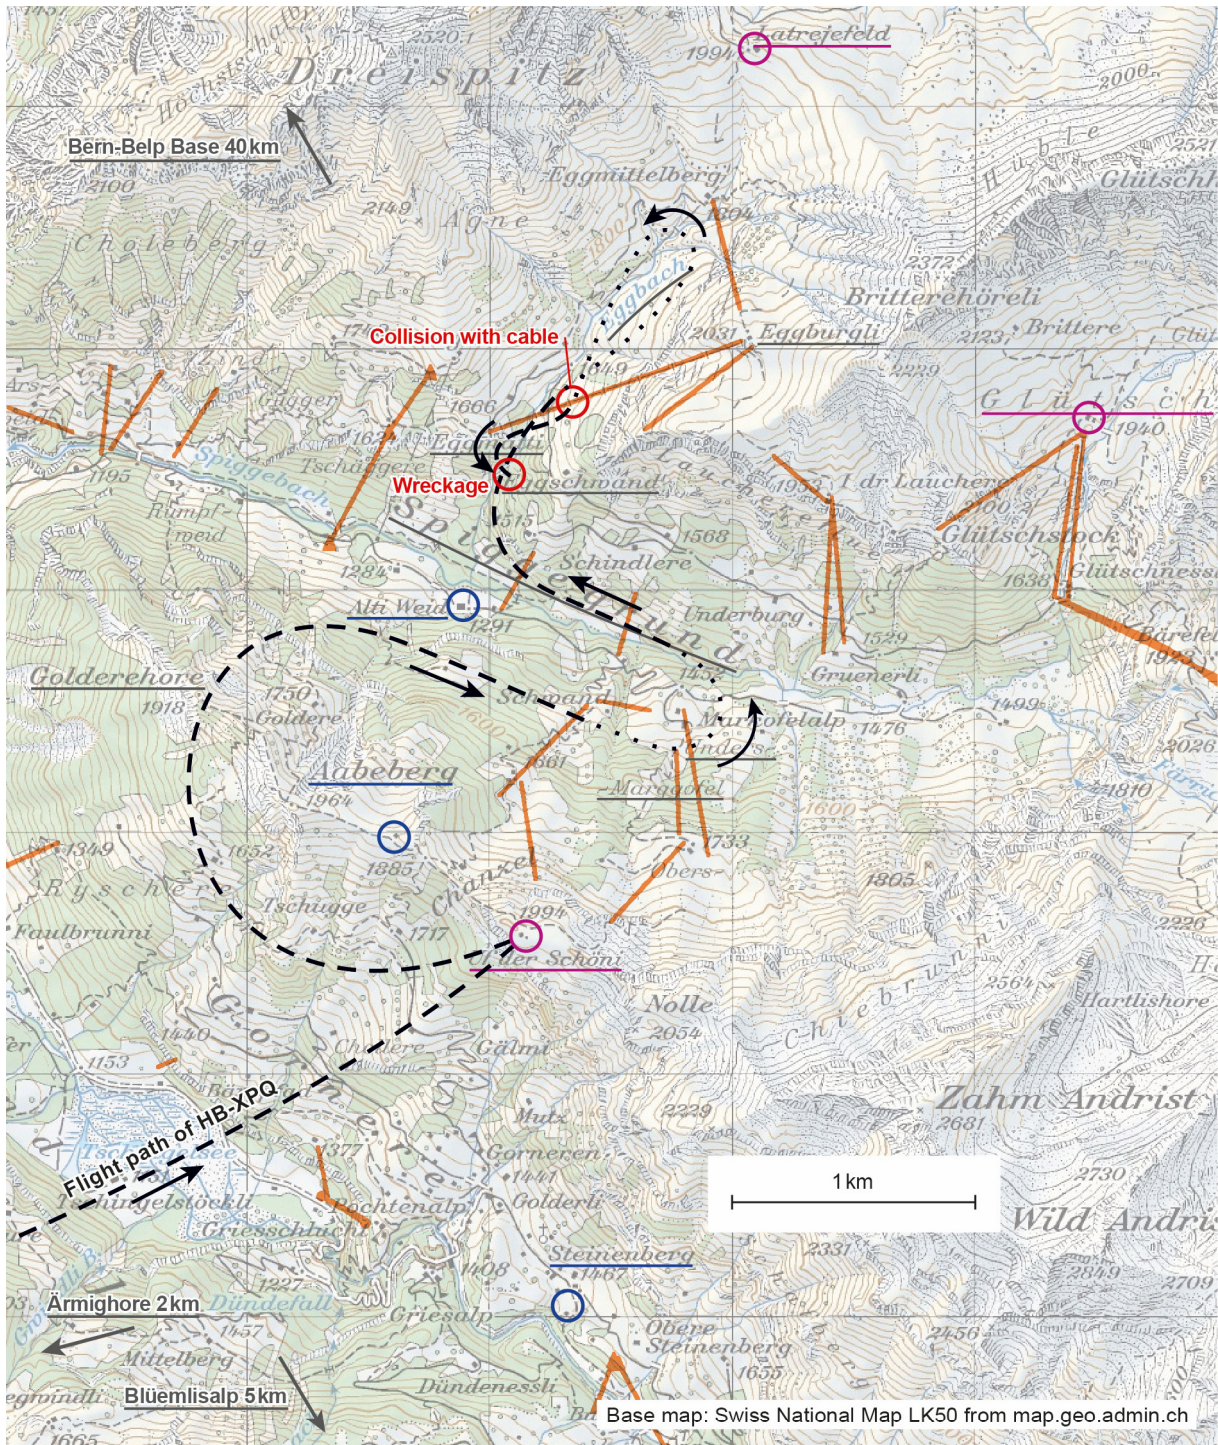
Annex 1: Map of the accident area

- Unterstrichen Geographic names mentioned in the report
- Flight path of HB-XPQ immediately before the accident, reconstructed according to eye-witness reports
- Flight path of HB-XPQ unknown
- Collision with cable, wreckage
- Eyewitnesses: herdsman on the "Aabeberg" alp, person at "Steinberg" alp, herdsman at the „Alti Weid“
- Landing sites: "Uf der Schöni", "Glütsch", "Latrejefeld"
- Air navigation obstacles according to the obstacle database at the time of the accident
