# **Final Report No. 2276**

concerning the accident involving the  
Eurocopter AS 350 B3,  
registration HB-ZLN,

on 21 December 2013

Ober Erlen, Glarus Süd municipality, GL

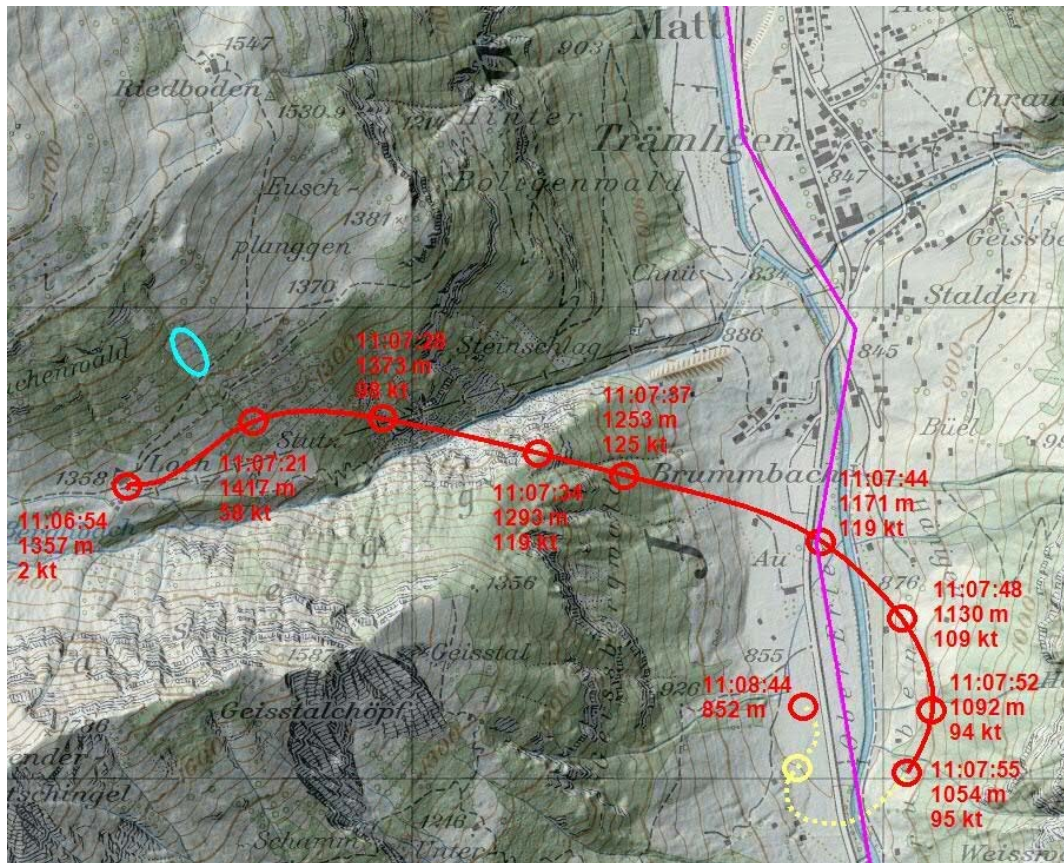
As the pilot had already realised at the Ziegerzug that there was a light southerly wind, he decided to slightly extend the downwind leg and therefore only turn into the base leg of the approach by one of the high-voltage pylons, a little further back than usual. According to the pilot, before the turn their height was approximately 15 - 20 metres above the pylon, corresponding to approximately 80 - 100 metres above ground. The nose of the helicopter was pointing slightly downwards and the pilot began to slowly reduce the speed. According to the pilot's statement, everything was normal until this point. The other occupants were also unable to determine anything unusual. At the start of the right turn, the groundspeed was approximately 95 kt at a calculated average rate of descent of approximately 2000 ft/min (cf. Fig. 1).

**Figure 1:** Red: the flight path of the flight involved in the accident according to the PowerFLARM<sup>2</sup> recording with information on altitude [m AMSL] and groundspeed [kt] at selected times [UTC]. Yellow: the last right turn and first impact (yellow circle) according to information provided by the crew, and the traces of impact on the ground. Magenta: the high-voltage power line on the valley floor along the Sernf river. Light blue: the Ziegerzug above Alp Loch; map / aerial photo reproduced by permission of the Federal Office of Topography Swisstopo (JA150149).

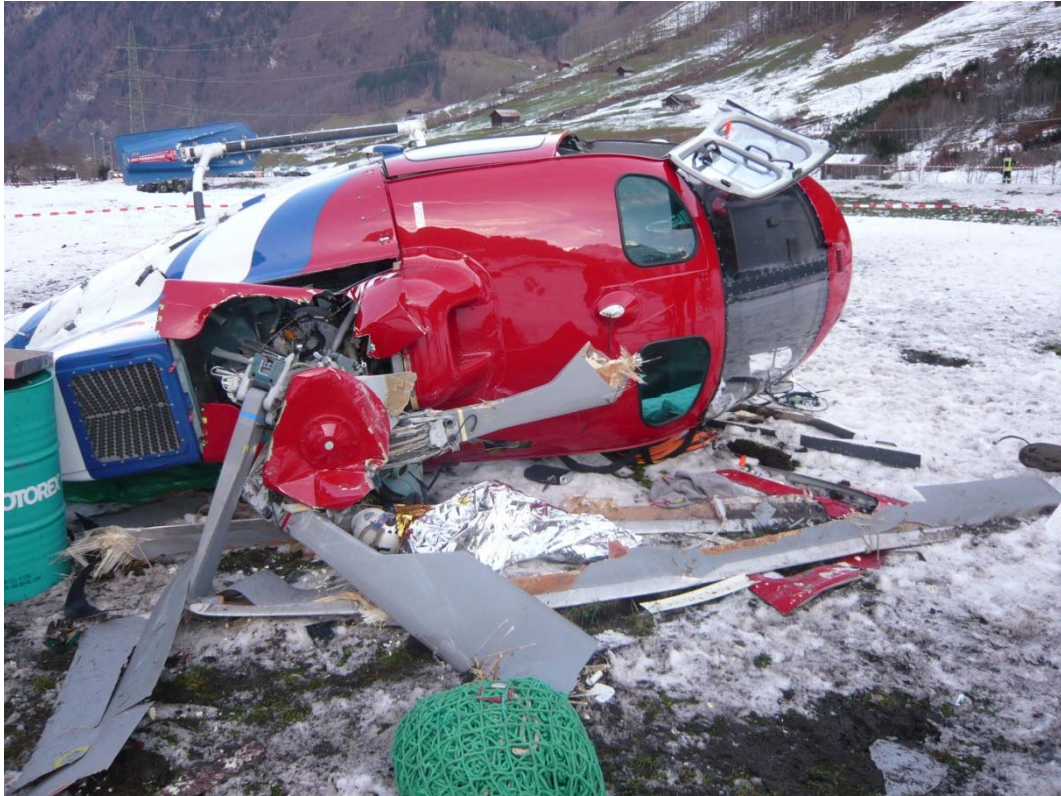
**Figure 2:** Final position of the helicopter (photo from the day of the accident)

The plastic of the high-visibility pilot's door had been torn off and the door lay next to the wreckage of the helicopter (cf. Fig. 2). Although the small door behind the pilot door on the right near the rear bench seat was deformed and had been torn from its latch, it was still in its original position. The doors on the left side were not damaged.

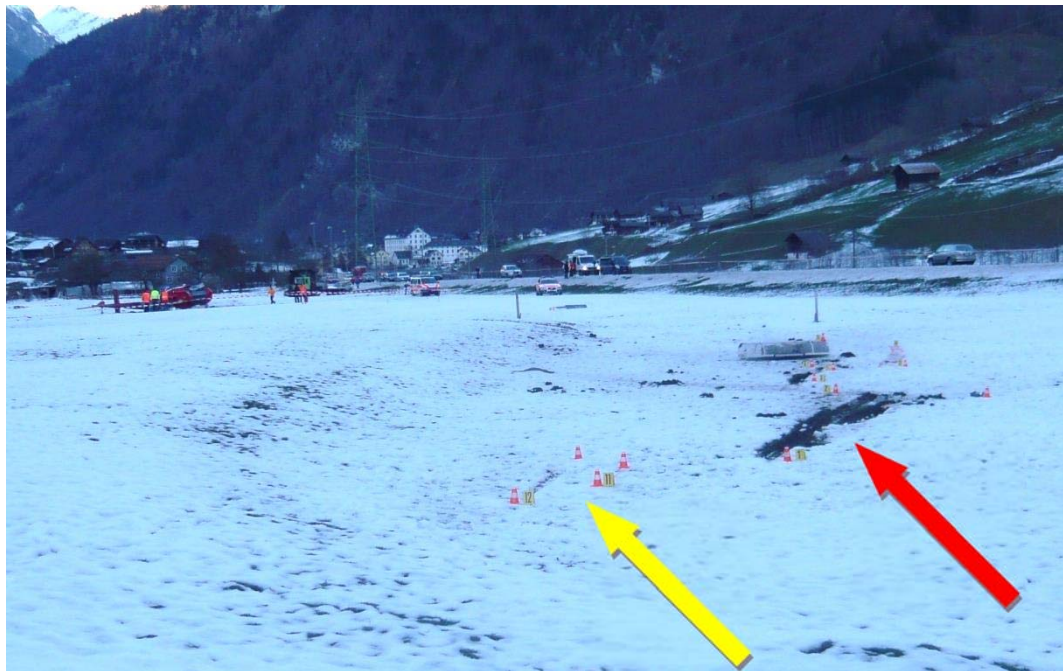
The traces indicate that the helicopter impacted the ground with significant vertical and forward speed. The right skid impacted the ground first (cf. Fig. 3). The tail boom then deflected downward and left small traces of the tail skid and the blade tips of the tail rotor.

**Figure 3:** The first traces of impact from the right skid on the ground (red arrow) and traces of the tail skid and blade tips of the tail rotor (yellow arrow). Final position of the cargo basket and final position of the helicopter (photo from the day of the accident).

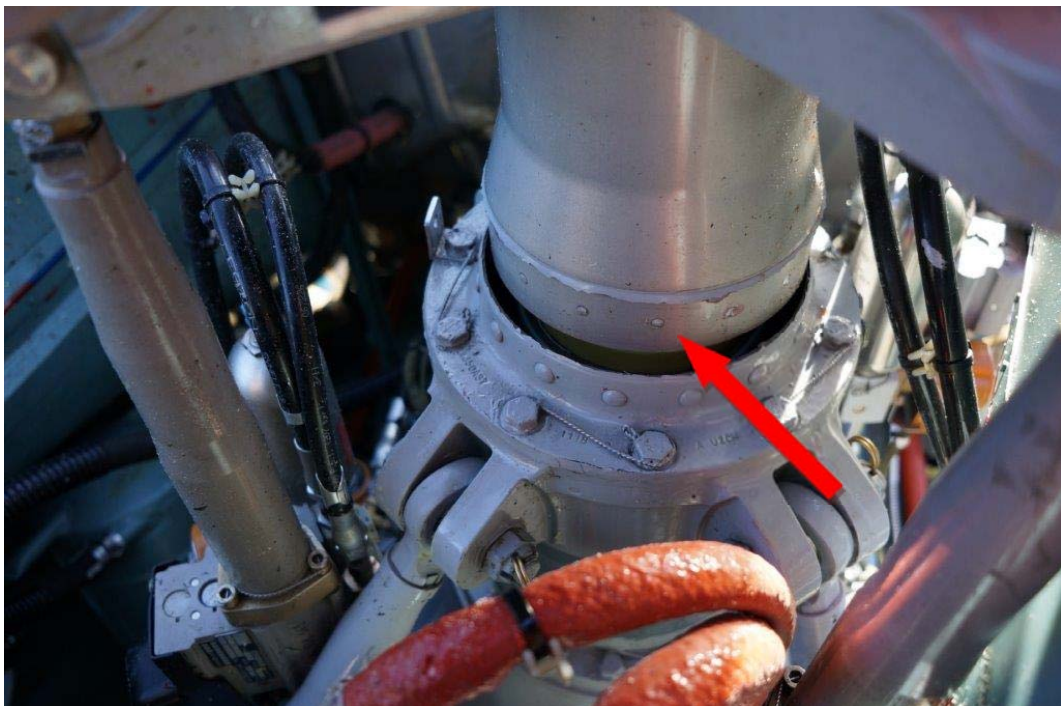
Some of the main rotor control pitch rods were fractured in the area around the main gearbox base plate. All three pitch rods between the upper, rotating part of the swashplate and the main rotor blades were fractured. The three main rotor control's hydraulic cylinders were in their original positions and were connected to the pitch rods and the lower, non-rotating part of the swashplate. The drive link (or drive scissor) between the upper, rotating part of the swashplate and the main rotor mast was deformed where it was attached to the main rotor mast and had been twisted against the mast. The swashplate guide, on which the swashplate has vertical axial movement along the main rotor mast, had been torn from its mount on the upper part of the main gearbox housing (cf. Fig. 4).

**Figure 4:** Swashplate guide, torn from its mount on the upper part of the main gearbox housing (red arrow).

The investigation revealed that the rivet connections between the swashplate guide, on which the swashplate has vertical axial movement along the main rotor mast, and the upper part of the main gearbox housing (cf. Fig. 4) had sheared off. According to information provided by the helicopter manufacturer, this type of damage is often observed in accidents involving contact with the main rotor. There is no known case of this type of damage having occurred under normal flying conditions.

Due to the type of damage to the rivets between the swashplate guide and the main gearbox housing, as well as the unhindered movement of the swashplate along the swashplate guide, it can be concluded that the rivets sheared off at the point at which the main rotor hit the ground. This damage is consistent with the sequence of the accident and, according to the statement provided by the manufacturer, had also been detected in other accidents involving contact with the main rotor. According to the statement provided by the manufacturer, there is no knowledge of rivets ever having sheared off while in flight.

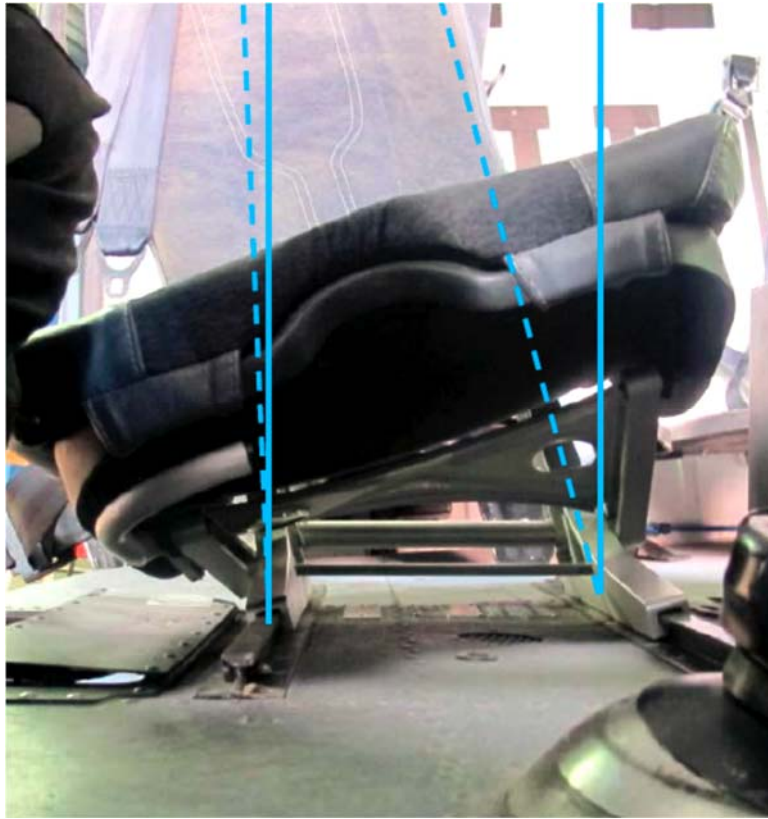
Most of the cabin interior remained intact. The rear bench seats were in their original positions and did exhibit signs of deformation. The pilot seat was in its original position and had been significantly deformed downwards and to the right

**Figure 5:** Pilot seat – significant deformation down and to the right

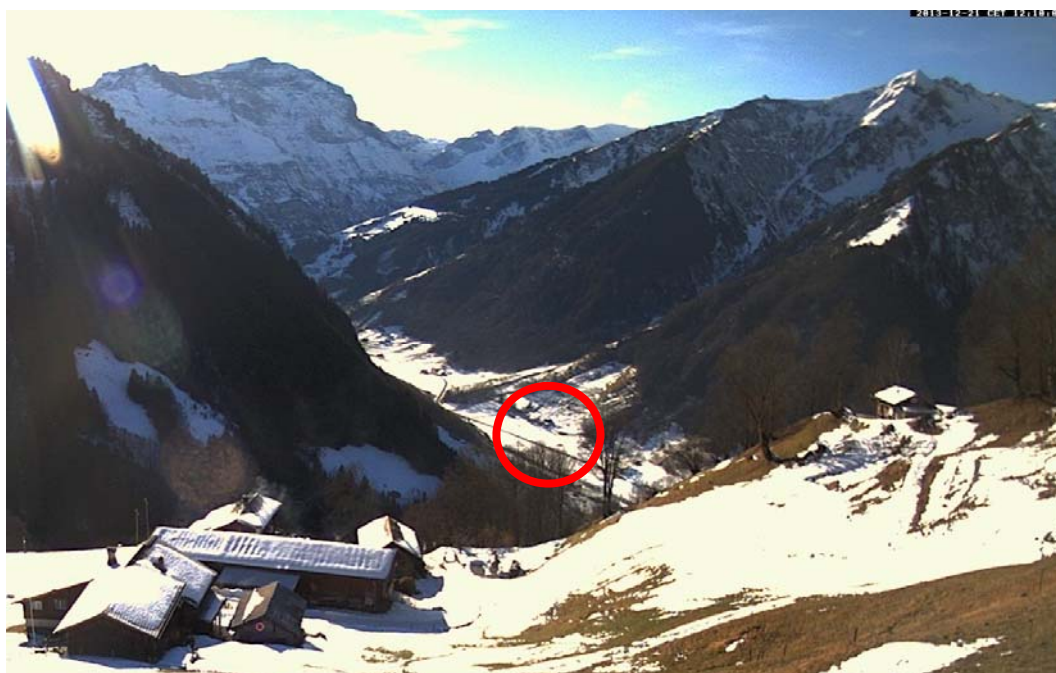
**Figure 6:** View to the south-west from Weissenberge above Matt (approx. 1300 m AMSL), 21 December 2013, 12:10. The site of the accident on the valley floor near Ober Erlen (red circle).

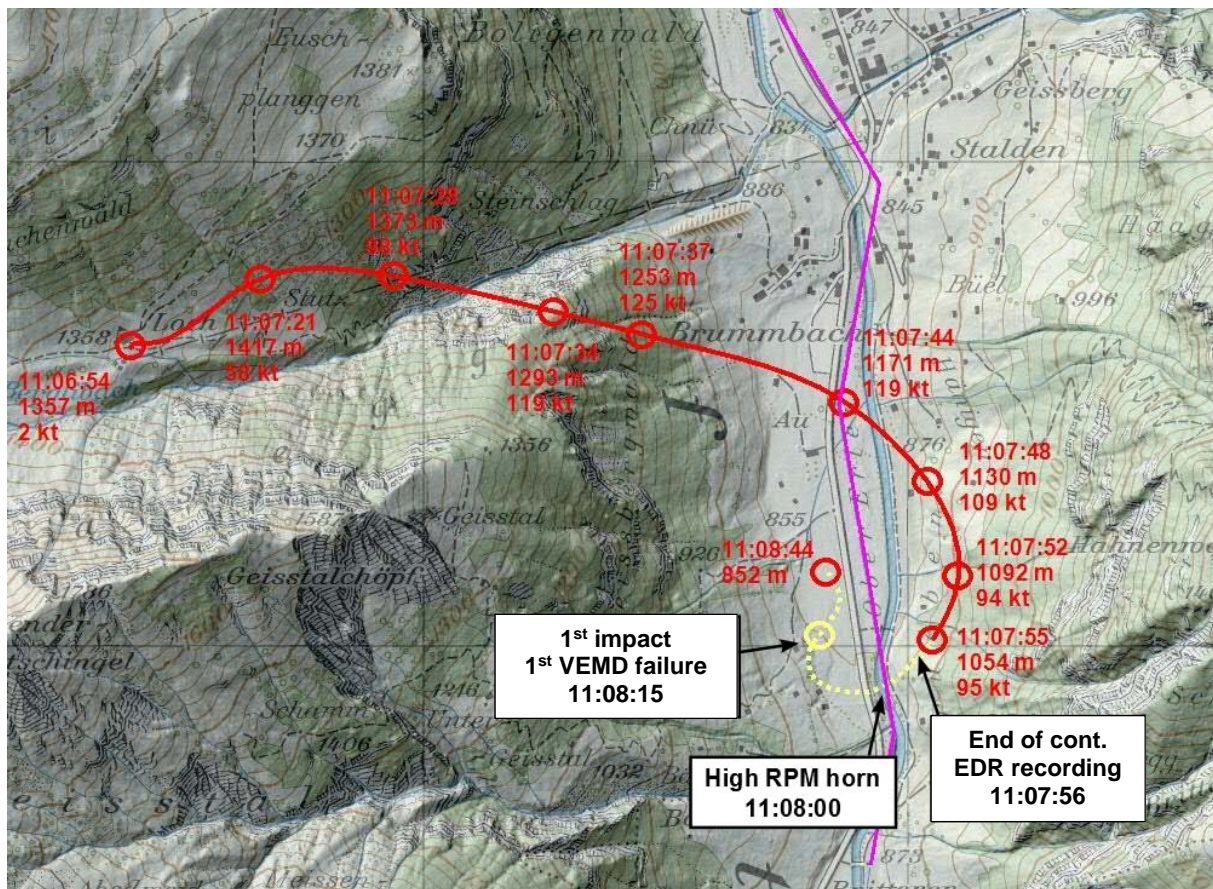
## Annex 1: Temporal relations according to analysis of the PowerFLARM, VEMD and EDR data

All failures and overlimits (and the timing thereof) registered by the vehicle and engine multifunction display (VEMD) or the engine data recorder (EDR) are consistent with the sequence of the accident (cf. Annex 1). It therefore appears plausible that the initial failure, which was registered at 2:12 min VEMD time, represents the initial impact with the ground, as a result of which the EDR and PowerFLARM suffered temporary interruptions to their power supply. This meant that part of the EDR and PowerFLARM recordings were lost with retroactive effect, which meant that their recordings abruptly ended approximately 19 seconds prior to the accident, while the helicopter was still in flight. As the EDR context and limit readings were influenced differently by the interruption to the power supply, these are available for an additional approximately 4 seconds.

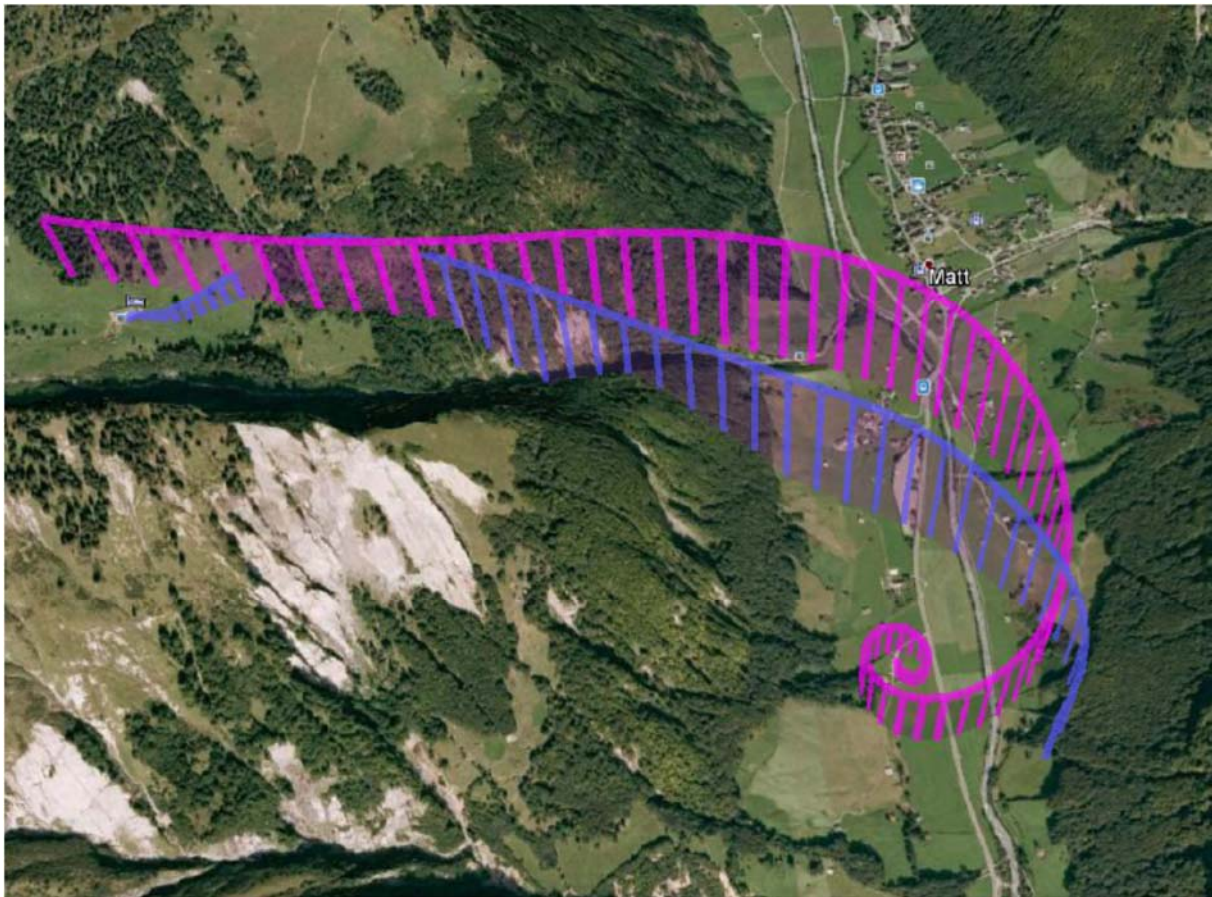
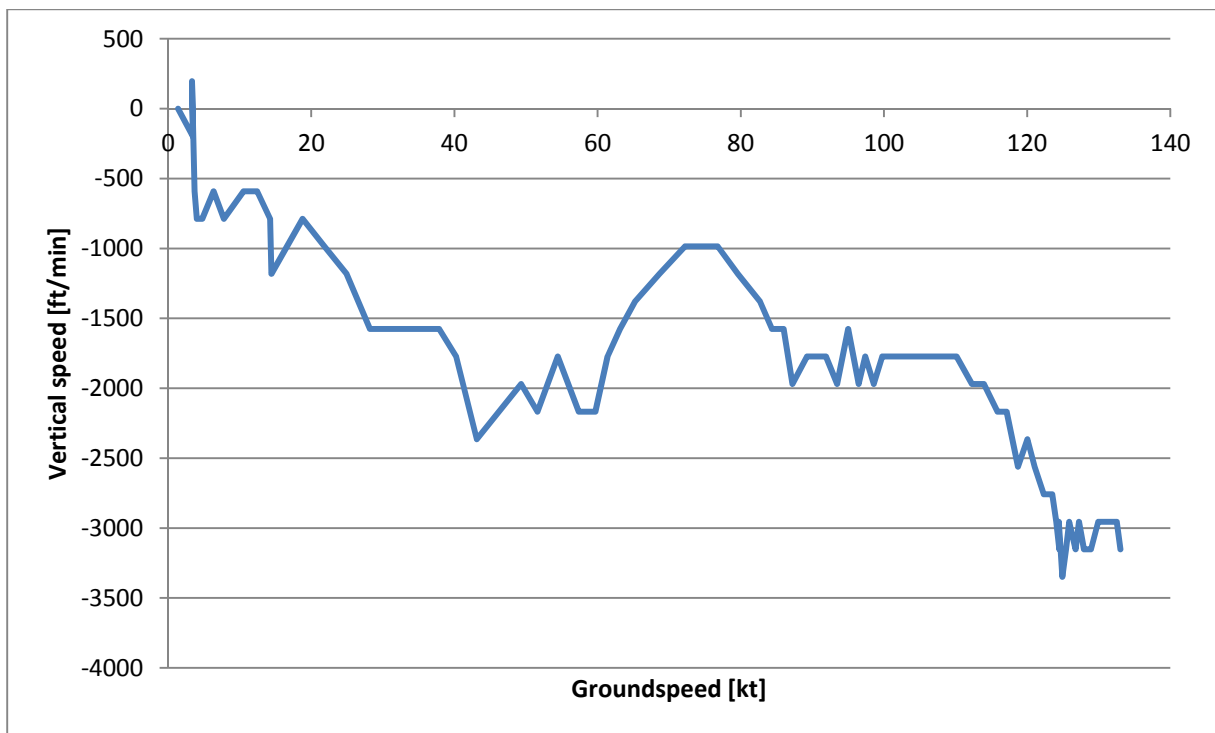
**Annex 2: Comparison of the two approaches on the landing site at Ober Erlen**

The analysis of the first approach on the landing site at Ober Erlen on the day of the accident (cf. Annex 2), however, reveals that based on the recorded horizontal speed and the calculated vertical speed the helicopter could have entered a vortex ring state towards the end of the approach. However, the missing recordings mean that a direct comparison with the approach during the flight involved in the accident is not possible.

First approach according to the recordings of the PowerFLARM in magenta. Second approach (flight involved in the accident) according to the recordings of the PowerFLARM in blue. All altitudes are corrected GPS altitude. Representation in Google Earth.

First approach: Recorded groundspeed [kt] vs. vertical speed (calculated from the recordings) [ft/min].
