**Baseline Coastal Assessment**

**Shelly Bay Road Upgrades**

**Prepared for**  
Wellington City Council

**Prepared by**  
Tonkin & Taylor Ltd

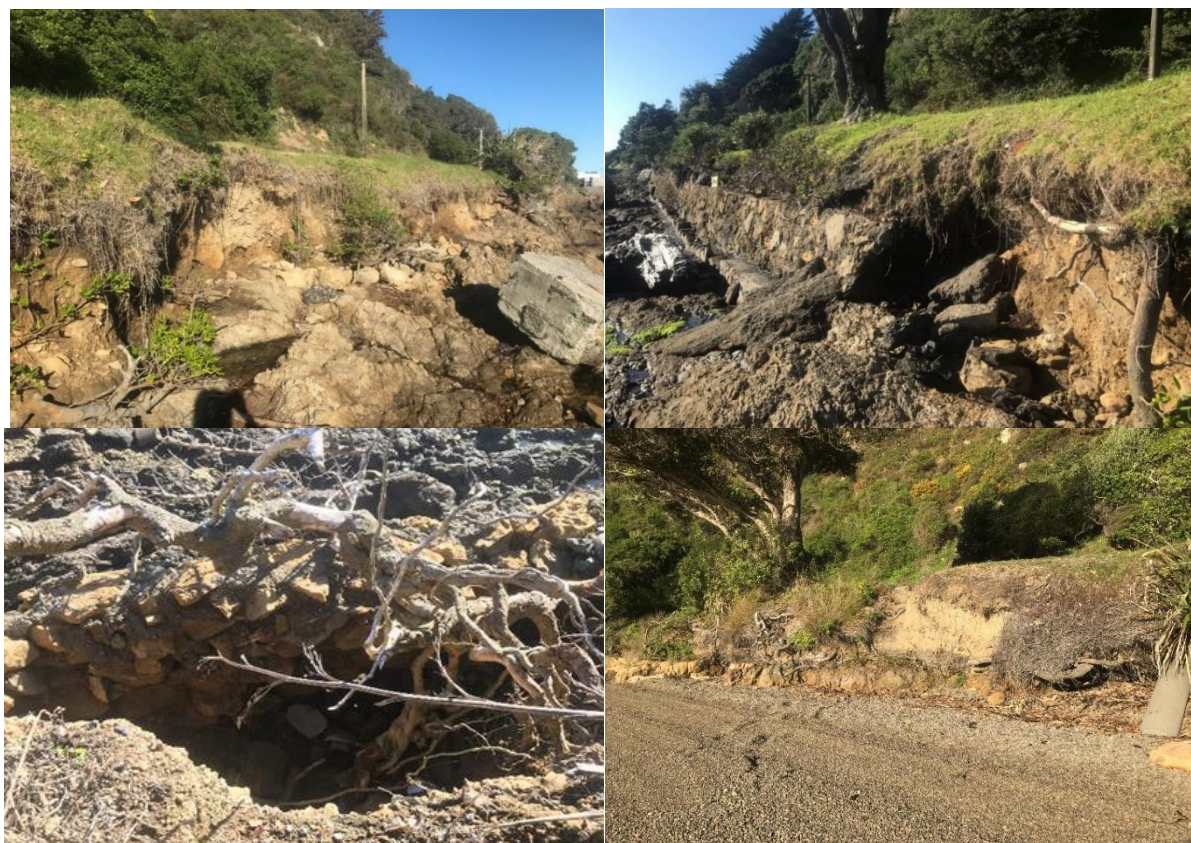
Figure 4-3: Erosion trends along the coastal line of Shelly Bay Road

There is evidence along the length of the project site that this area is subject to ongoing erosion due to wave attack. The presence of significant lengths of seawall along Shelly Bay Road indicates vulnerable areas that have been repaired over the lifetime of the road. There are also areas of recent erosion and during the site walkover evidence of damage to the backshore and some seawalls was observed reflecting this ongoing erosional trend (refer **Figure 4-3**).

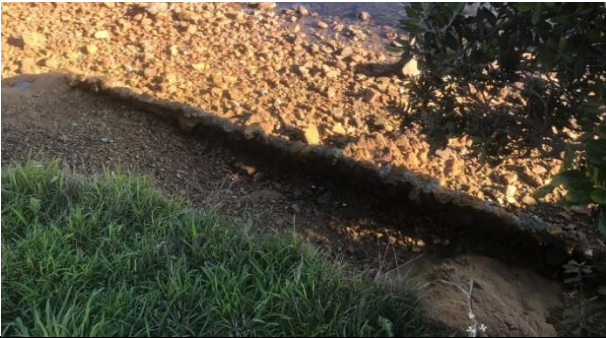
Asset ID	Changes noted since 2016 condition assessment and image
<p>14555 Vertical wall Mortared rock</p>	<p>2016 condition: Poor Present Day condition: Very poor</p> <ul style="list-style-type: none"> <li>• Overtopping and undermining of wall</li> <li>• Scour of crest</li> <li>• Damage to face</li> </ul>

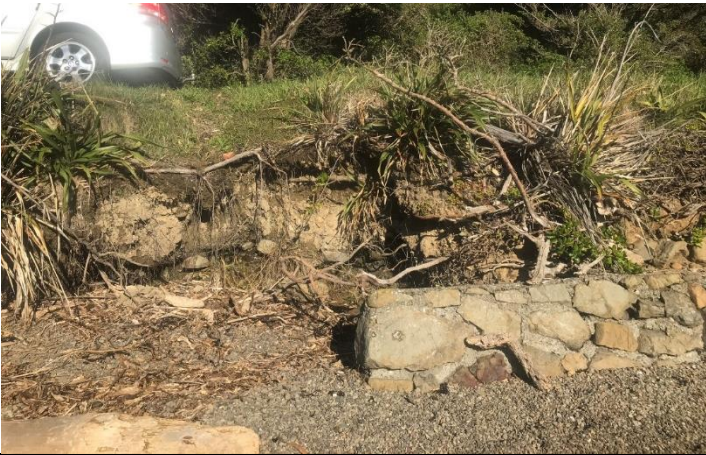
<p>14740 Vertical wall Mortared rock</p>	<p>2016 condition: Poor Present Day condition: Very poor</p> <ul style="list-style-type: none"> <li>• Overtopping and undermining of wall</li> <li>• Scour of crest</li> <li>• The seawall isn't protecting the bank behind</li> <li>• Damage to face</li> <li>• End-scour of wall</li> <li>• Higher seawall likely needed such as the one adjacent</li> </ul>

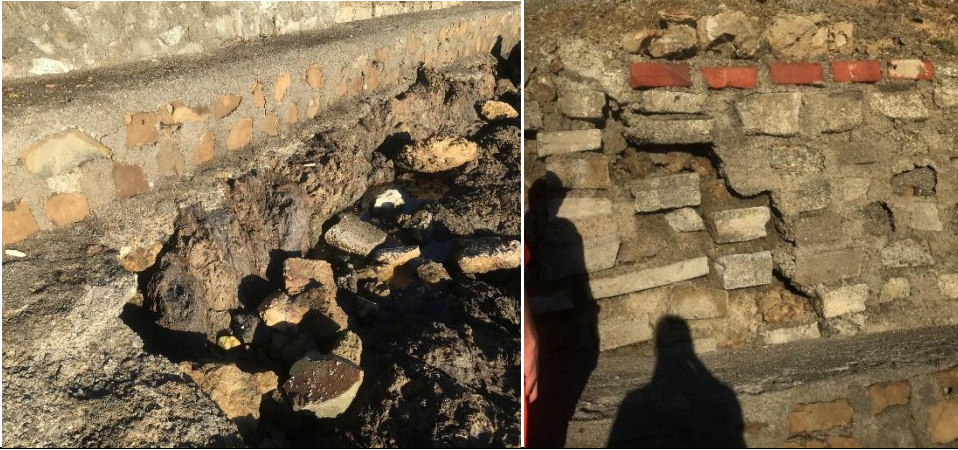
<p>11205 Stepped vertical wall Mortared rock</p>	<p>2016 condition: Average Present Day condition: Poor</p> <ul style="list-style-type: none"> <li>• Localised undermining of wall</li> <li>• Localised significant damage to face</li> </ul>

<ul style="list-style-type: none"> <li>• End-scour of wall (particularly at the southern end)</li> </ul>

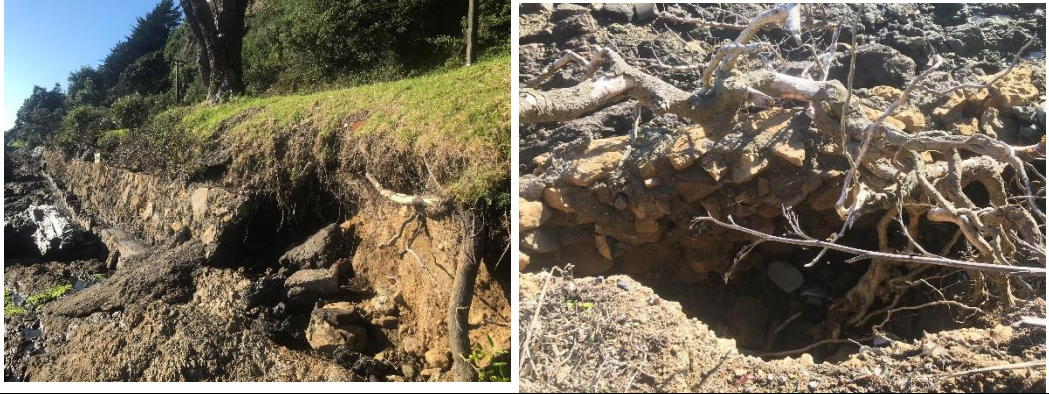
<p>14581 Vertical wall Mortared rock</p>	<p>2016 condition: Average Present Day condition: Poor</p> <ul style="list-style-type: none"> <li>• Localised undermining of wall</li> <li>• Damage to face</li> <li>• End/outflanking scour (more significant at the southern end)</li> <li>• At the end of a wall there are large concrete blocks that may have been put there to prevent erosion, but they have since been displaced</li> </ul>

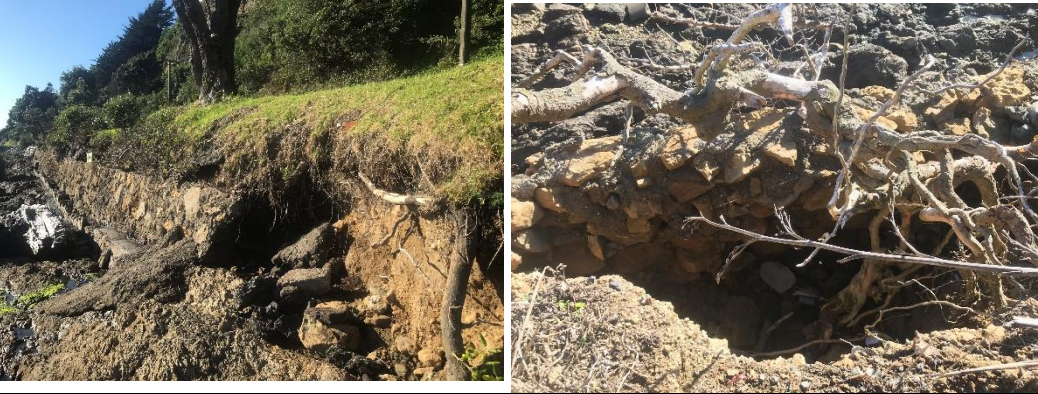
<p>14584 Vertical Wall Mortared rock</p>	<p>2016 condition: Average Present Day condition: Very poor</p> <ul style="list-style-type: none"> <li>• Void behind wall caused by undermining failure</li> <li>• Damage to face</li> <li>• End-scour of wall</li> </ul>

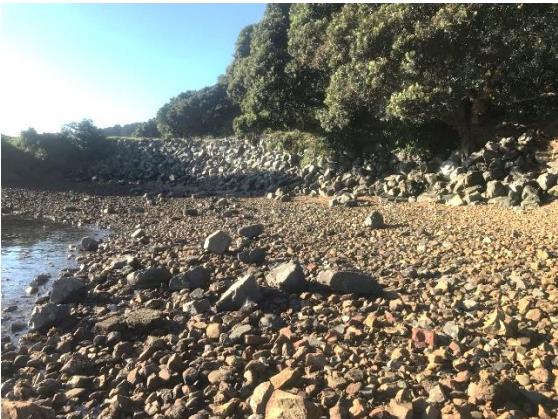
<p>NW04</p>	<p>This wall was not included in the 2016 assessment and has likely been installed post-2016.</p>

<p>Revetment Rip rap rock</p>	<p>Present Day condition: Poor-Average</p> <ul style="list-style-type: none"><li>• It can be seen in the image that several rocks have been plucked from this revetment and are located on the beach. This is likely due to the revetment being constructed too steep for the size of rock used. It is anticipated this plucking will continue to occur in future storm events.</li></ul>

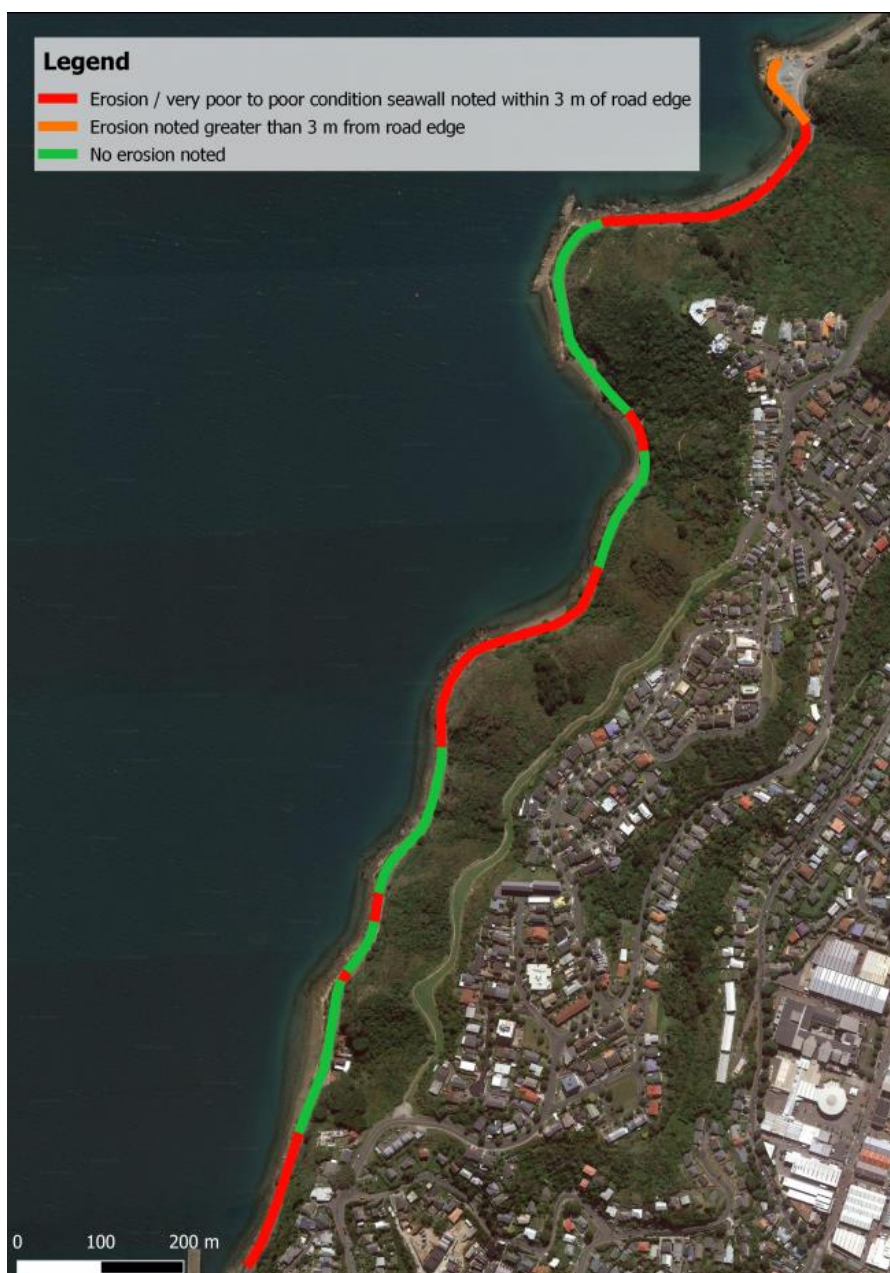
Figure 6-1: High level erosion summary along the project site based on site observations

- There is evidence of erosion along the edge of the current road alignment, particularly where the road edge is unprotected along the seaward edge by natural features such as rocky outcrops (refer Figure 6-1 for high level erosion summary along the site). This indicates a general erosional trend which will increase into the future as sea levels rise. There are locations where seawall repairs and construction of new seawalls will need to be considered if the road corridor alignment remains the same width. Extending the road corridor seaward will increase this risk and will require new seawall construction along significant lengths, particularly where present day MHWS is within 5m of the road edge (refer Table 6-1).

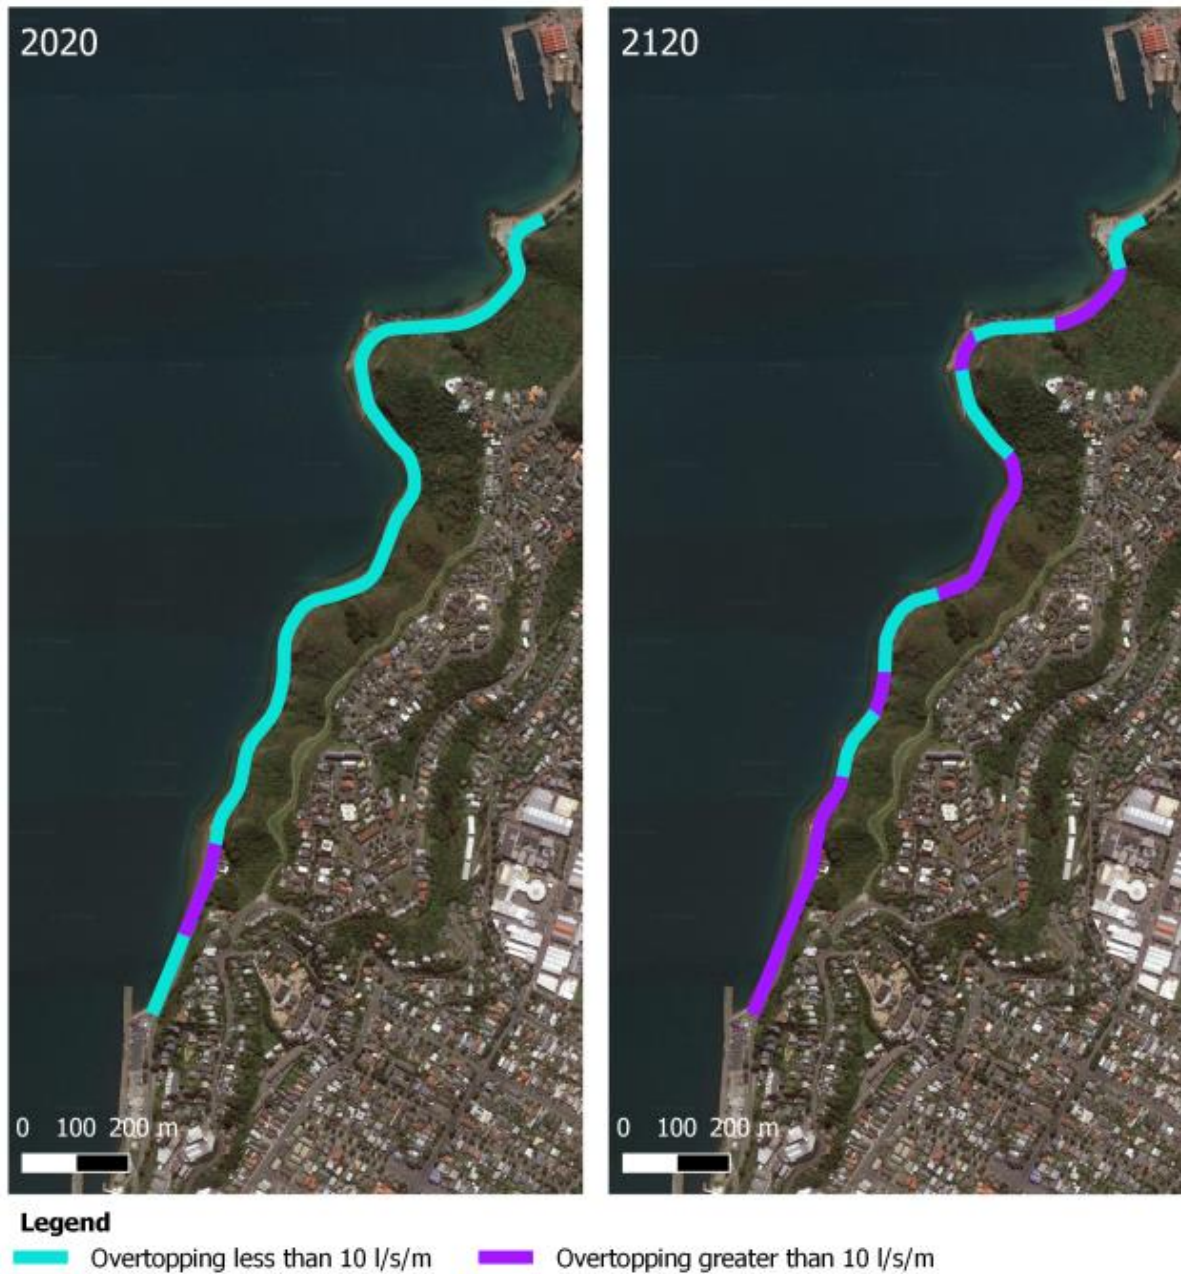
Figure 6-2: High level overtopping summary along the project site for present day (left) and 2120 (RCP8.5) (right) sea levels during a 1%AEP storm event

- Overtopping of the road edge during extreme storm events is an important consideration when assessing design road elevation, particularly where a seawall is required to support this road edge (refer Figure 6-2 for high level overtopping summary along the project site). High levels of overtopping can result in hazardous conditions for road users and cause damage to the backshore and road surface. Overtopping flows will increase if the road corridor shifts seaward and will also increase into the future as sea levels rise. Particular attention should be given to lengths of the road with lowest elevations, where current seawalls are present or where the road edge is within 5m of the present day MHWS. It is recommended that a minimum road/seawall crest elevation of at least 3.5m RL be considered in these locations. Where this is not feasible, alternate mitigation measures may be required in the future such as road closures during large storm events.

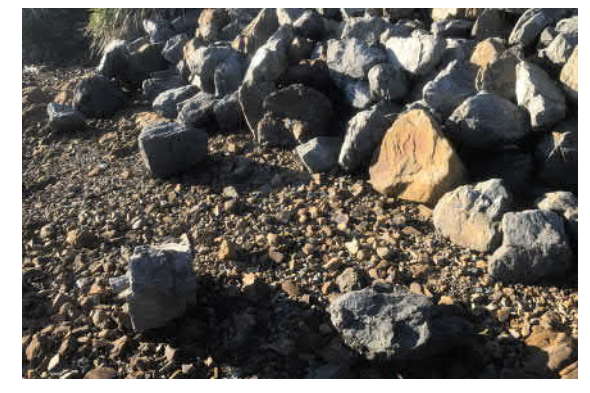
No toe key, rock over steep, plucking and movement of toe rock noted

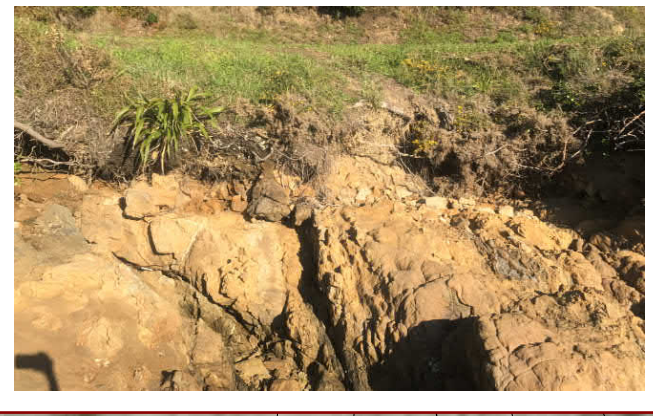
Erosion noted
