Dunynaig and Hinterland Assessment Project

DHAP2021 Data Structure Report

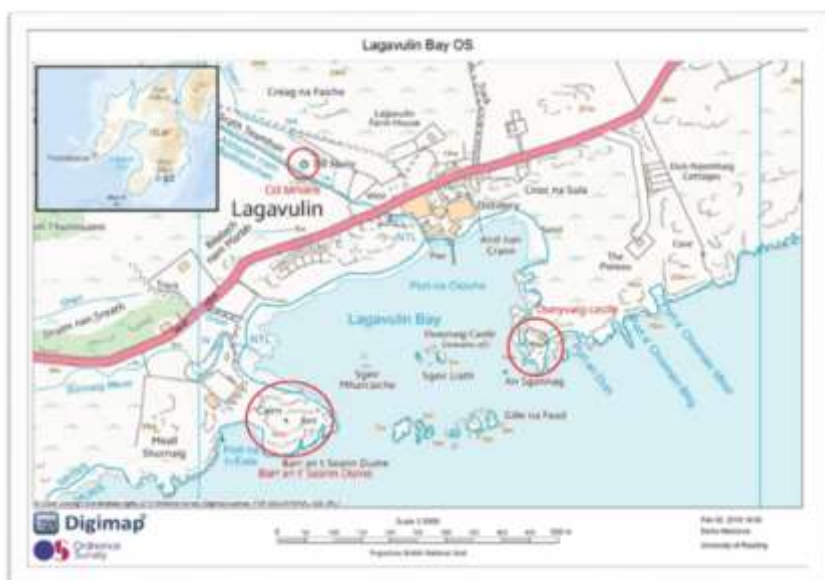
Figure 1 Location of Dunyvaig Castle, Barr an t-Seann Duine and Cill Mhoire sites.

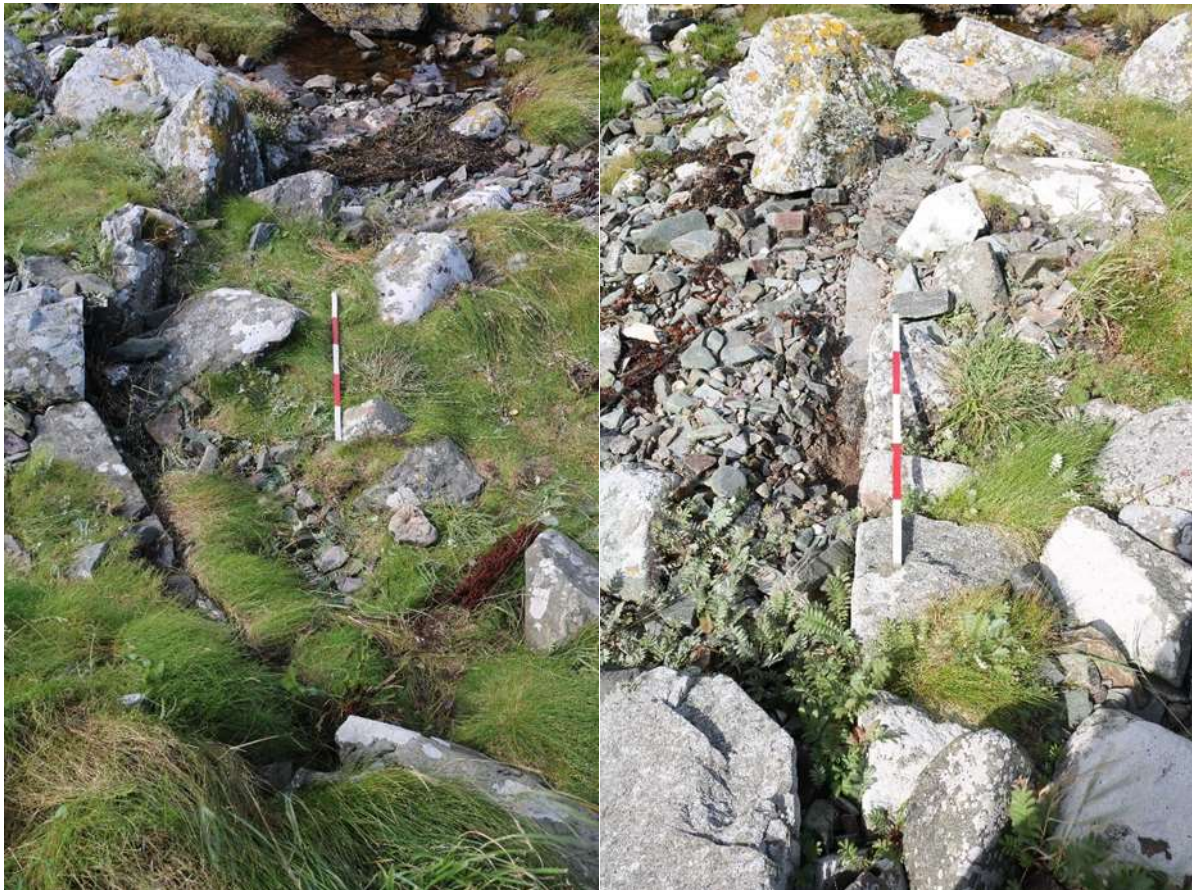
Figure 3 a) View of the proposed curved inner face of the bastion tower and b) straight outer wall face.

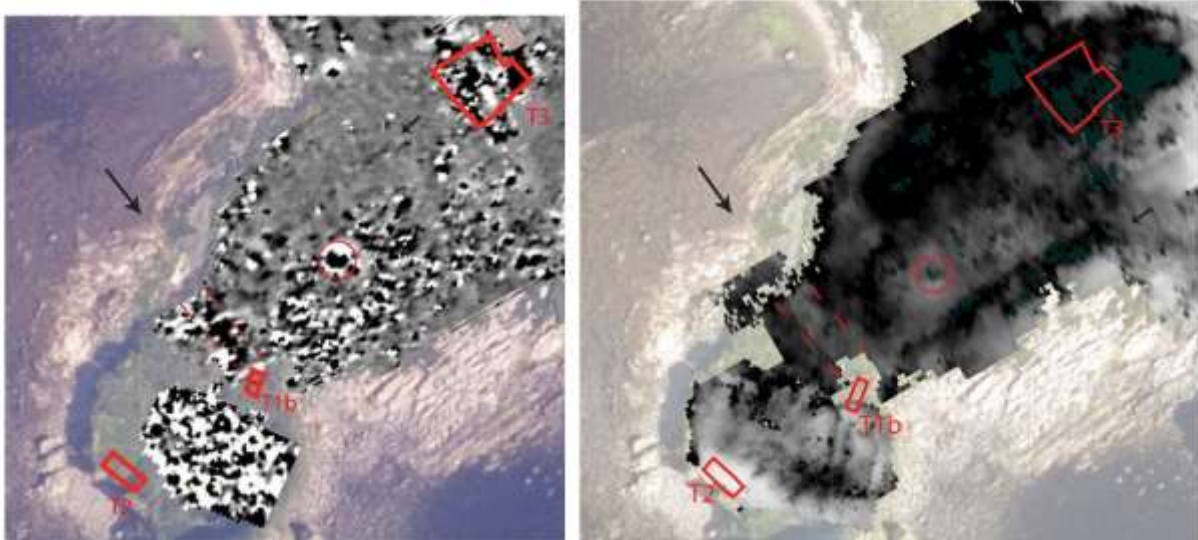
Figure 4 Comparative geophysics data from magnetic gradiometry (left) and electrical resistance (right) showing the linear anomaly targeted by Trench 7.

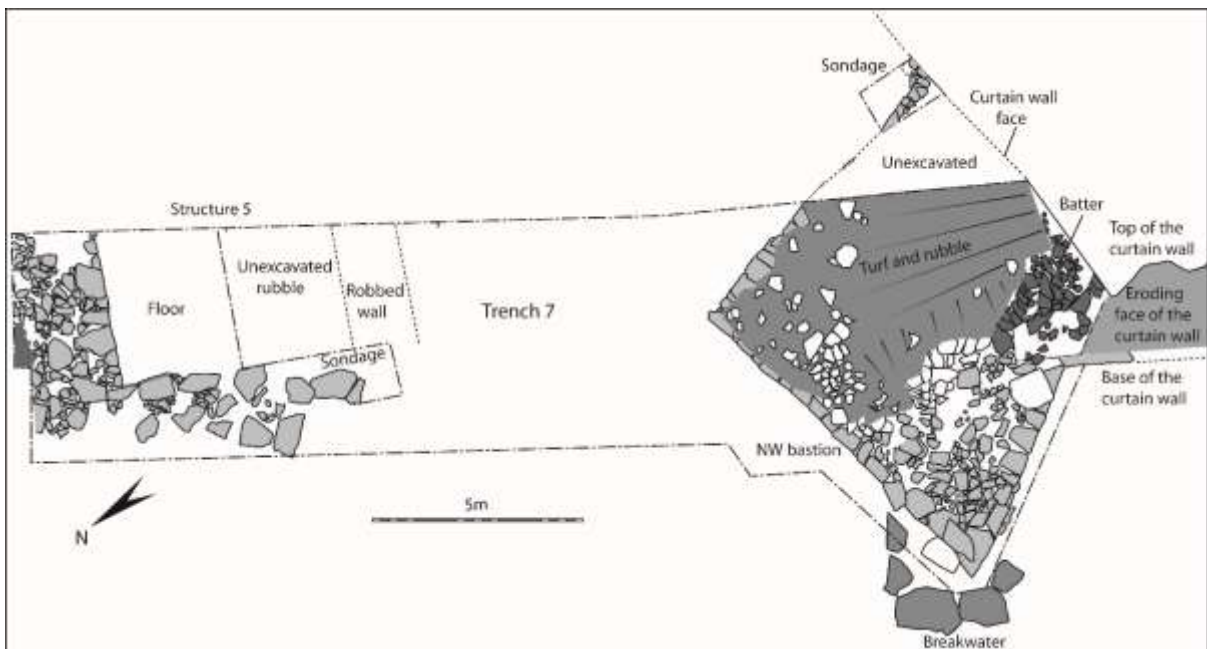
Figure 8 Plan of structures in Trench 7

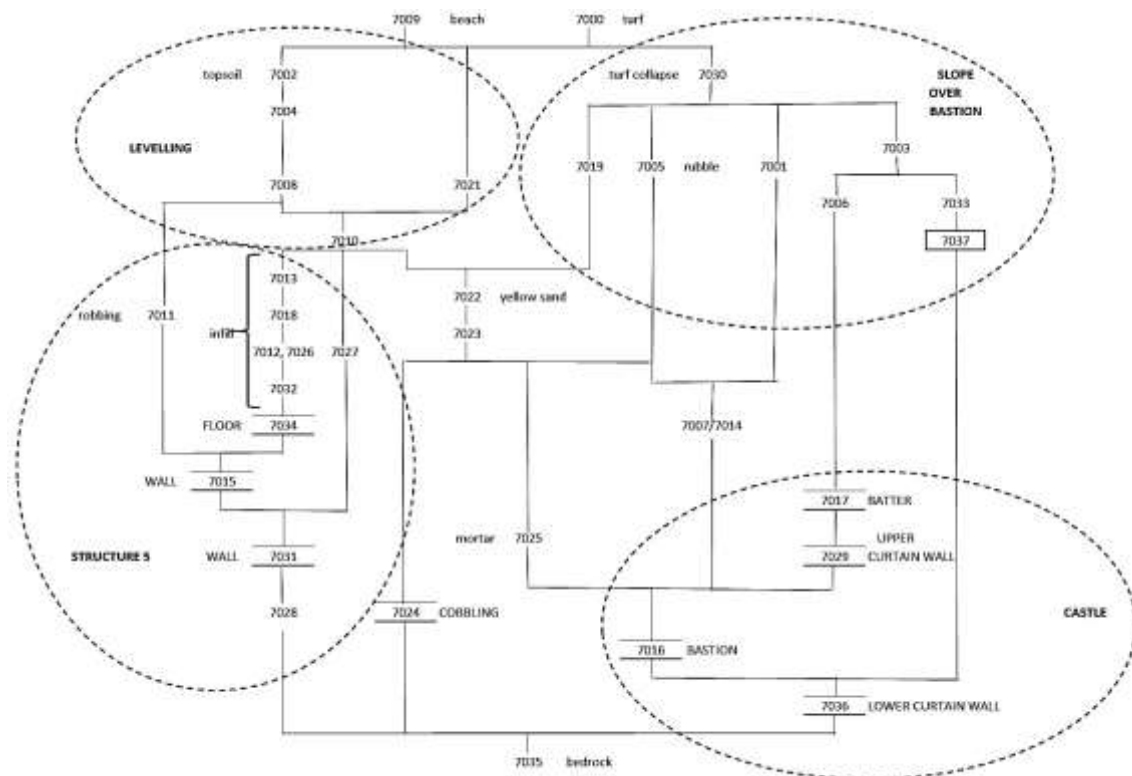
Figure 9 Stratigraphic matrix for Trench 7 and adjacent sondage

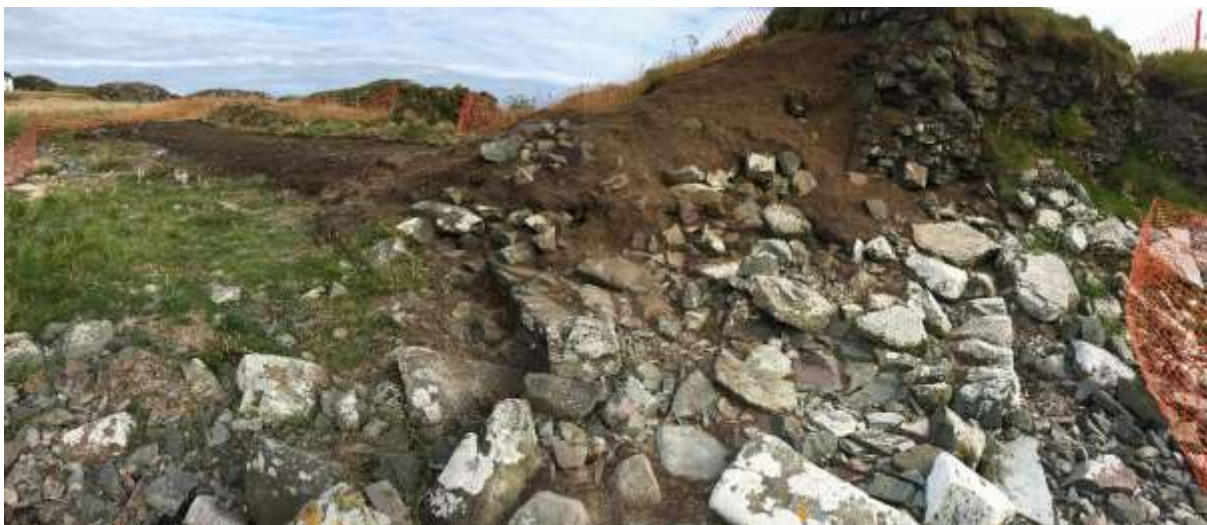
Figure 10 Oblique view of Trench 7 from the west with exposed part of the bastion in the foreground, stepped up slope covered in redeposited turf (7030) and the rest of the trench with darker topsoil (7002) in the background to the northeast.

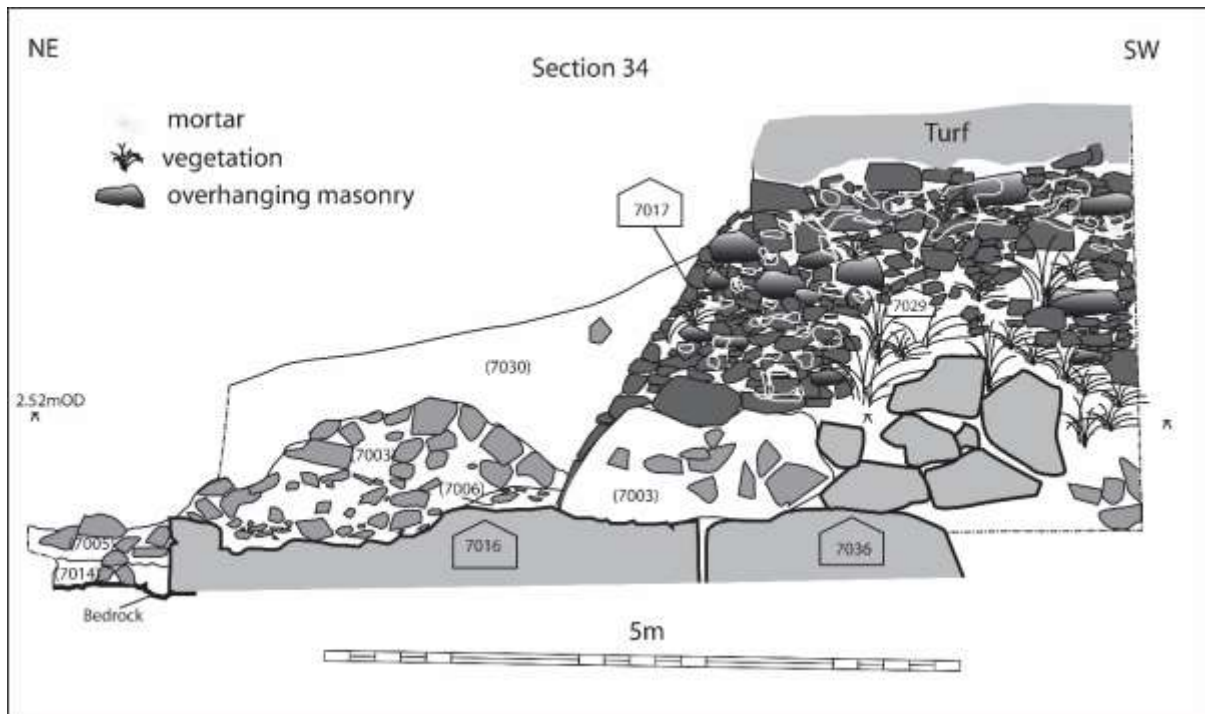
Figure 11 Section 34 through deposits overlying and abutting bastion foundations (7016) and batter (7017). Core of the eroding curtain wall (7029) is also shown, as drawn from photogrammetry. The face of curtain wall (7036) was disturbed above the bottom course, but remaining near to its original position.

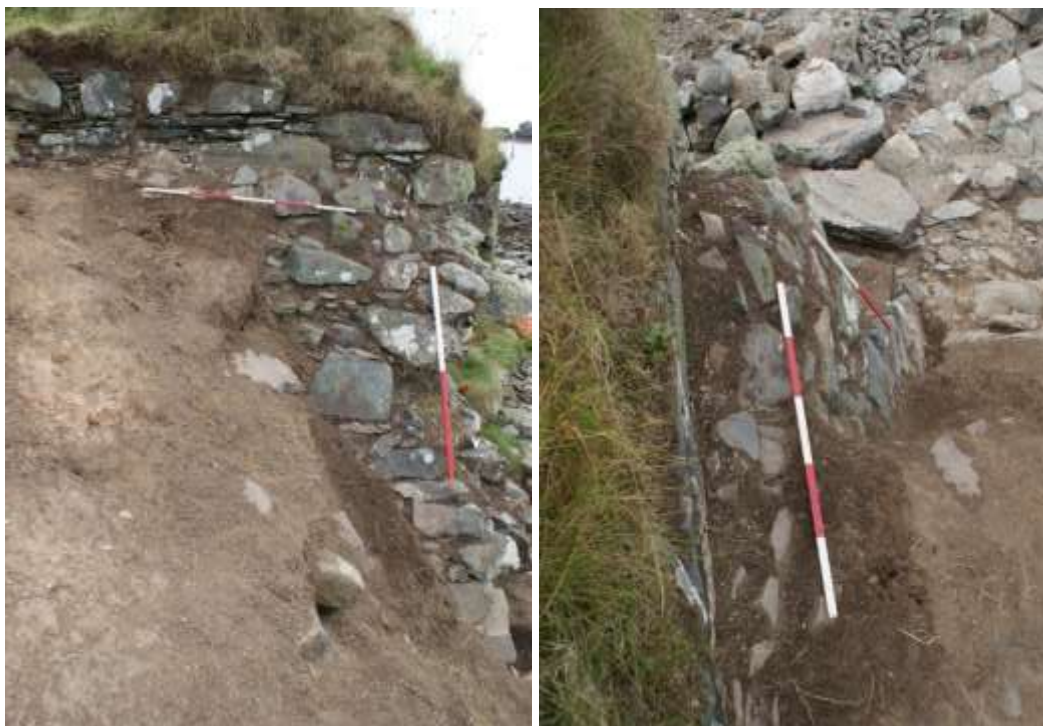
Figure 12 Exposed part of batter or buttress (7017) from the north (left) and from above looking west and showing how it abuts face of curtain wall (7029) at the top.

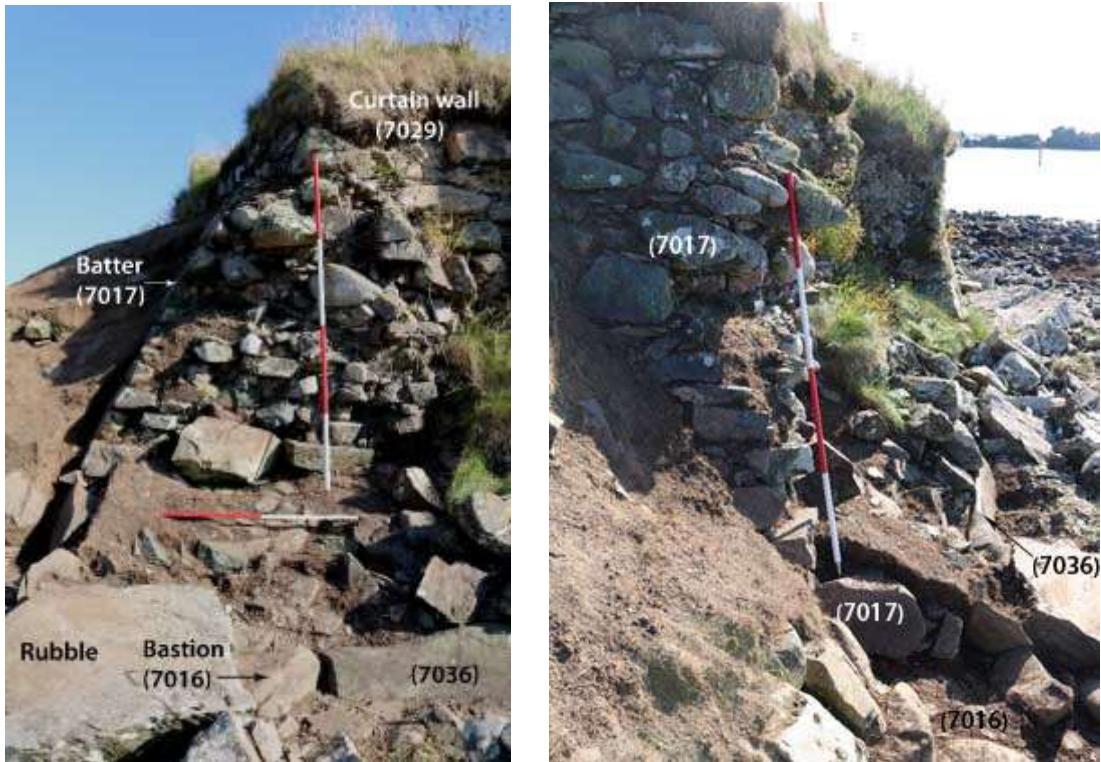
Figure 13 Left: Annotated structural components at the northwest corner of the outer courtyard showing the relationships between bastion (7016), earlier curtain wall face (7036), later curtain wall (7029) and batter (7017); Right: view of batter (7017) and surviving bottom course of curtain wall (7036) in relation to the better surviving face of the curtain wall on the same line in the background demonstrating the volume of masonry lost to erosion.

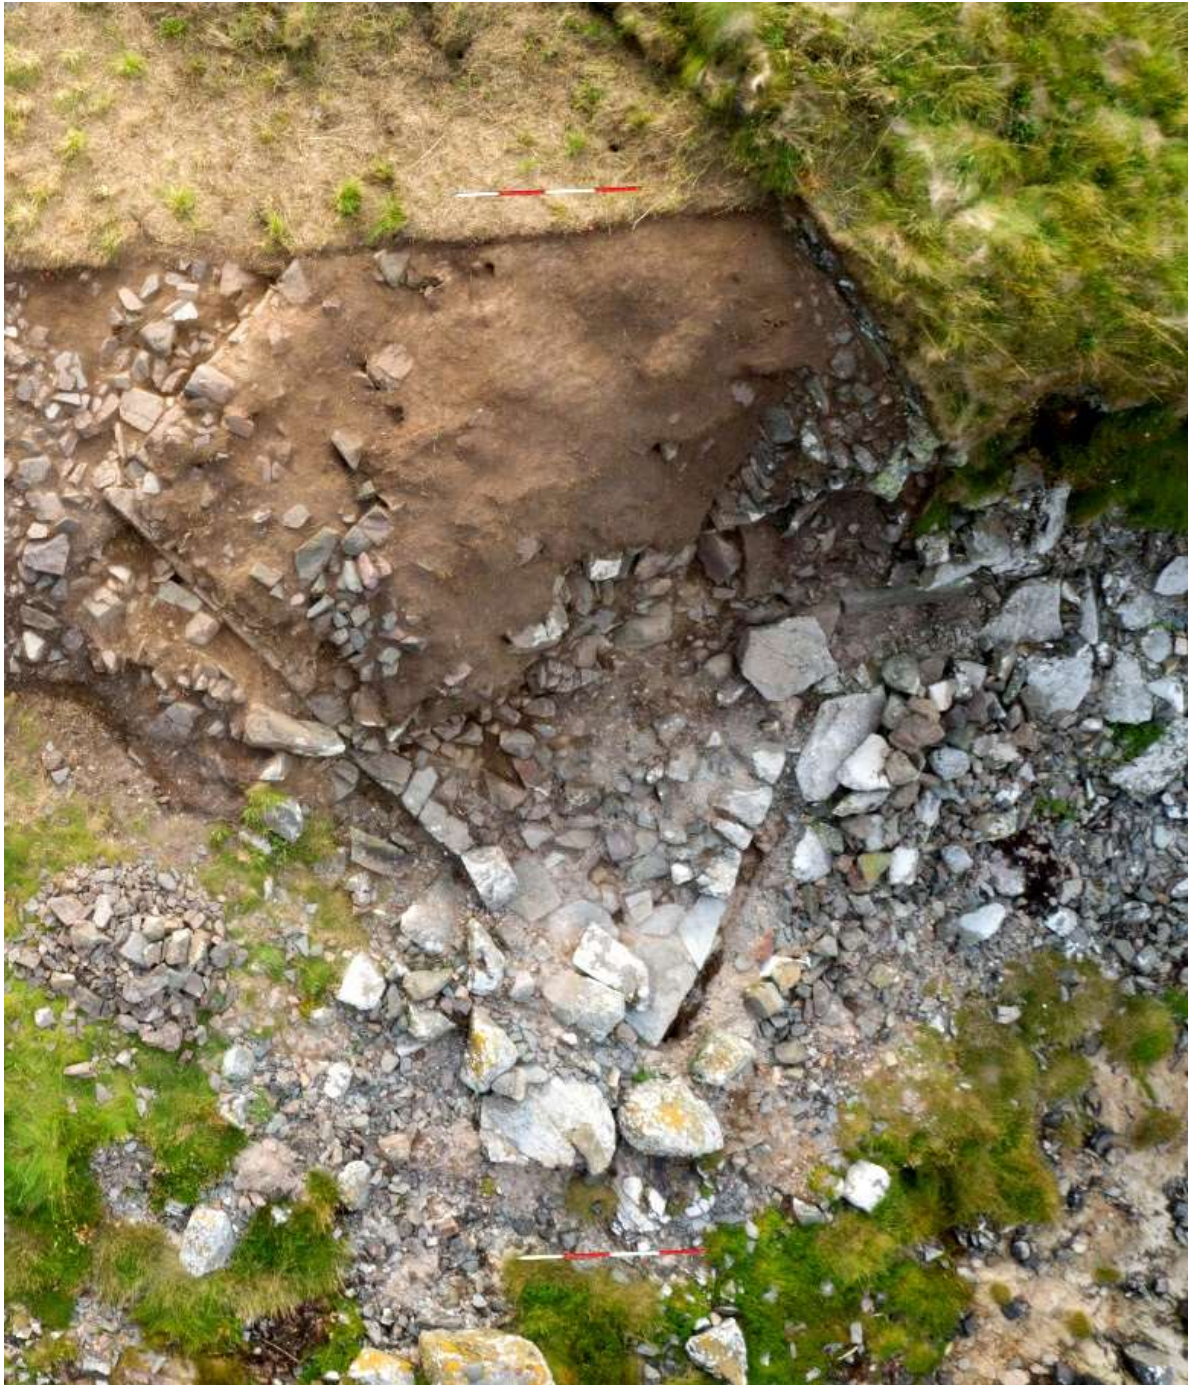
Figure 14 Aerial image of the partially exposed remains of the bastion at the southwest end of Trench 7 showing three-sided angular structure and the large stones protecting the northwest tip in the lower part of the photo. Scales 2m. Drone photography; Sarah Lambert-Gates

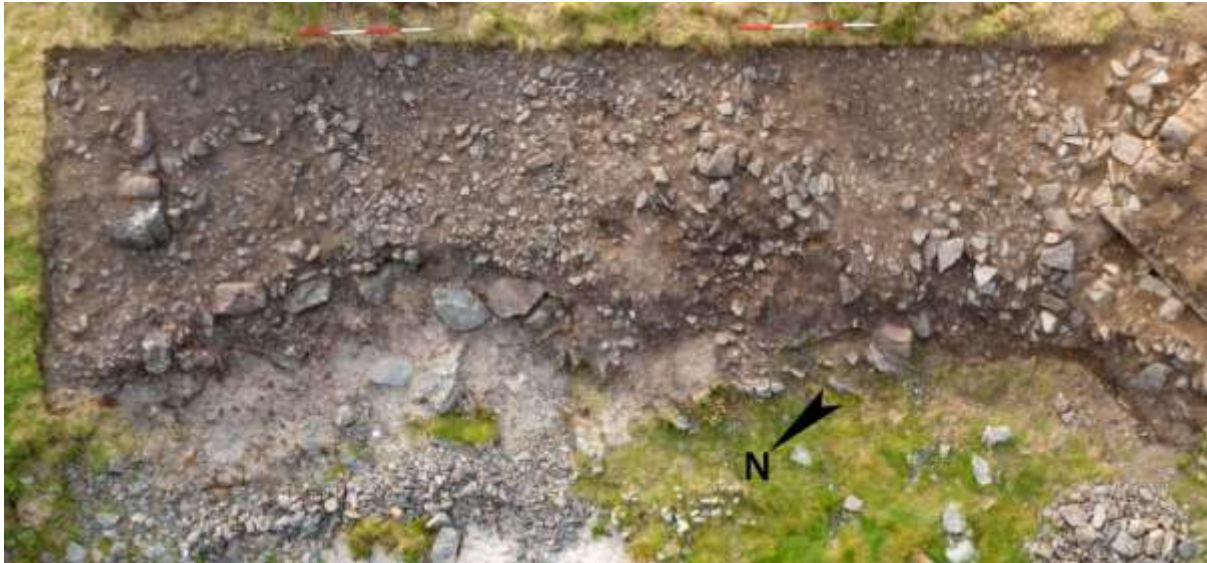
Figure 18 Aerial photo of Trench 7 north of the bastion showing extensive area of rubble and the emerging walls of Structure 5 at the northeast end.

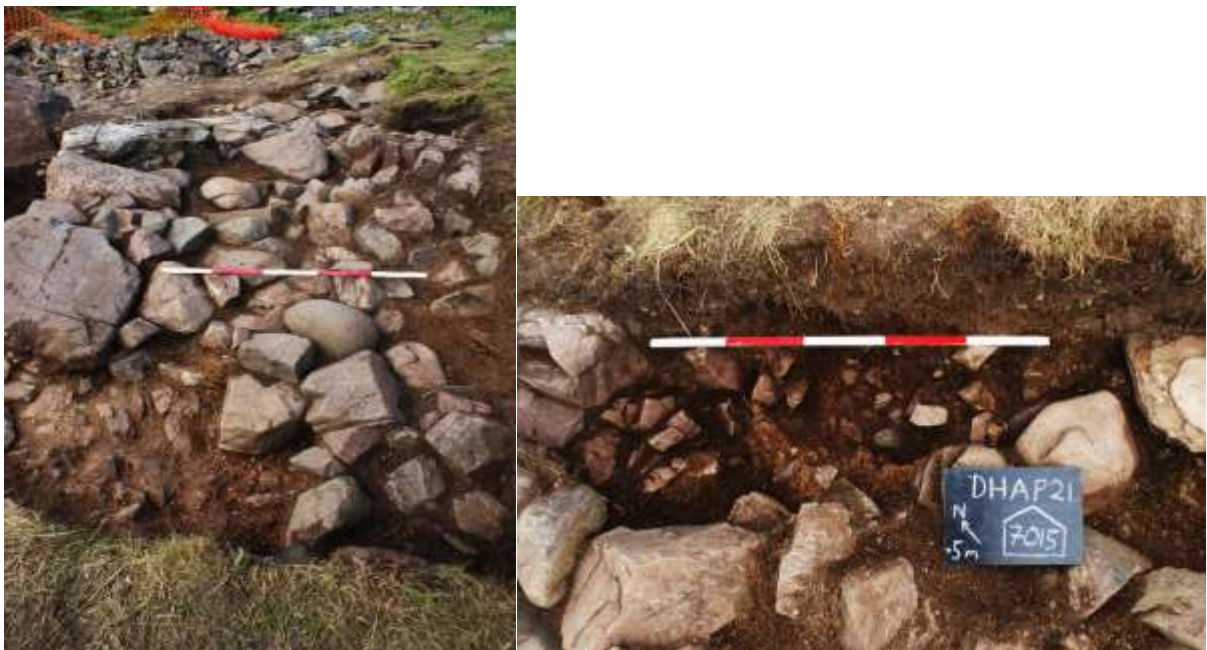
Figure 19 Rubble (7011) over wall (7015) from the southeast showing extended edge of the trench (left) and detail of robbed wall (7015) mortared onto the bedrock outcrop (right). Scales 1m.

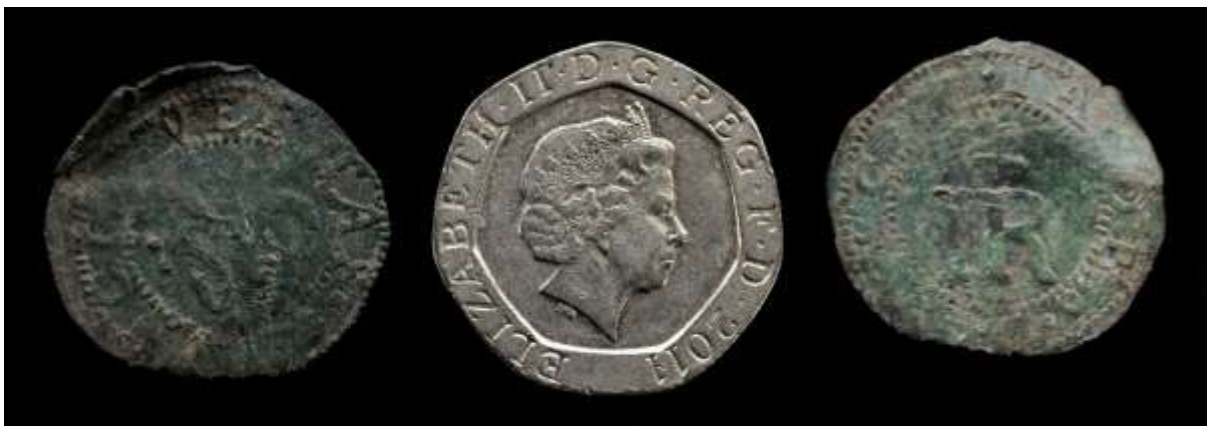
Figure 21 A billon hardhead of James VI found in deposit (7013).

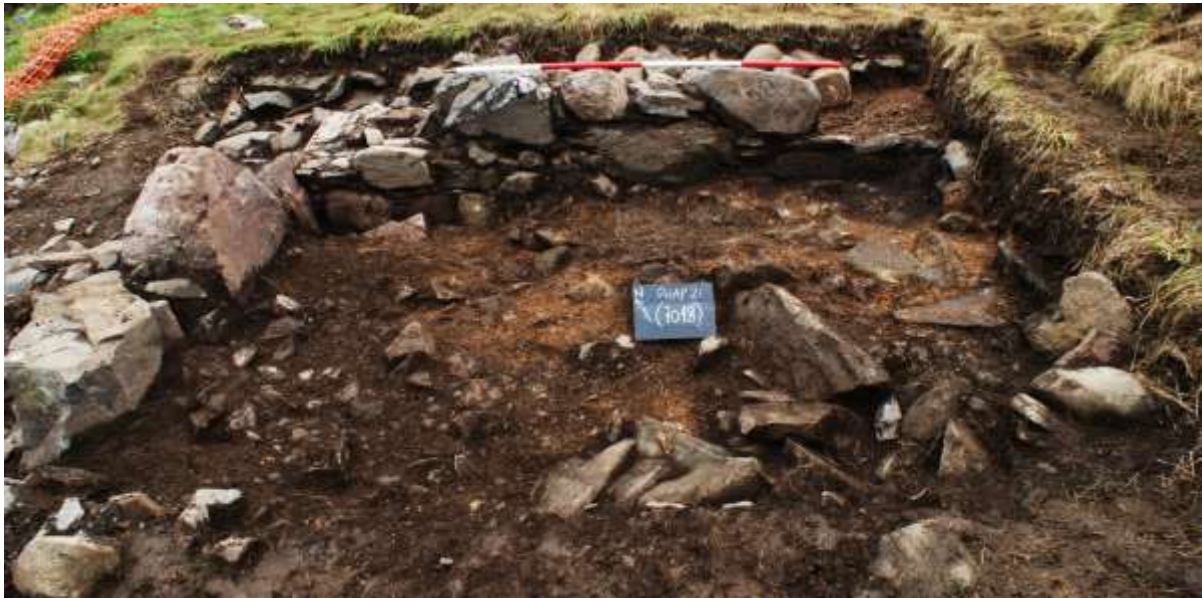
Figure 22 Mortar and rubble collapse (7018) from the southwest.

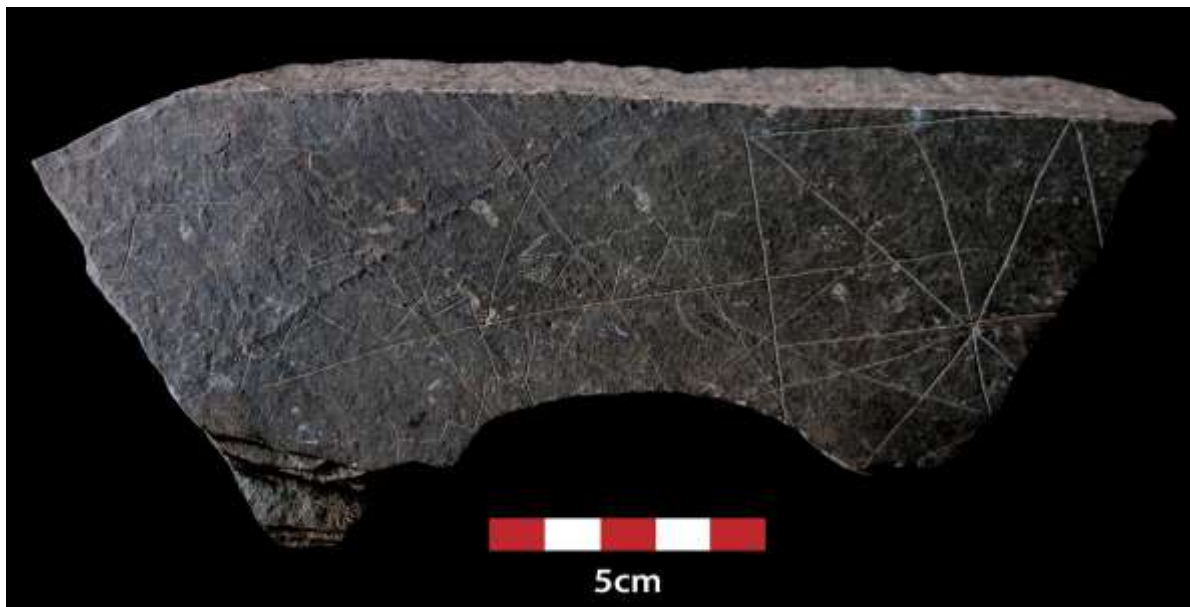
Figure 23 Incised stone SF197 with part of game board design on the right and zig-zags on the left.

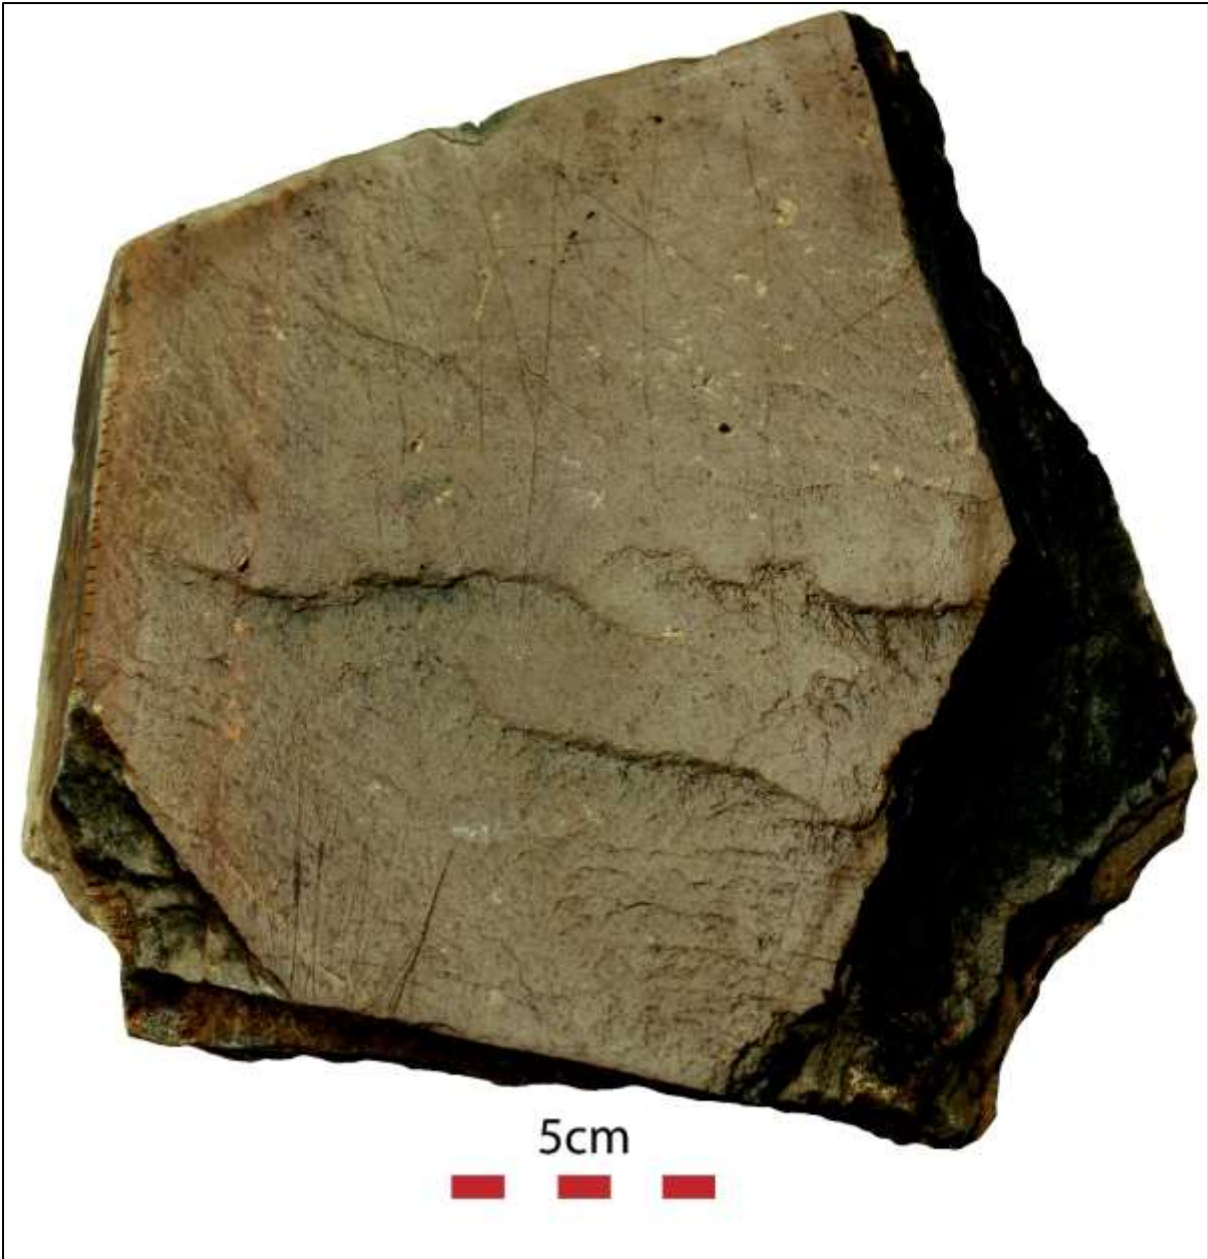
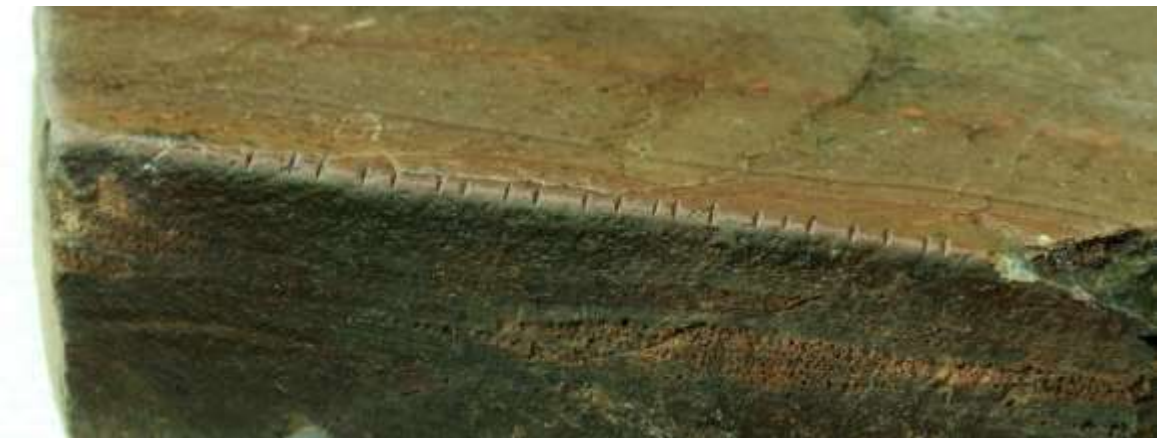
Figure 24 Incised slab SF203 with game board and other markings (top) and the detail of the edge with the notches relating to a possible game tally (bottom).

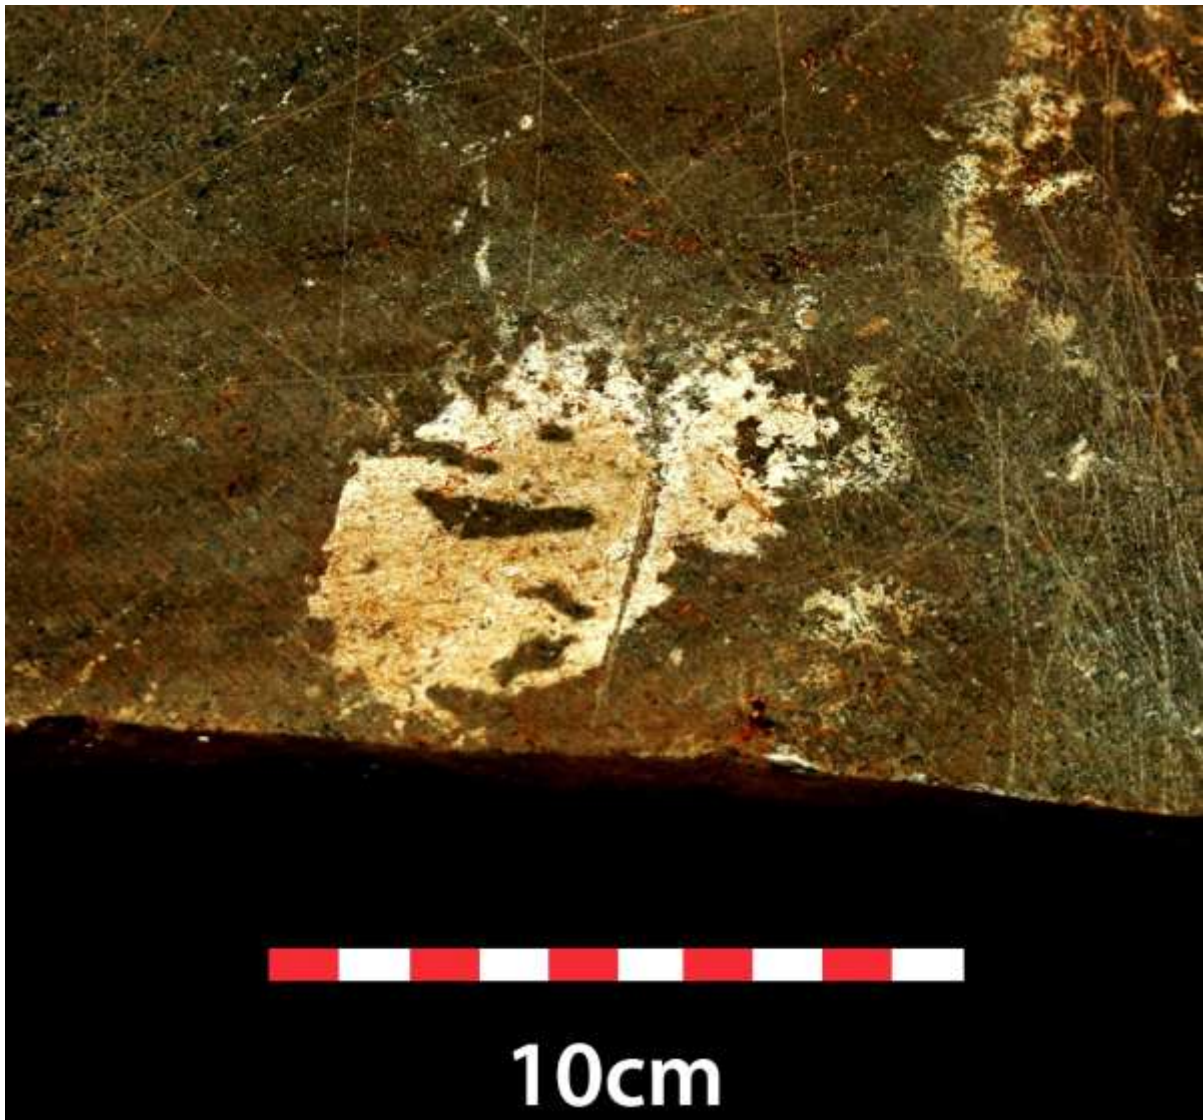
Figure 25 Incised stone SF202 showing detail of gaming board design and other scoring including lines that cross mortar residue adhering to the stone.

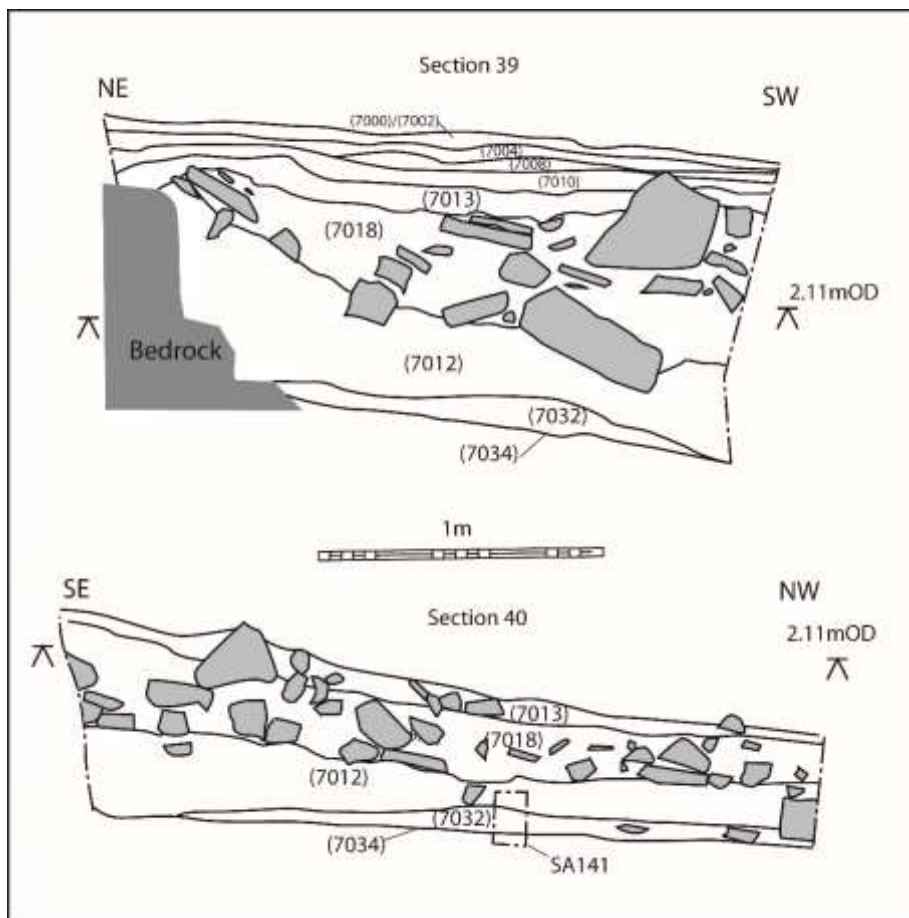
Figure 27. Sections 39 and 40 through deposits inside Structure 5

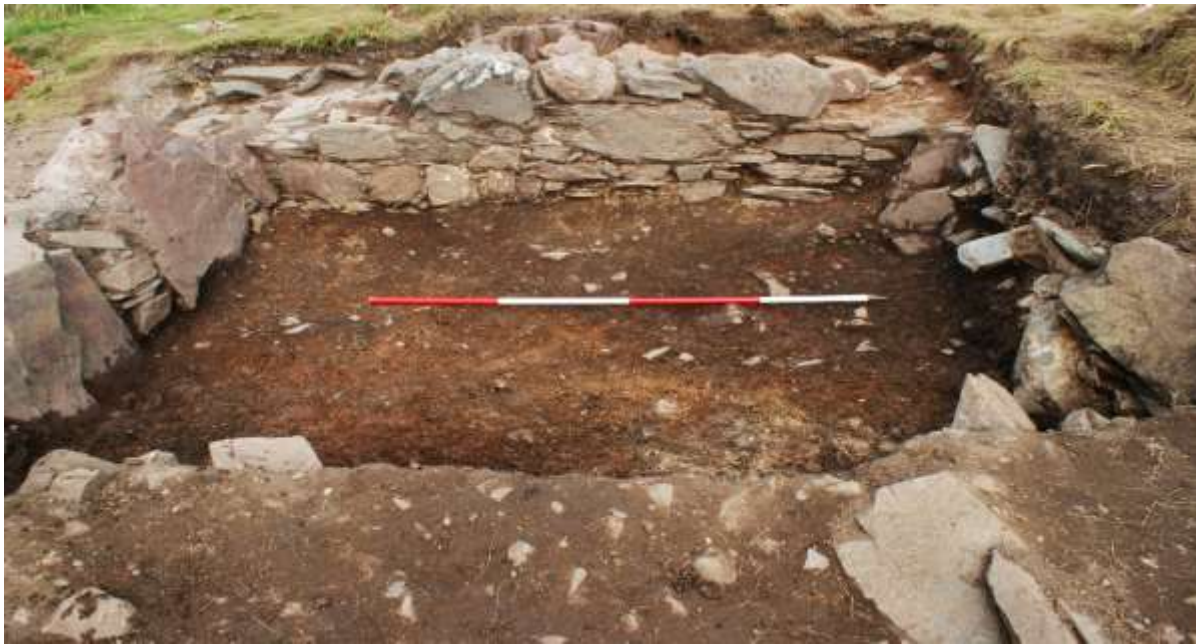
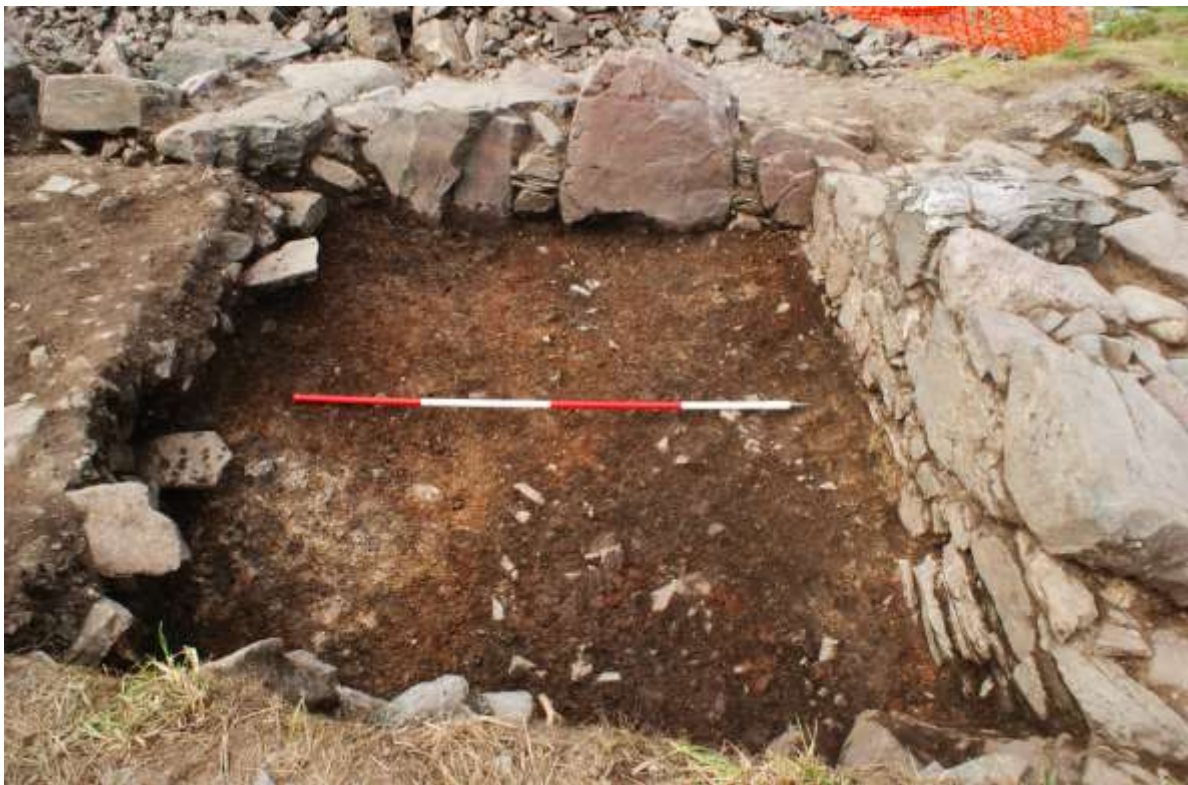
Figure 28 Slot through deposits in Structure 5 at the end of the excavation showing floor (7034) and the internal elevations of walls (7015) and (7031). Views from SW and SE, scale 2m.

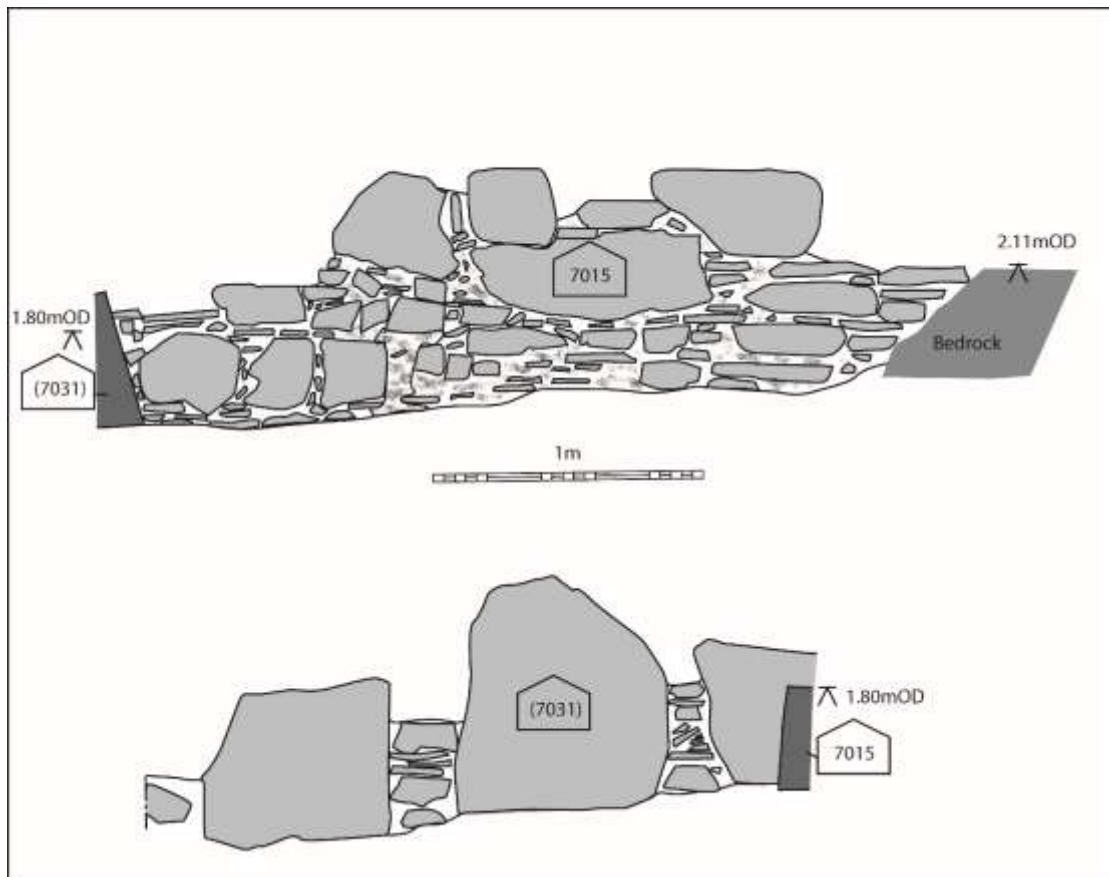
Figure 29 Internal elevations of the walls of Structure 5 exposed within the excavation slot.

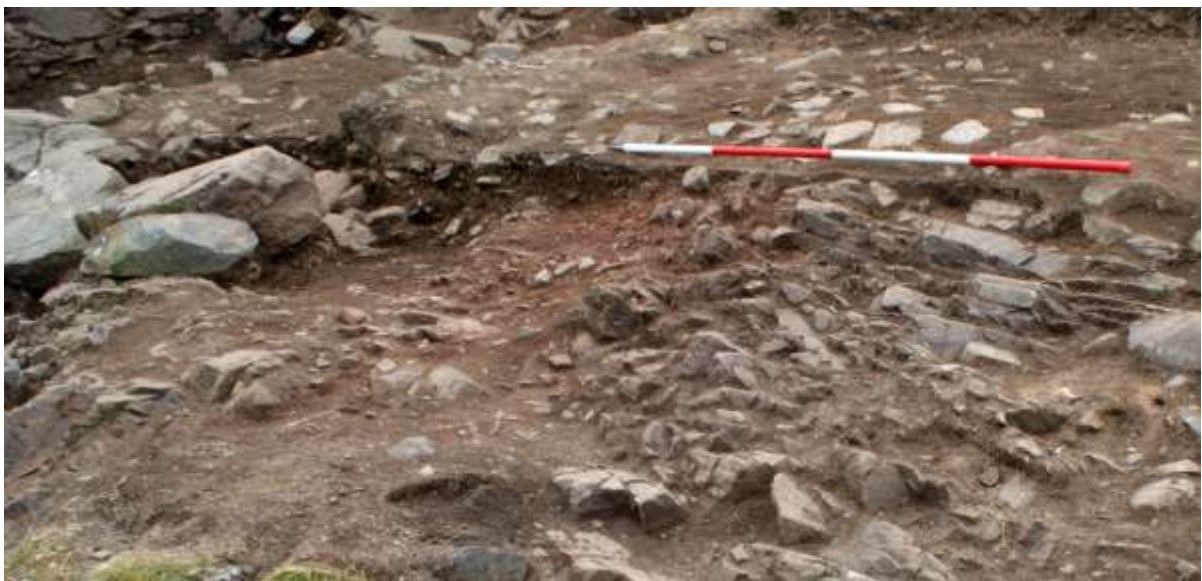
Figure 30 Area of raised bedrock at the end of wall line (7031) where Structure 5 was unlikely to have extended.

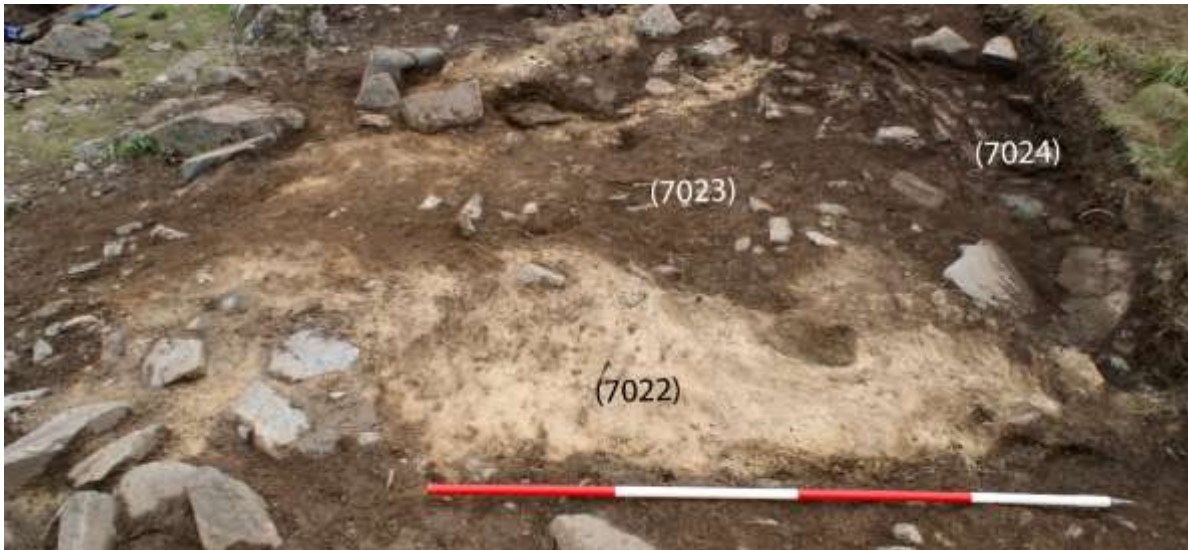
Figure 32 deposits underlying rubble (7010) in the central part of the trench, showing sand (7022), gritty silt (7023) and cobbled surface (7024).

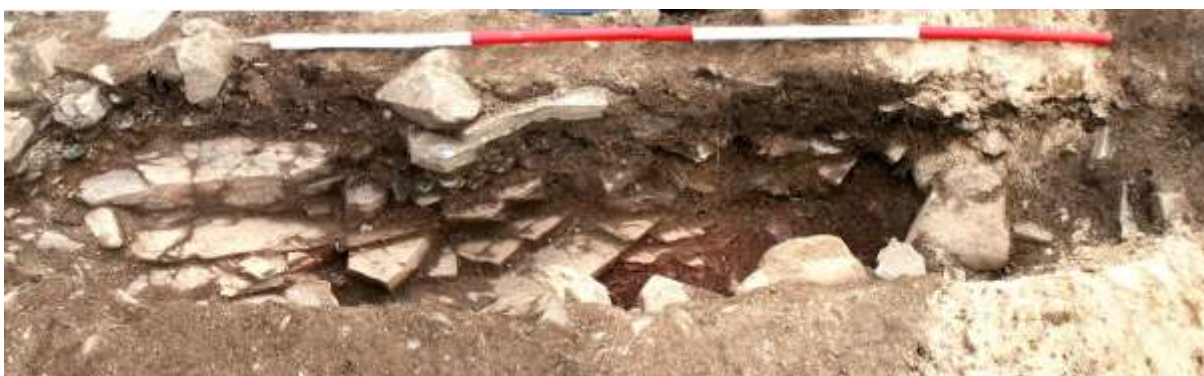
Figure 33 Slot through deposits (7022) and (7023) excavated down to natural (7035).

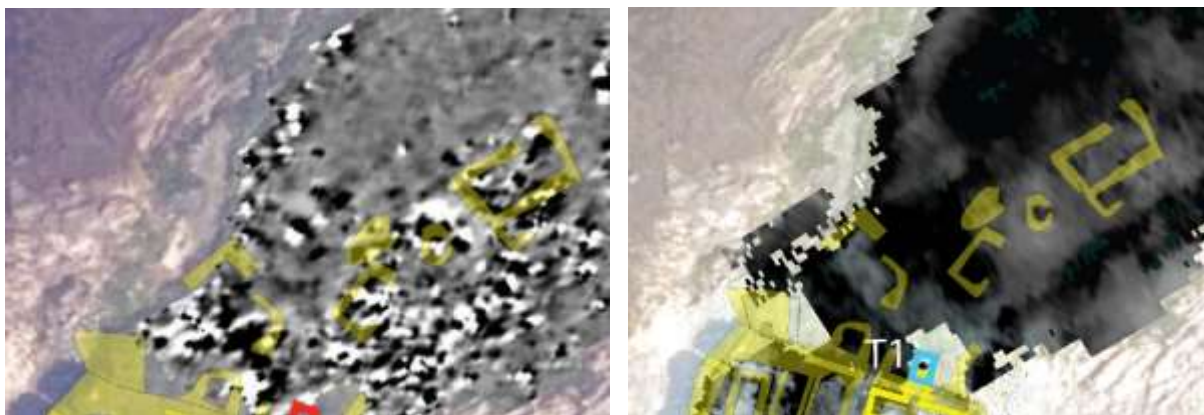
Figure 28 Geophysical results in relation to the surveyed and excavated structures in the environs of the castle: left – magnetic gradiometry; right: electrical resistance.
