Summary of findings from the Survey of Potential Turloughs 2015

Report for:
NPWS, 7 Ely Place, Dublin 2

Volume I: Main Report

October 2015

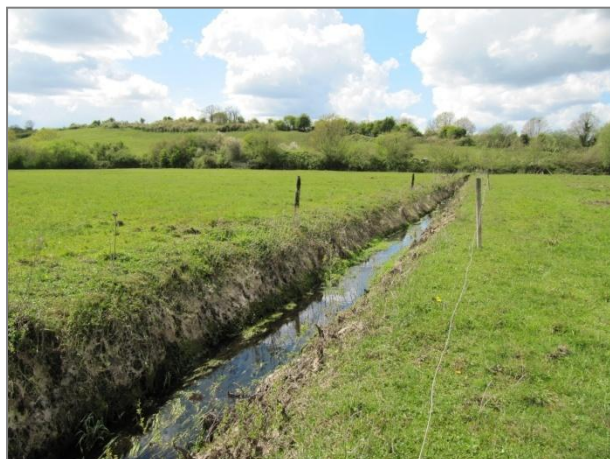
NTSV14_Photo_022_17_FON_01a.jpg
17 Drains

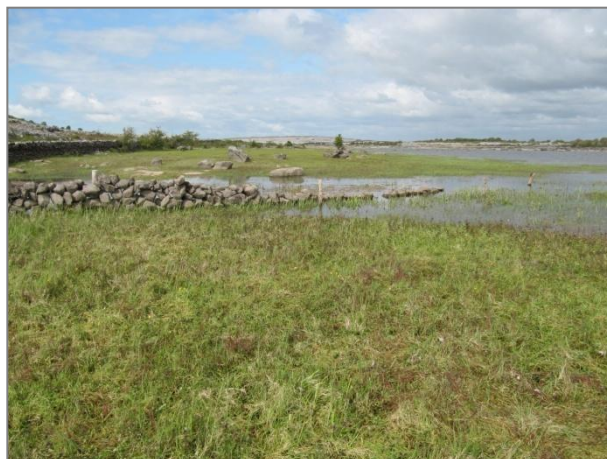
NTSV14_Photo_019_18_FON_01a.jpg
18 Discontinued hedges/walls

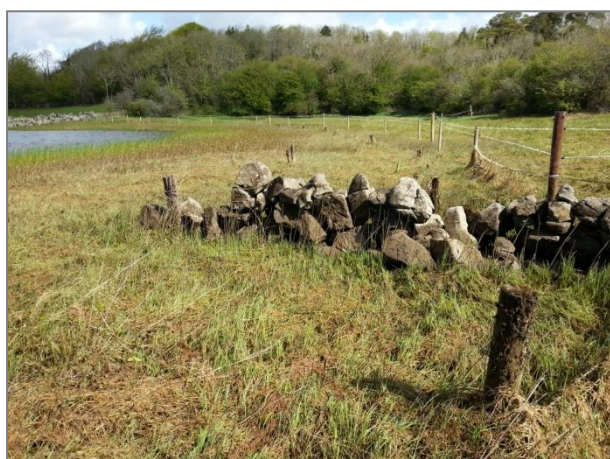
NTSV14_Photo_040_18_JM_01a.jpg
18 Discontinued hedges/walls

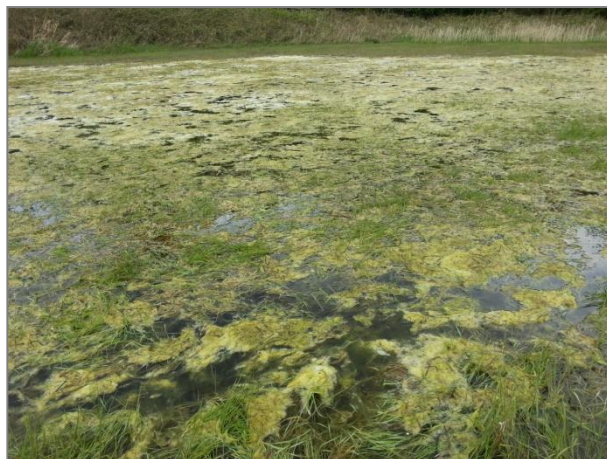
NTSV14_Photo_531_21_JM_01a.jpg
21 Evidence of nutrient enrichment

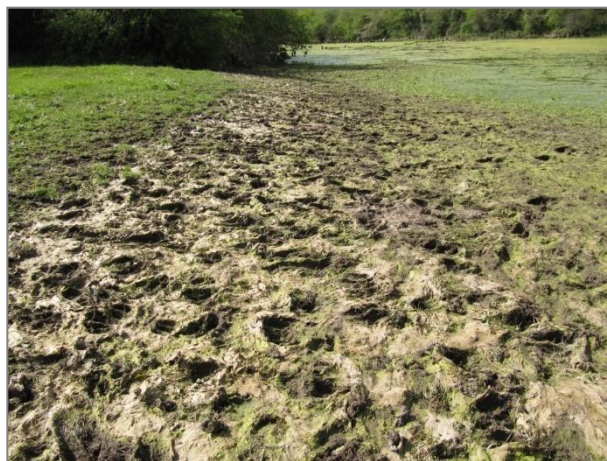
NTSV14_Photo_021_22_FON_01a.jpg
22 Evidence of ecologically unsuitable grazing

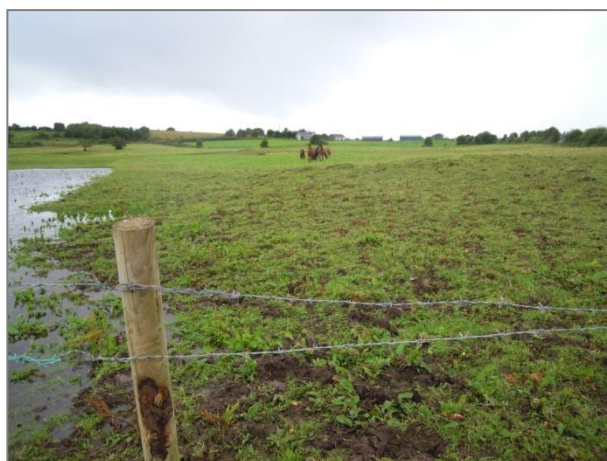
NTSV14_Photo_385_22_DD_01a.jpg
22 Evidence of ecologically unsuitable grazing
