BEACHAM/WILLIAMS STREET CORRIDOR STUDY

CITY OF CHELSEA,
MASSACHUSETTS

JUNE 26 2018

TECHNICAL APPENDIX

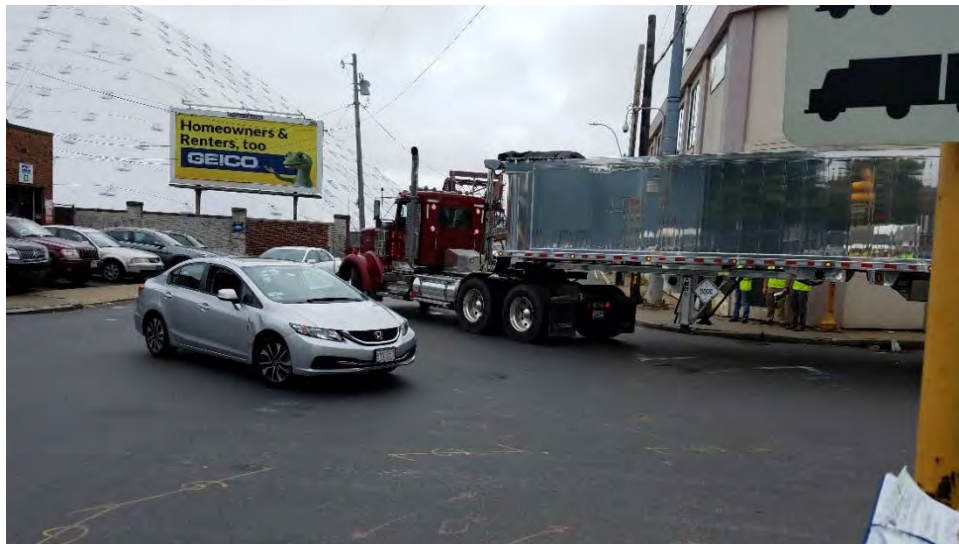
2. Corner radii are small in this intersection. It was observed that eastbound trucks turning from Williams onto the bridge encroach into the oncoming lane to execute the movement. There was also evidence of vehicles clipping obstructions as they encroached on the curb while executing turning movements. This included damaged signs and poles. This creates a concern for the safety of pedestrians waiting on the corner.

Image 1: Williams Street at Pearl Street – Truck attempting to turn right from Williams onto McArdle Bridge

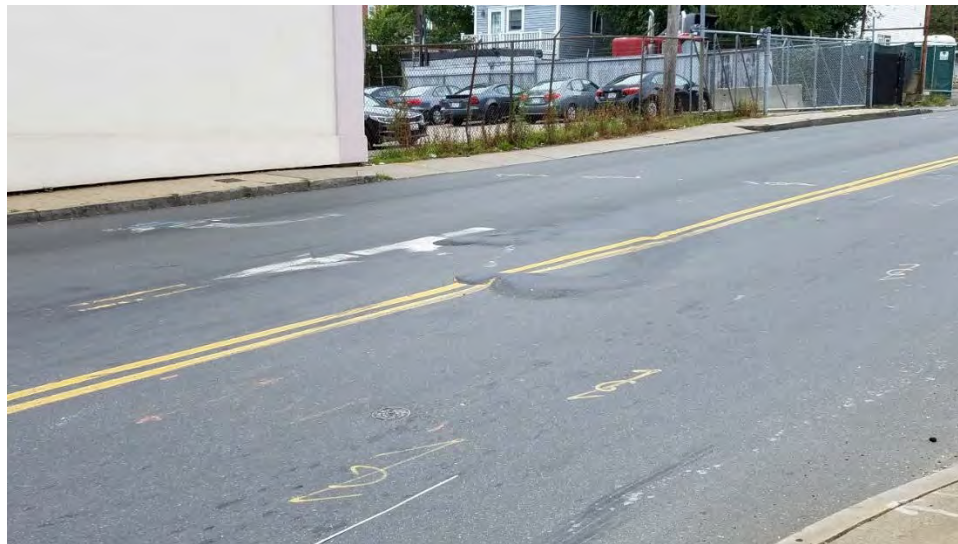
- The pavement on Williams Street is worn and has numerous patches. There are also areas of rutting most likely due to the heavy vehicles and braking as vehicles approach the intersection from the West. The rutting can make controlling a vehicle or bicycle difficult.

Image 2: Williams Street at Pearl Street – Williams Street approach showing worn pavement markings and rutted pavement.

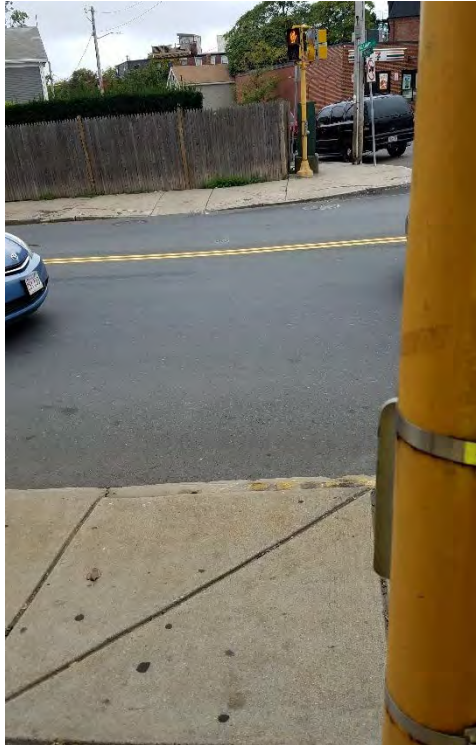
- There is currently a pedestrian signal and crossing across Williams Street, south of Tremont Street. There are no crosswalk markings and the post-mounted signal is hard to see since the post is located against the building. In addition, there is a sign that says, “Stop here on Red”. This combined with the proximity to the Broadway signal creates confusion as to where vehicles should stop when waiting at a red light. There was a pedestrian crash that occurred at this location. Another pedestrian crash occurred while a pedestrian was crossing the western crosswalk.

Image 3: Crossing at Williams Street at Tremont Street. No crosswalk but pedestrian signals present.

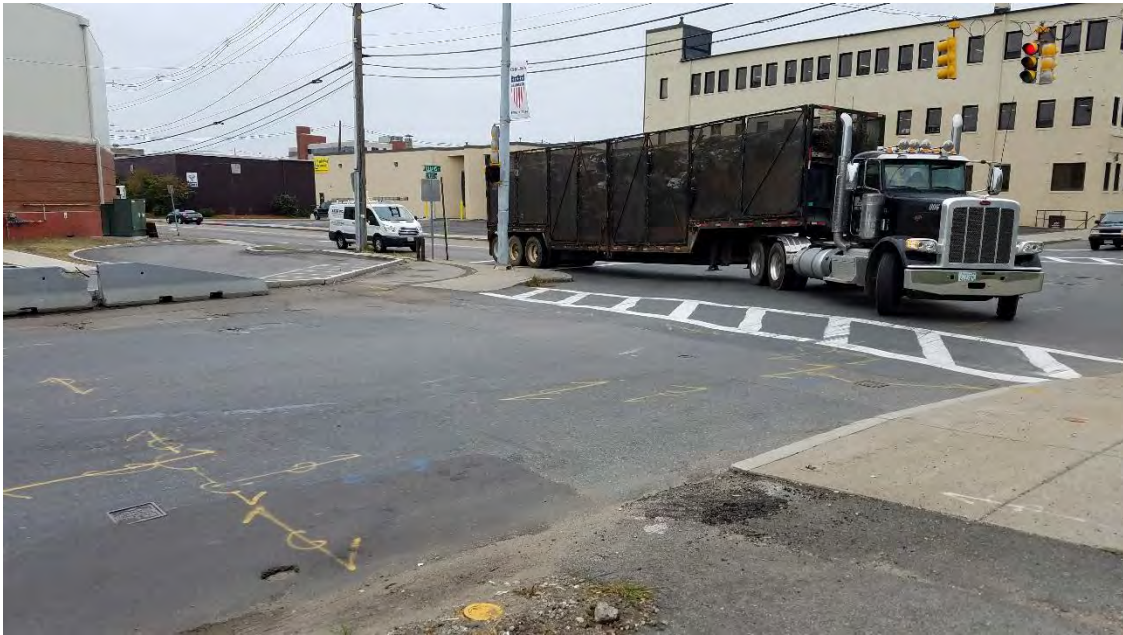
Image 5: Williams Street at Spruce Street – Truck turning right from Spruce onto Williams. Encroaching into oncoming lane on Williams Street.

Potential Enhancement: Evaluate curb radii for truck turns and consider relocating any potential obstructions (utility poles, signs, etc.) to ensure that vehicles can execute movements without encroaching on curb. Evaluate location of stop bars and ensure that pavement markings/signage clearly convey stop location to vehicles.
