COLDWATER CONSERVATION PLAN
SOUTH BRANCH OF THE LITTLE AUGHWICK CREEK
SUMMER 2009

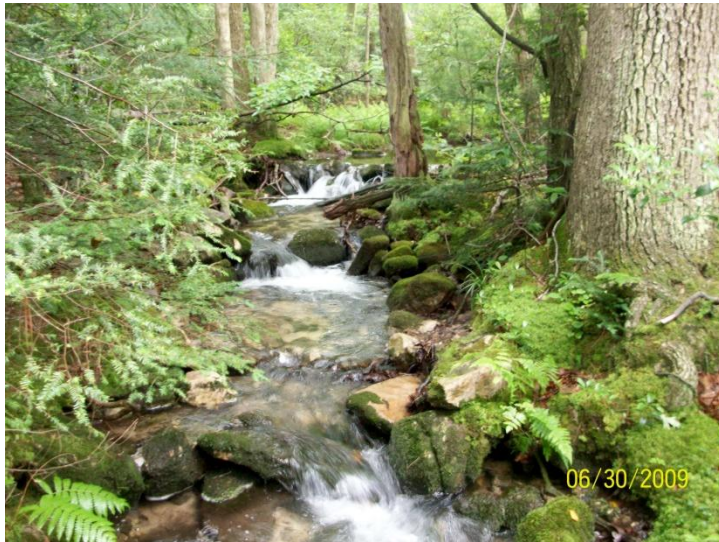
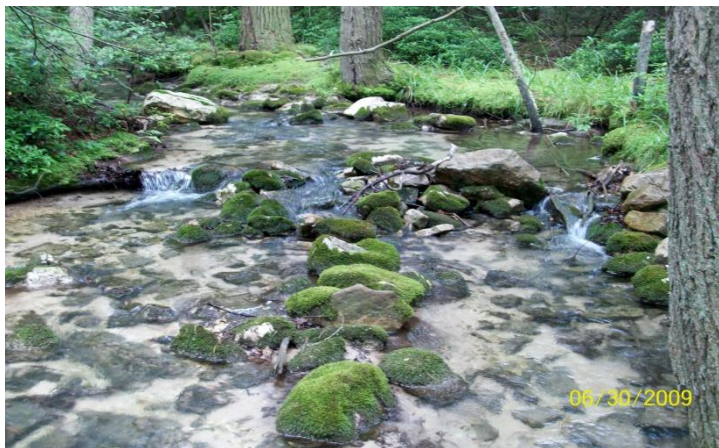
Site #1 - These two photos show healthy head waters

Logging in the upper watershed should be closely monitored to ensure minimal erosion. Several cabins, located on leased PA DCNR land, are found near the stream in the upper watershed. Educational efforts could inform these part time residents of the need for proper on-lot wastewater treatment and vegetated stream buffers. (See photos of site #1-3)

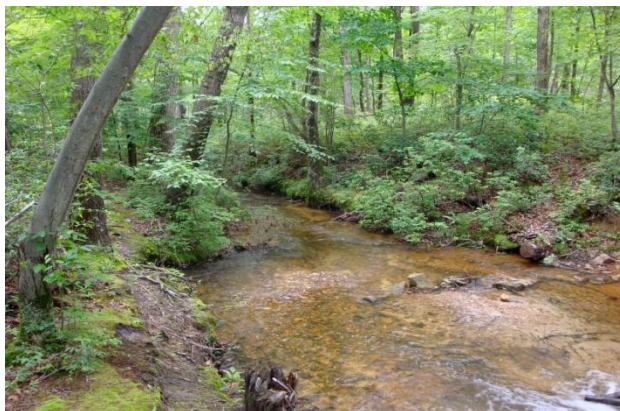
Site #2– Stream starts to widen and is now coming in contact people and yards.

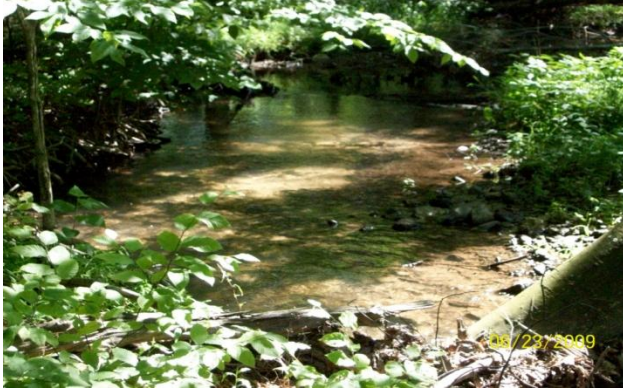
Site #3 – More impact by road; stream access to the right where there is a well-worn path.

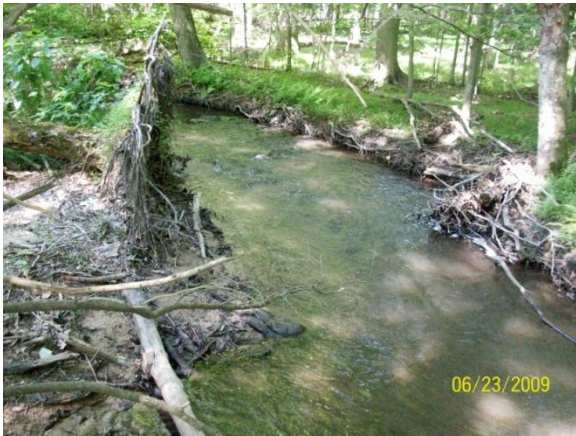
Site #4 – Just below the WWTP at Cowans Gap Lake. Largely eroded banks present in this area.

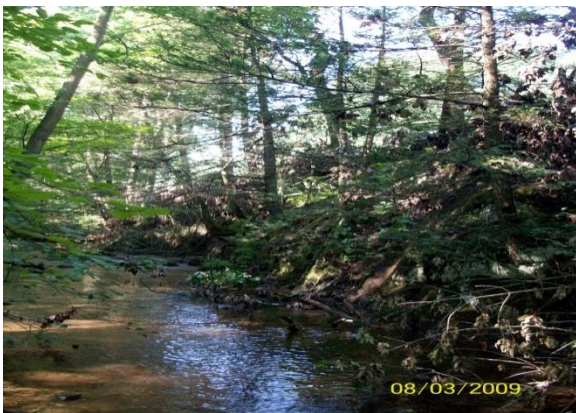
Site #5 – Floodplain is an easy access to the right, with a steep bank with the Aughwick Road just at the top of the bank on the left.

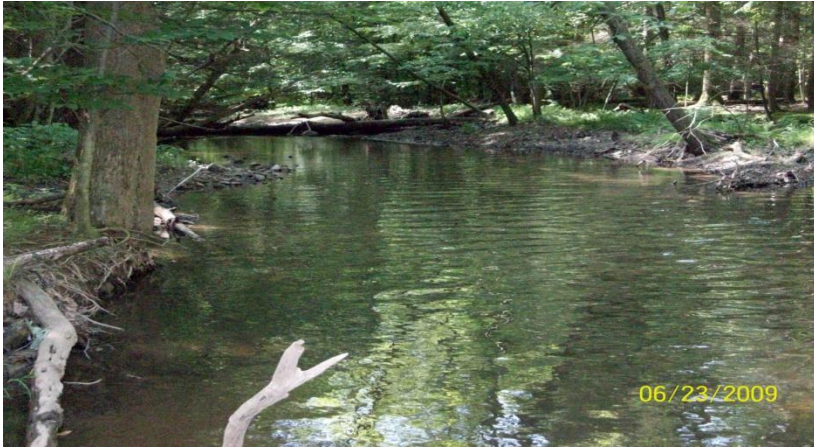
Site #6 – Decent sloping banks showing access to the floodplain, some erosion present by it is not significant.

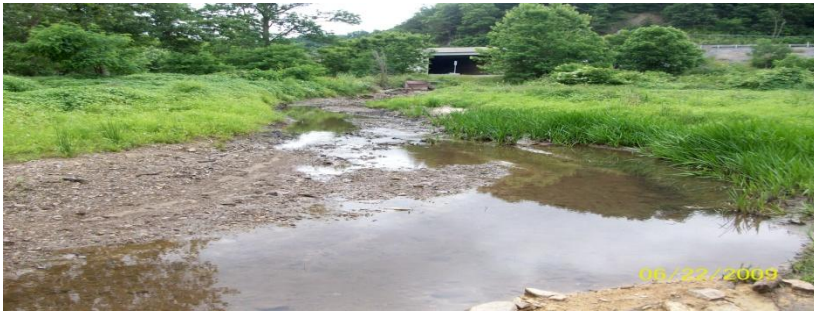
Site #7 – This is feeder stream that has broken through the dam and is carrying the legacy sediment around the dam and into the stream below.

- (2) The compromised dam above the Burnt Cabins Grist Mill threatens to introduce a large amount of fine sediment to the lower SBLAC watershed. At low water, the dam still represents an impediment to fish passage. Efforts should continue to raise funds to implement a restoration project that will allow the historic Grist Mill to function while enhancing the stream and eliminating the potential erosion and sedimentation now present.

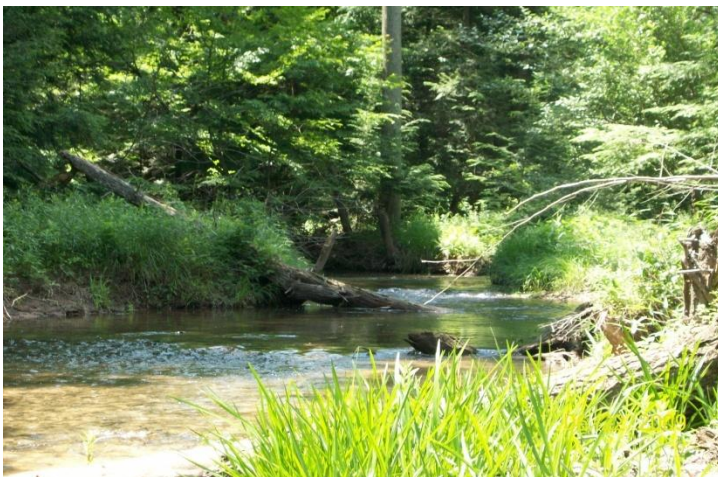
Site #8 – Area just below Decorum Road.

The last portion of the South Branch from the grist mill dam to the confluence of the North Branch is still rated by DEP's Water Quality Standards as High Quality-Cold Water Fishes (HQ-CWF) (See photo of site #8). This area runs through the village of Burnt Cabins and some agricultural areas. Agricultural pollutants, sewage, and the proximity of yards to the stream are the main concerns for the area. Another major concern along this reach of stream is the pending plan for a stream-discharge wastewater treatment facility in the village of Burnt Cabins. The plans for the plant have been on hold for a few years now because of funding and unhappy citizens. However, funding is currently in place and, the plant is likely to be constructed within the next two to three years. Area anglers and locals are concerned about the stream and how it is going to be affected. Further research is needed on the impacts of failing on-lot septic systems in the village of Burnt Cabins on both stream water quality and private water wells. Phosphorus concentrations appeared to rise at the Decorum Rd. site (furthest downstream) and it was noted that an area about a half a mile upstream appears to have some animal wastes running into the water from a backyard barnyard. Further nutrient testing above and below the village of Burnt Cabins is recommended to look for potential effects from barnyard runoff and/or failing septic systems in Burnt Cabins.

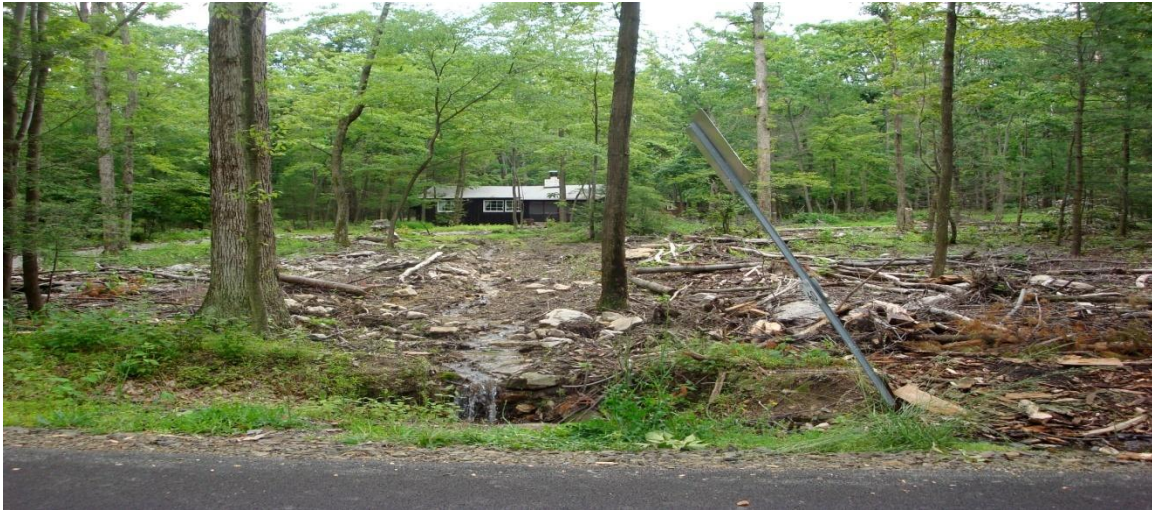
Photo 9. This running water flows through this front yard of the cabin. An area that was timbered over the winter of 08-09.

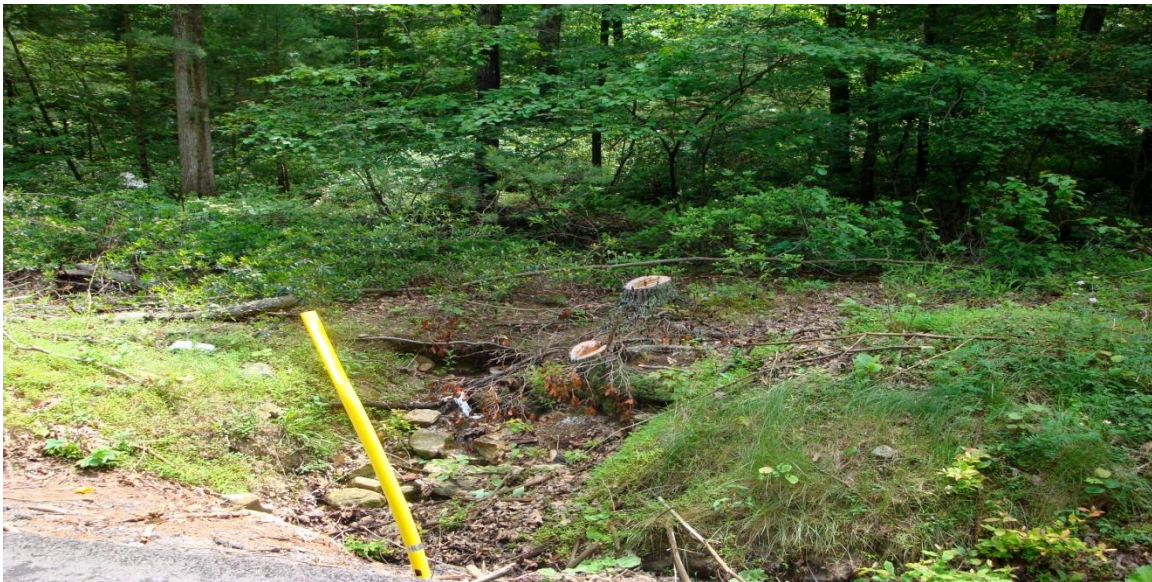
Photo 10. An area in Buchanan State Forest where the bank was stabilized by tree roots from erosion. However, now that the trees were cut the bank might fail and the sediment will run under the road and into the South Branch.

- (4) Forest management will continue throughout the watershed and it should be a priority to encourage forestry practices that protect the unique resource that is the South Branch of the Little Aughwick. Where possible, streamside forests should remain intact and large woody debris should not be removed from the system. Information on sustainable forestry and the importance of streamside forests should be provided to private landowners in the watershed.

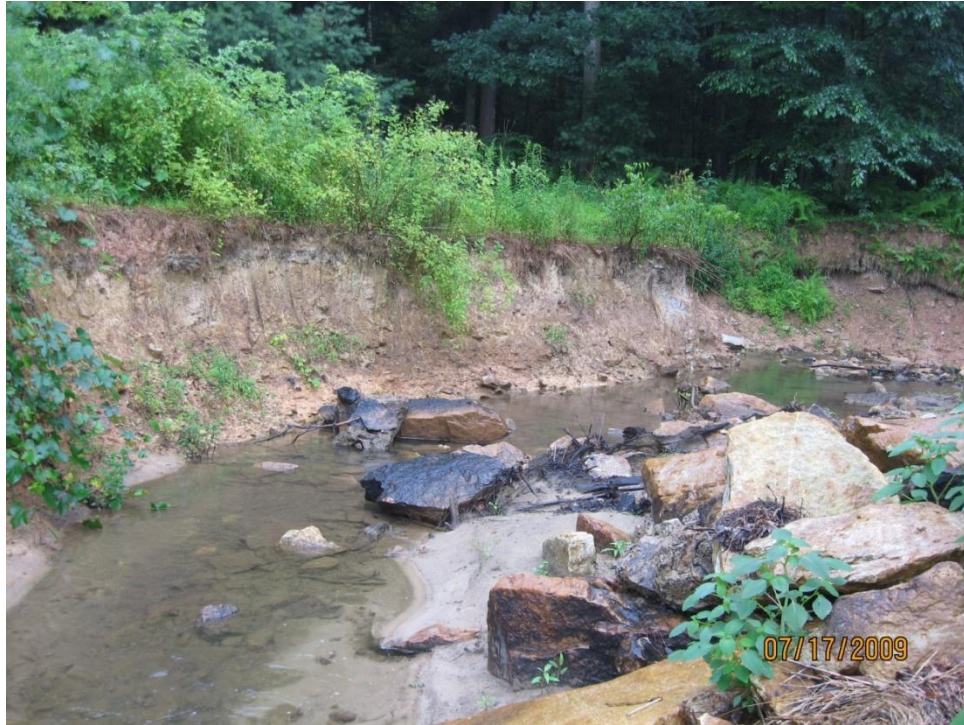
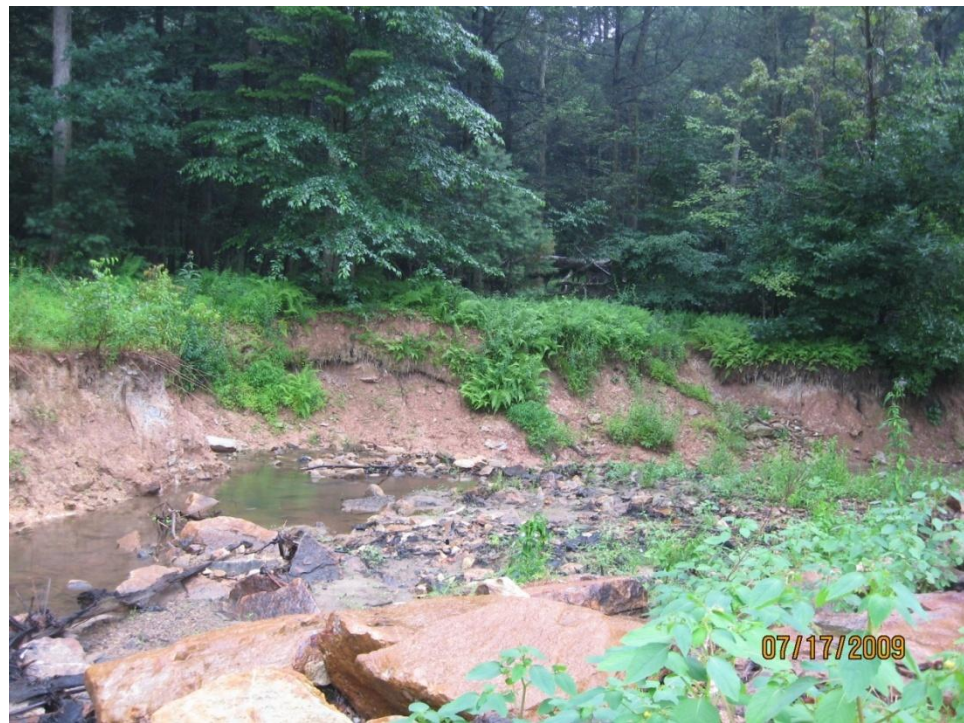
Photo 11. Breach in former emergency spillway at Burn Cabins Grist Mill leads to excessive erosion - Bank approx. 9 ft. high

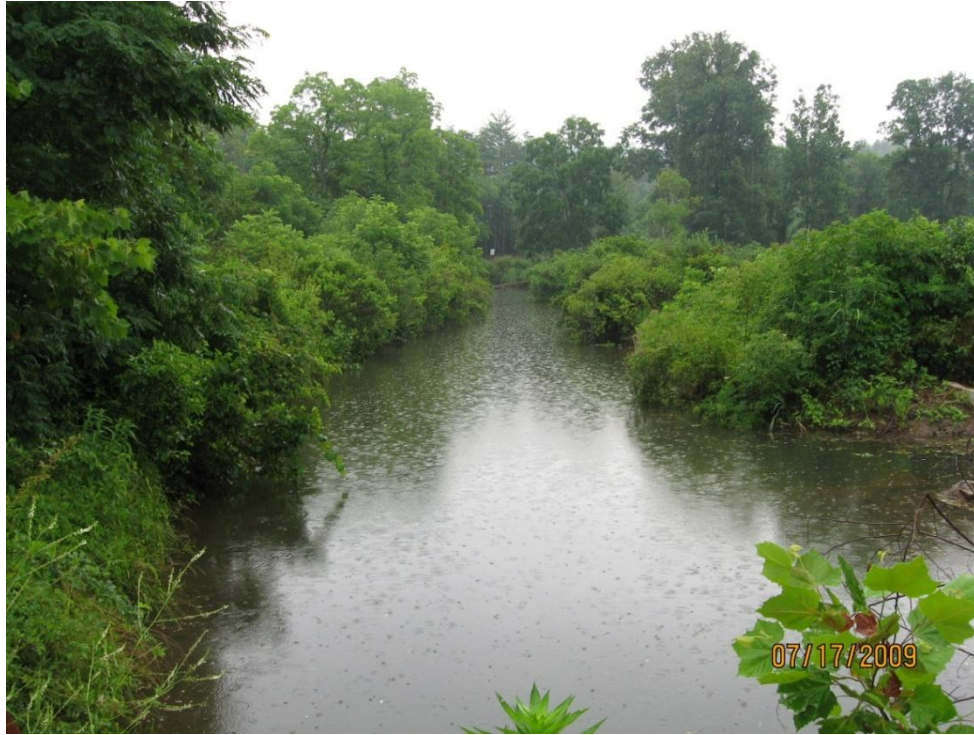
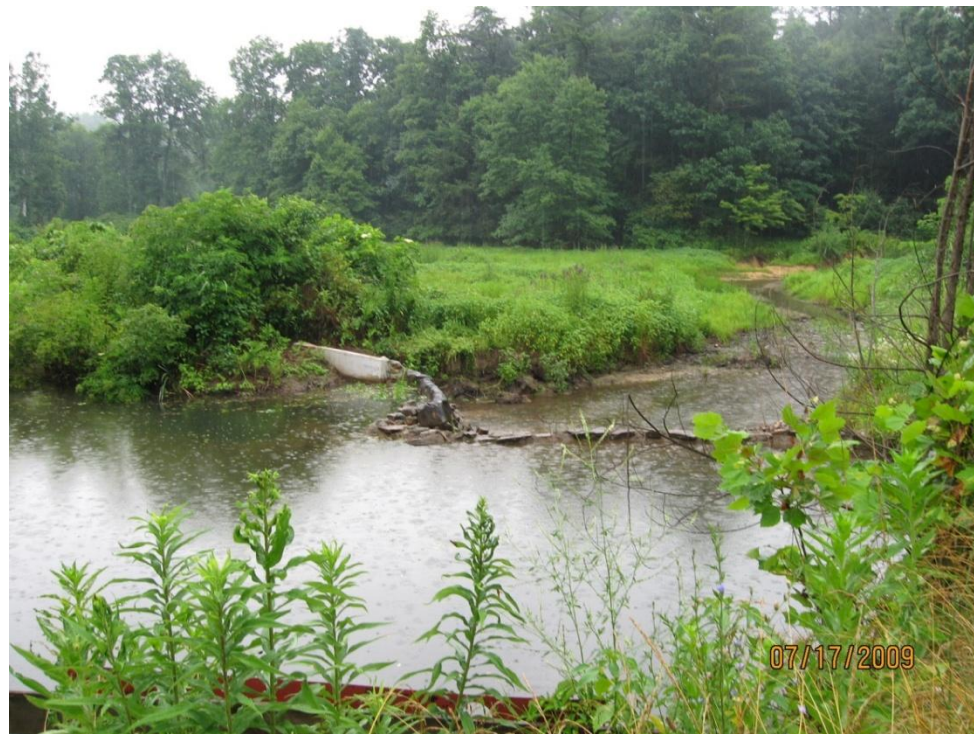
Photo 12. Looking at the current impoundment above the Burnt Cabins Grist Mill, with some flow running parallel to the impoundment and flowing over the spillway. The small dam in the foreground is a makeshift structure to facilitate the needed height for water to enter the gate valve at the top of the mill race (on which the photographer is standing)

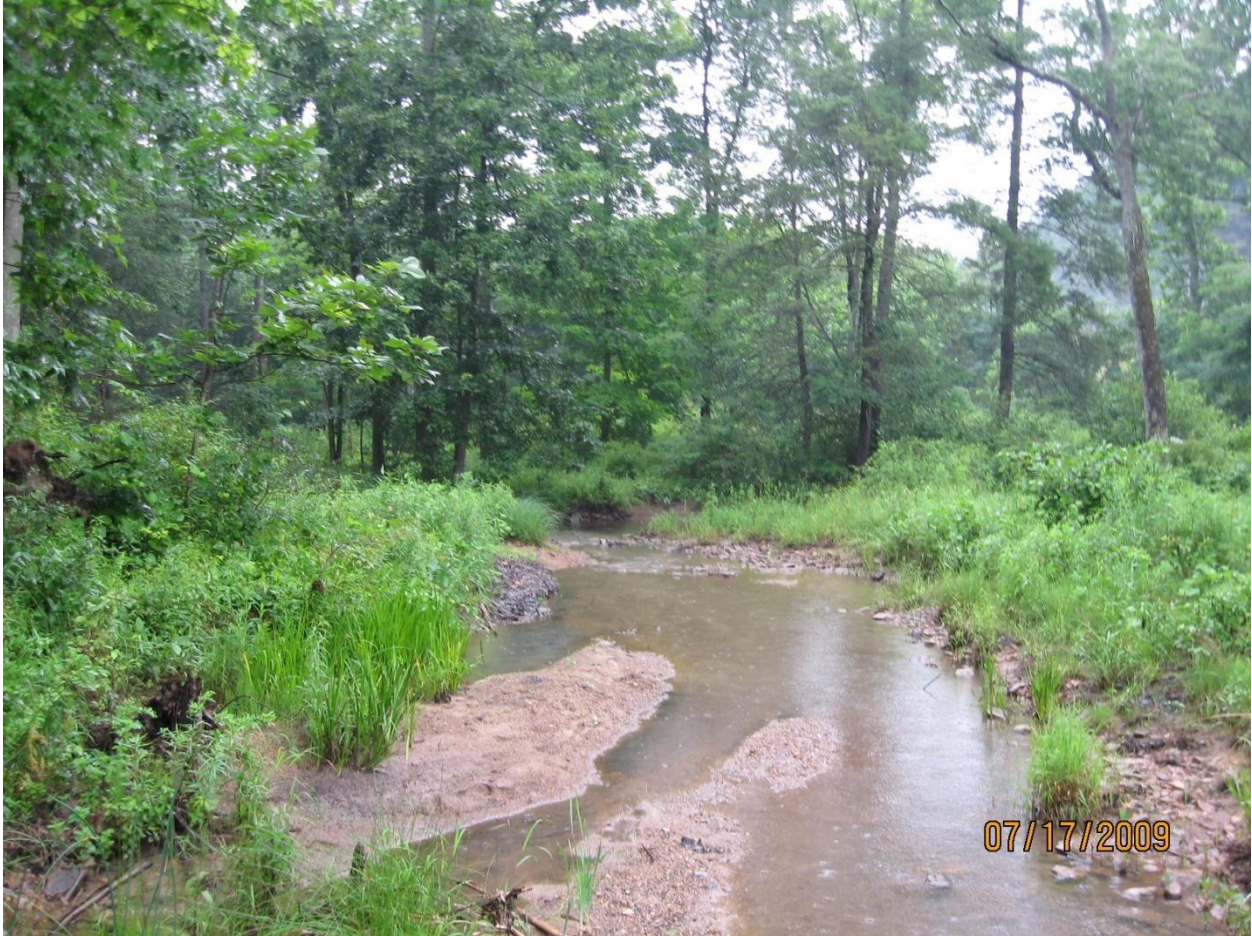
Photo 13. Streamflow below the impoundment looking downstream. Notice excessive sedimentation.
