# Memorandum

**File:** 07-LA-010-45.73  
59-93034-N  
0000001016- 6SSCN  
Gary Avenue UC  
Bridge No. 53-0855

**Subject:** **Evaluation of Fault Rupture Potential, Gary Avenue UC, Bridge No. 53-0855, Post Mile 45.73, Interstate 10 (San Bernardino Freeway), Los Angeles County, California**

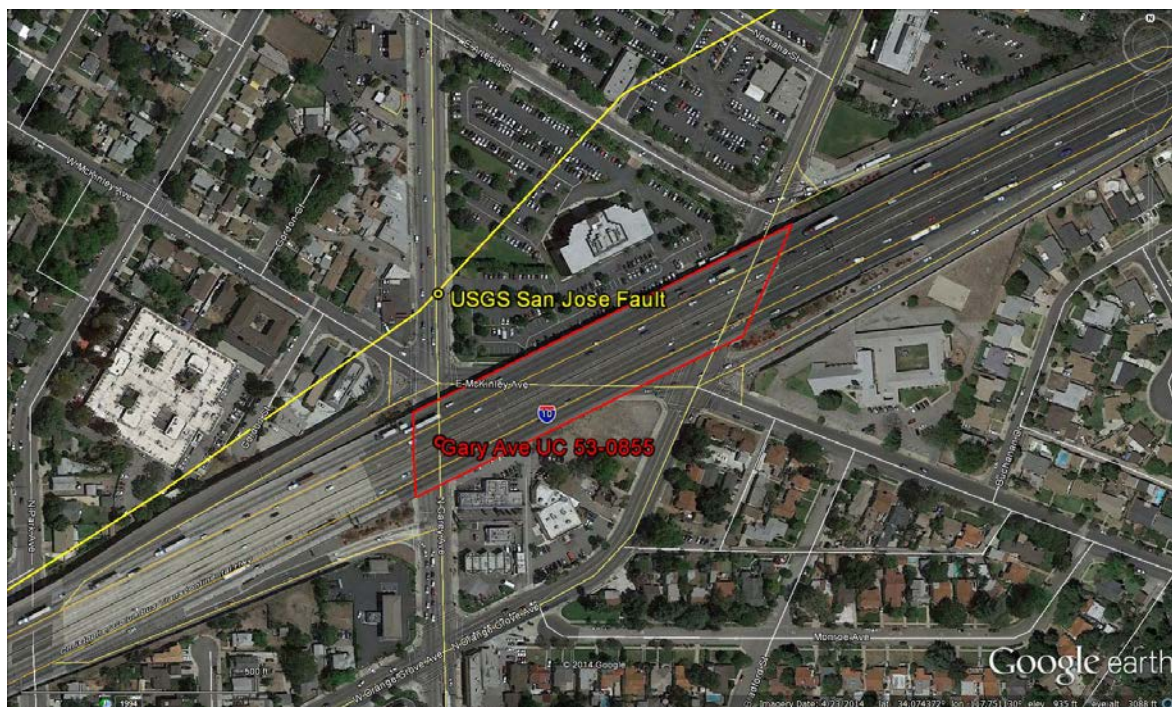
The closest trace of the San Jose Fault mapped by the USGS is located about 170 feet north of abutment 1 of the Gary Avenue UC bridge. However, the fault trace as mapped by the DWR based on an inferred groundwater barrier is located about 490 feet south of the bridge. Evidence of a shallow groundwater barrier indicative of a fault in the alluvium under the bridge was not evident from the Log of Test Borings for the bridge that were reviewed for this evaluation. Geotechnical work on the campus of California State Polytechnic University, Pomona located 3.7 miles west of the bridge, has located shallow groundwater barrier faults, and reports the fault to have been active within the past 3,500 years. Other shallow groundwater barriers that are also defined as the fault are located 2 miles northeast of the bridge, at the Pilgrim Place Manor in Claremont. The fault should be considered active by Caltrans criteria.

Figure 1: Gary Avenue Undercrossing (after USGS/Google Earth Faults, 2014).

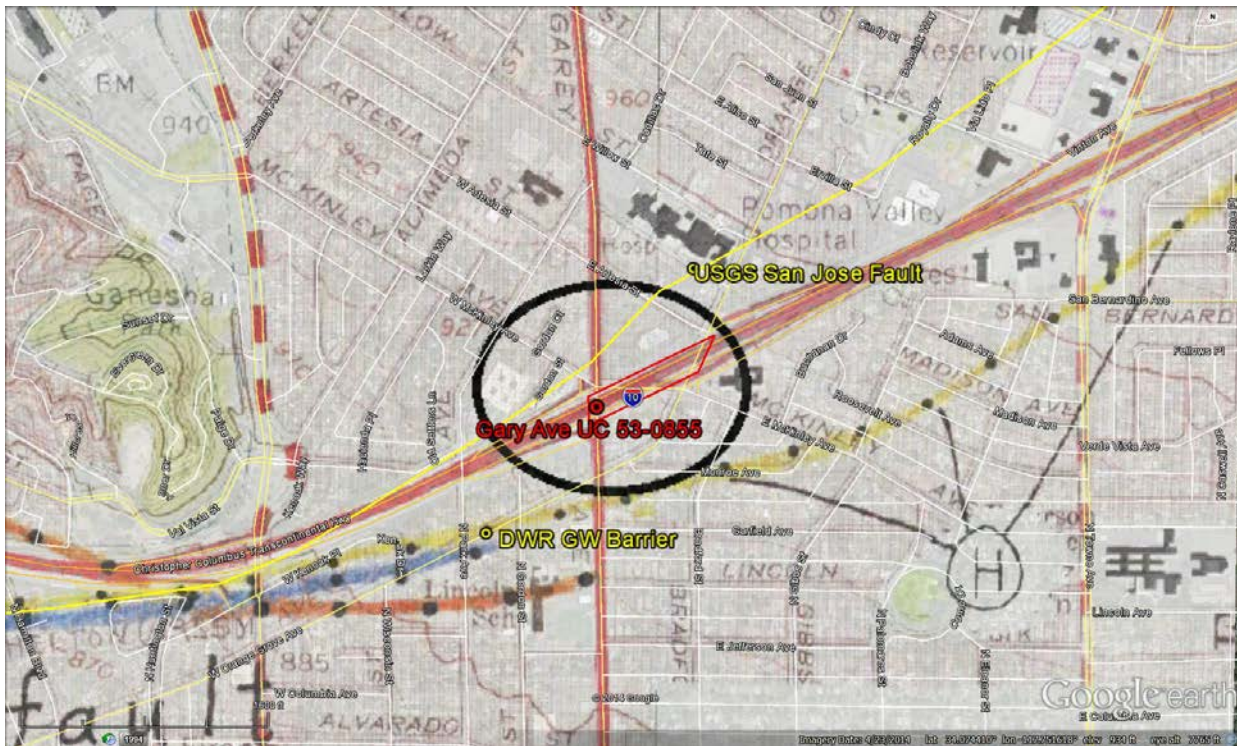
Figure 4: Image of Gary Avenue UC after CGS FER-68 (1977) and FER-68S (1978) after DWR (1970). Inferred groundwater barriers are black dotted and highlighted in yellow, blue and orange.

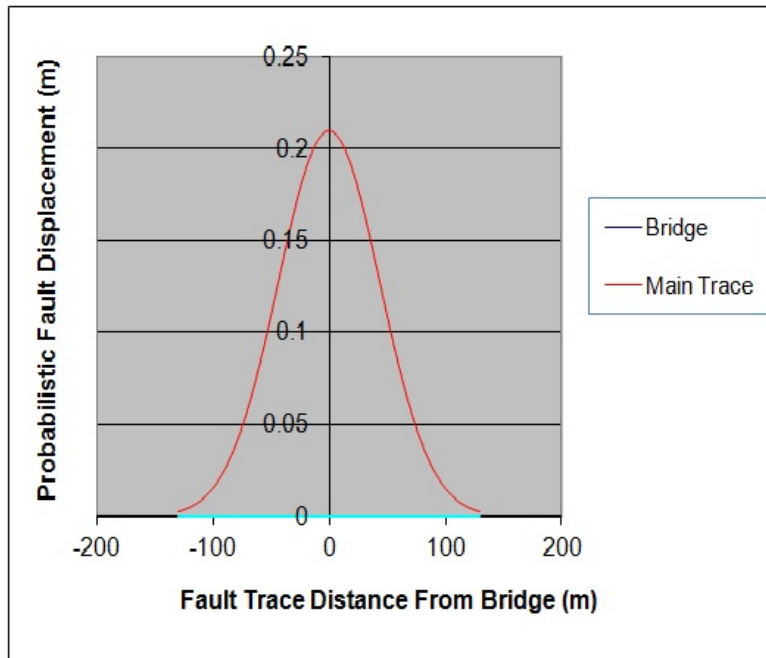
The bridge is located across an inferred trace of the fault. A deterministic fault displacement hazard analysis (DFDHA) and a probabilistic fault displacement hazard analysis (PFDHA) of 5% in 50 years (975 year mean recurrence interval) were performed using magnitude, slip rate (for PFDHA), mapping and base map errors, and likelihood of secondary fault traces. The expected maximum moment magnitude earthquake for the San Jose Fault is  $M_w=6.6$  and slip rate is 0.6 mm/yr. Accordingly the calculated fault displacement would be 17 inches (0.42m) deterministic and 8 inches (0.21m) probabilistic displacement (Figures 5 and 6).

Figure 5: About 17 inches (0.42m) of deterministic displacement at the bridge

Additional work to accurately locate the fault in the field maybe recommended if it is determined that the bridge structure cannot accommodate the reported amount of lateral displacement. Please contact Douglas Cook at (916) 227-4514 if you have any questions.
