Pacific Highway NH2U Threatened Flora Monitoring Year 3 April 2020

Threatened Flora Monitoring – 2019/20

Transport for NSW | June 2020 | Final Report version 3

Pacific Highway Upgrade - Nambucca Heads to Urunga Operational Phase
Threatened Flora Monitoring Year 3 Annual Report

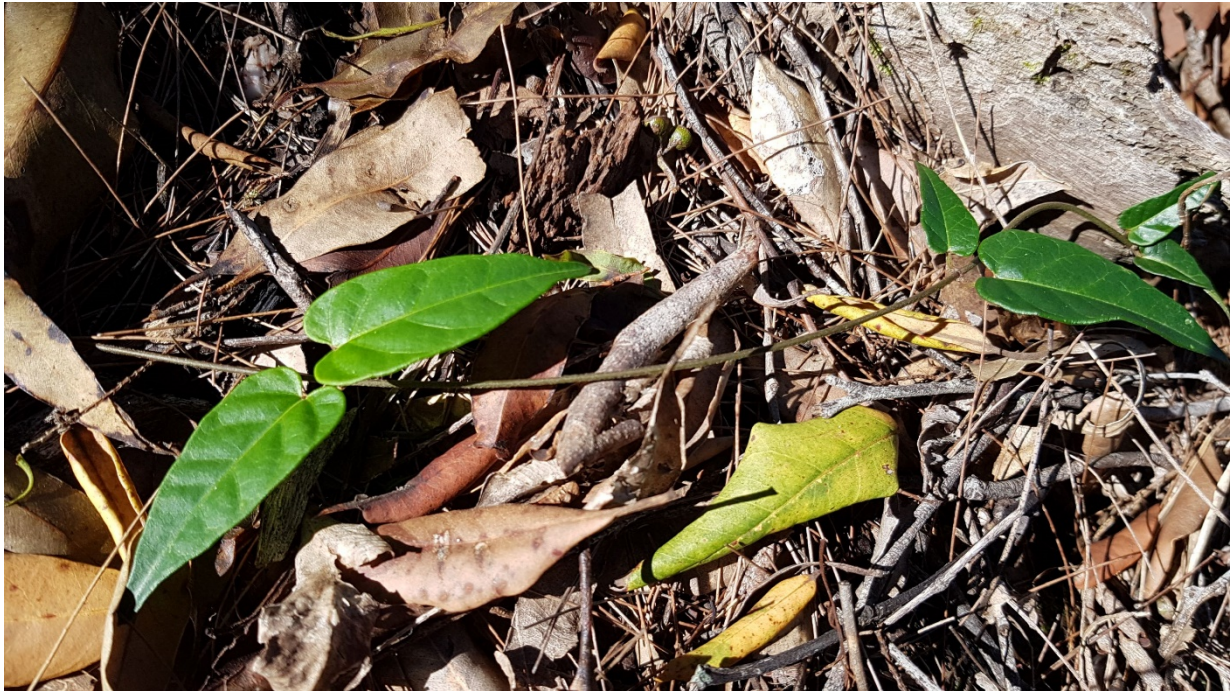
Figure 4: *In situ* Slender Marsdenia UTW3 in Feb 2020.

Of the five *in situ* Slender Marsdenia plants being monitored, one (ML119) had died back, and the remaining sites supported healthy plants, with a median condition class of 3. Site UTW3 (Figure 4), like last year, had three plants recorded close to the flagged survey point. Site UTW4 had two plants recorded this year compared to one last year.

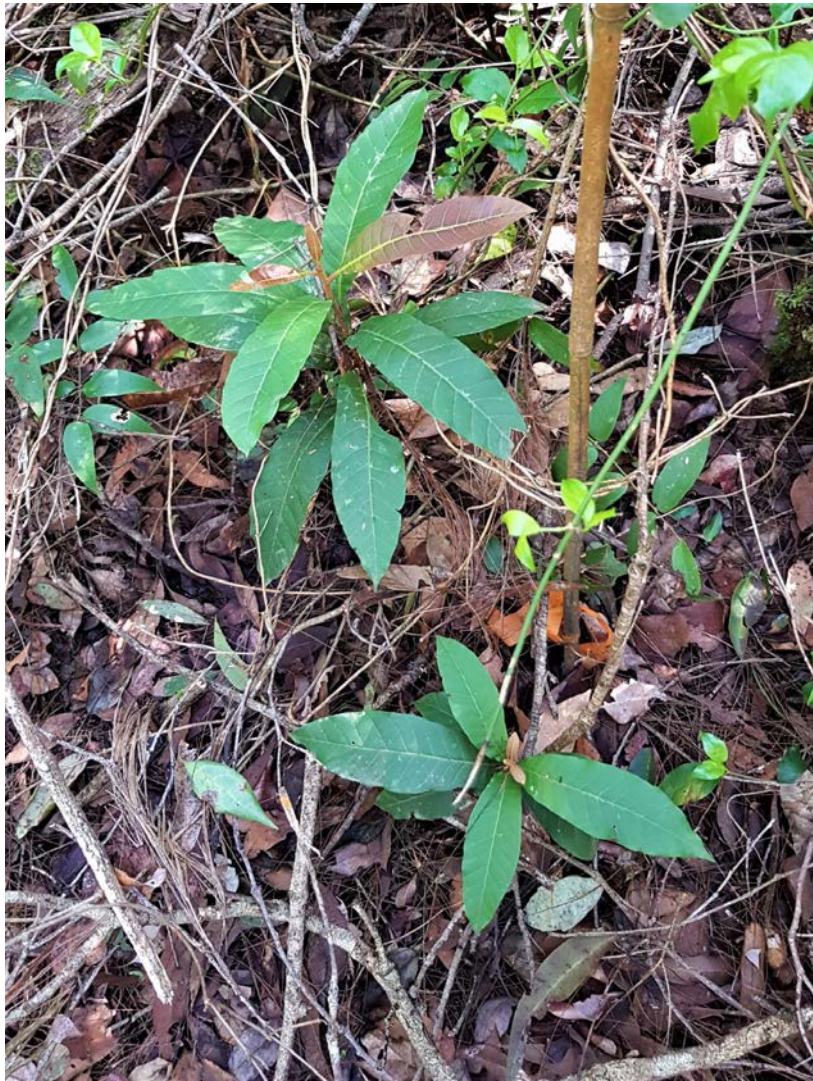
Figure 5: Rusty Plum transplanted tree No. 1 in good health with new growth.

The current survey revealed no losses since the previous survey, with a survival rate of 67%. Plant 1 bore a healthy, basal stem shoot which had increased in size from the previous survey (Figure 5). Plant 3 was in excellent health with a flush of new growth.

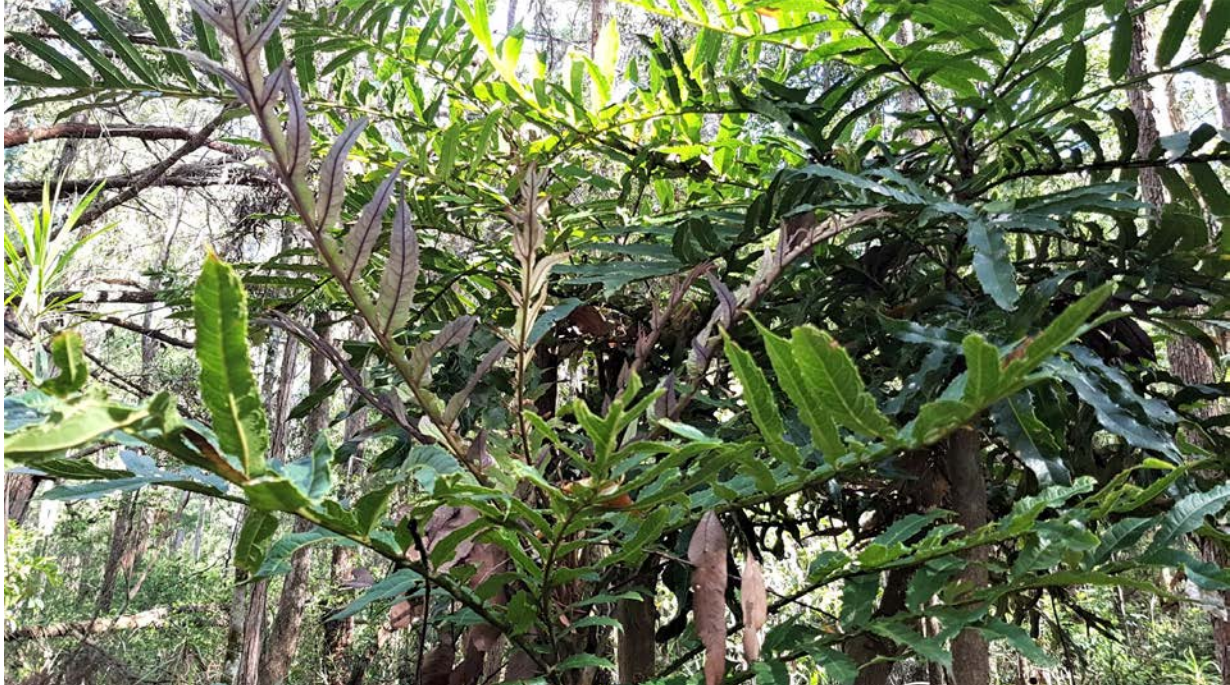
Figure 6: New leaf shoots on Red Bopple Nut transplant in TA1 Feb 2020

A single Red Bopple Nut tree was transplanted to Sector H in TA1. The tree was recorded in excellent condition during the current survey. Although it appeared that flowering had failed due to the extremely dry winter-spring, the plant bore new leaf shoots (Figure 6) which probably appeared after heavy rains in January/February 2020. No fruit-set was observed at the time of the survey.

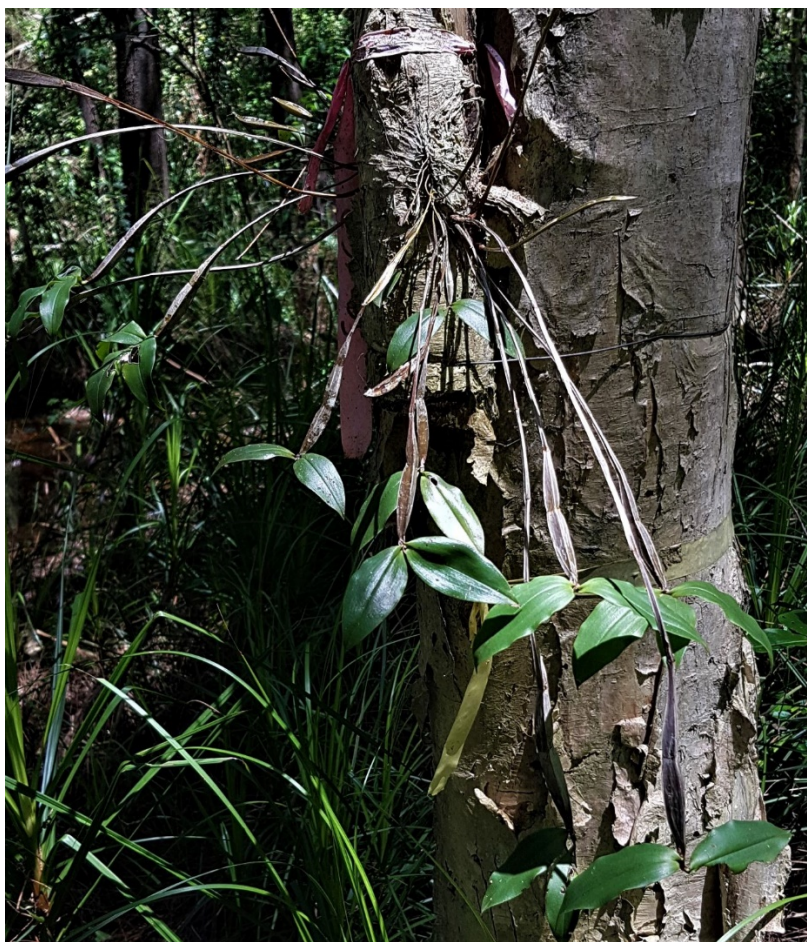
Figure 7: Spider Orchid transplants 8a and 8b in excellent health, TA2 Feb 2020

Of the 60 Spider Orchid transplants at TA2 recorded in 2016 (Ecos Environmental 2016a), 44 were recorded as alive during the current survey, a survival rate of 73.3%, which represents a slight increase from the previous survey result of 71.7% survival. This figure may underestimate actual survival, as some plants were not able to be re-located during the current survey whilst another six plants that were not located in the 2018 survey were re-found during the current survey.

Along with the slight improvement in survival rate, other results showed an improvement in the population, including an increase in the mean length of the longest pseudobulb; a small increase in mean number of pseudobulbs with leaves per plant, and a significant increase in the number of plants bearing new shoots. Median condition class of the translocated Spider Orchids has remained at 3. This accords with the general impression that the majority of surviving translocated Spider Orchids remain in good health (Figure 7). Several old inflorescence axes were observed during the current survey, indicating that flowering had occurred in the previous spring. However, no evidence of fruit production was recorded. Monitoring results for all translocated Spider Orchid surveys are summarised below in Table 11.
